Ocean Networks Canada

Ferry Maintenance Report – Queen of Oak Bay

Vessel: Queen of Alberni

Date: Sept. 7, 2016

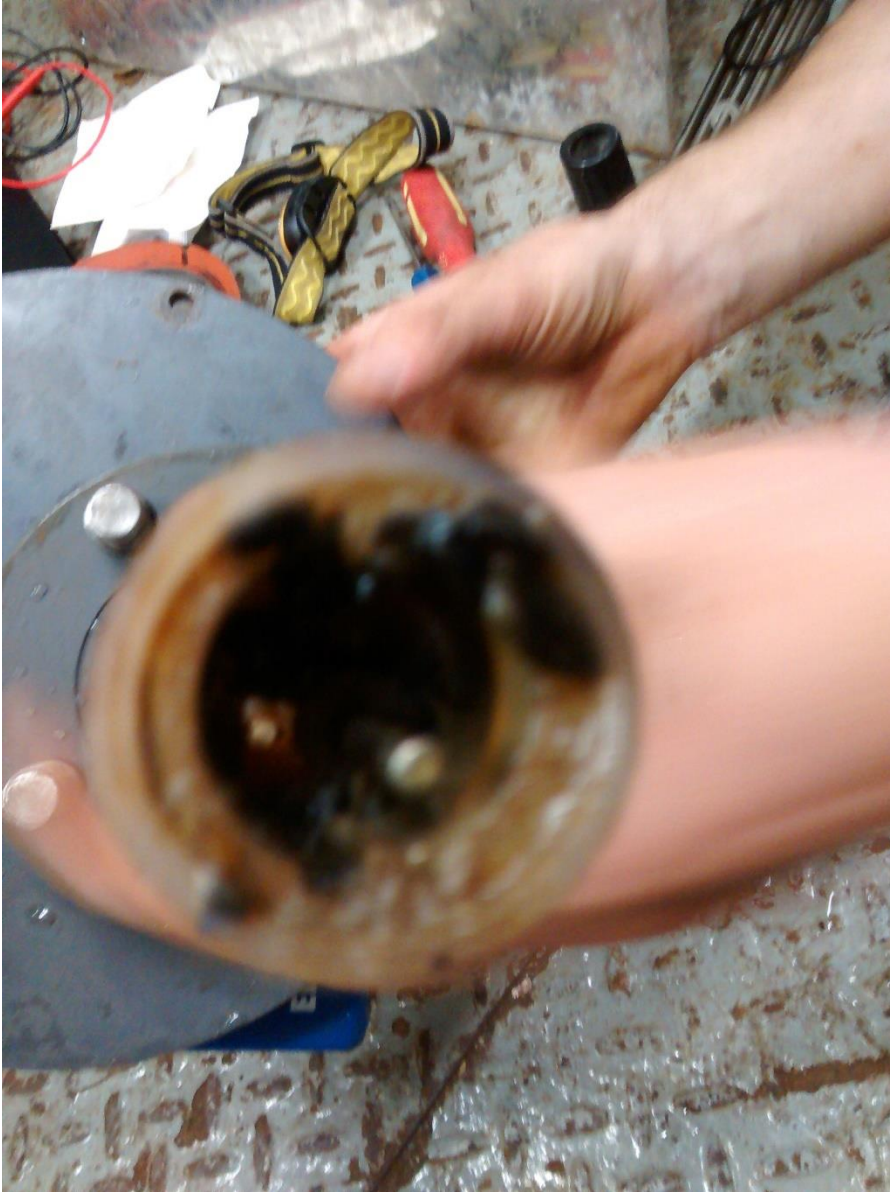
11. Valve was disassembled. Revealed substantial biofouling

Figure 2 Biofouling on valve inlet

12. Biofouling was removed, valve and sea chest were reassembled.

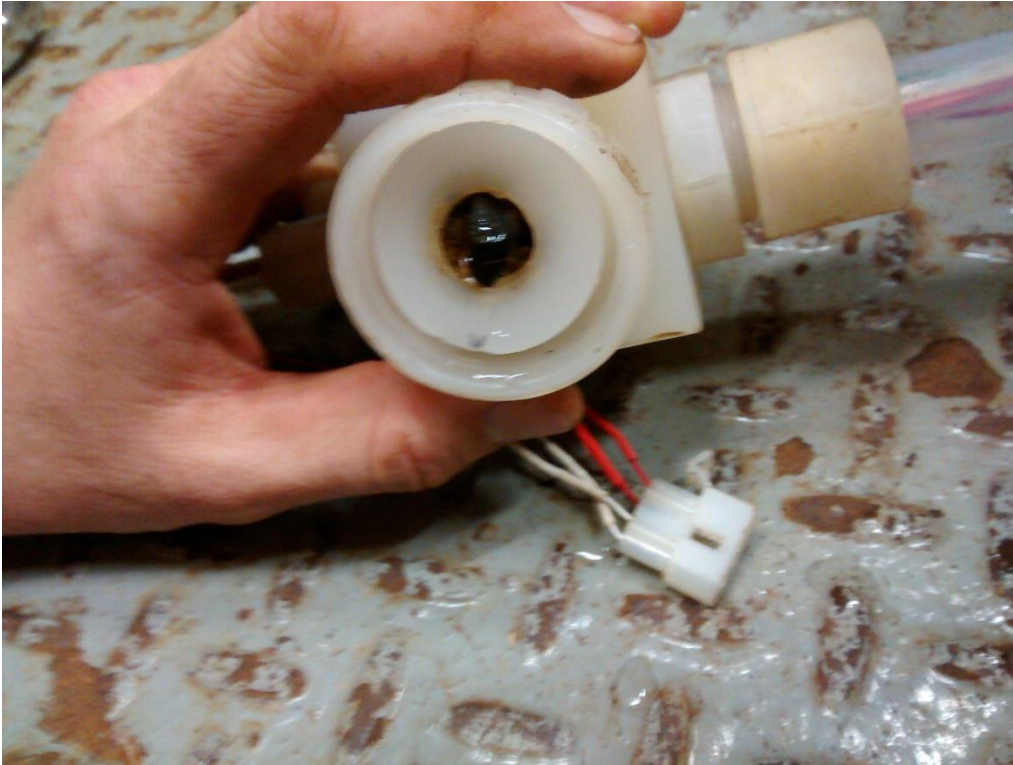
*Figure 3
Biofouling
on Valve
fittings*

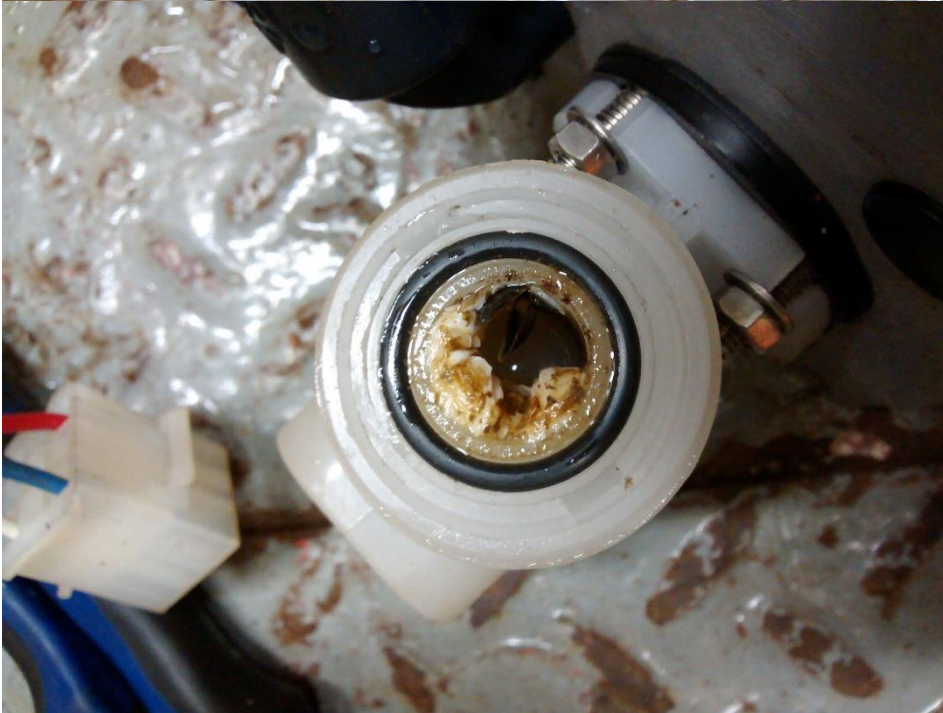
Figure 4 Biofouling on valve fittings

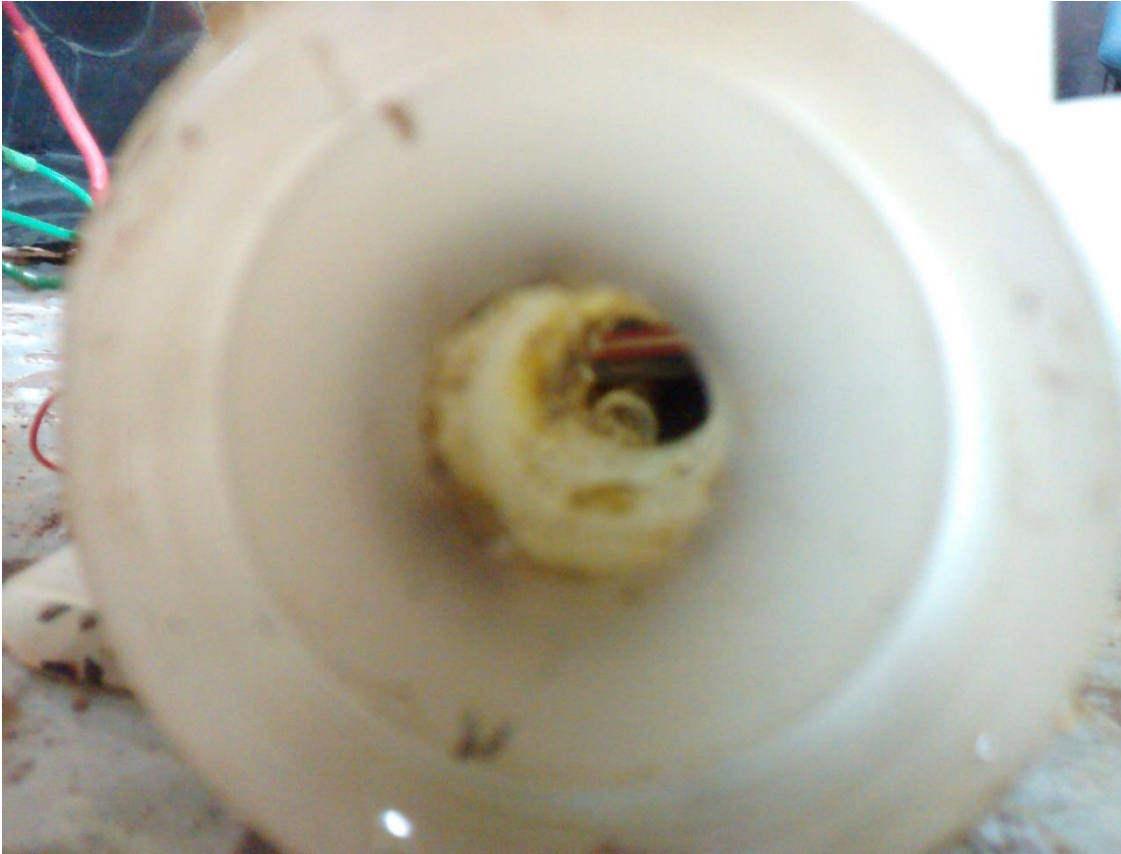
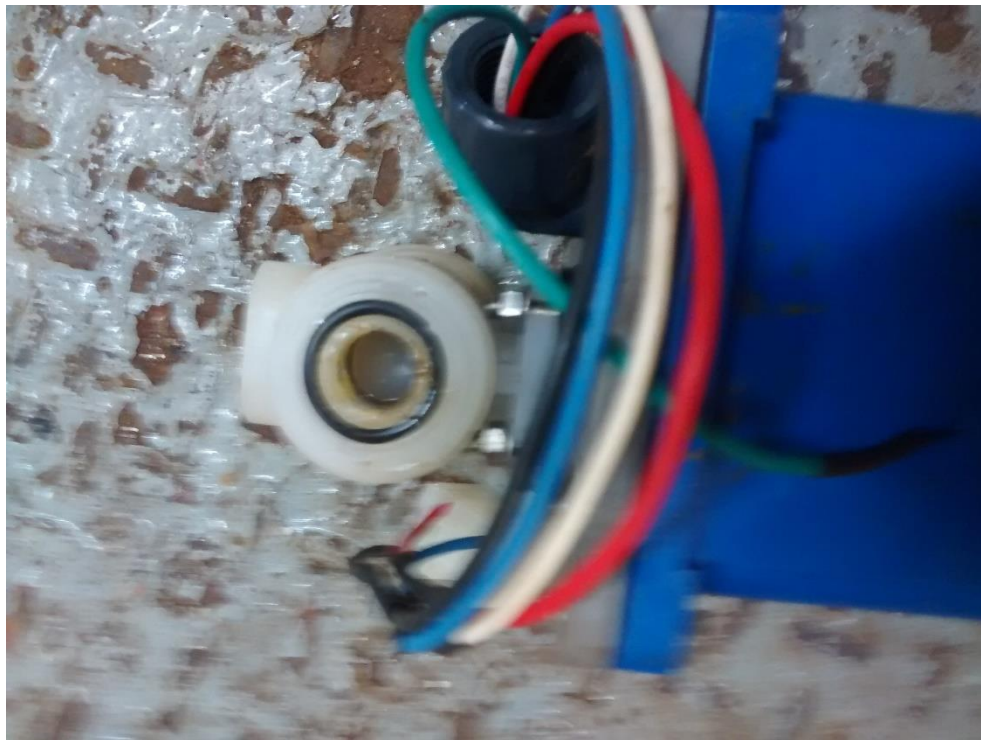
Figure 5 &6 Cleaned valve fittings
