# Ocean Networks Canada

## Ferry Maintenance Report – Queen of Alberni

Vessel: Queen of Alberni

Date: May 1<sup>st</sup>, 2017

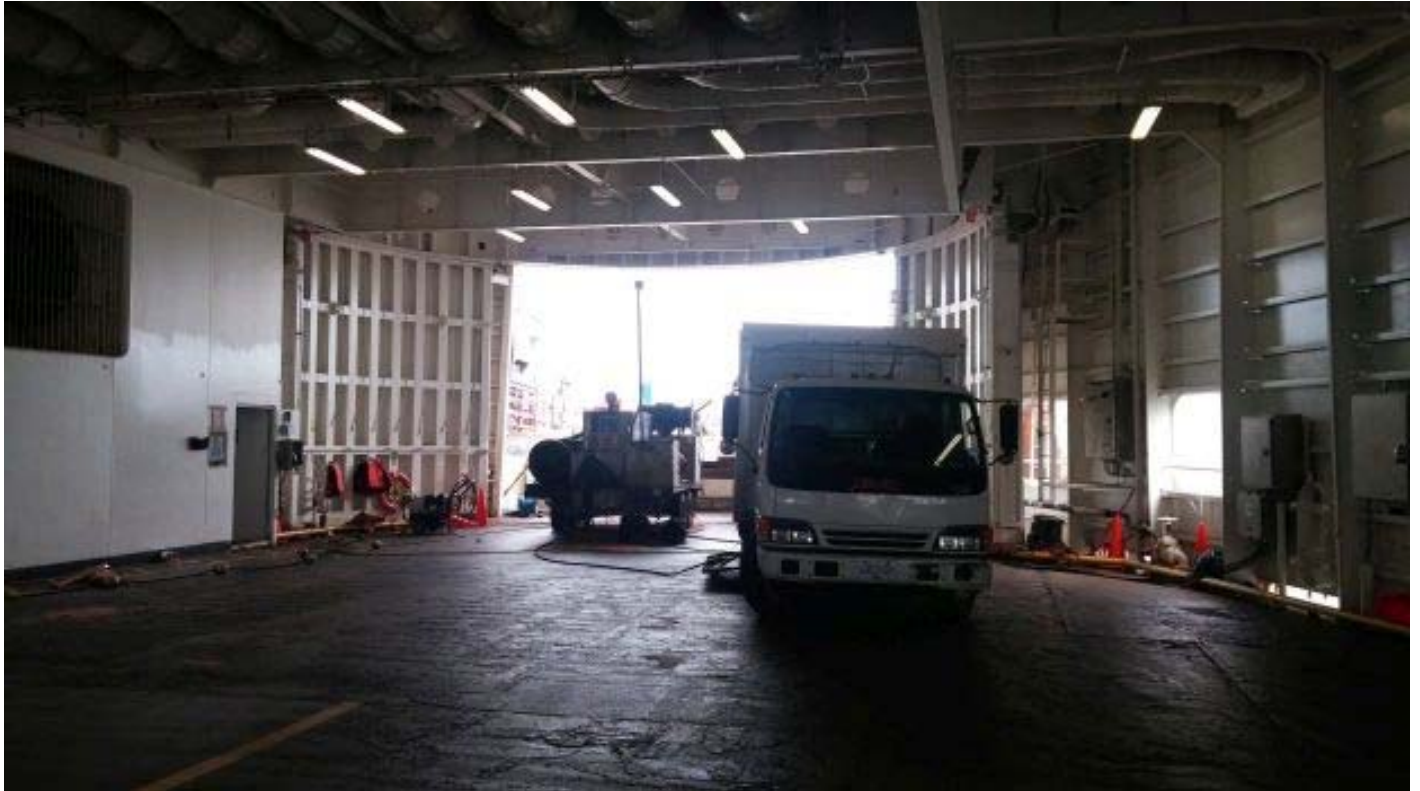
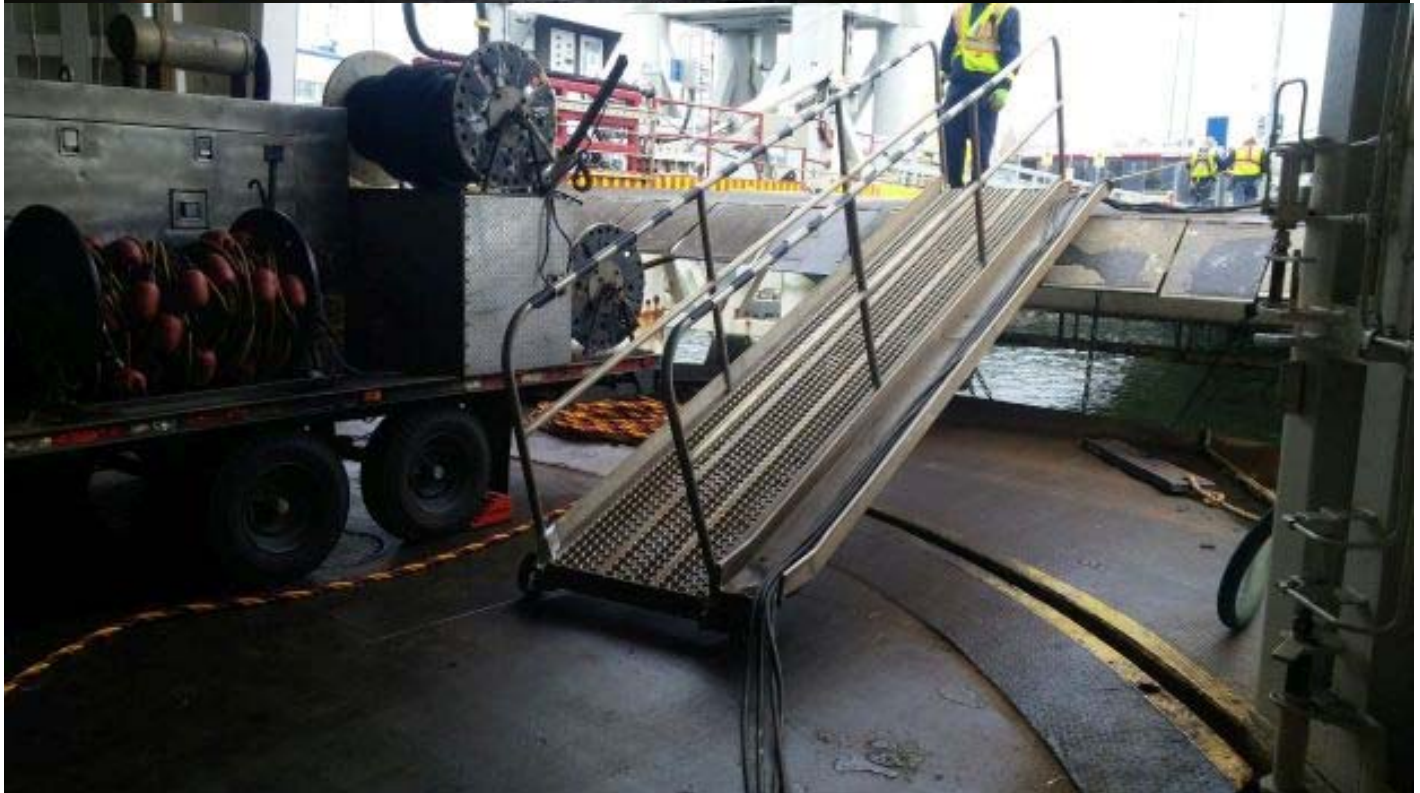
Below: setup of diver station near ramp

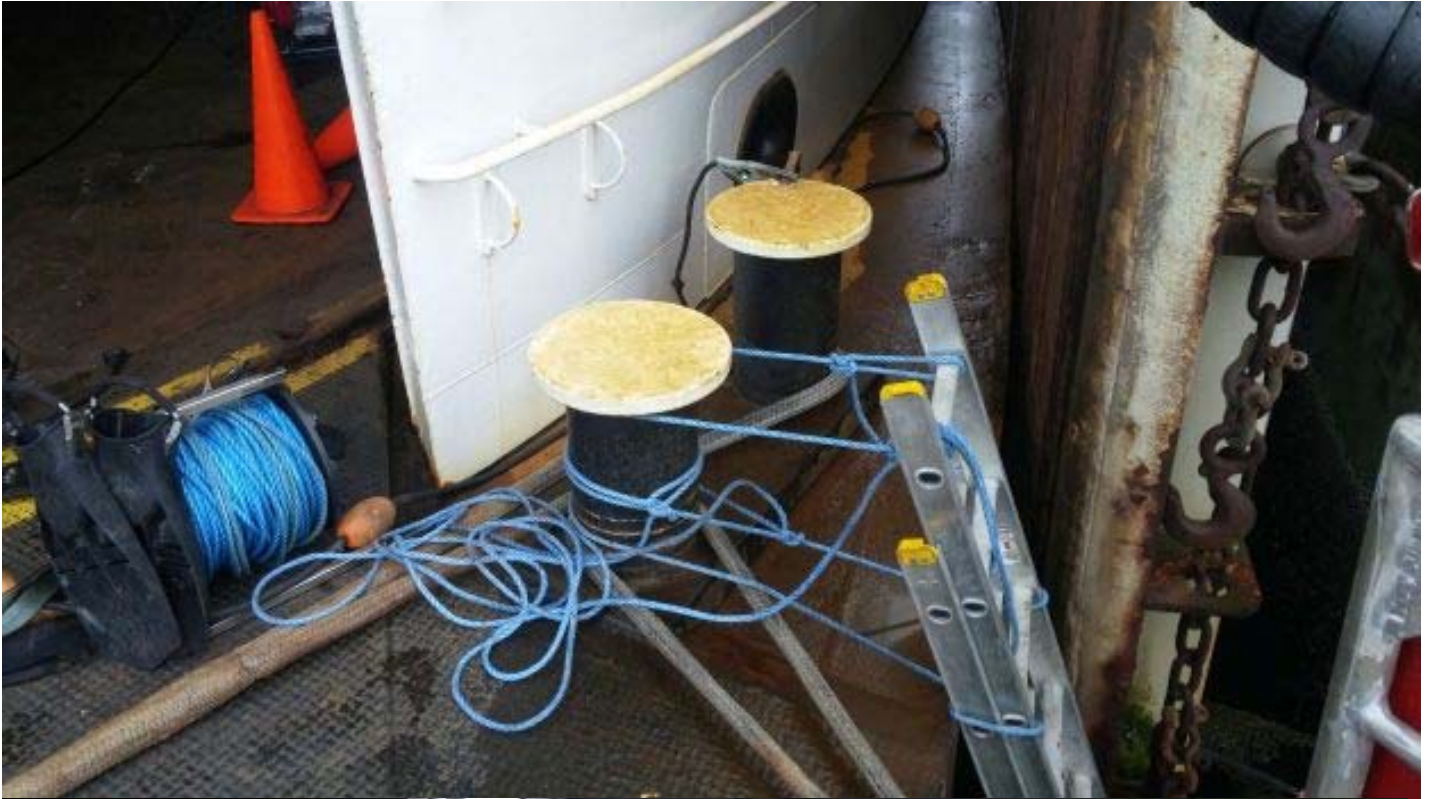
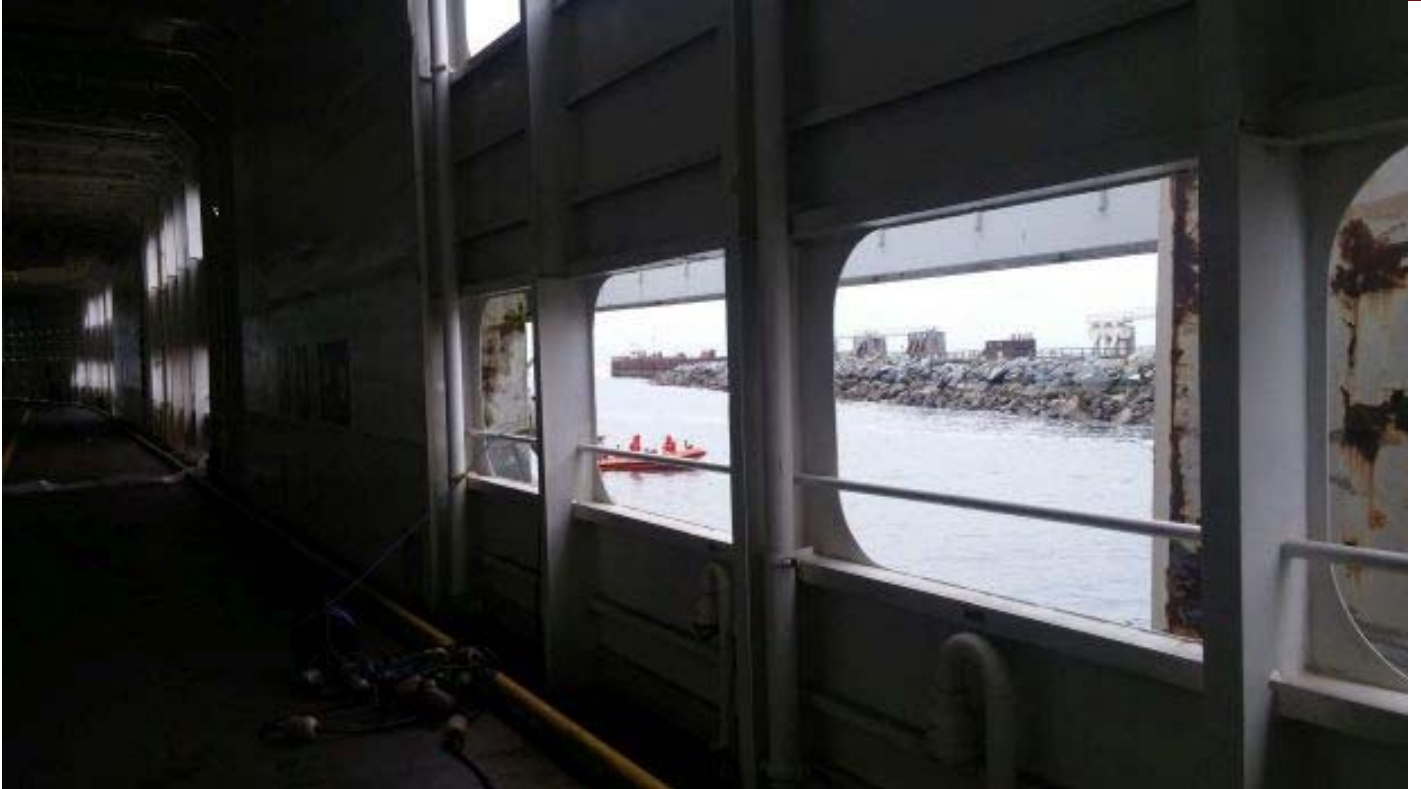
Top: diver ladder, Bottom: safety boat
