Ferry Maintenance Report

Vessel: Queen of Alberni

Date: Sept 26, 2013

Reason for Visit

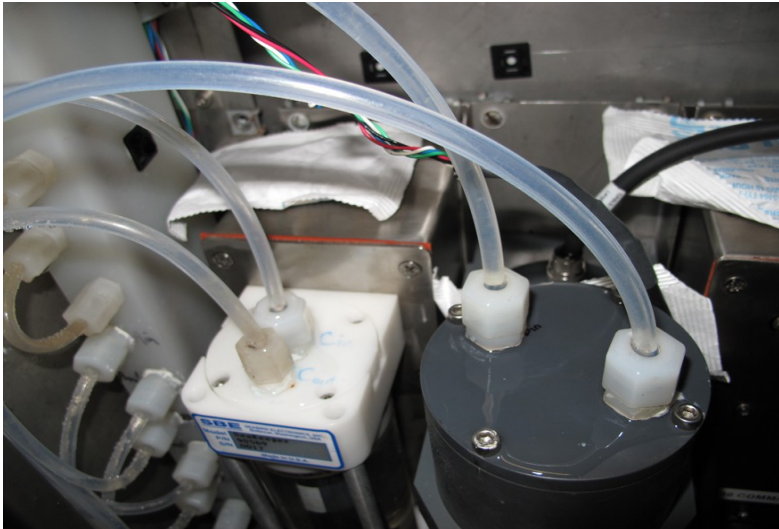
1. Found water on bottom of instrument enclosure, which was submerging leak sensor which stopped the Seakeeper system.
2. CTD had puddle formed around intake/outtake fittings

3. Leak apparent on ECO Triplet Intake/Outake fittings see picture above – Grey housing

1. Drained water from bottom of instrument enclosure
2. Dry wet areas
3. Power Down Seakeeper system
4. Pull off instruments, and take to Engineering room for servicing / cleaning – found instruments clean
5. Install new end pressure fitting caps to instruments
6. Re-install instruments
7. Measured SLA 12Vdc battery at 14.4 Vdc
8. Replaced leak sensor, and mount into tub below enclosure – see picture

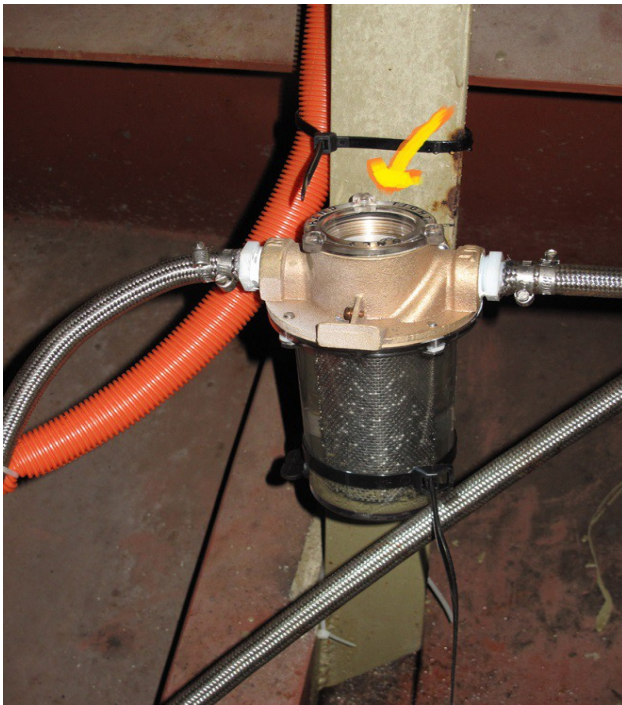
9. Turn ON Seakeeper system
10. Pump turned ON, and continuously ran without delivering seawater
11. Diagnose issue. Went into hull area; check intake valve, and Sea chest.
12. Open Sea strainer cap – unscrew top cap. Felt no pressure nor see water leaking from its sides. Open cap and take off. No flow of sea water passing through strainer – see picture

- I had a conversation with the 1st officer on the ship. He stated that the ship will be going on its annual re-fit October 15th 2013 for one month. They will dock it in Twassasen around the 15th and afterwards take it to shipyards. We have a cruise during this time.
- Recommendations:
 1. Design + Make a new intake on the hull.
 2. Install a flowmeter inline of Intake to monitor water flow
 3. Design + Make a new Water manifold in instrument enclosure - brass fittings.
 4. Install temperature and humidity sensor in instrument enclosure for monitoring
- Swap CTD, ECO Triplet, and 3835 oxygen sensor due to Calibration outstanding
- Immediately commence hull intake design and development
- Search for flow meter suitable for marine environment to monitor flow at Intake

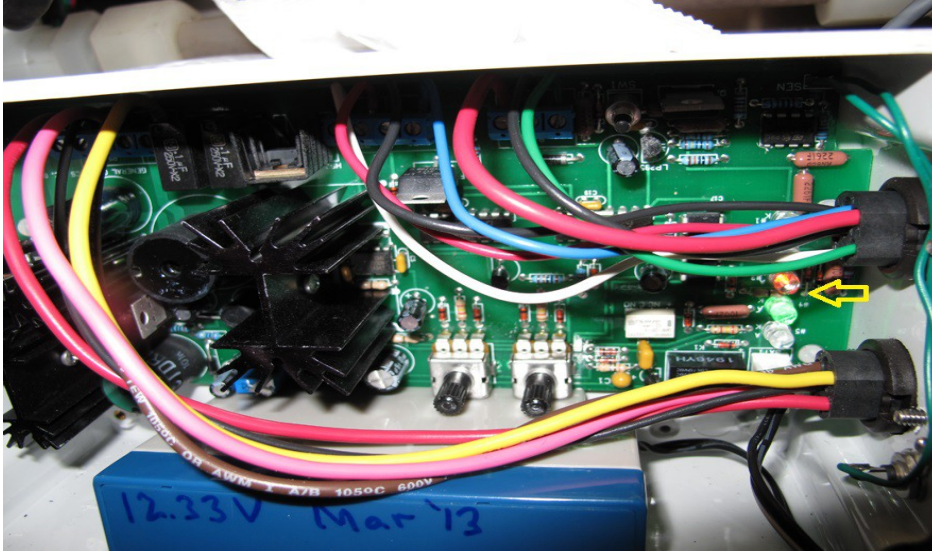
13. Check Sea chest for leaks = none apparent. Intake and outlet valves open.
14. Tighten cable connections between enclosures
15. Monitor data logger on PC – looks OK
16. Replaced desiccant packs in enclosure
17. Suspect electronics controlling solenoid valve at Intake or solenoid itself or intake at hull plugged. Leak detection electronics board after pressing reset indicated a Red light ON – see picture
