Ferry Maintenance Report

Vessel: Queen of Alberni

Date: Jan 17, 2014

Regular instrument servicing, checkup, and MET station re-positioning

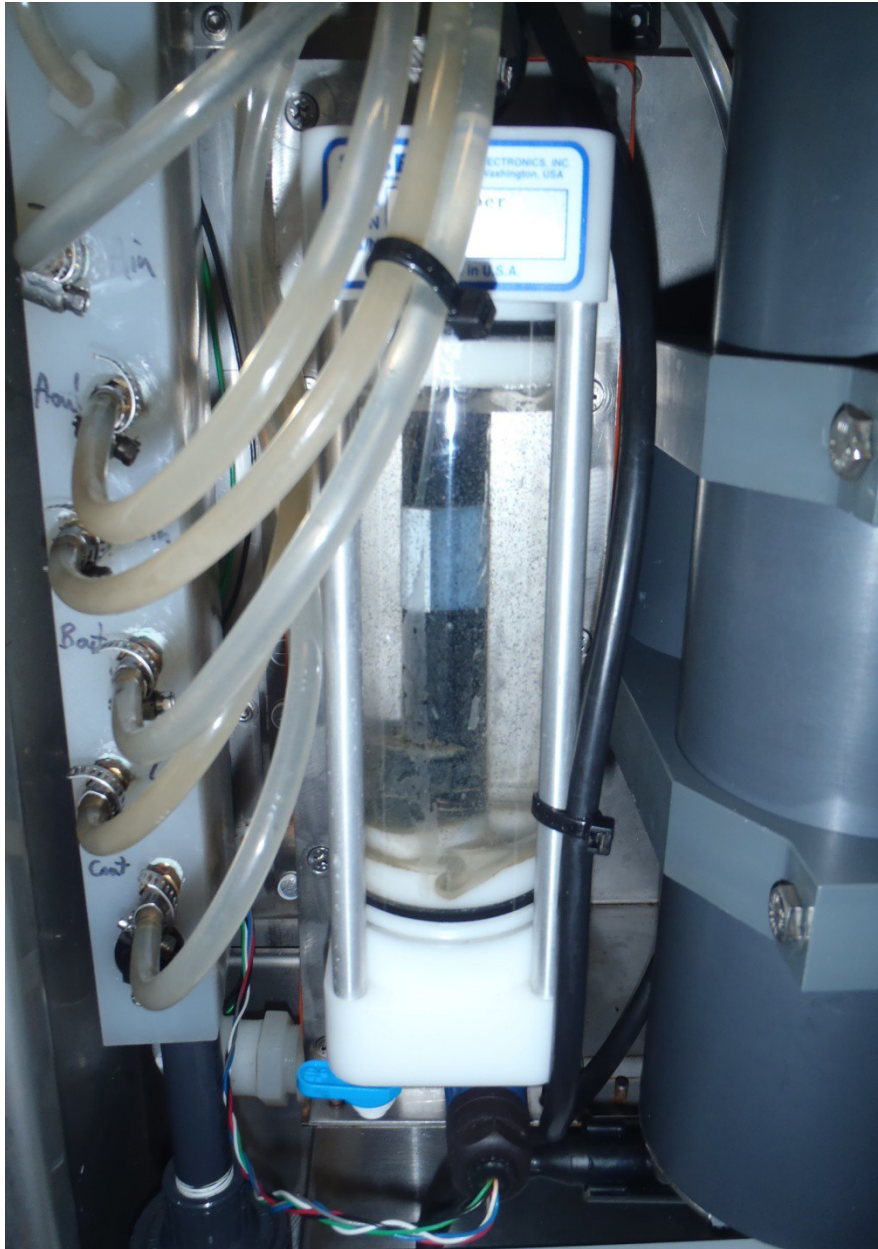
1. In Instrument Box, there were no signs of moisture, no leaks anywhere.
2. AADI optode had no debris nor sediment within its housing- very clean
3. BBLF2 had some sediment/debris on the face of the instrument
4. Seabird 45 CT sensor was also clean, minor sediment debris within its housing
5. Sea chest dry and no leaks
6. Check inline Filter (sea strainer) no debris, was clean

Seabird CT sensor upon arrival

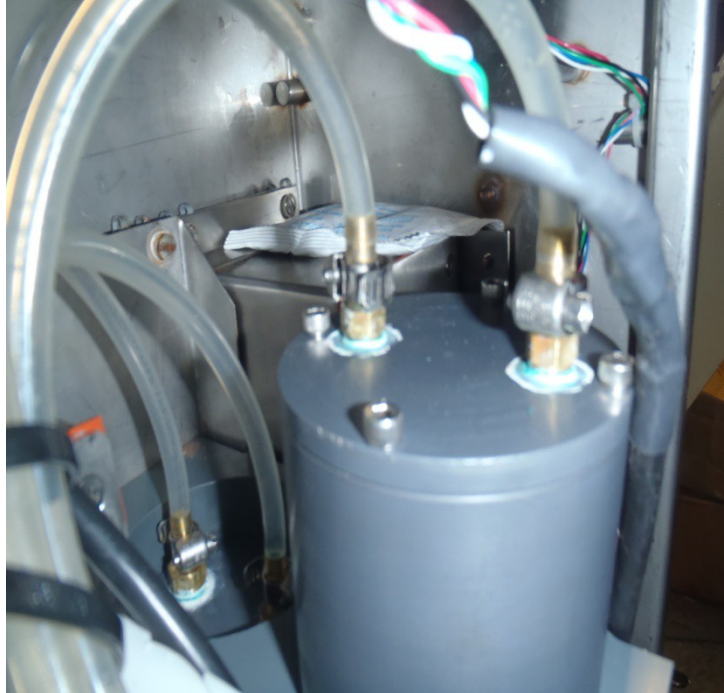
BBFL2 housing upon arrival = dry no leaks

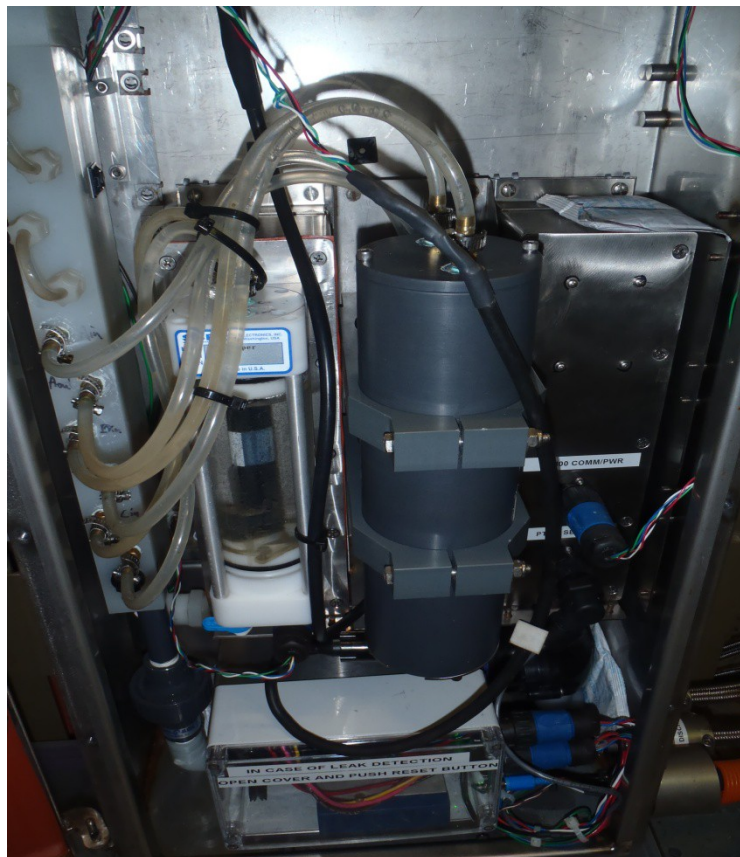
Seakeeper instruments upon arrival

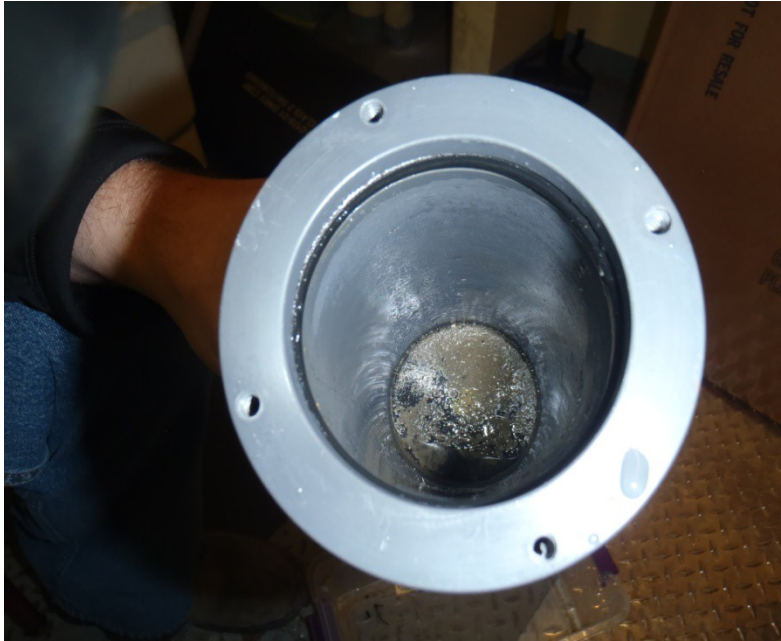
BBFL2 Eco Triplet residue / sediment in housing prior to servicing

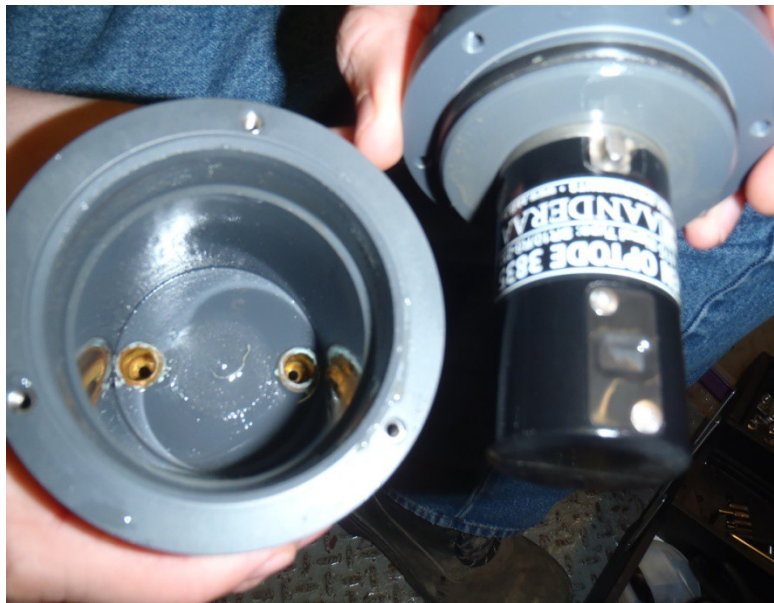
AADI Optode prior to service = very clean !

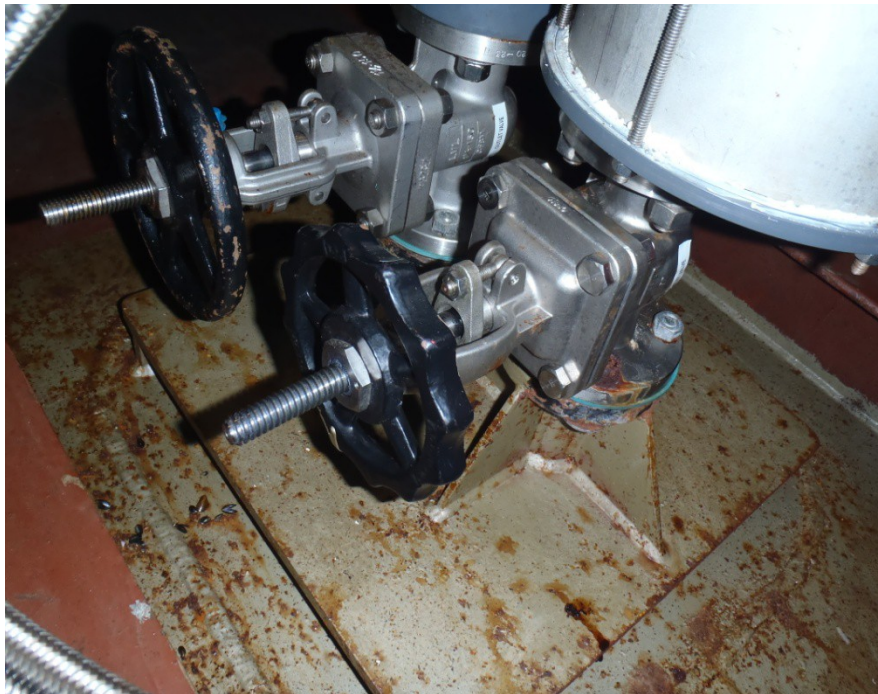
Hull Intake/ Outlet valves inspection

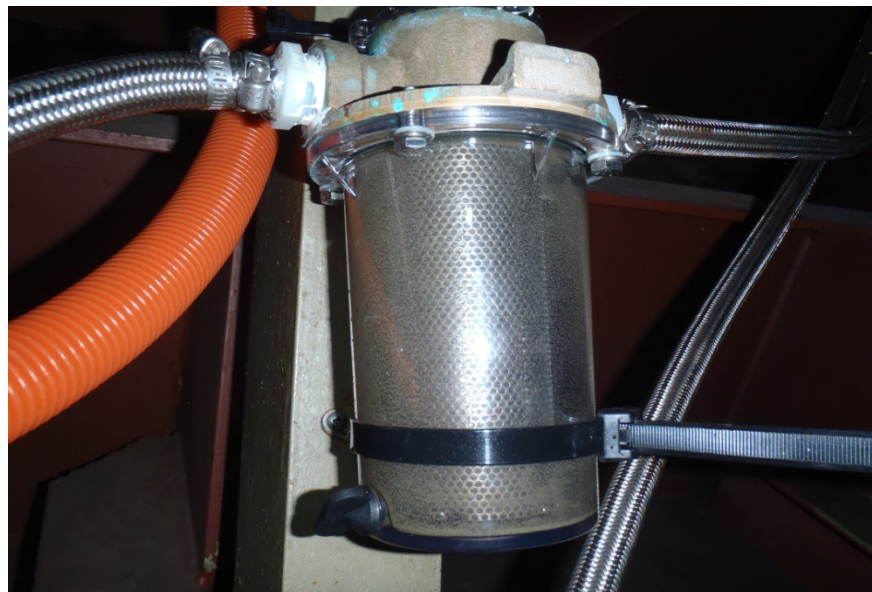
SeaStrainer inspection

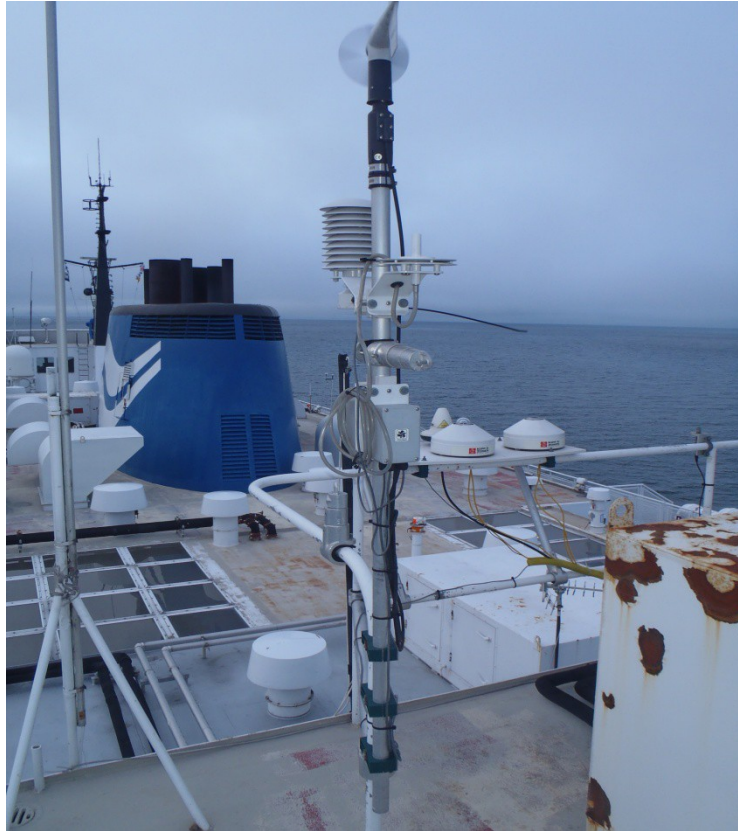
Queen of Alberni Jan 17th, 2014 MET station new position
