Ferry Maintenance Report

Vessel: Queen of Alberni

Date: February 7, 2014

Regular instrument servicing, repositioning of BBFL2

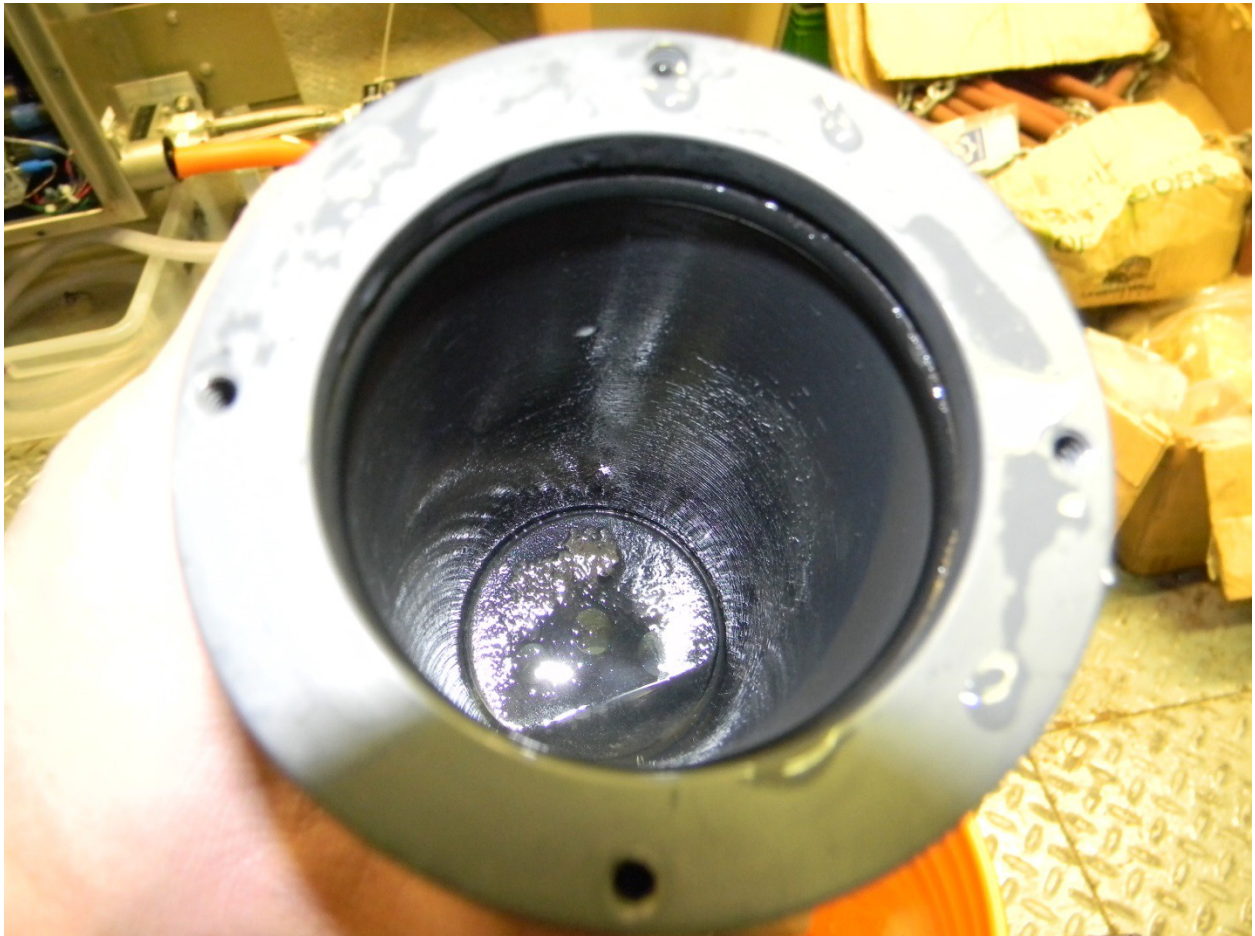
1. In the Instrument Box there were no signs of moisture or leaks.
2. The AADI optode had no debris or sediment within the housing.
3. The BBFL2 had a very minor partial layer of sediment and/or fouling on the sensing surface.
4. The Seabird 45 CT sensor was very clean, with almost no sediment within the sensor.
5. The sea chest showed no signs of leaks.
6. The inline filter (sea strainer) was checked and showed no signs of debris.

Figure : BBFL2 upon arrival, with water drained carefully (no loose sediment noted in drained water)

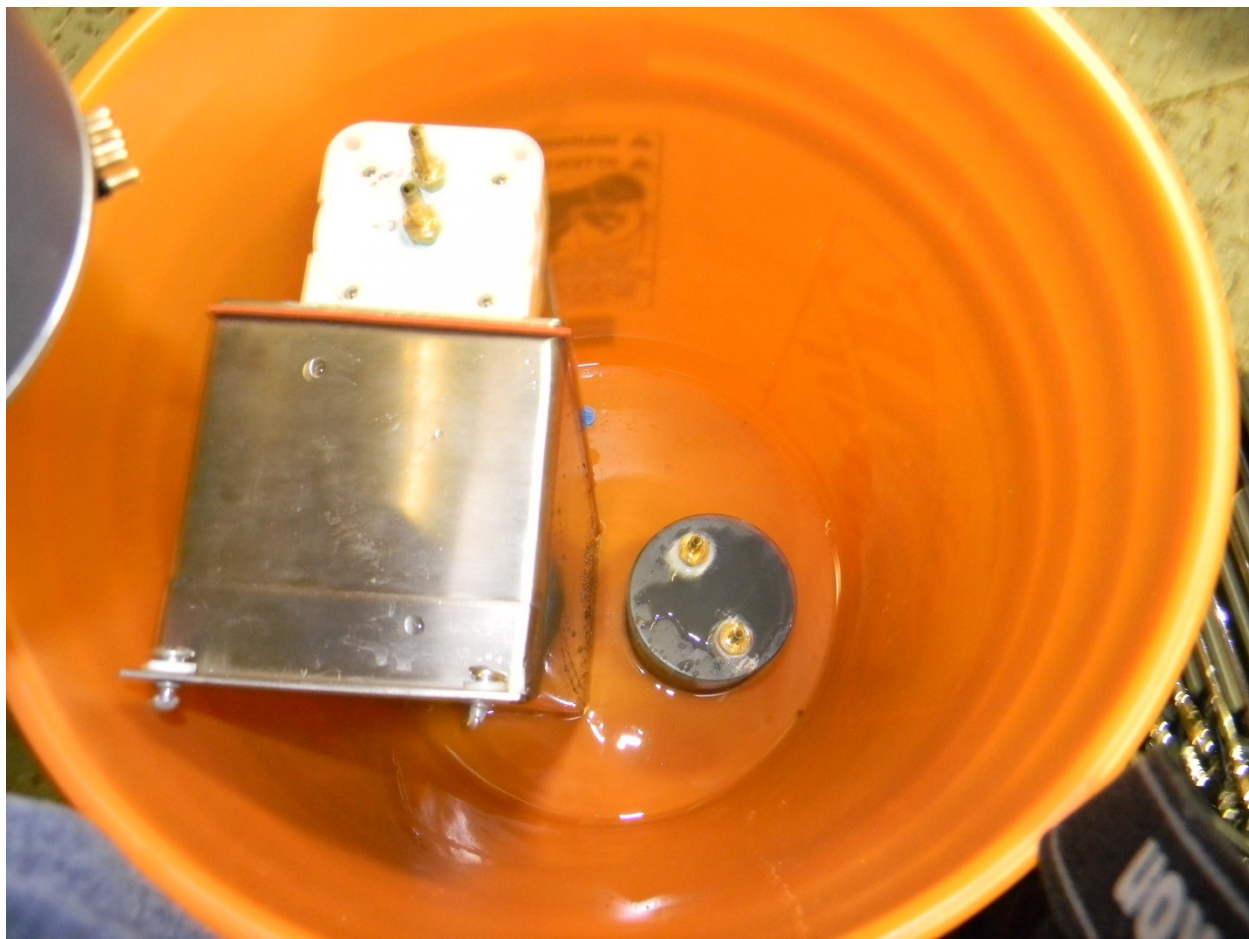
Figure : Water drained from BBFL2 in bottom of sample bucket. Note no sediment apparent.

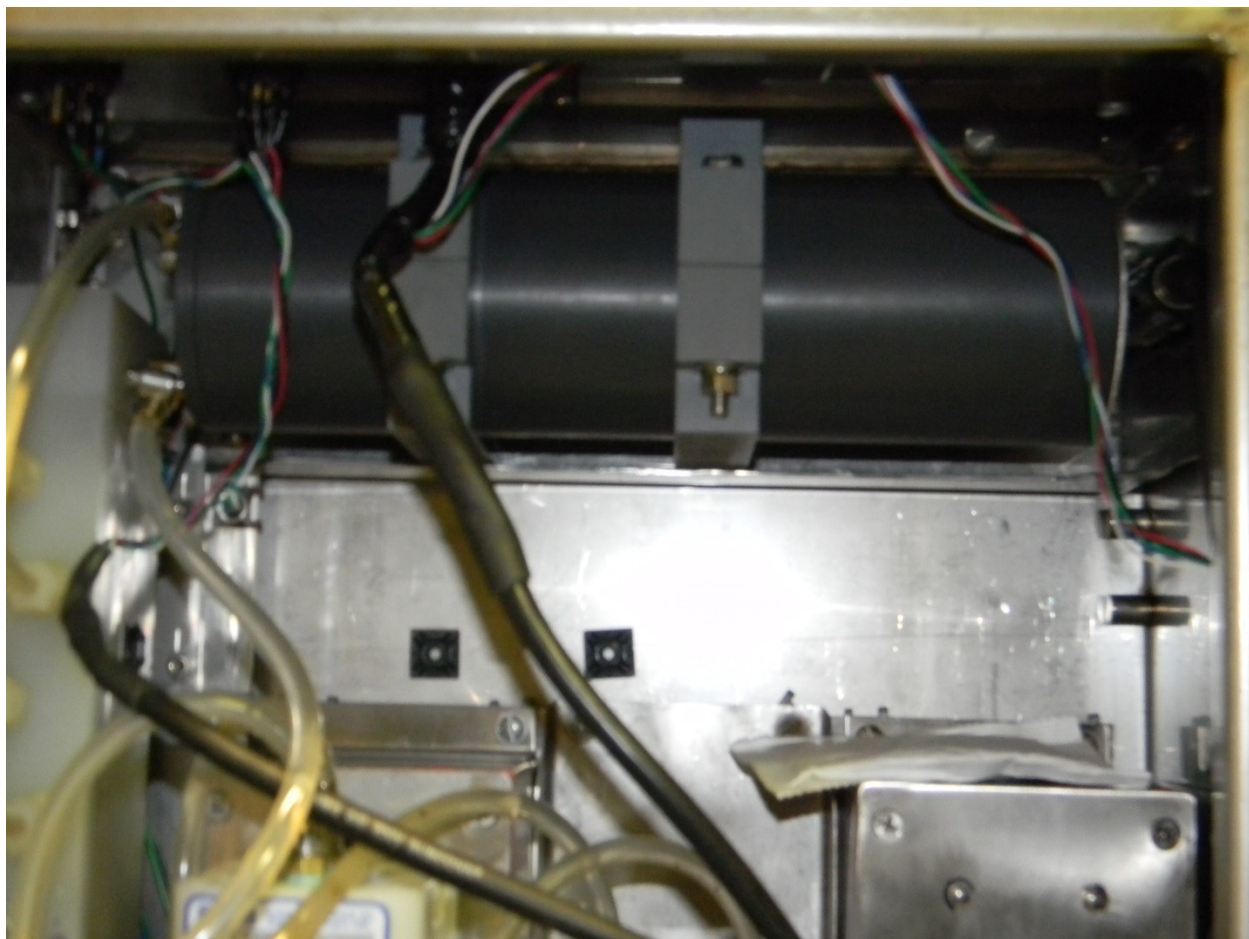
Figure : New position of the BBFL2. Inlet at left, bottom. Outlet at left, top.

1. Opened both boxes and observed function. Working well, no leaks anywhere.
2. Powered down and disassembled instruments in lower assembly.
3. Cleaned and checked over instruments in Engineering room.
4. Re-Assembled the instruments in the lower box, moving the BBFL2 to the horizontal mounting bracket in the upper mounting position after swapping the NPT fittings for 90 degree versions. The BBFL2 was mounted in such a manner that the inlet was low on the housing and the outlet was high.
5. Checked over Sea chest and valves, no leaks apparent.
6. Checked the sea strainer.
7. Turned ON the system.

8. No leaks in instrument housing and checked flow output at sea strainer. Flow was good. Visually confirmed flow direction at the BBFL2 and confirmed the volume filled with water and began draining correctly.
9. Signed out at Engineering room.

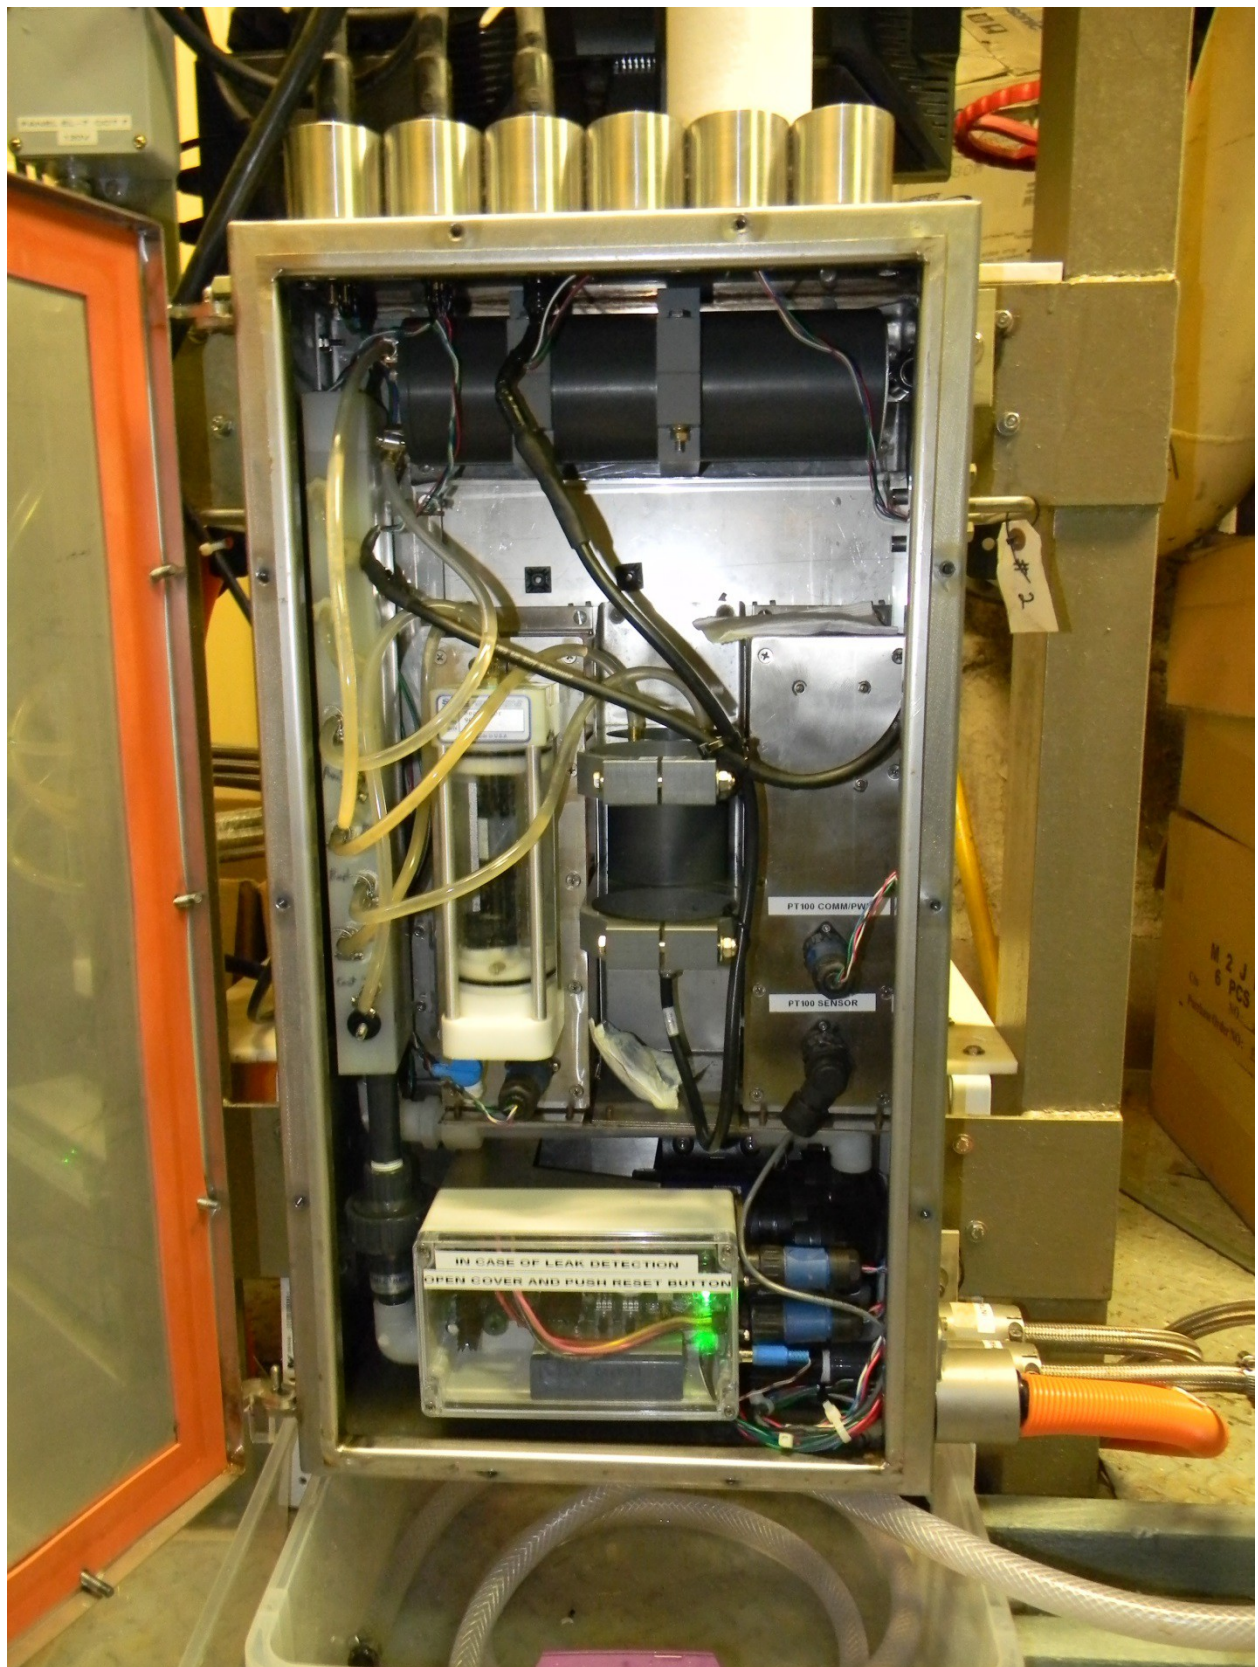
Figure : Overall view of revised installation.
