## **Ferry Maintenance Report**

**Vessel: Queen of Alberni**

Date: March 14, 2014

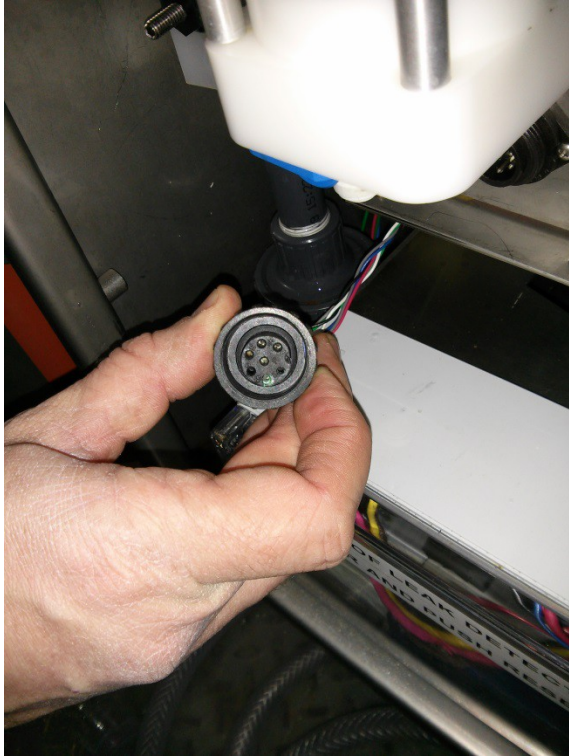
Figure 1: Corrosion evident on connector pin #5

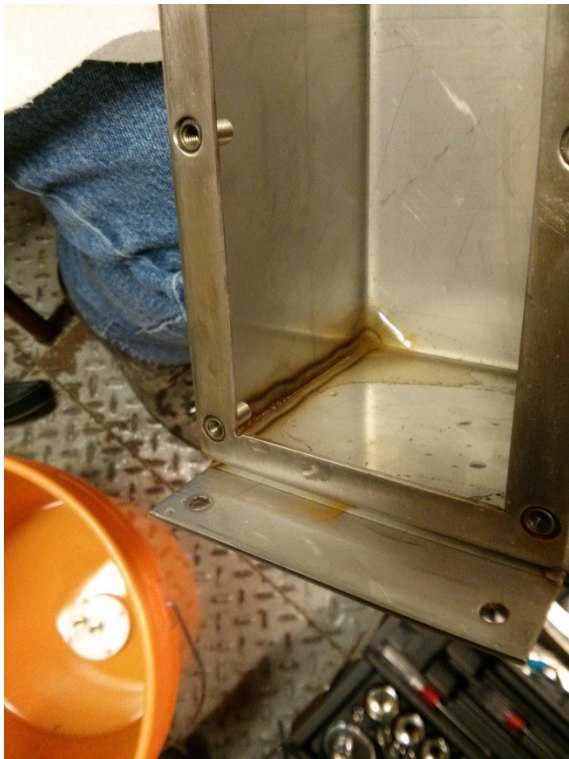
Figure 2: Water collecting inside Seabird electronics housing

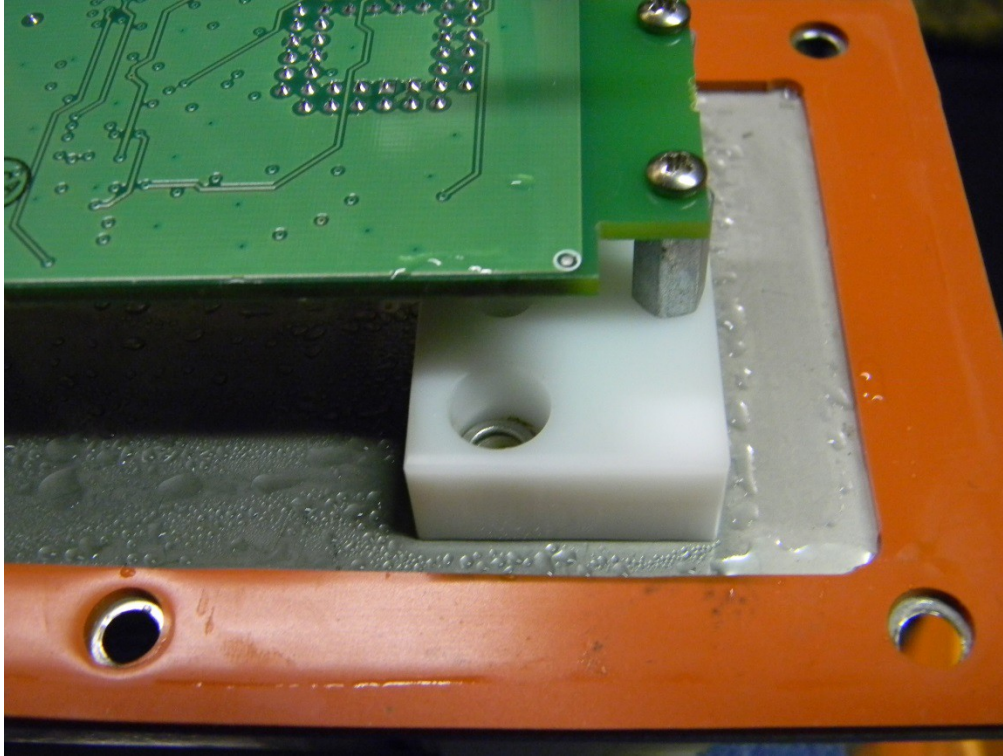
Figure 3: Water evident within housing and on boards

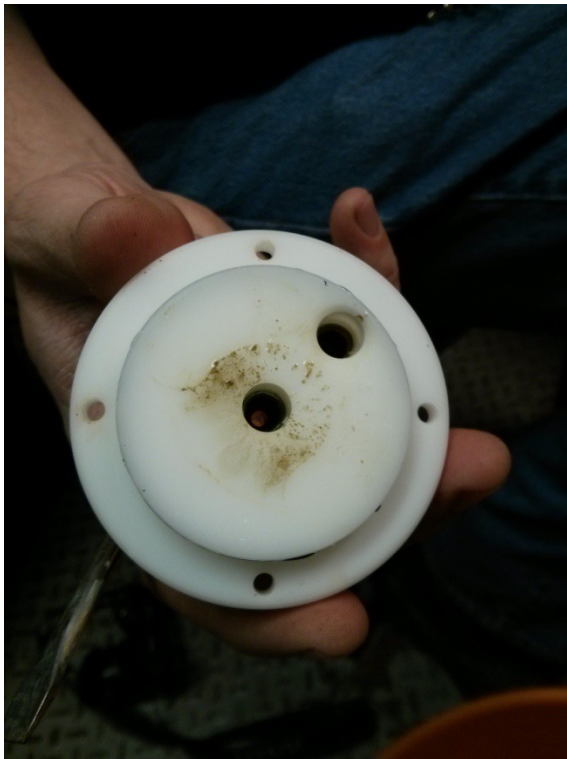
Figure 4: Sediment staining inside Seabird sensor

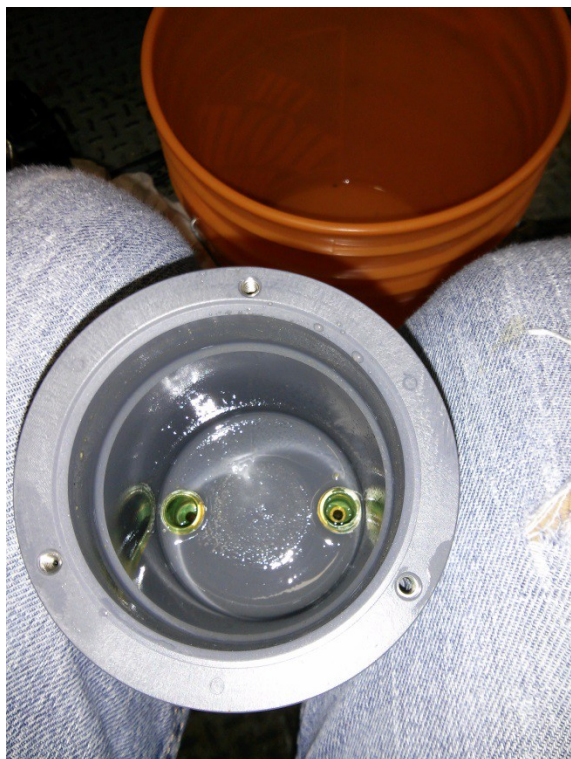
Figure 5: Interior of Optode housing prior to cleaning

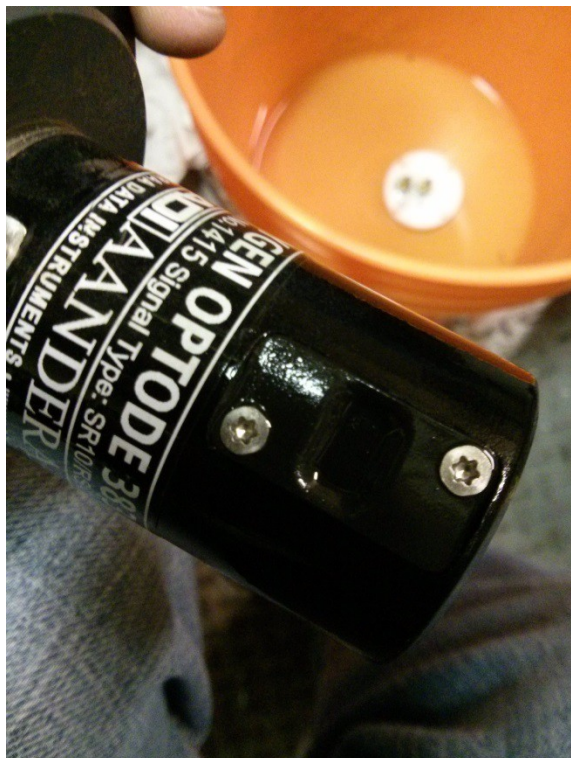
Figure 6: Optode sensing face prior to cleaning

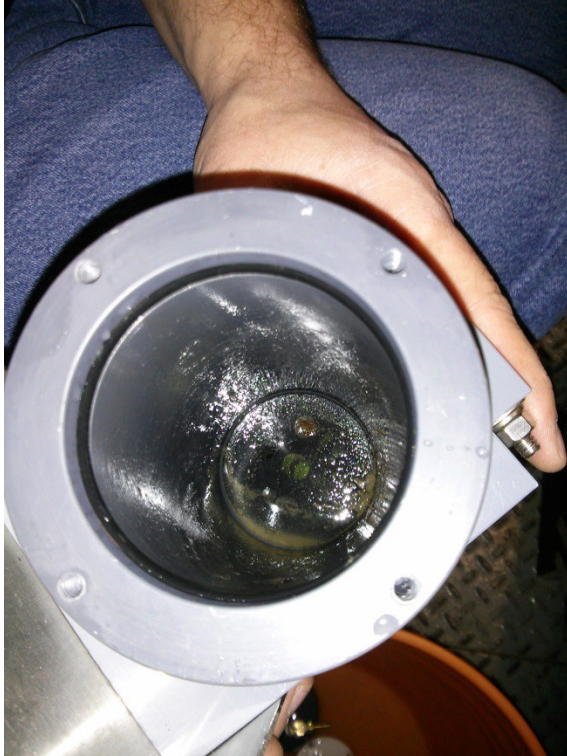
Figure 7: BBFL2 housing prior to cleaning. Note that sediment was NOT on the sensor face prior to removal from system. The housing cannot be kept level and the water must be agitated during removal

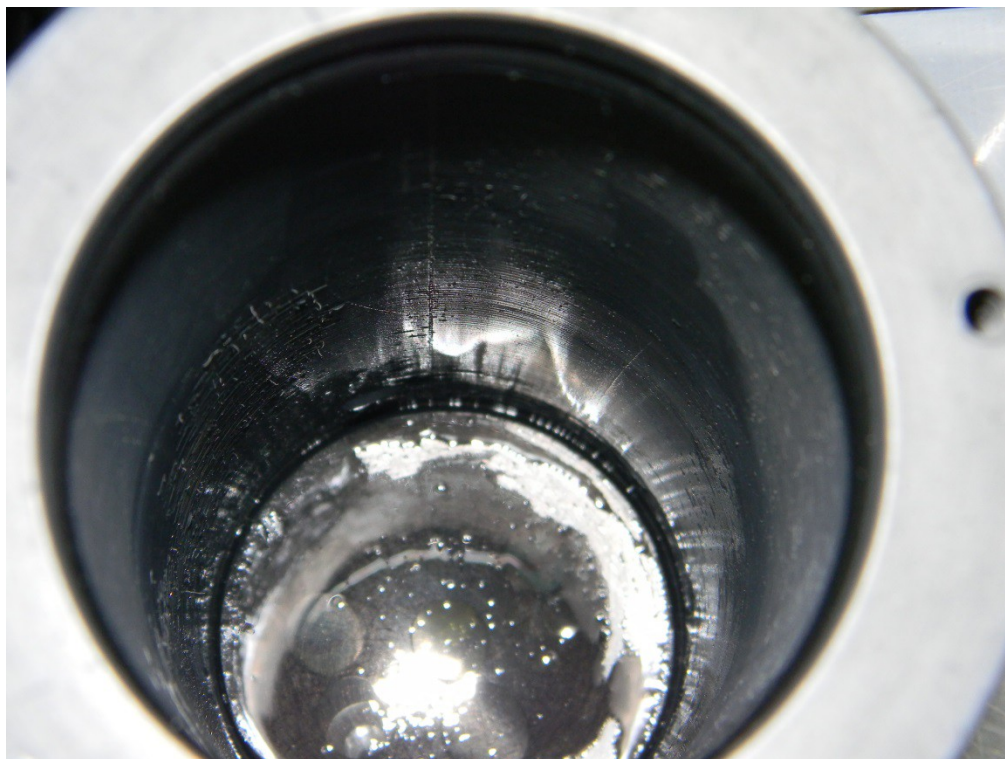
Figure 8: BBFL2 Post-Cleaning; note irregular surface of sensor

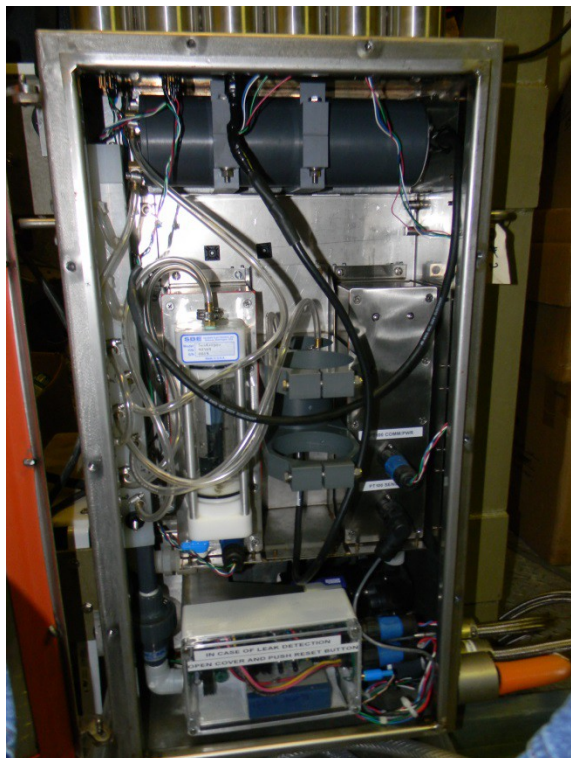
Figure 9: System as completed with new hoses and cleaned instruments

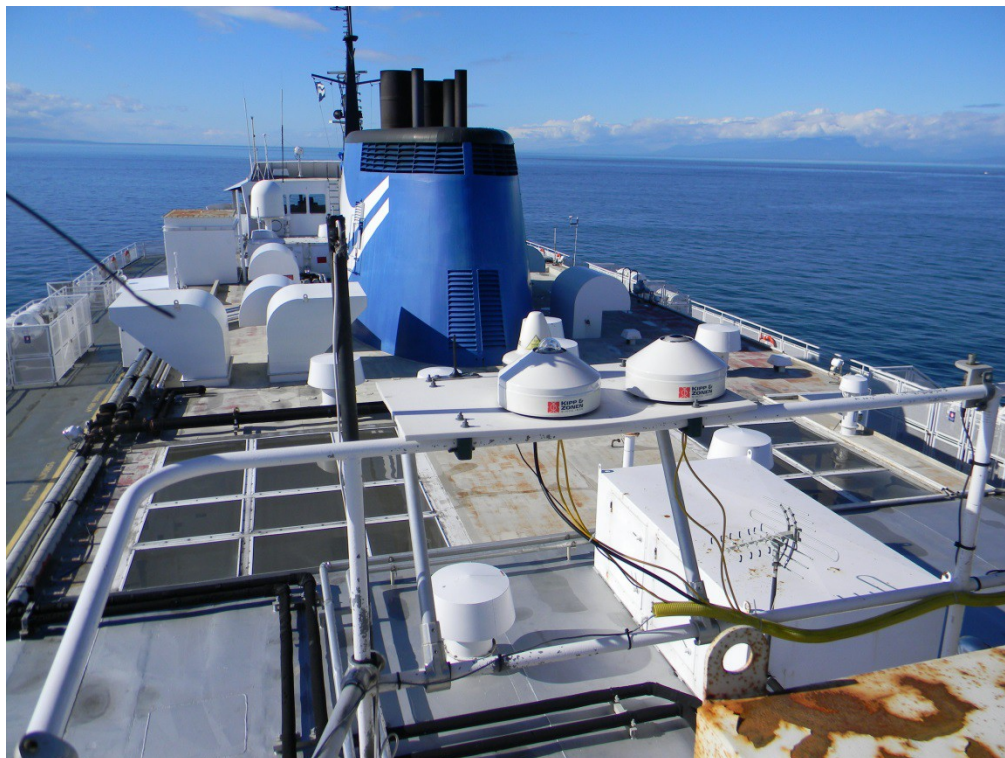
Figure 11: Met station; note shadow cast by black BC Ferries antenna

1. Monitor BBFL2 fitting seals. Double check connections for leaks upon next servicing.
2. Check for possible corrections to shadowing antenna on met station.
3. Labels for all ONC boxes.

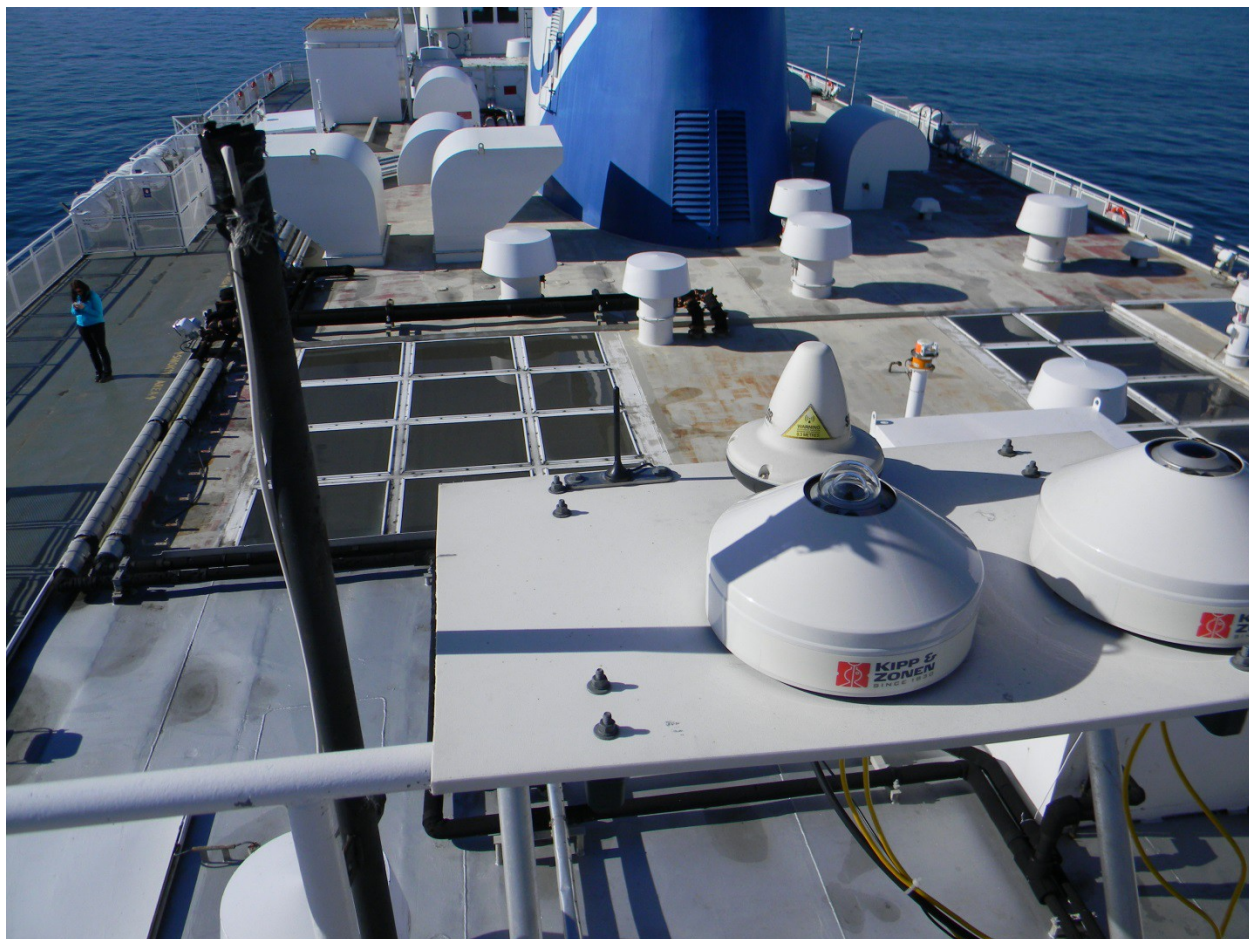
Figure 12: Close-up of shadow cast by BC Ferries antenna
