Ferry Maintenance Report

Vessel: Queen of Alberni

Date: March 27, 2014

Reason for Visit

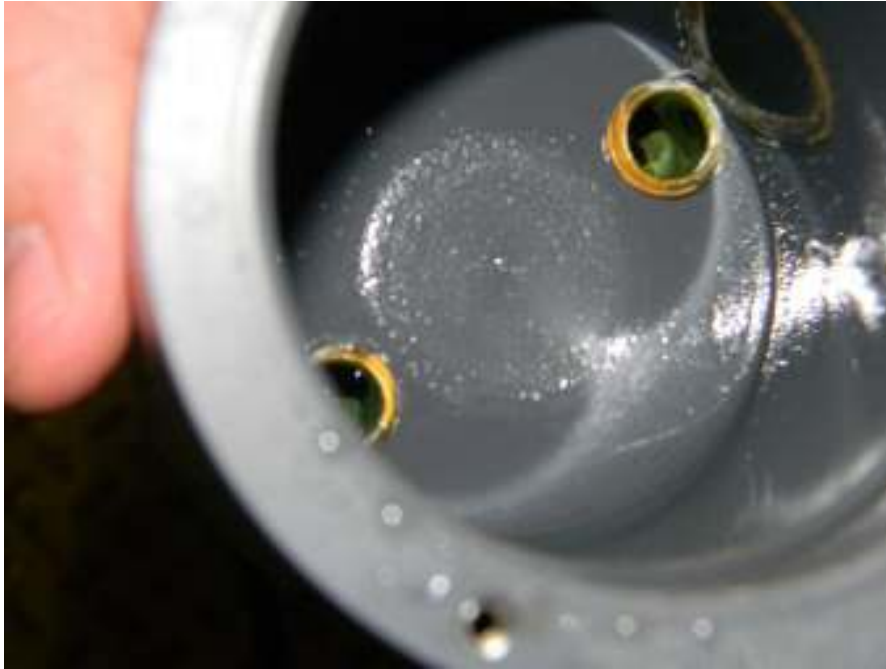
Figure 1. Interior of optode housing before cleaning

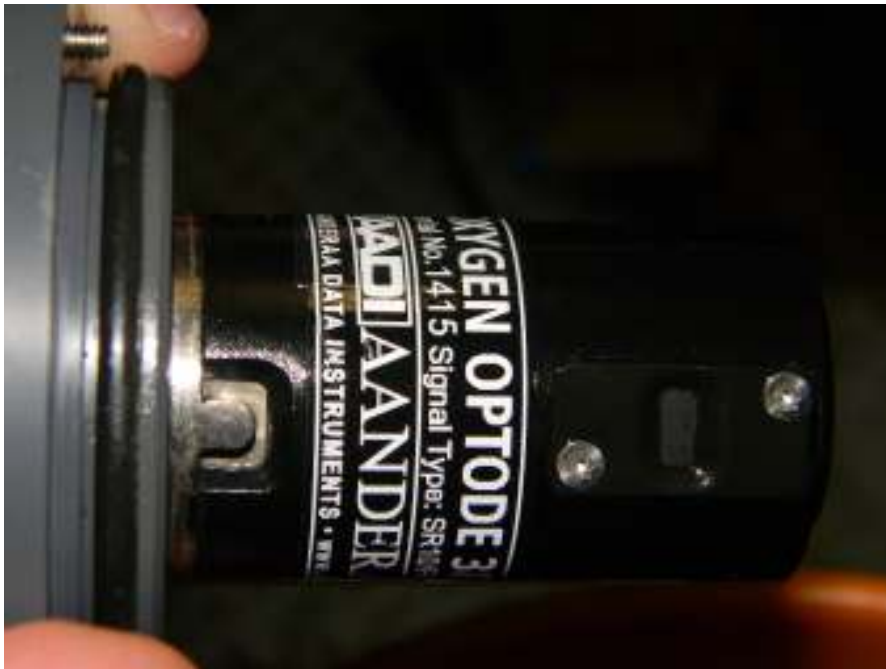
Figure 2. Aandera optode: optical window prior to cleaning

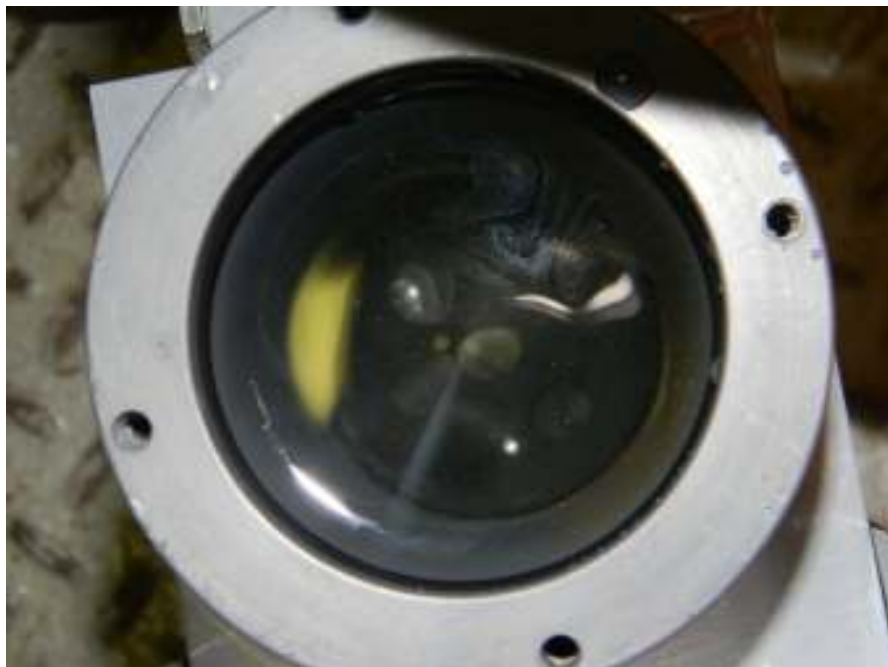
Figure 3. Interior of BBFL2 housing before cleaning

1. Purchase more appropriate geometry cleaning tools for accessing the internal surfaces of the BBFL2.
2. Contact Engineering on Q of A for potential assistance in removal of interfering antenna on 2nd bridge (which seems to be non-functional).

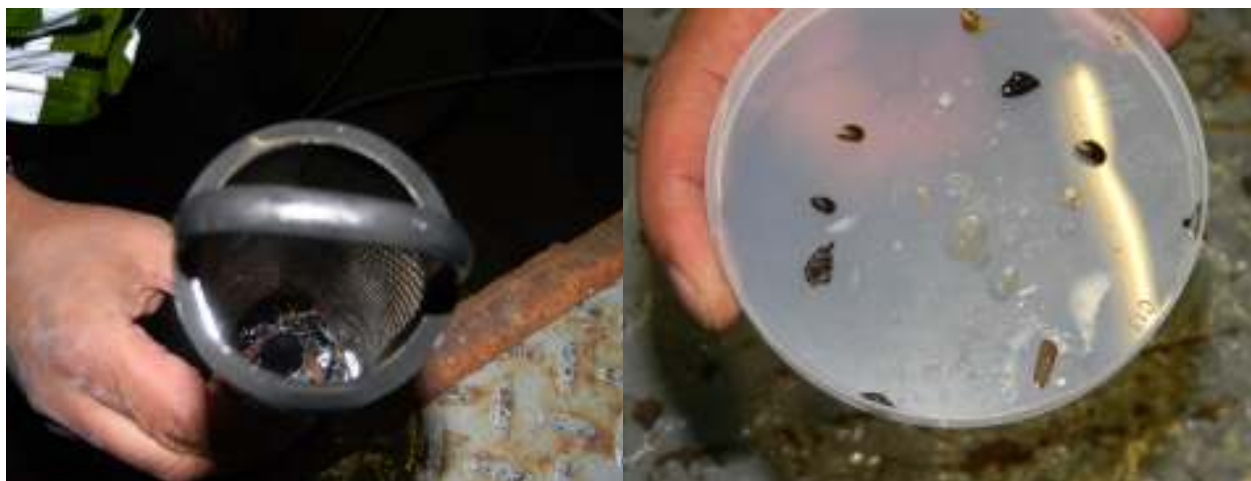
Figure 4. Sea-strainer before cleaning (left image) and larger material contents (right image; note bivalves) removed from the base of the strainer.

5. Re-assembled the instruments in the lower box.
6. Checked over Sea chest and valves, no leaks apparent.
7. Checked and cleaned the sea strainer.
8. Turned ON the system.
