Ferry Maintenance Report

Vessel: Queen of Alberni

Date: April 11, 2014

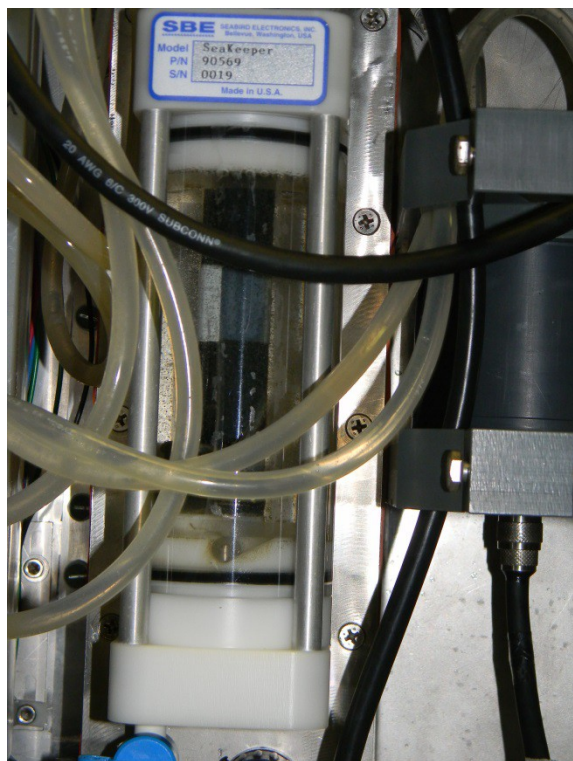
Figure 1: Seabird CT Before Cleaning

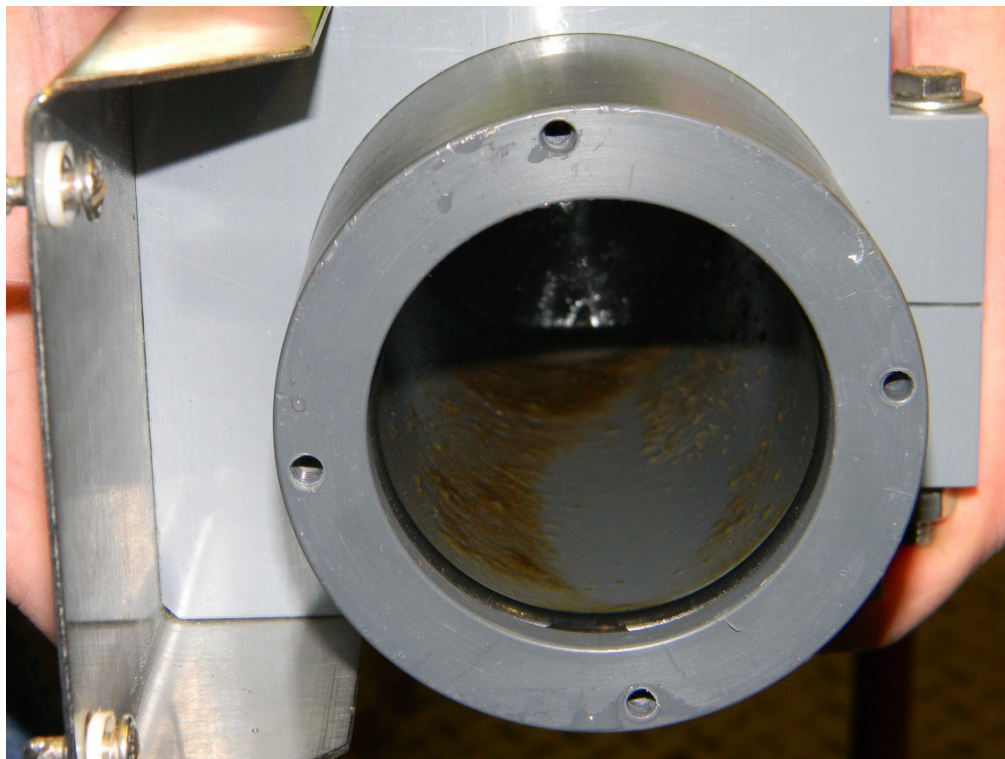
- 1.—There were no signs of moisture or leaks In the Instrument Box.
- 2.—The AADI optode had very little or no debris or sediment within the housing.
- 3.—The BBFL2 had a minor partial layer of sediment in the housing and minor fouling on the sensing surface. Minor fouling was noticed on the “bottom” surface of the horizontal housing.
- 4.—The Seabird 45 CT sensor was relatively clean, with only minor sediment within the sensor.
- 5.—The sea chest showed no signs of leaks.
- 6.—The inline filter (sea strainer) was checked and cleaned and some small debris particles were removed from the bottom of the strainer.

Figure 2: Biofouling within BBFL2 Housing

- 1.—Opened both boxes and observed function. Both were working well, no leaks anywhere.
- 2.—Powered down and disassembled instruments in lower assembly.
- 3.—Cleaned and checked over instruments in Engineering room. Tried three new methods for cleaning and determined that all had their benefits and detriments. Further trials will determine the best product.
- 4.—Ran pre- and post- calibration with standard solutions and with Orange test stick and white substitute test stick for CDOM fluorescence and Chl fluorescence.
- 5.—Re-assembled the instruments in the lower box.

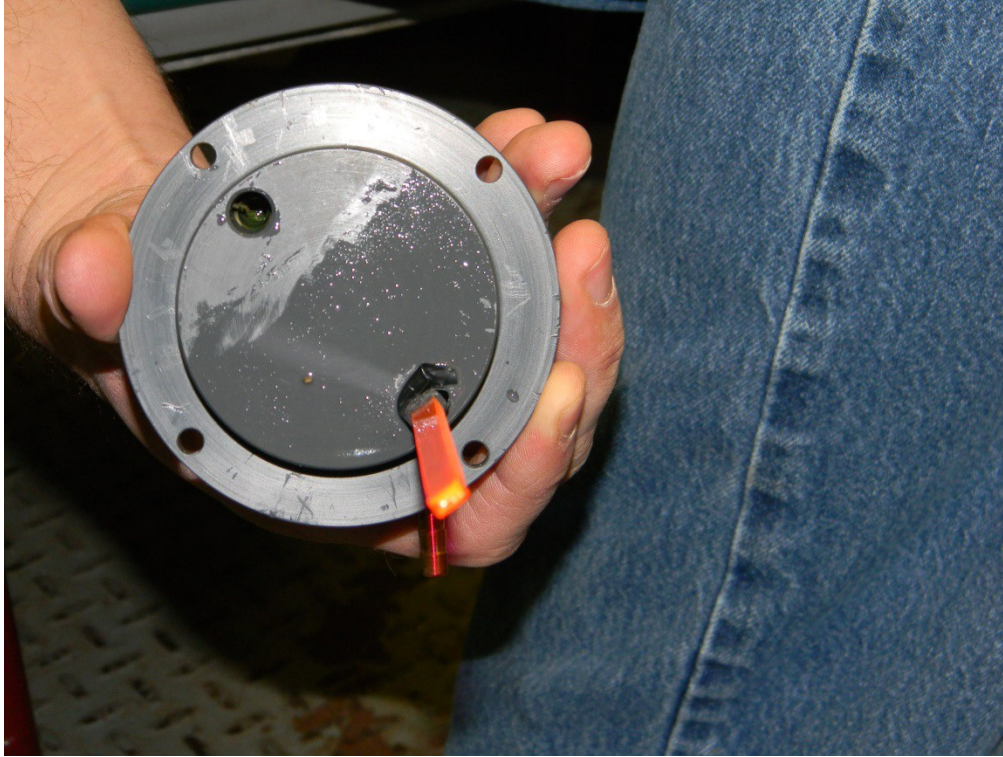
Figure 3: Positioning of Test Stick within Housing (13.5cm into housing)

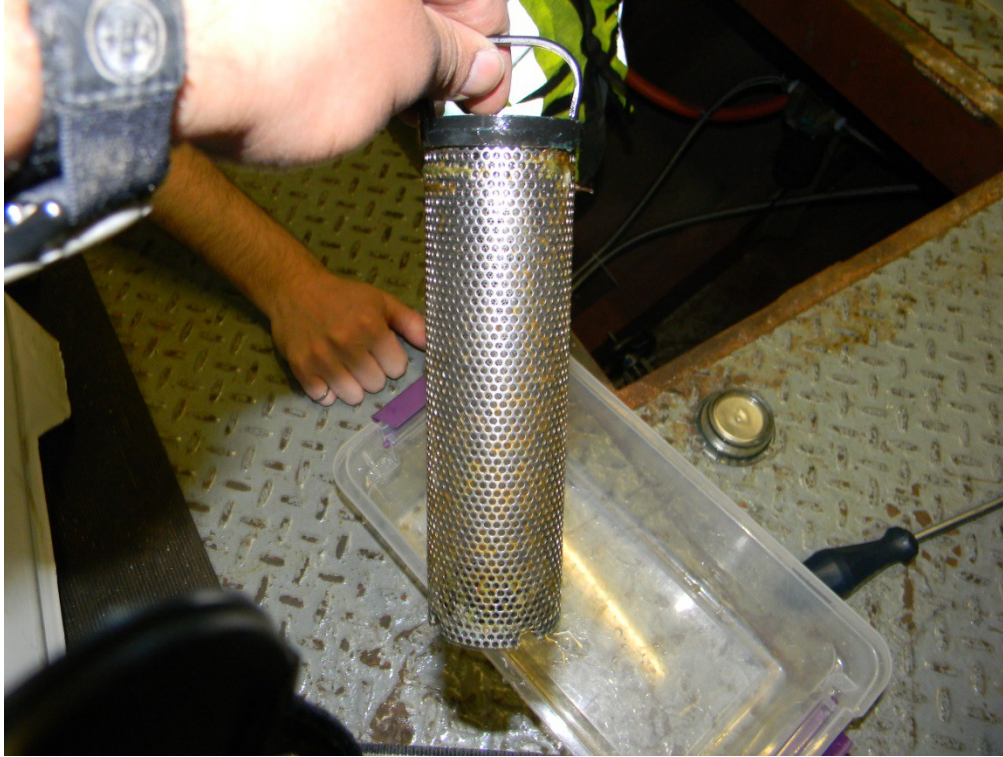
Figure 4: Sea Strainer Condition

~~7.~~ Checked and cleaned the sea strainer.
