## **Ferry Maintenance Report**

**Vessel: Queen of Alberni**

Date: May 2, 2014

### **Reason for Visit**

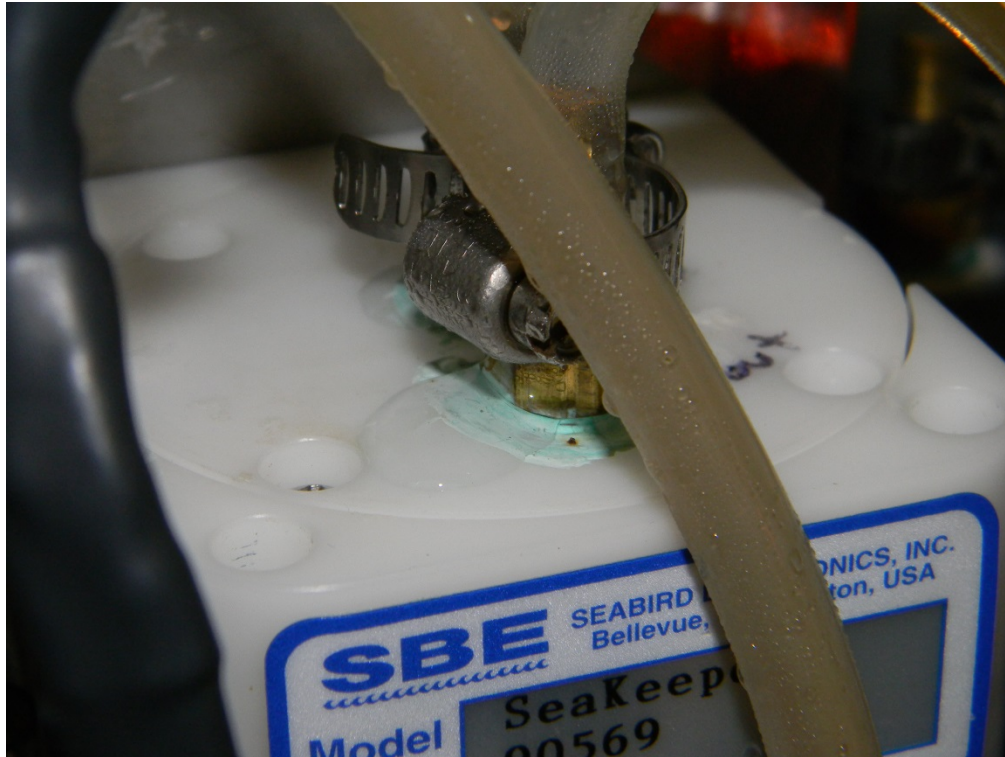
1. There was a slight sign of moisture or leaks In the Instrument Box. This was traced to a slightly loose hose on the BBFL2 which was replaced and tightened.
2. The AADI optode had moderate debris or sediment within the housing.
3. The BBFL2 had a partial layer of sediment in the housing and fouling on the sensing surface. Fouling was noticed on the "bottom" surface of the horizontal housing.
4. The Seabird 45 CT sensor had sediment and fouling within the sensor.
5. The sea chest showed no signs of leaks.
6. The inline filter (sea strainer) was checked and was found to contain significant levels of biofouling and some levels of sediment, although the strainer was no-where near clogging.

Figure 1: Leakage dripped down onto top of CT sensor. Note fouling in hoses.

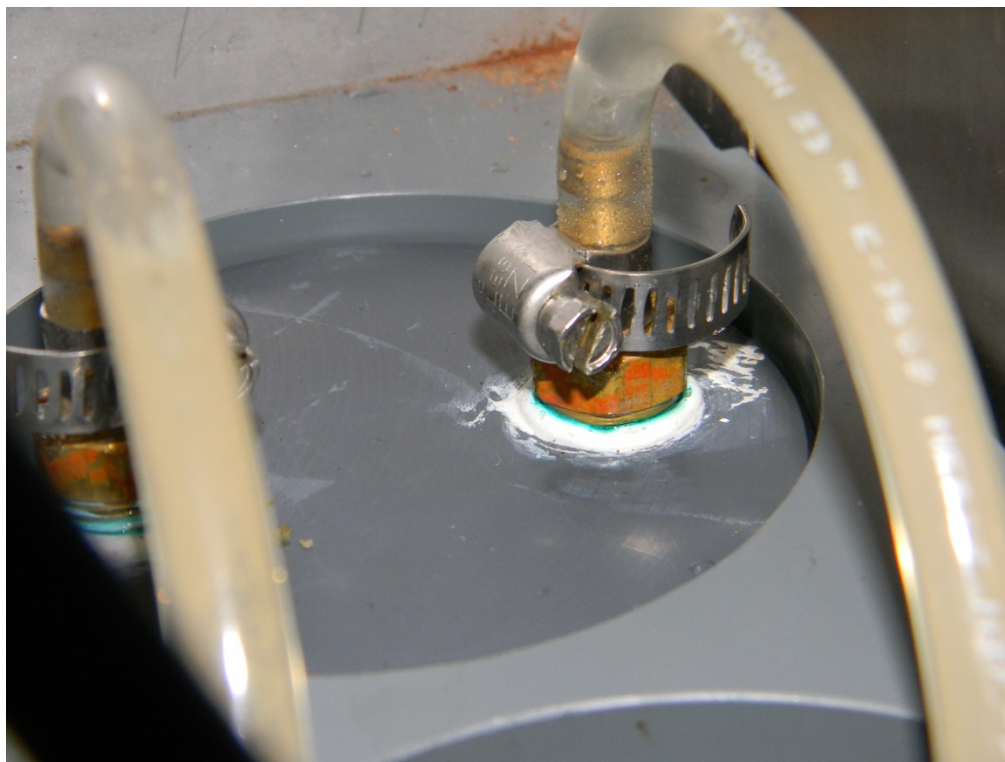
Figure 2: Leakage dripped down onto Optode sensor

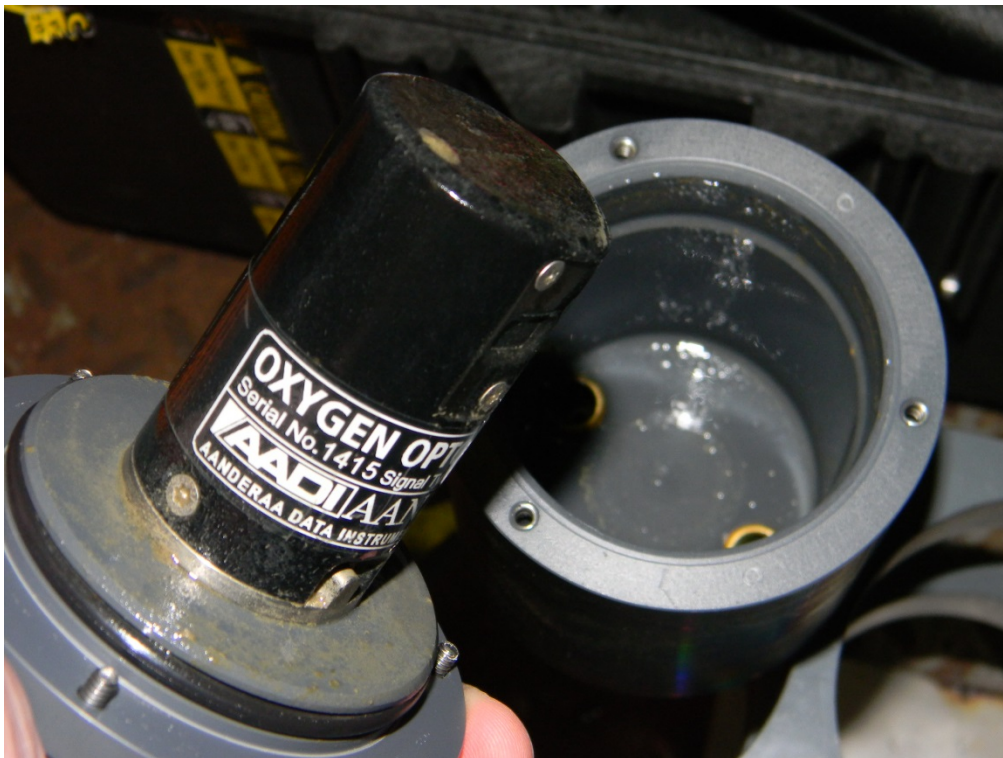
Figure 4: Fouling within the Optode sensor

3. Cleaned and checked over instruments in Engineering room. The flat songe stick proved effective in cleaning the BBFL2 and Optode housings. The bottle brush proved effective at cleaning the Seabird CT sensor.

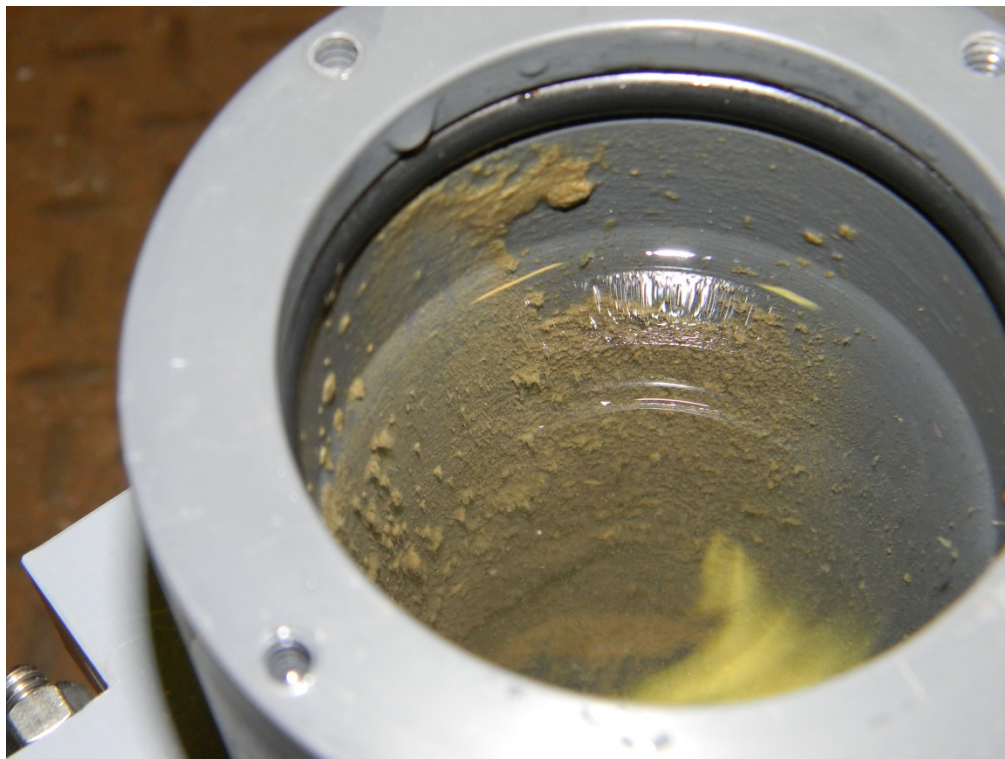
Figure 5: Fouling within the BBFL2 sensor

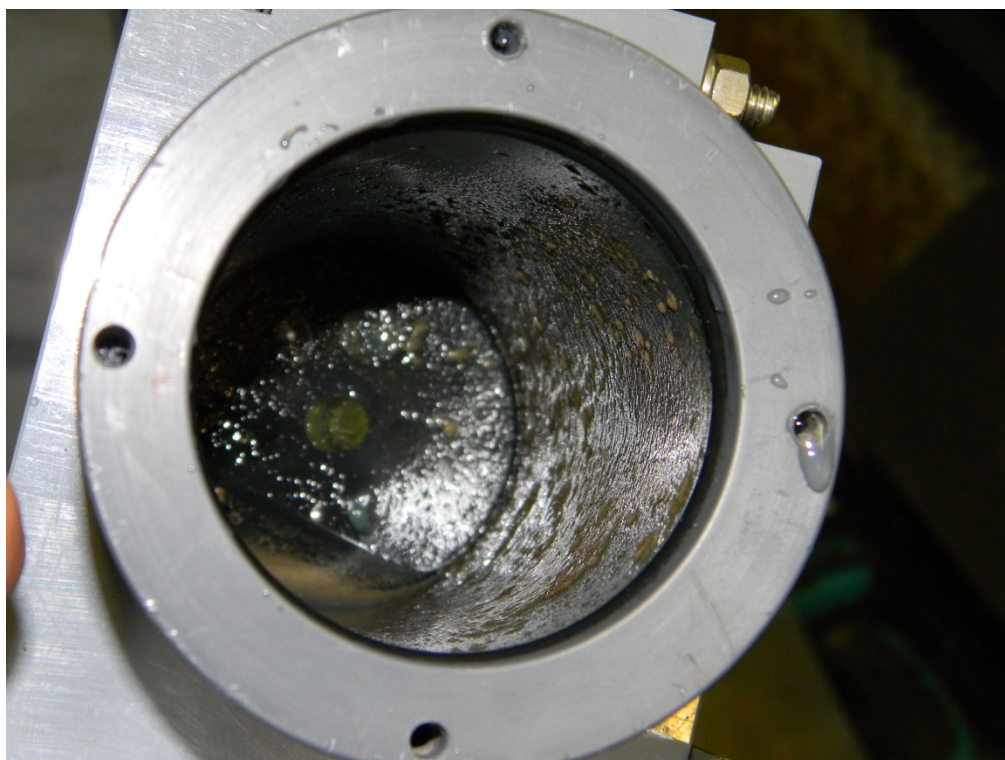
Figure 6: Fouling within the BBFL2 sensor

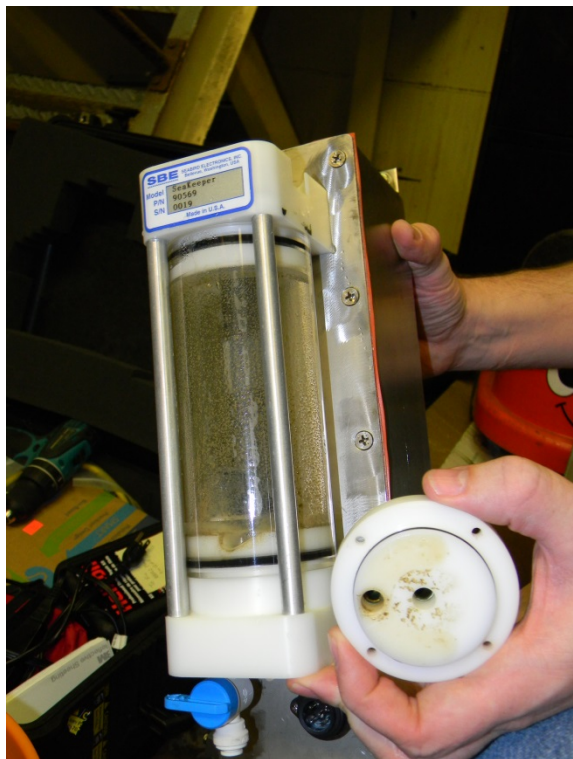
Figure 7: Fouling within the Seabird CT sensor

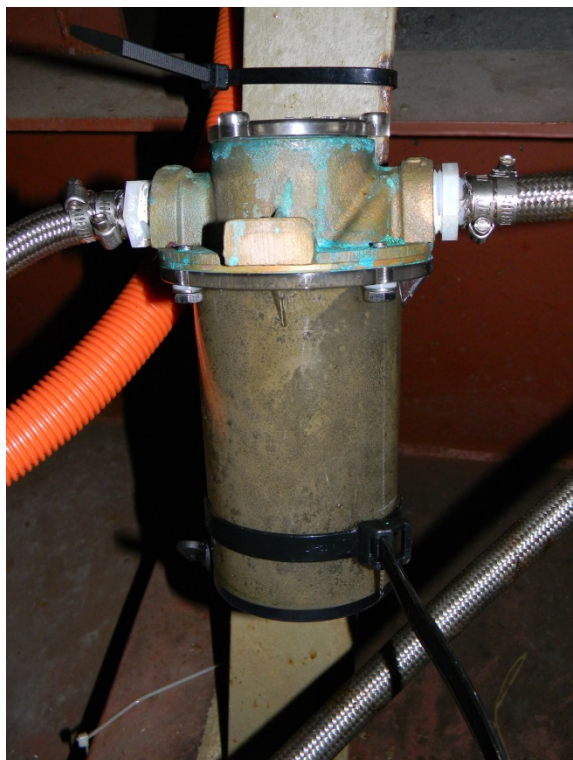
Figure 12: Suspended sediment buildup within the Sea Strainer

5. Re-assembled the instruments in the lower box. Replaced all hoses with new material.
6. Checked over Sea chest and valves, no leaks apparent.
7. Checked and cleaned the sea strainer.

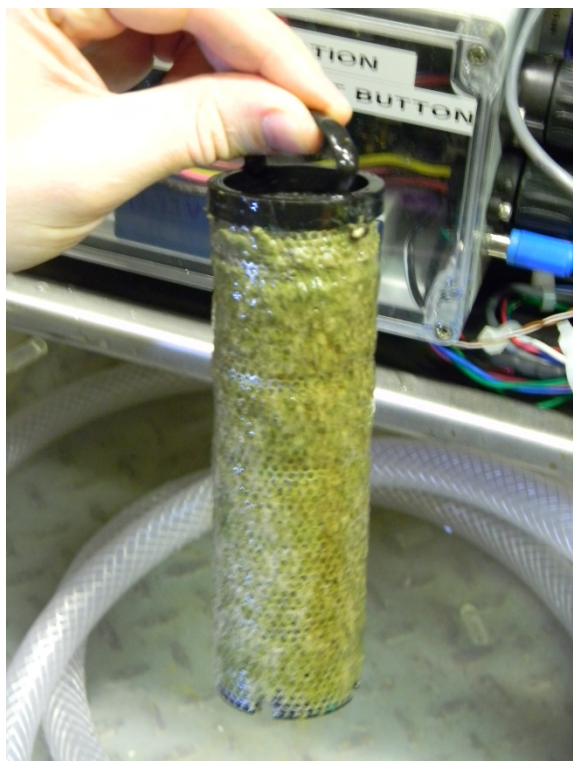
Figure 13: Biofouling buildup on the Sea Strainer filter
