Ferry Maintenance Report

Vessel: Queen of Alberni

Date: May 16, 2014

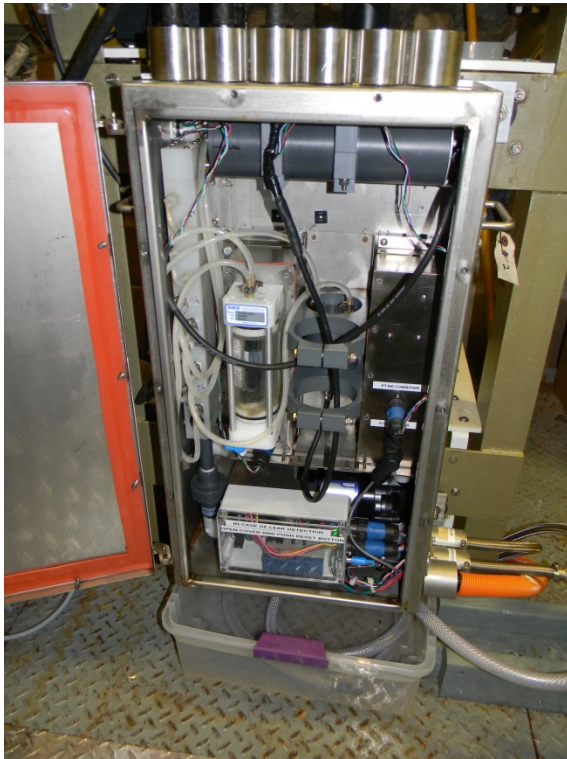
1. There was a slight sign of moisture or leaks in the Instrument Box. This is suspected to be condensation, but fittings on the BBFL2 are a second possibility.
2. The AADI optode had little to no debris or sediment within the housing.
3. The BBFL2 had minor fouling on the sensing surface. Limited fouling was noticed on the "bottom" surface of the horizontal housing.
4. The Seabird 45 CT sensor had minor sediment and fouling within the sensor.
5. The sea chest showed no signs of leaks.
6. The inline filter (sea strainer) was checked and was found to contain minor levels of biofouling and some levels of sediment.

Figure 1: Instrument Box upon opening

1. Opened both boxes and observed function. Both were working well, minor leaks not preventing function.
2. Powered down and disassembled instruments in lower assembly.

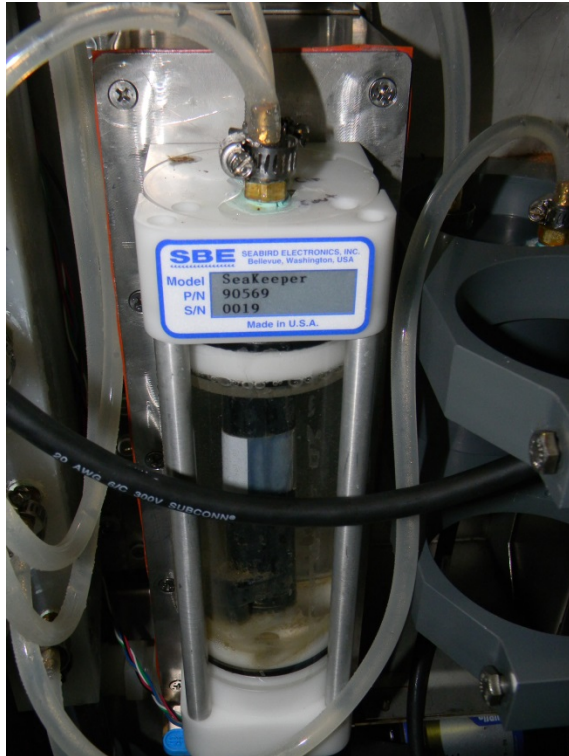
Figure 2: CT Sensor showing condensation/drips puddling on top

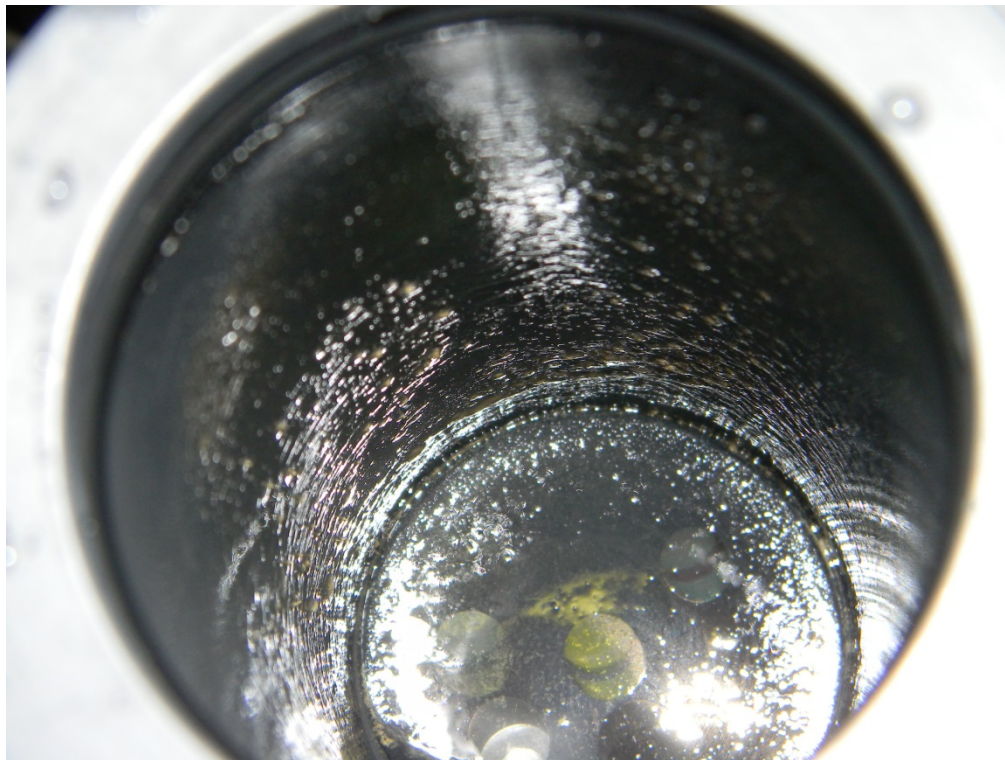
Figure 3: Interior and fouling of BBFL2

3. Cleaned and checked over instruments in Engineering room. The flat sponge stick proved effective in cleaning the BBFL2 and Optode housings. The bottle brush proved effective at cleaning the Seabird CT sensor.

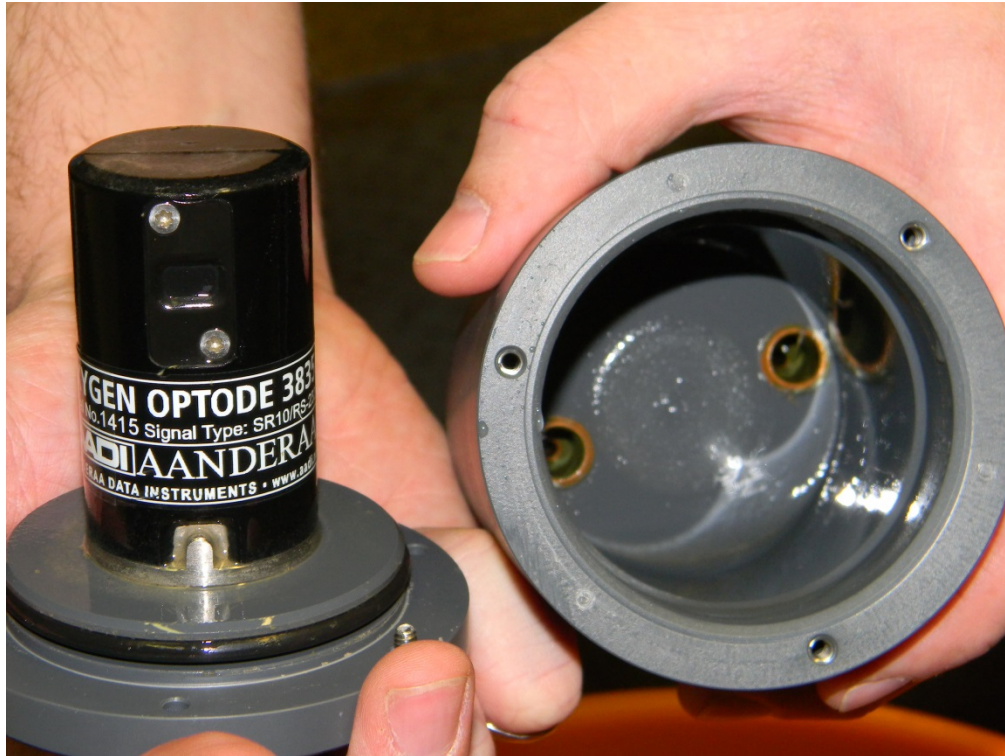
Figure 4: Interior of Optode

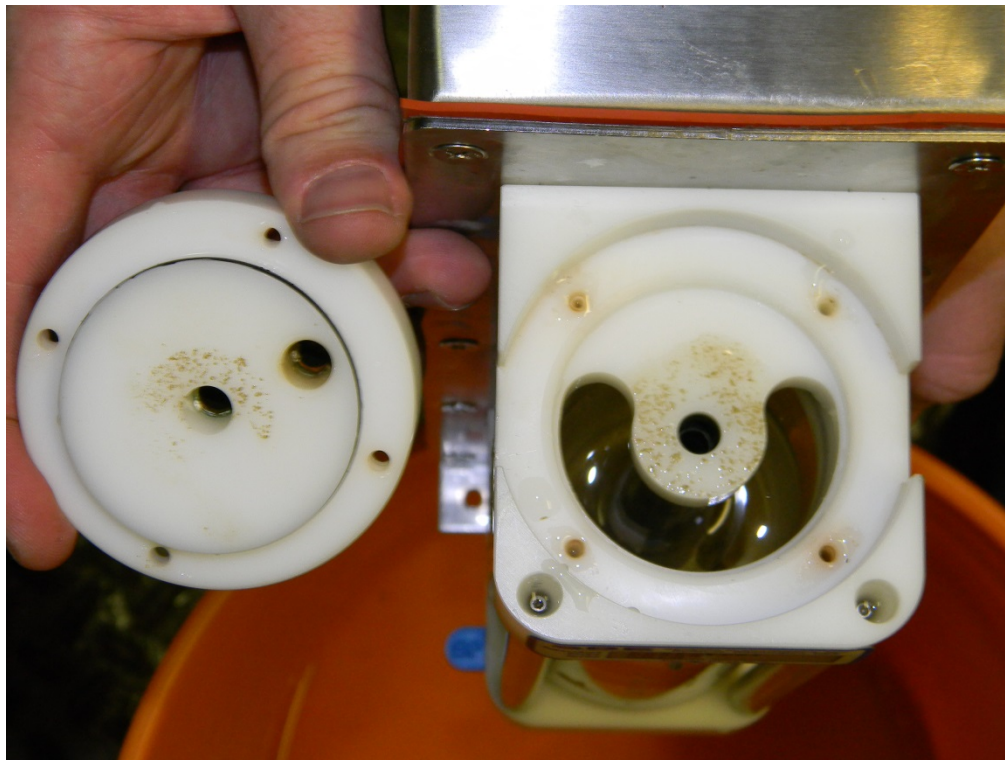
Figure 5: Interior and fouling of CT sensor

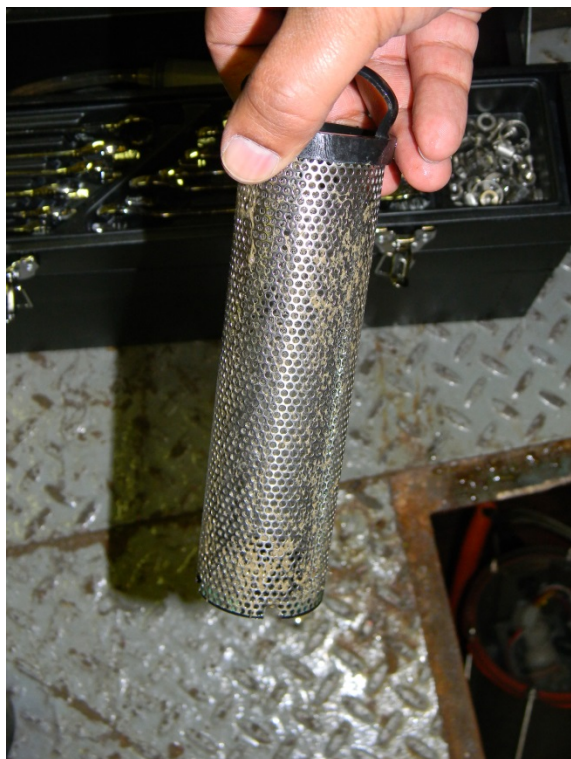
Figure 6: Sea strainer fouling

5. Re-assembled the instruments in the lower box. Tightened BBFL2 connectors.
6. Checked over Sea chest and valves, no leaks apparent.
7. Checked and cleaned the sea strainer.

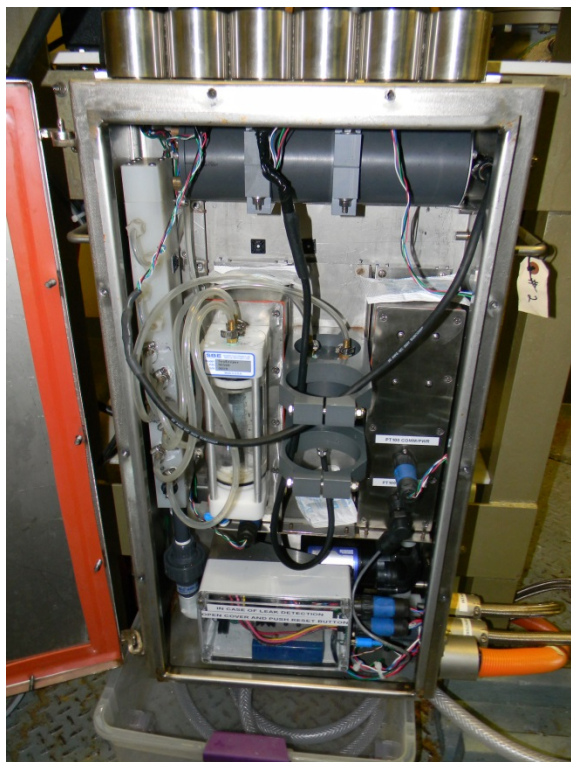
Figure 7: Instrument box after maintenance

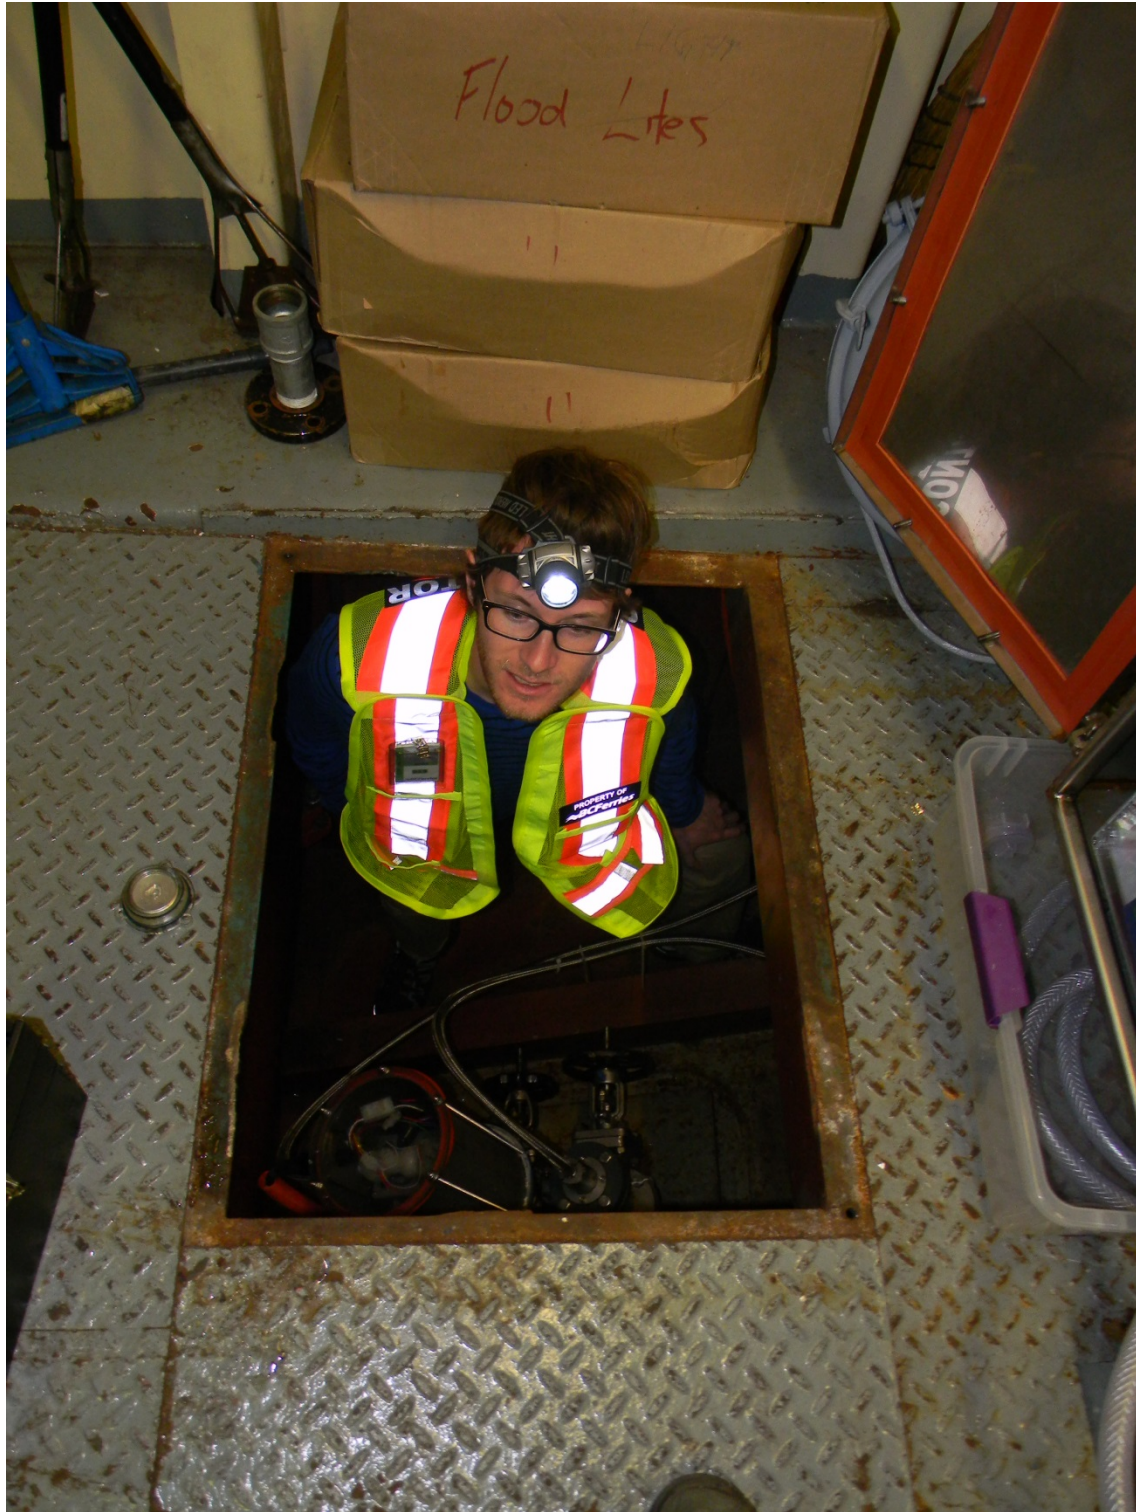
Figure 8: Jeremy Krogh in the bilges performing Sea Strainer maintenance
