Ferry Maintenance Report

Vessel: Queen of Alberni

Date: May 30, 2014

Regular instrument servicing

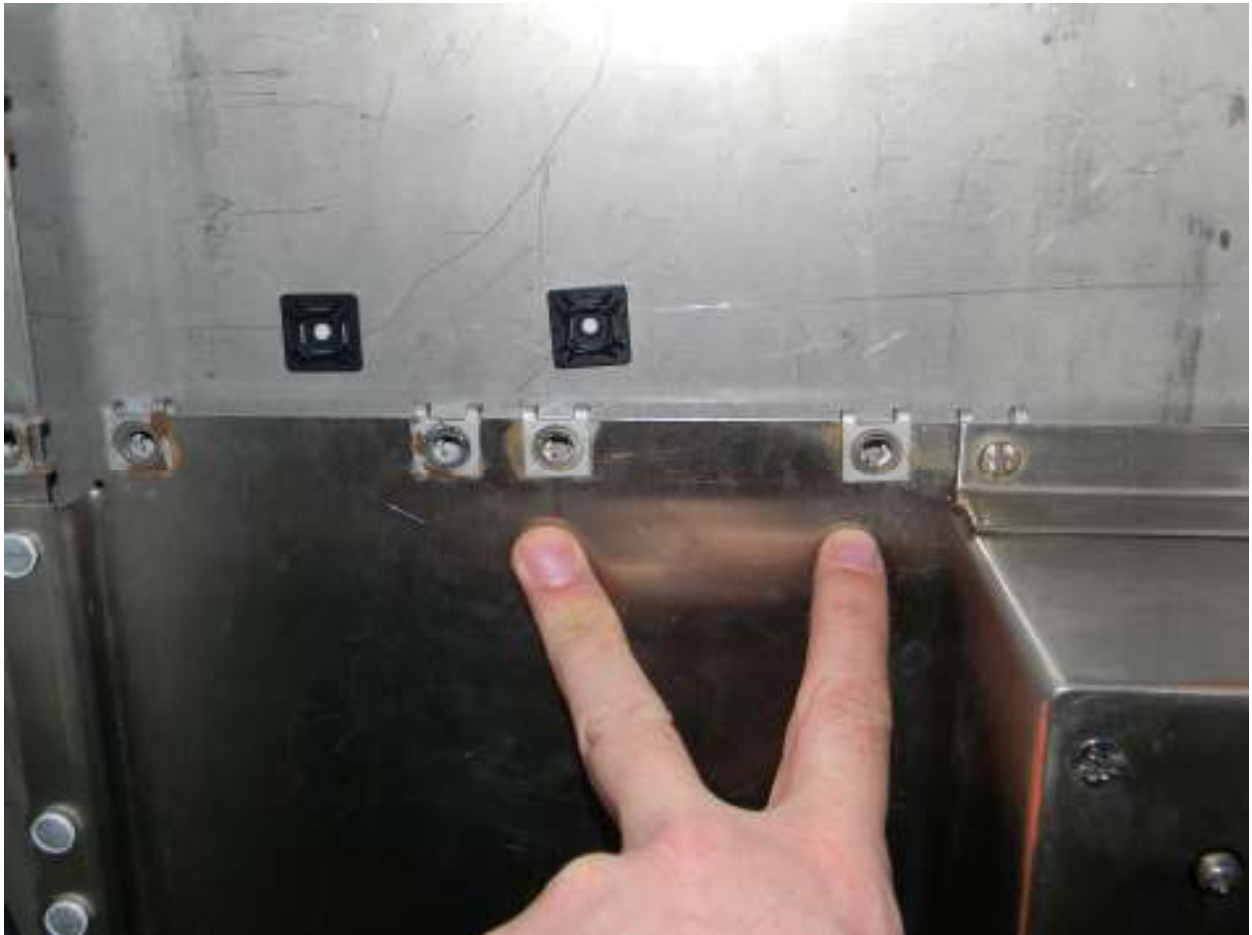
Figure 1. Replacement of panel clips located behind the BBFL2 is typically housed

5. Re-assembled the instruments in the lower box. The BBFL2 unit and housing was swapped out from BBFL2-786 to unit BBFL2-787.
6. Exchanged 3 panel clips for new panel clips.

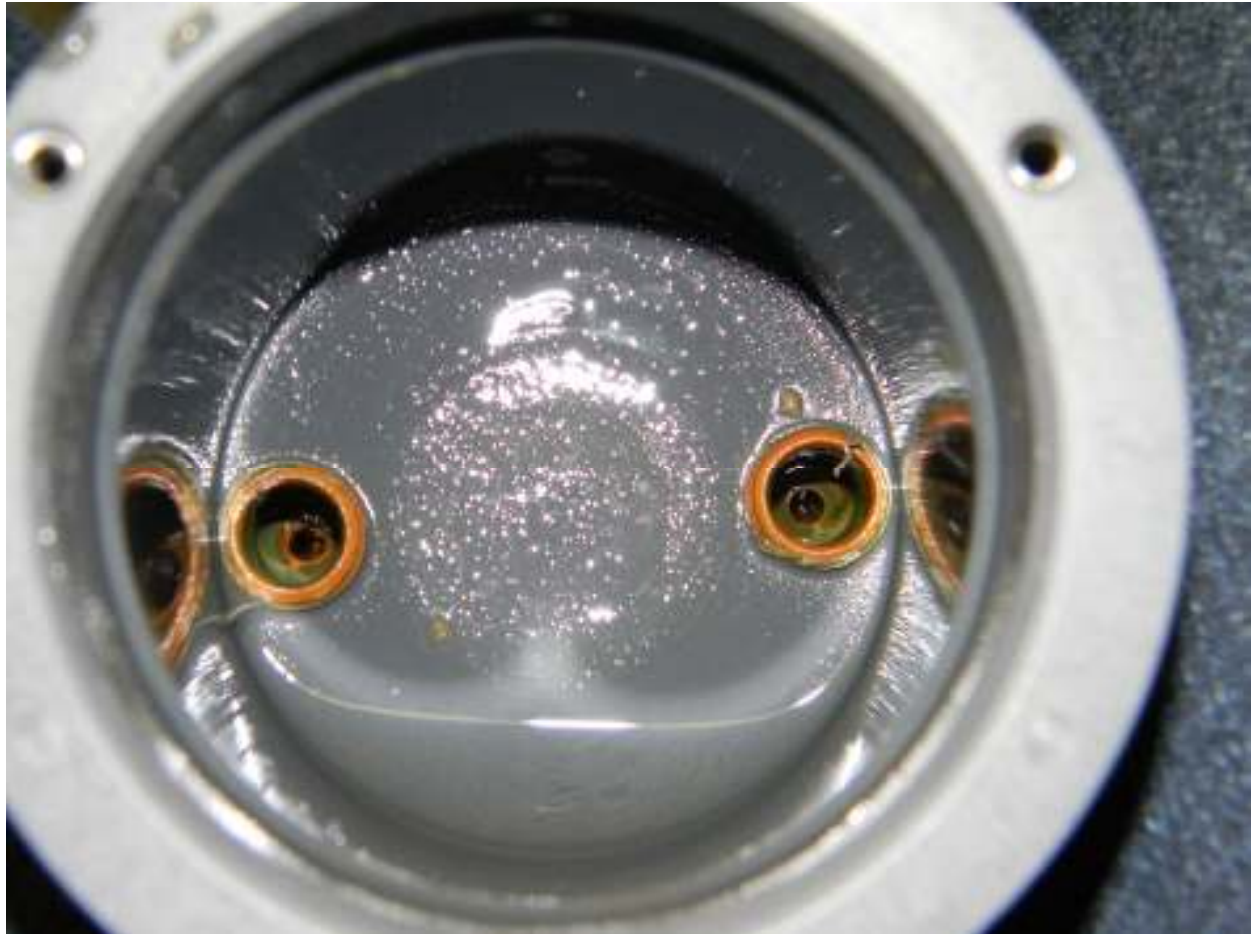
1. There was negligible moisture and no signs of leaks In the Instrument Box.
2. Hoses from manifold to instruments were clear of obvious fouling.
3. Minor sedimentation in the Seabird 45 CT sensor unit.
4. Moderate to high sedimentation in the optode housing
5. Moderate to medium biological material and biofouling of the BBFL2 comparable to the previous trip: May 16, 2014.
6. The sea chest showed no signs of leaks.

Figure 2. Aanderaa optode: housing with moderate sedimentation.

1. Opened both boxes and observed function. Both were working well, no leaks anywhere.
2. Powered down and disassembled instruments in lower assembly.
3. Cleaned and checked over instruments in engineering room.

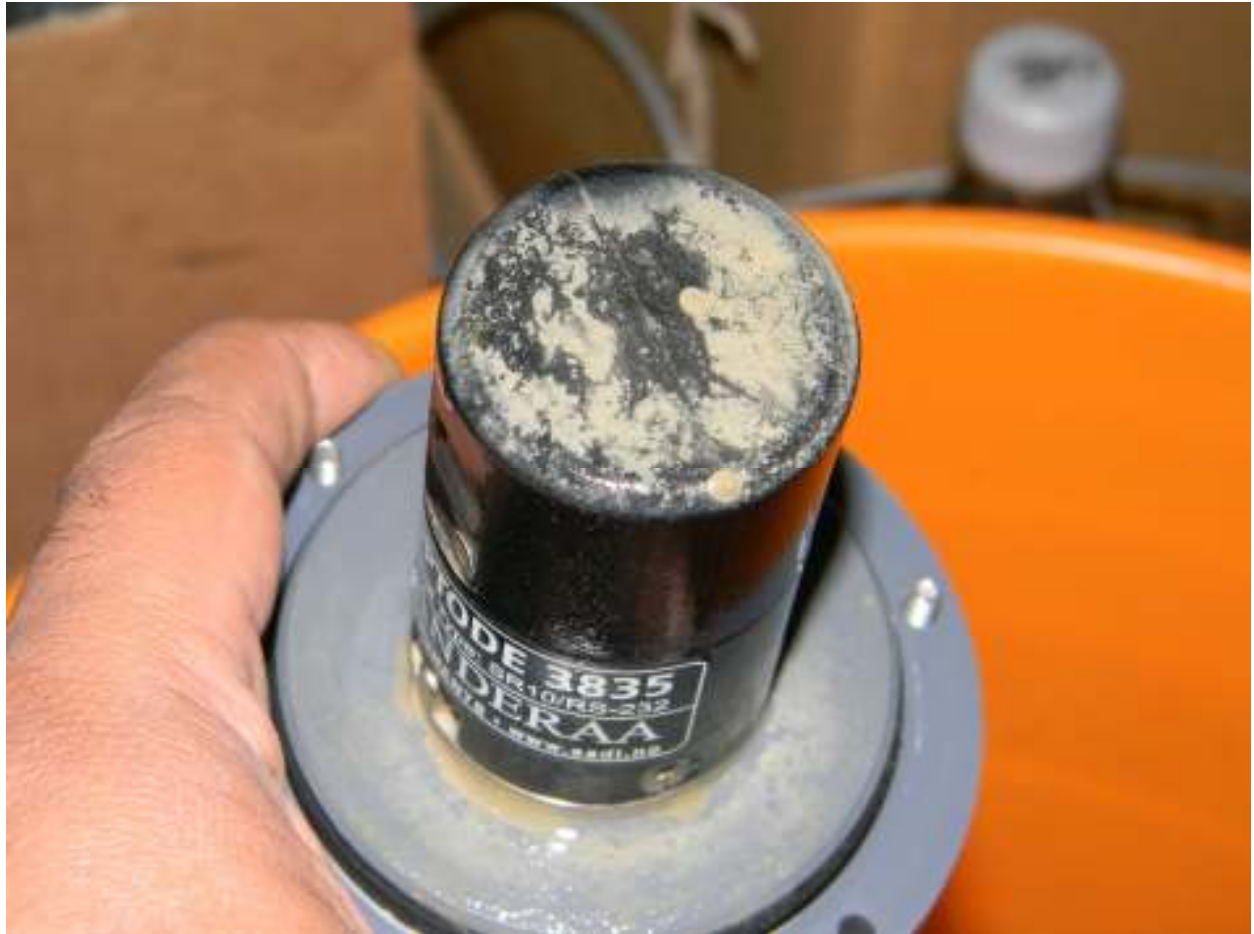
Figure 3. Moderate to high sedimentation on the optode.

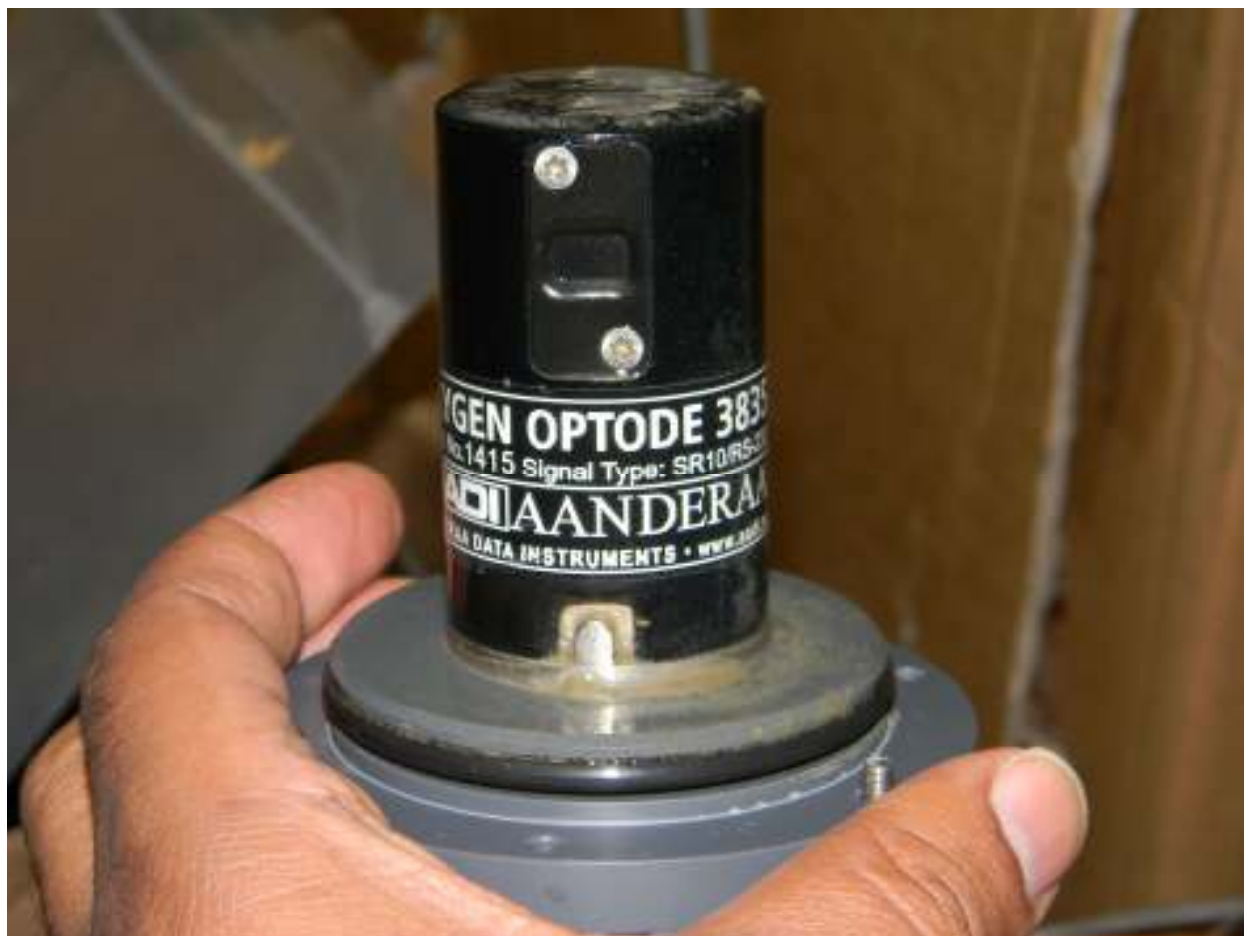
Figure 4. Optode window relatively clean.

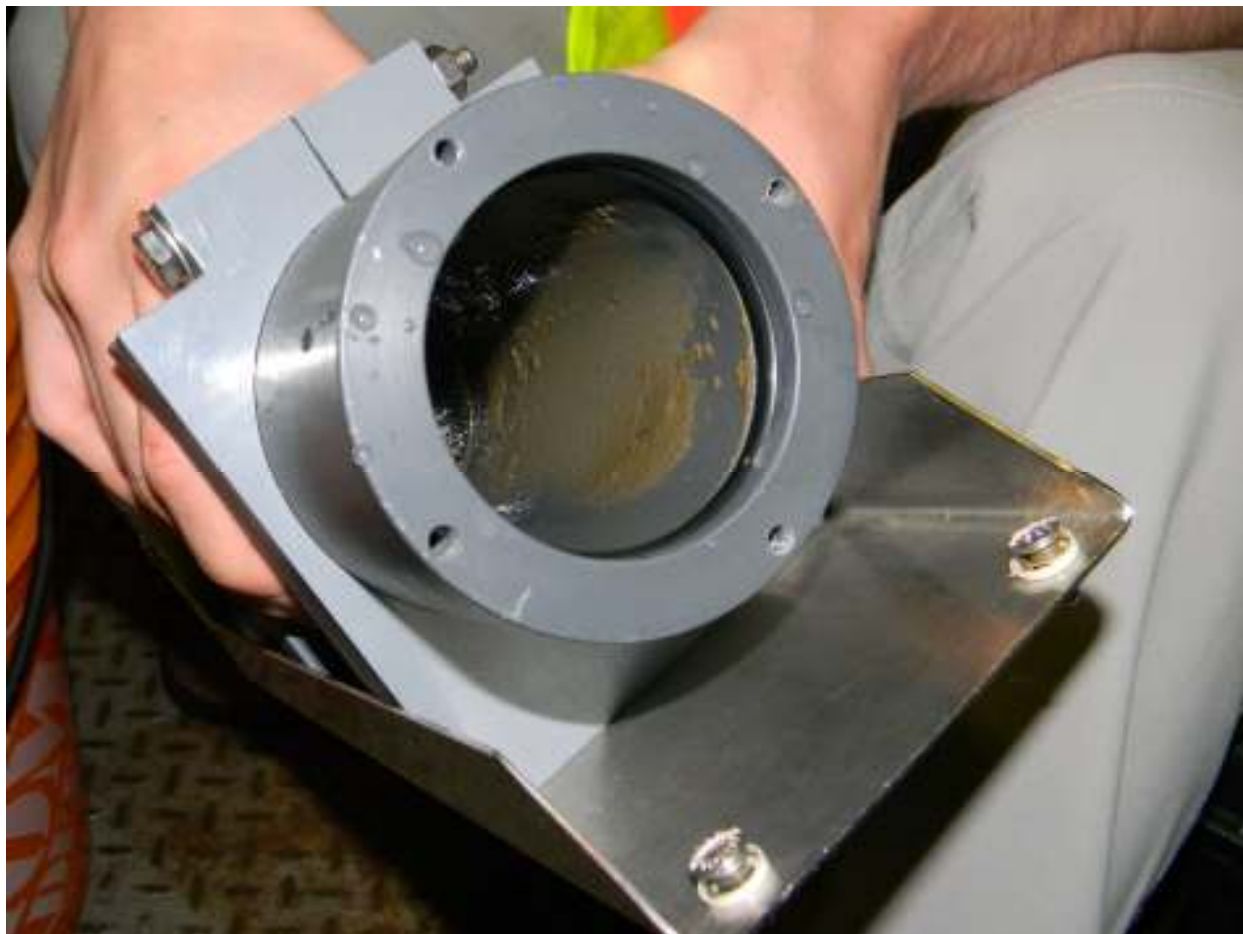
Figure 5. Buildup of sediment and biological material within the BBFL2-786 housing.

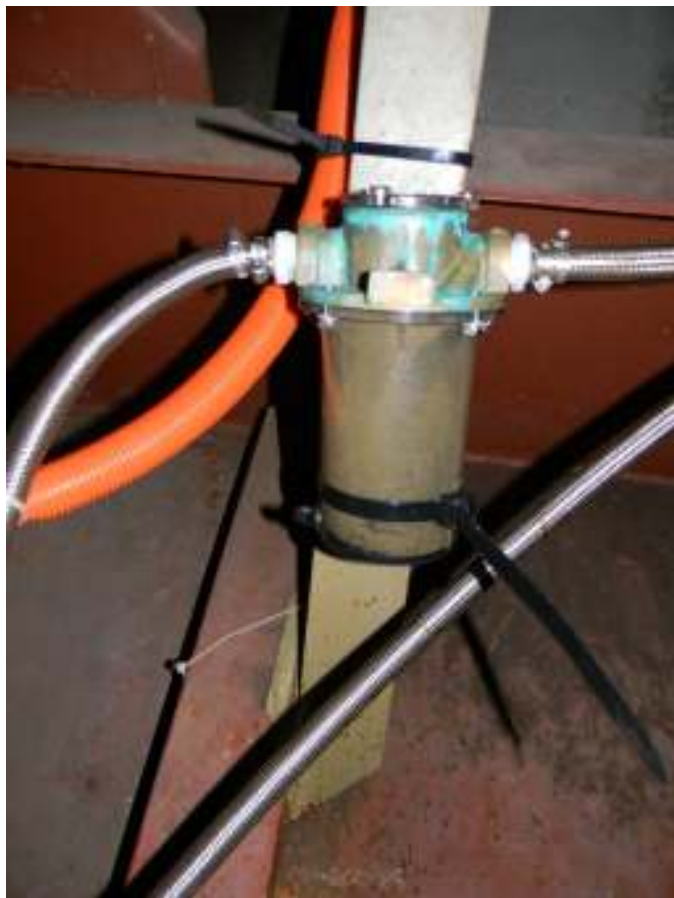
Figure 6. Sea-strainer before cleaning.

7. Checked over Sea chest and valves, no leaks apparent.
8. Checked and cleaned the sea strainer.
9. Turned ON the system. Re-named the BBL2 ID (from BBFL2 786 to BBFL2 787) in the SeaKeeper system software on board.
