Ferry Maintenance Report

Vessel: Queen of Alberni

Date: July 4, 2014

Reason for Visit

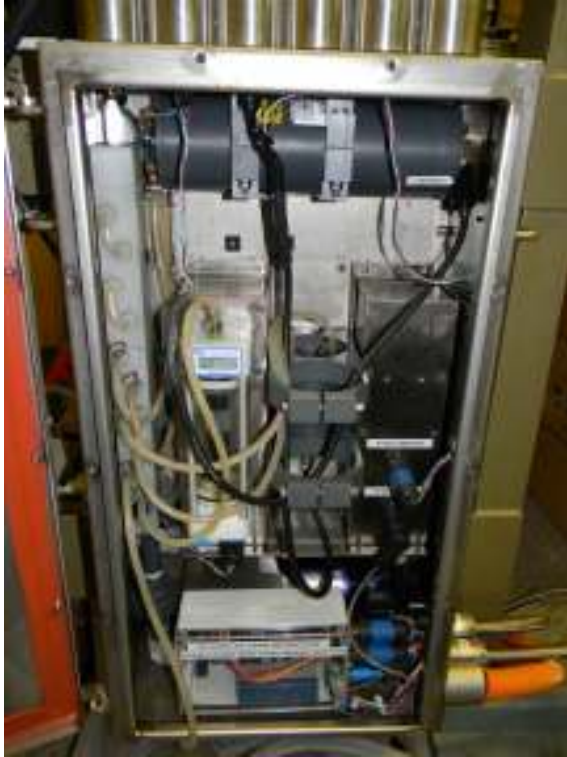
Figure 1: System upon arrival. Note dirty condition of flex tubing

4. Ran pre- and post- calibration with standard solutions and with pink and blue fluorescence test sticks for Chl and CDOM fluorescence.
5. Re-assembled the instruments in the lower box. Replaced all flex tubing with new material.
6. Checked over Sea chest and valves, no leaks apparent.
7. Checked and cleaned the sea strainer.
8. Turned ON the system.
9. No leaks in instrument housing and checked flow output at sea strainer. Flow was good. Visually confirmed flow direction at the BBFL2 and confirmed the volume filled with water and began draining correctly.
10. Signed out at Engineering room.

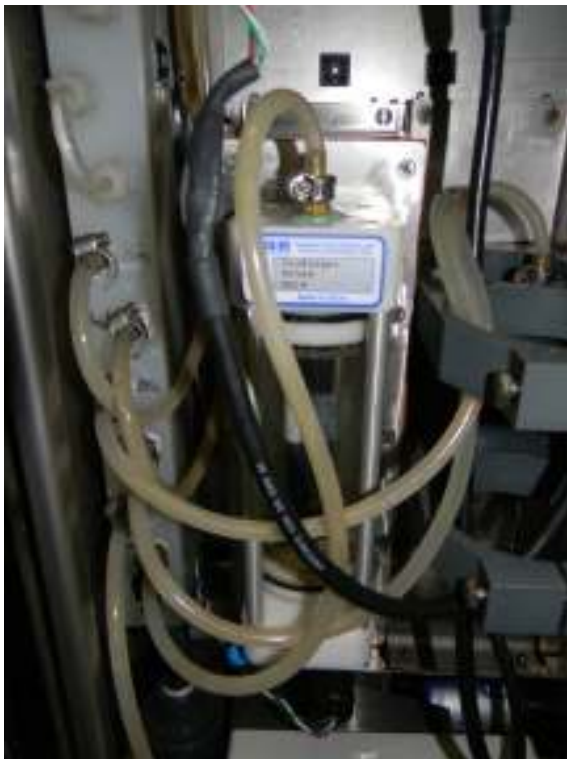
1. Opened both boxes and observed function. Both were working well, no leaks anywhere.
2. Powered down and disassembled instruments in lower assembly.
3. Cleaned and checked over instruments in Engineering room. Eight small Mussels (1/8" to 1/4" long) were found in the CT housing. These were removed during cleaning.

Figure 2: Some Mussels just visible above o-ring on lower end cap of CT unit.

1. Potentially replace CT sensor so that complete housing strip-down and cleaning can occur. Check with Denis regarding instrument spare situation. Replace CT connectors at the same time (shipboard connector will need to be re-soldered).
2. Monitor growth of Mussels within the system.

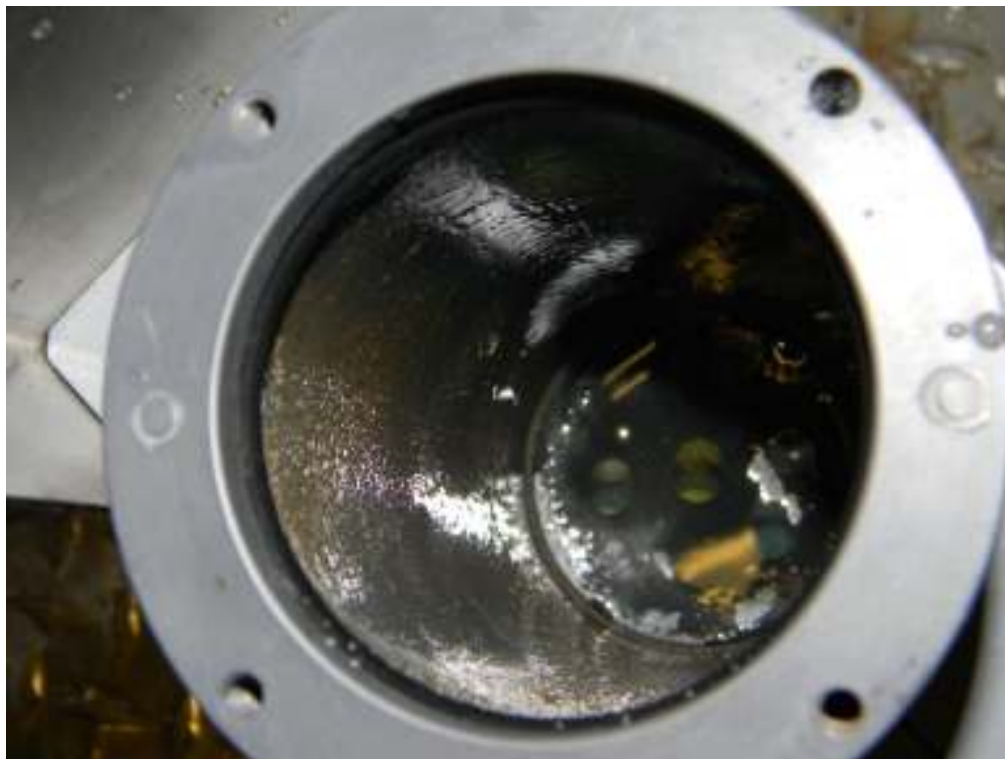
1. There were no signs of moisture or leaks In the Instrument Box.
2. The AADI optode had very little or no debris or sediment within the housing.
3. The BBFL2 had a minor partial layer of sediment in the housing and minor fouling on the sensing surface. Minor fouling was noticed on the "bottom" surface of the horizontal housing.
4. The Seabird 45 CT sensor was dirty with eight small mussels found within the housing.
5. The flex tubing was dirty enough to warrant replacement.
6. The sea chest showed no signs of leaks.
7. The inline filter (sea strainer) was checked and proved to be quite clean.
8. The CT connector corrosion has grown slightly but no evidence for signal degradation yet.

Figure 3: Interior of BBFL2 housing after opening.

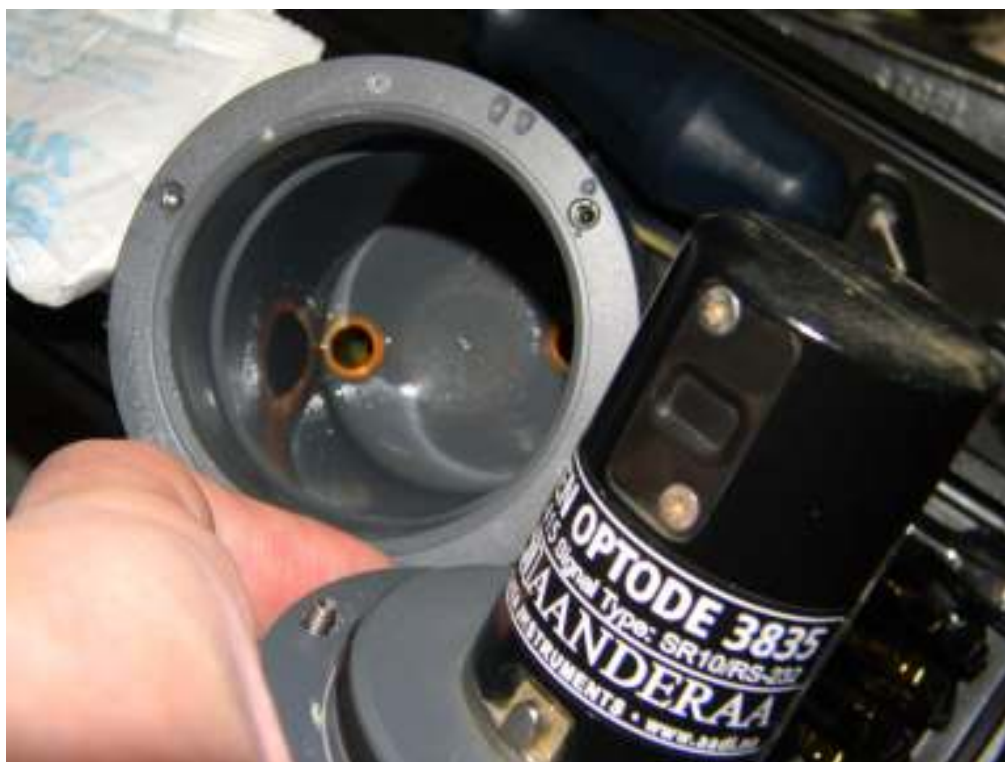
Figure 4: Optode upon opening

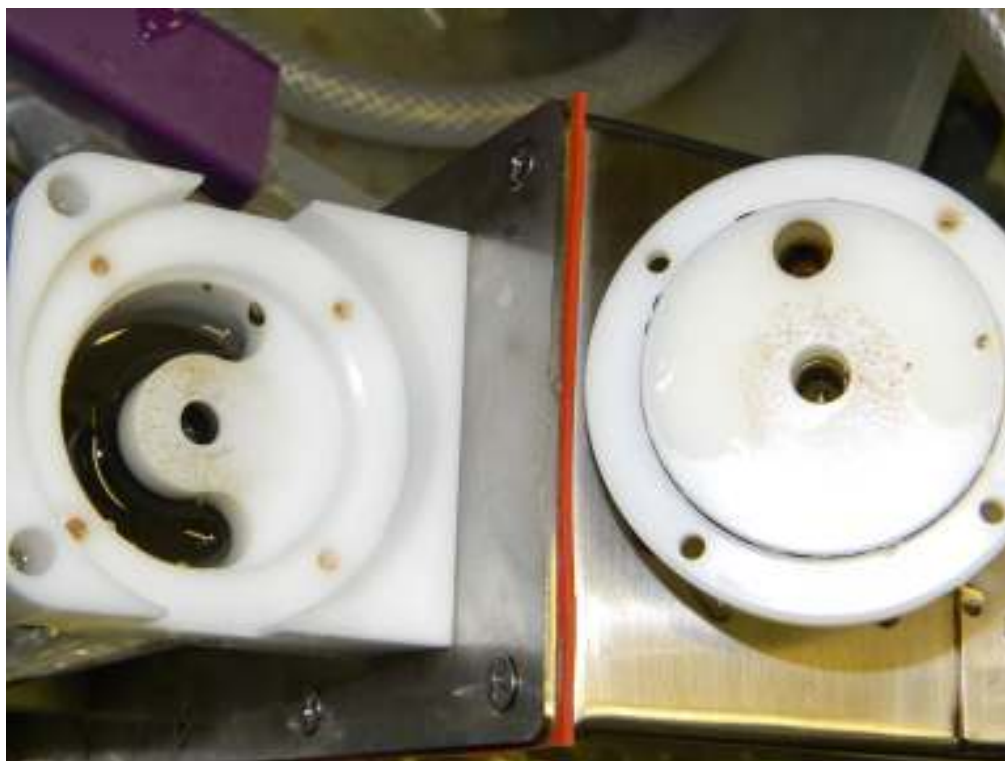
Figure 5: CT upon opening

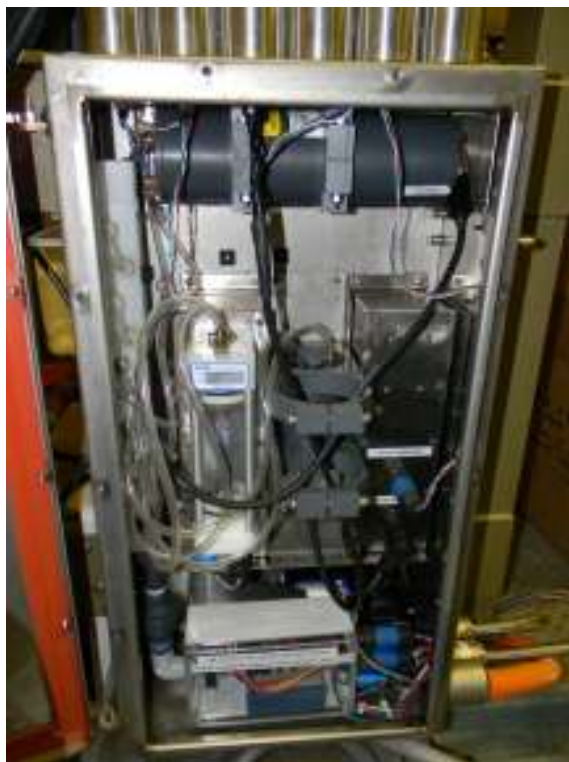
Figure 6: System post-cleaning

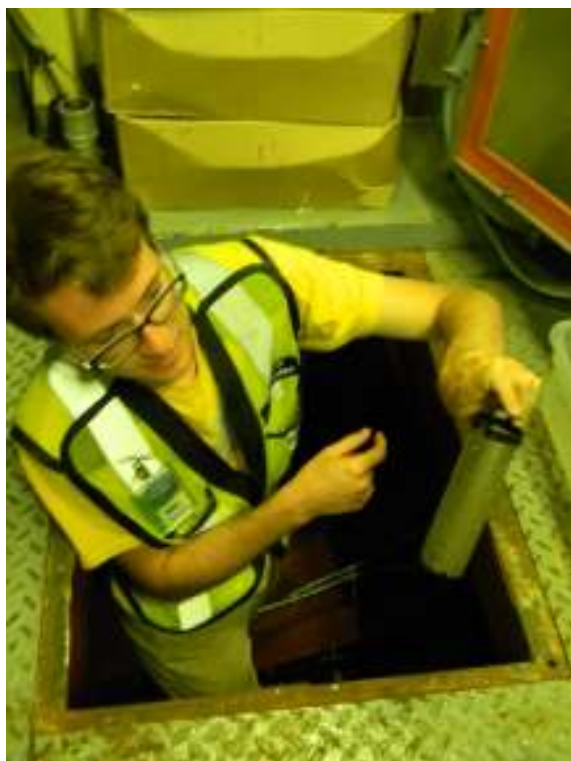
Figure 7: Sea strainer inspection
