Ocean Networks Canada

Ferry Maintenance Report – Queen of Alberni

Date: July 18, 2014

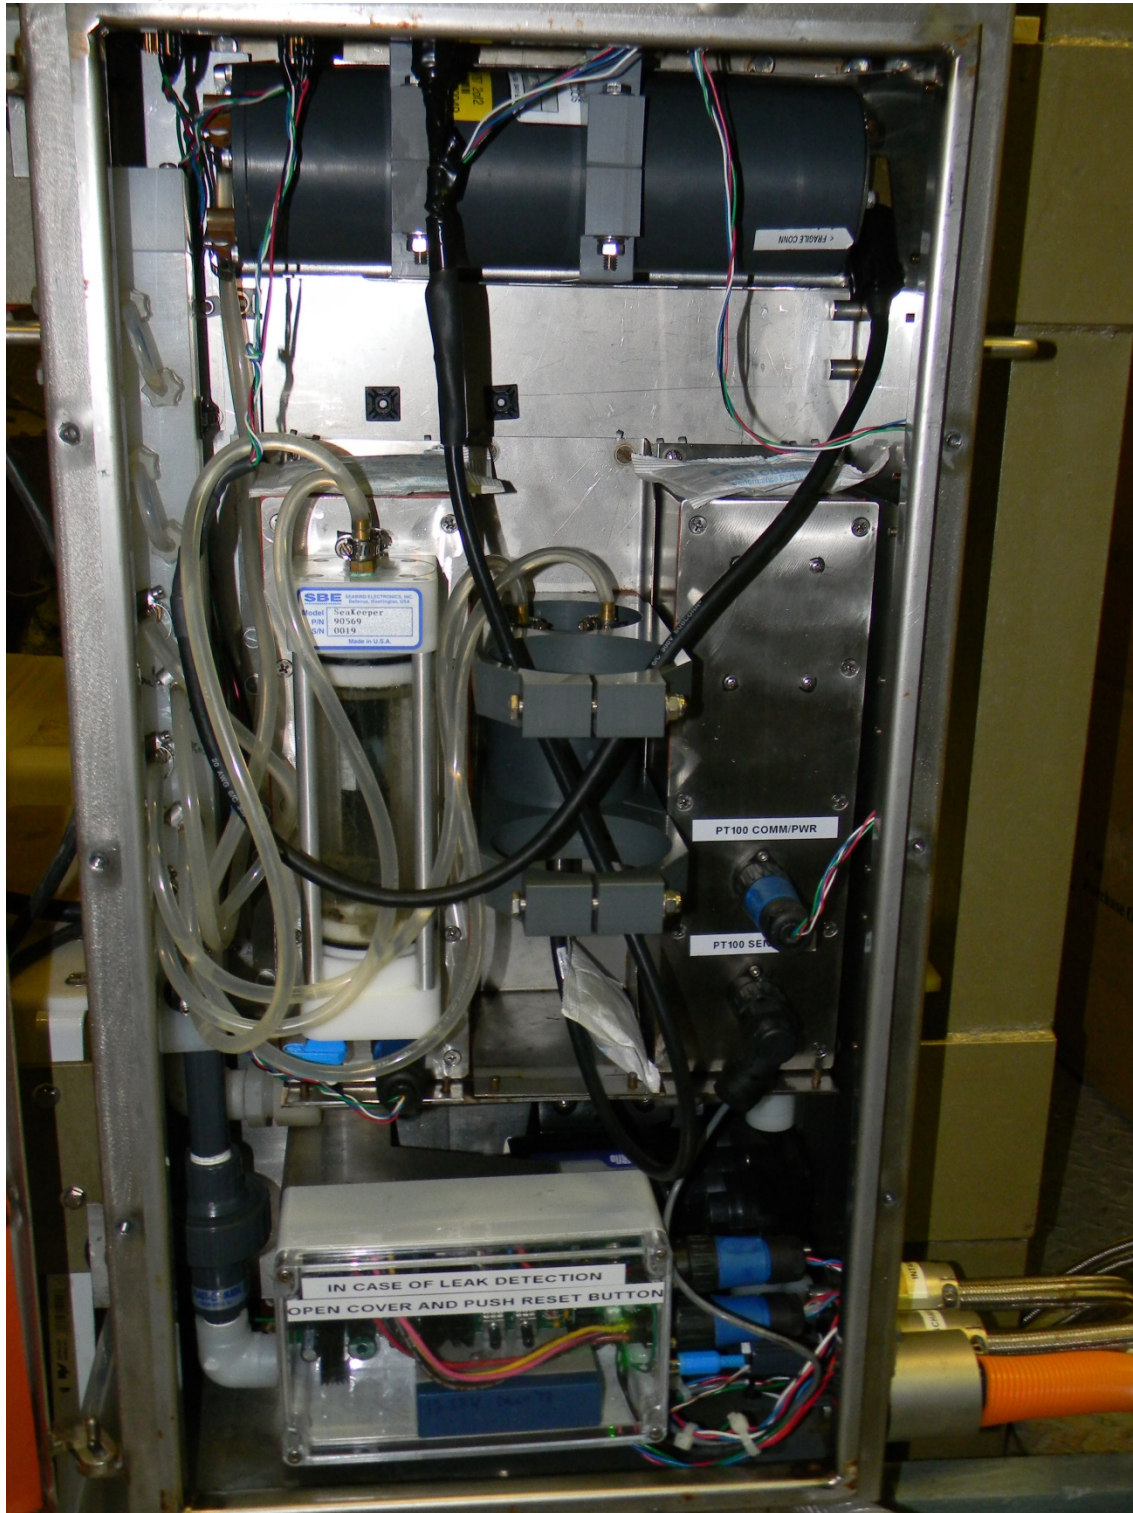
Figure 1: System Upon Arrival

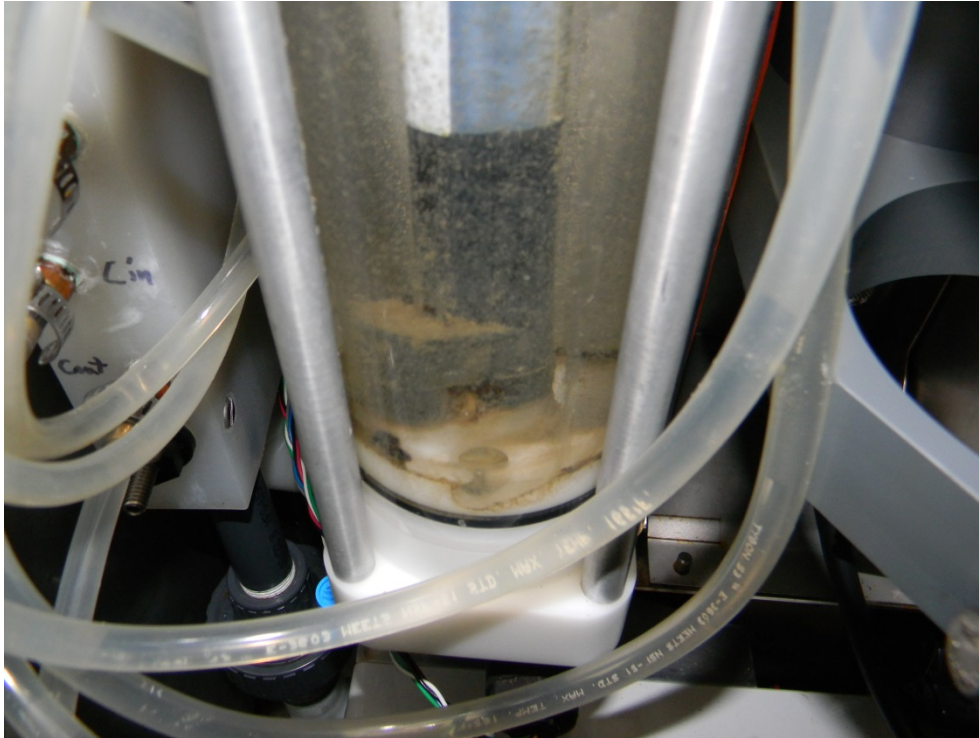
1. Opened both boxes and observed function. Both were working well, no leaks anywhere.
2. Powered down and disassembled instruments in lower assembly.
3. Cleaned and checked over instruments in Engineering room. Numerous small Mussels (1/8” to 1/4” long) were found in the CT housing. These were removed during cleaning. The CT sensor was completely disassembled for a thorough cleaning rather than the normal simple cleaning through the cleaning port. Cleaned CT sensor connector to remove corrosion scale.

Figure 2: Mussel Growth within CT Sensor

1. Potentially replace CT connector (shipboard connector will need to be re-soldered).
2. Monitor growth of Mussels within the system.
3. Purchase and stock DOW #4 silicone grease on ship. Purchase new #2 Philips Screwdriver (missing from toolkit). Purchase longer Slot screwdriver to make installation of panel screw for BBFL2 easier and less time consuming.

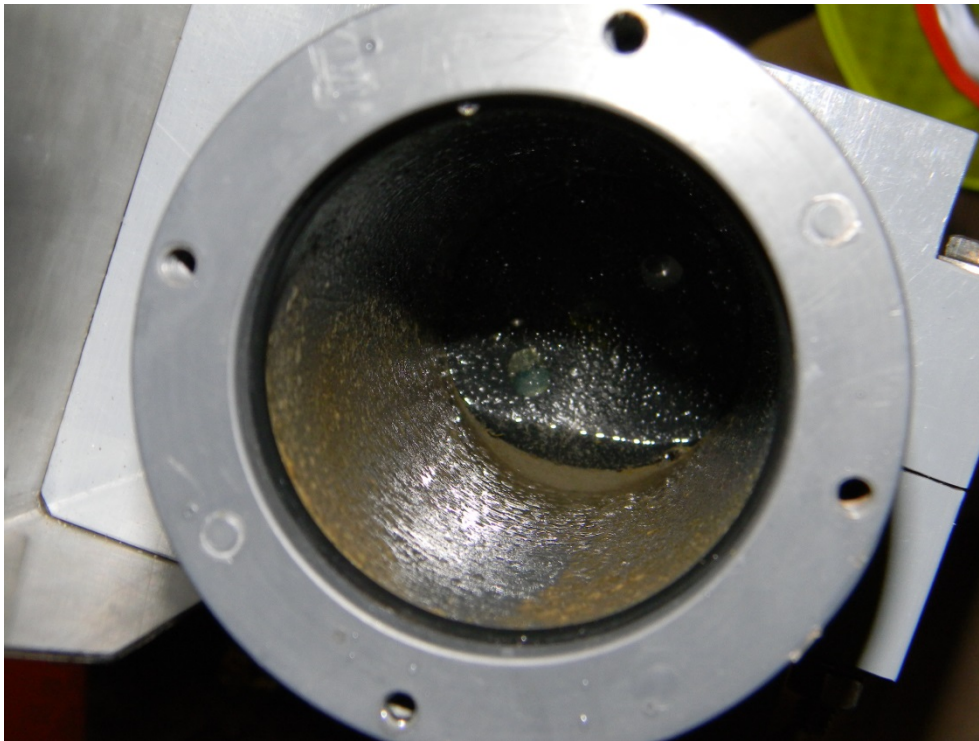
1. There were no signs of moisture or leaks In the Instrument Box.
2. The AADI optode had very little or no debris but had more than usual sediment/biofilm growth within the housing.
3. The BBFL2 had a partial layer of sediment in the housing and fouling on the sensing surface. Fouling was especially noticed on the “bottom” surface of the horizontal housing.
4. The Seabird 45 CT sensor was dirty with numerous small mussels found within the housing. This is the dirtiest the CT sensor has been since regular cleaning started.
5. The flex tubing was did not need replacement.
6. The sea chest showed no signs of leaks.
7. The inline filter (sea strainer) was checked and was found to be exceptionally dirty and required cleaning.
8. The CT connector corrosion has grown slightly but no evidence for signal degradation yet.

Figure 3: Fouling within BBFL2

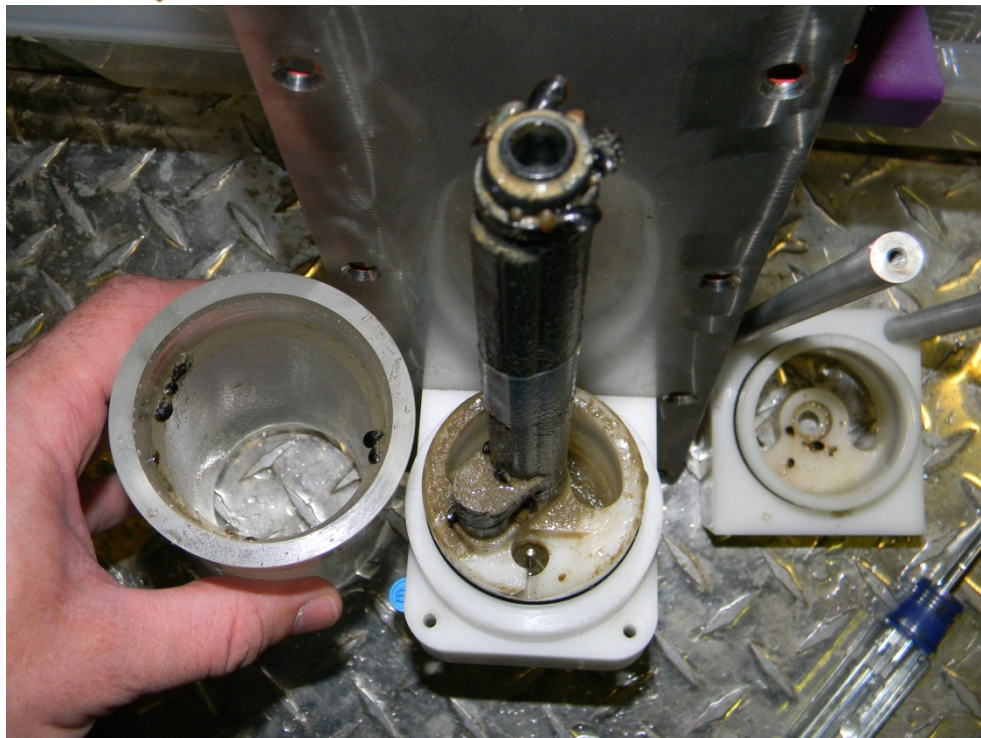
Figure 4: Mussel Growth and Fouling within Disassembled CT Sensor

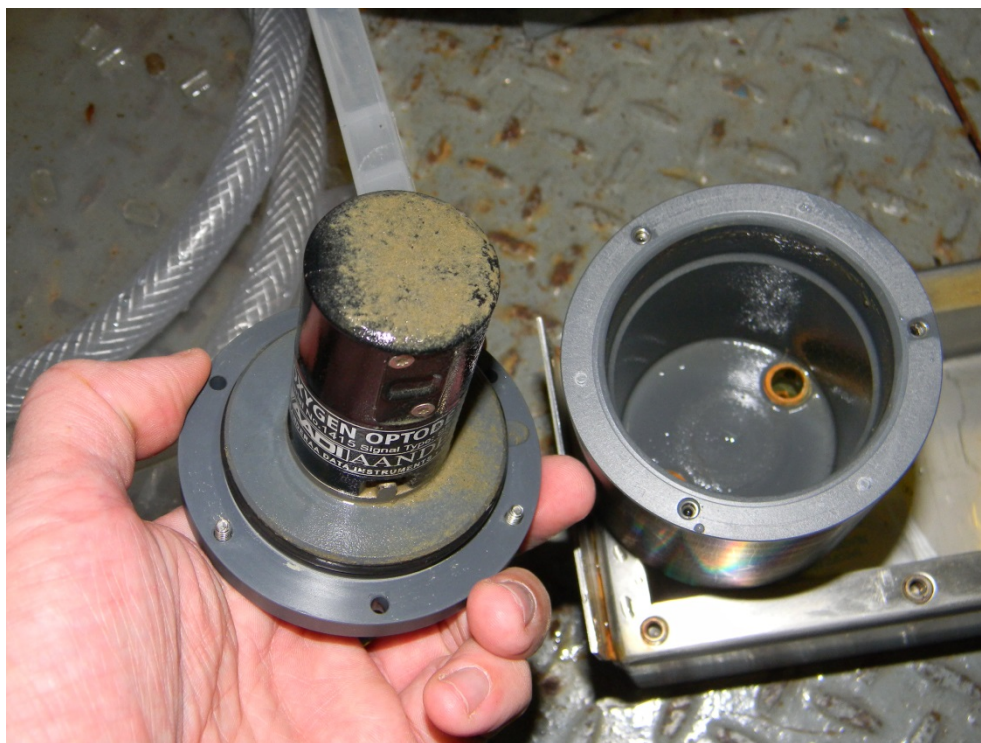
Figure 5: Fouling within Optode Sensor

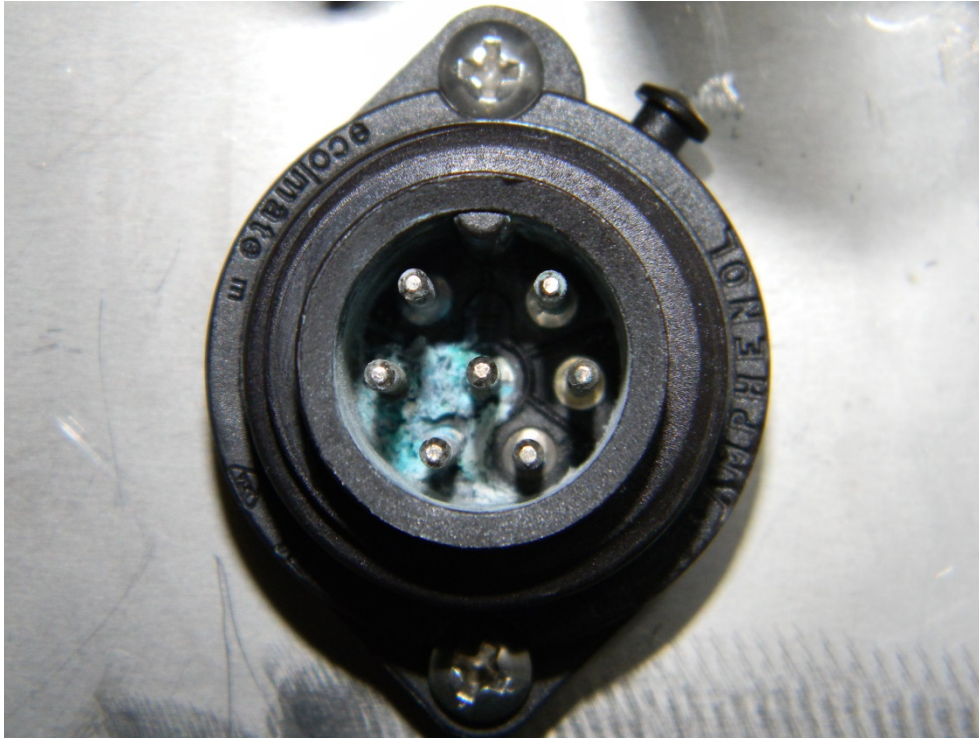
Figure 6: Corrosion within CT Sensor Connector

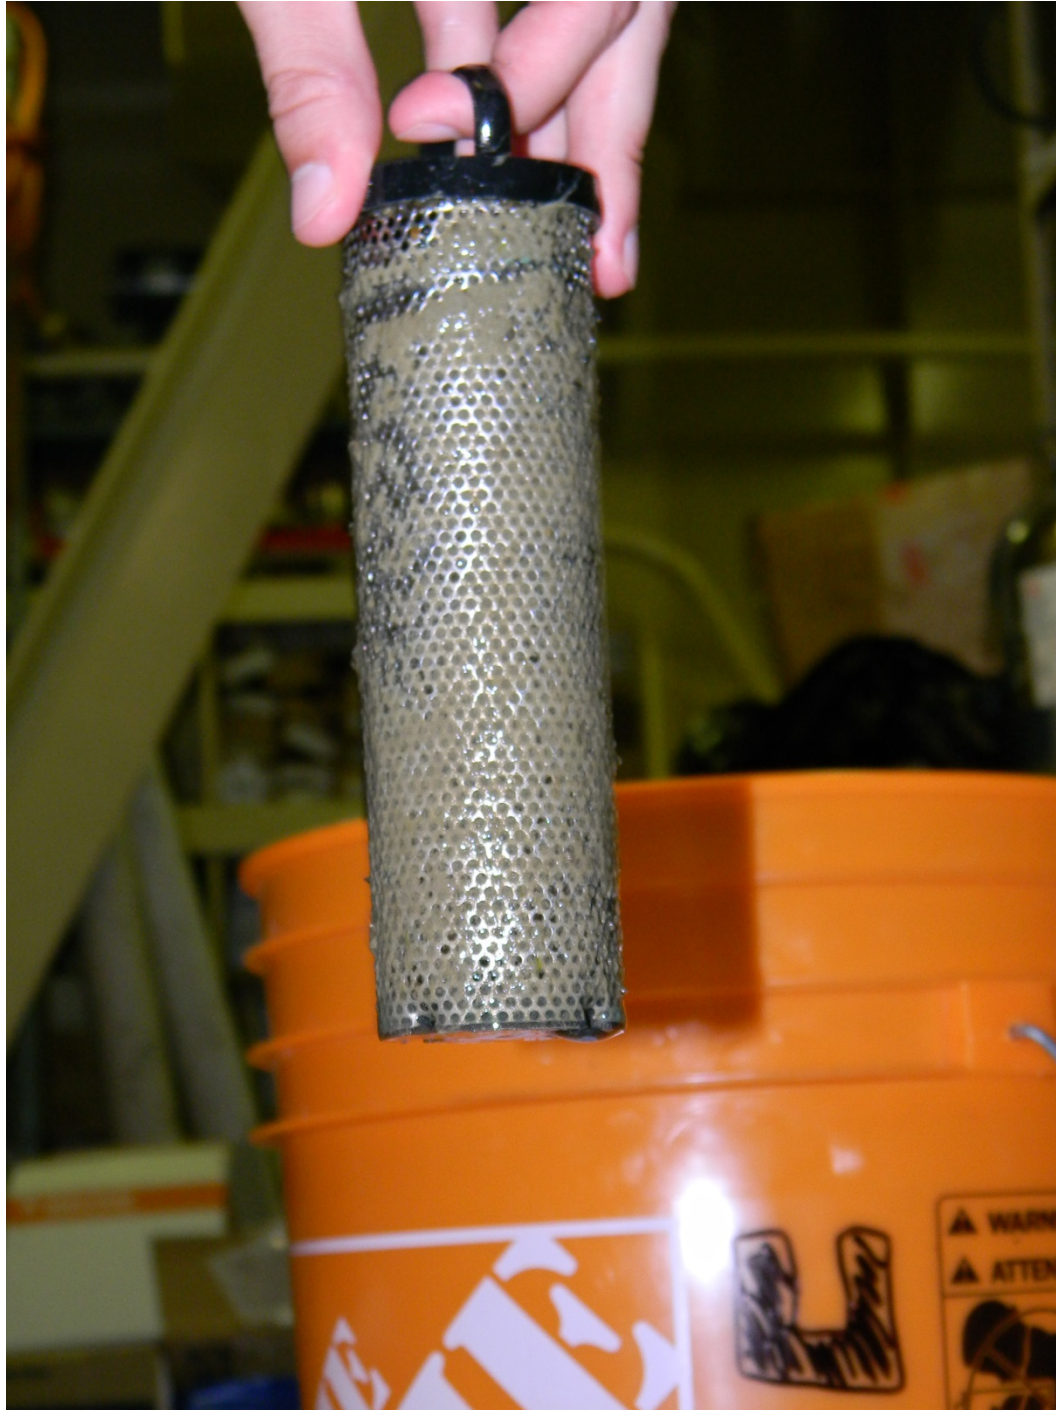
Figure 7: Fouling in Sea Strainer

4. Ran pre- and post- calibration with standard solutions and with Orange test stick and blue test stick for CDOM fluorescence and Chl fluorescence.
5. Re-assembled the instruments in the lower box.
6. Checked over Sea chest and valves, no leaks apparent.
7. Checked and cleaned the sea strainer.
8. Turned ON the system.
9. No leaks in instrument housing and checked flow output at sea strainer. Flow was good. Visually confirmed flow direction at the BBFL2 and confirmed the volume filled with water and began draining correctly.
10. Signed out at Engineering room.

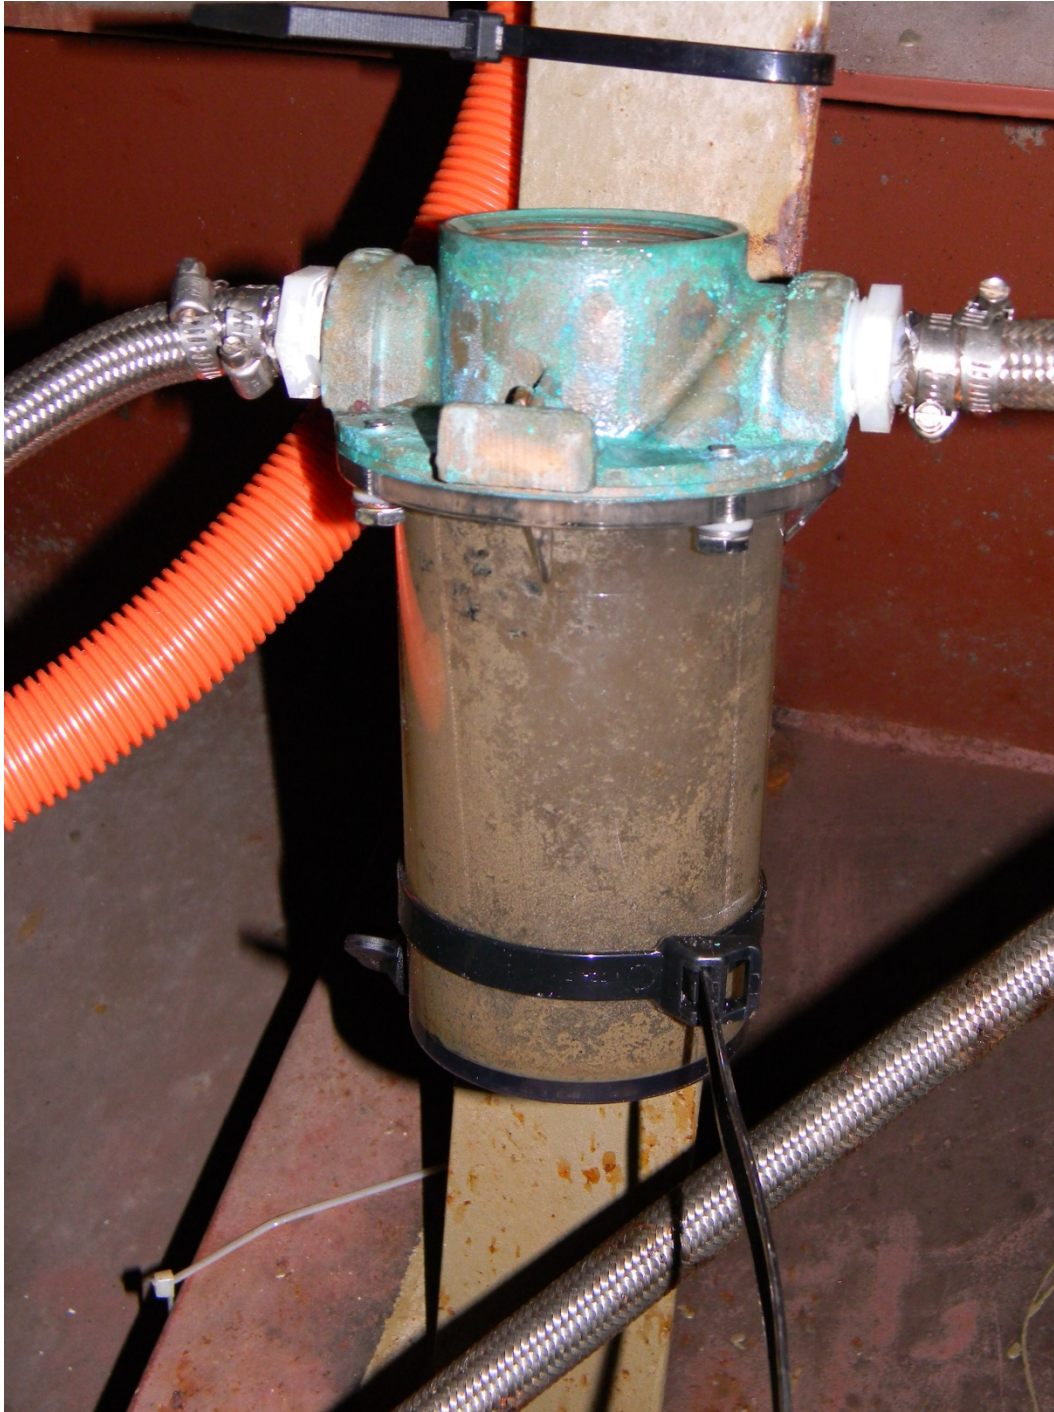
Figure 8: Fouling in Sea Strainer

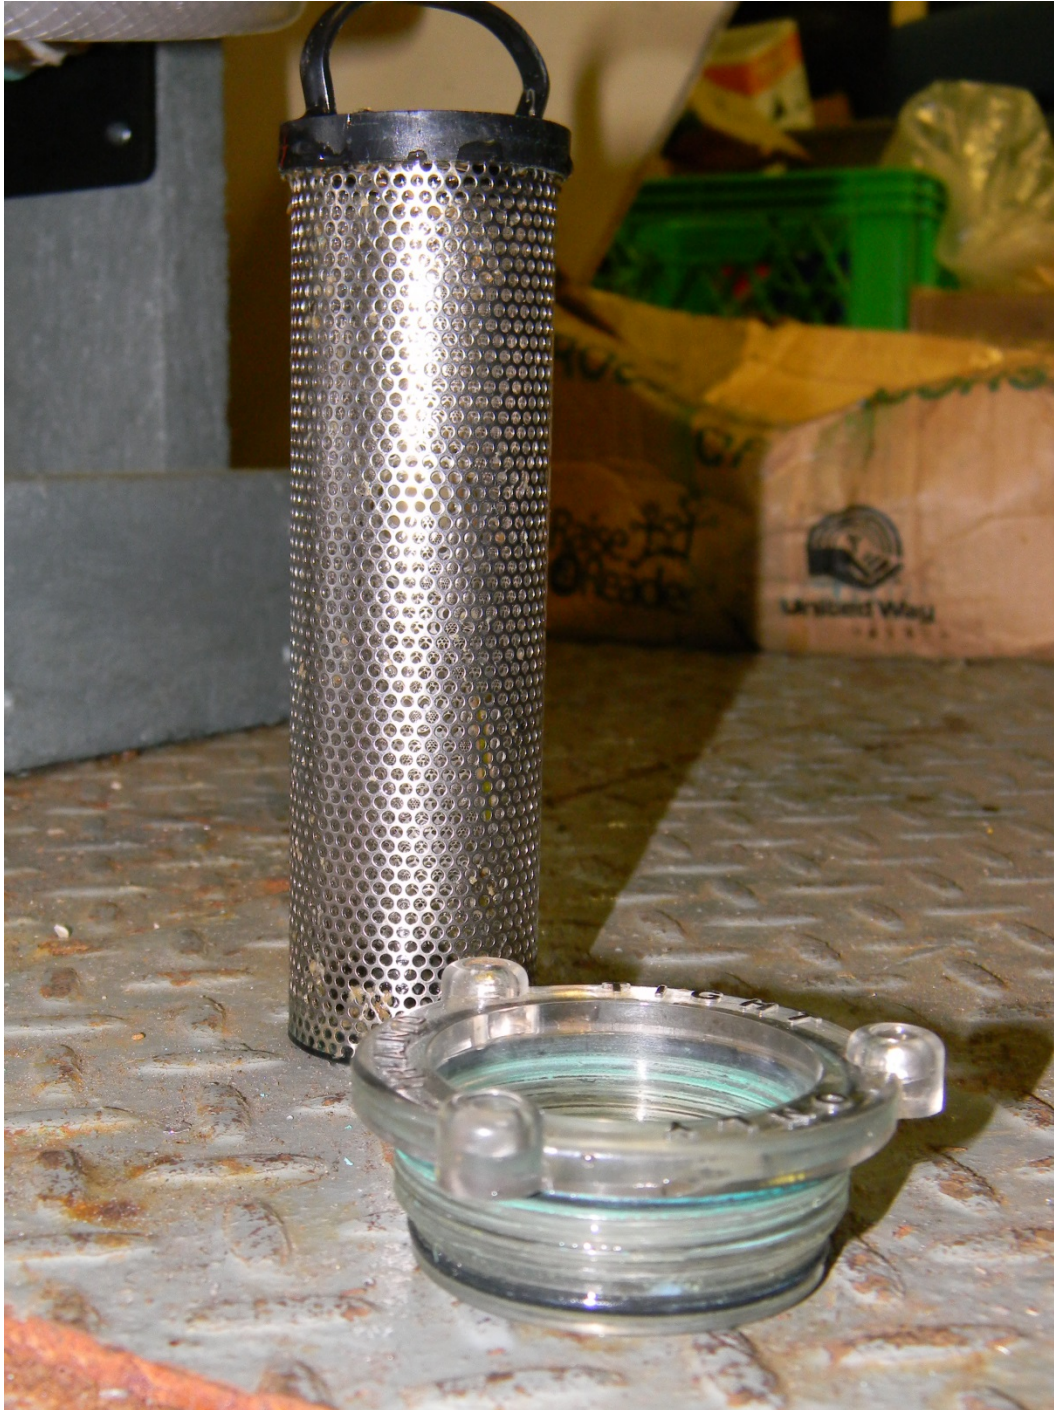
Figure 9: Cleaned Sea Strainer

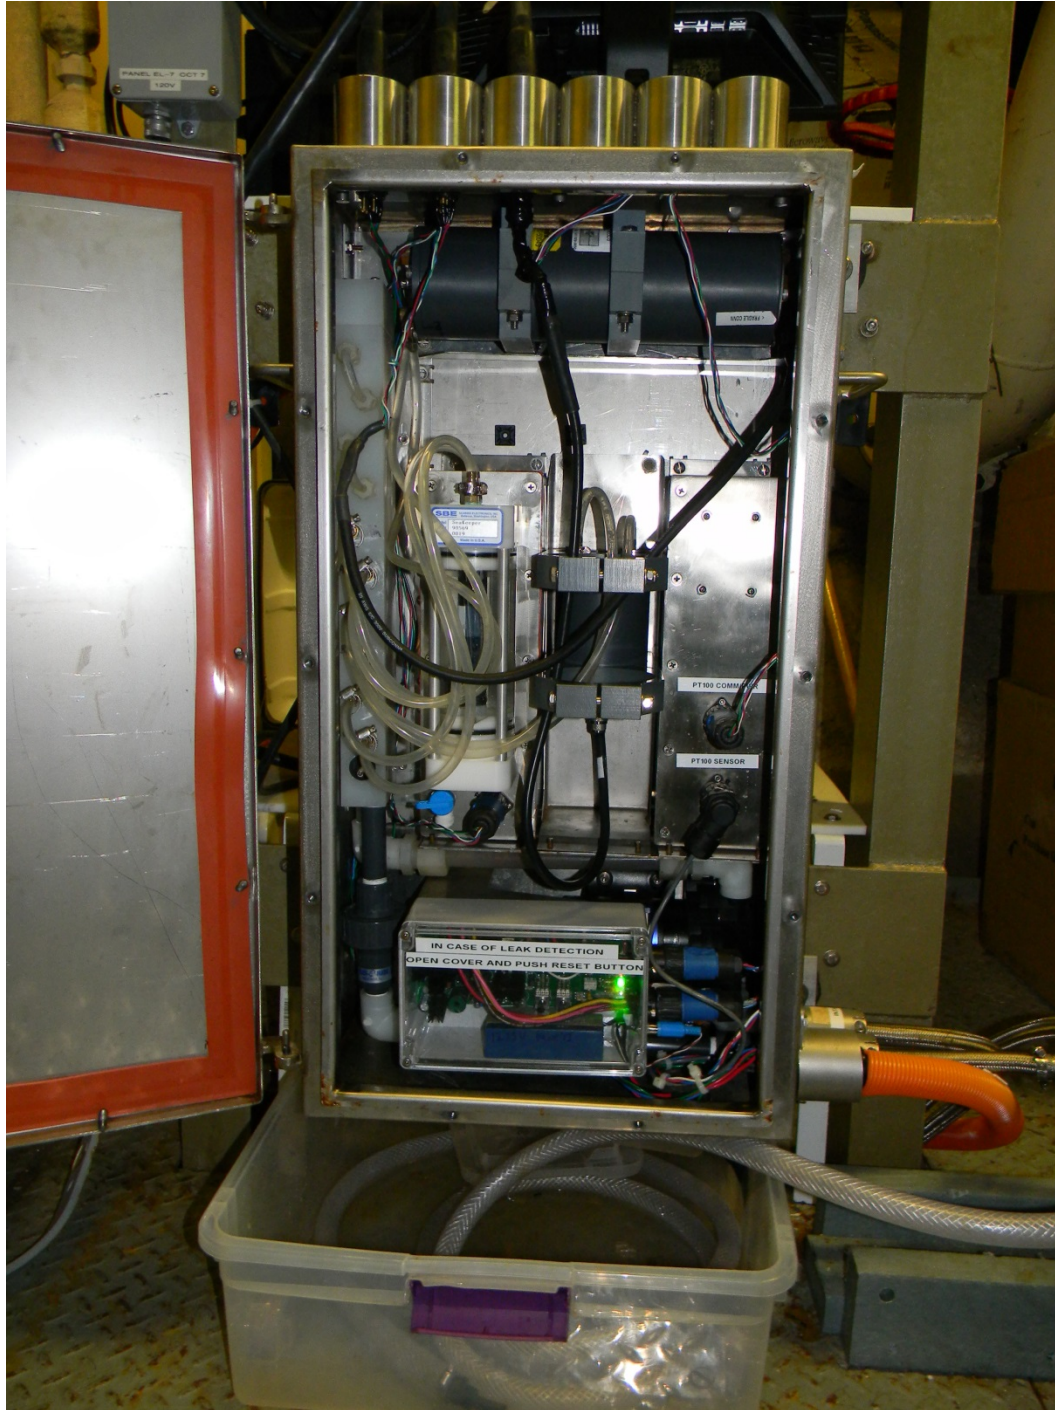
Figure 10: Cleaned System Operating post-Servicing
