Ocean Networks Canada

Ferry Maintenance Report – Queen of Alberni

Date: August 1, 2014

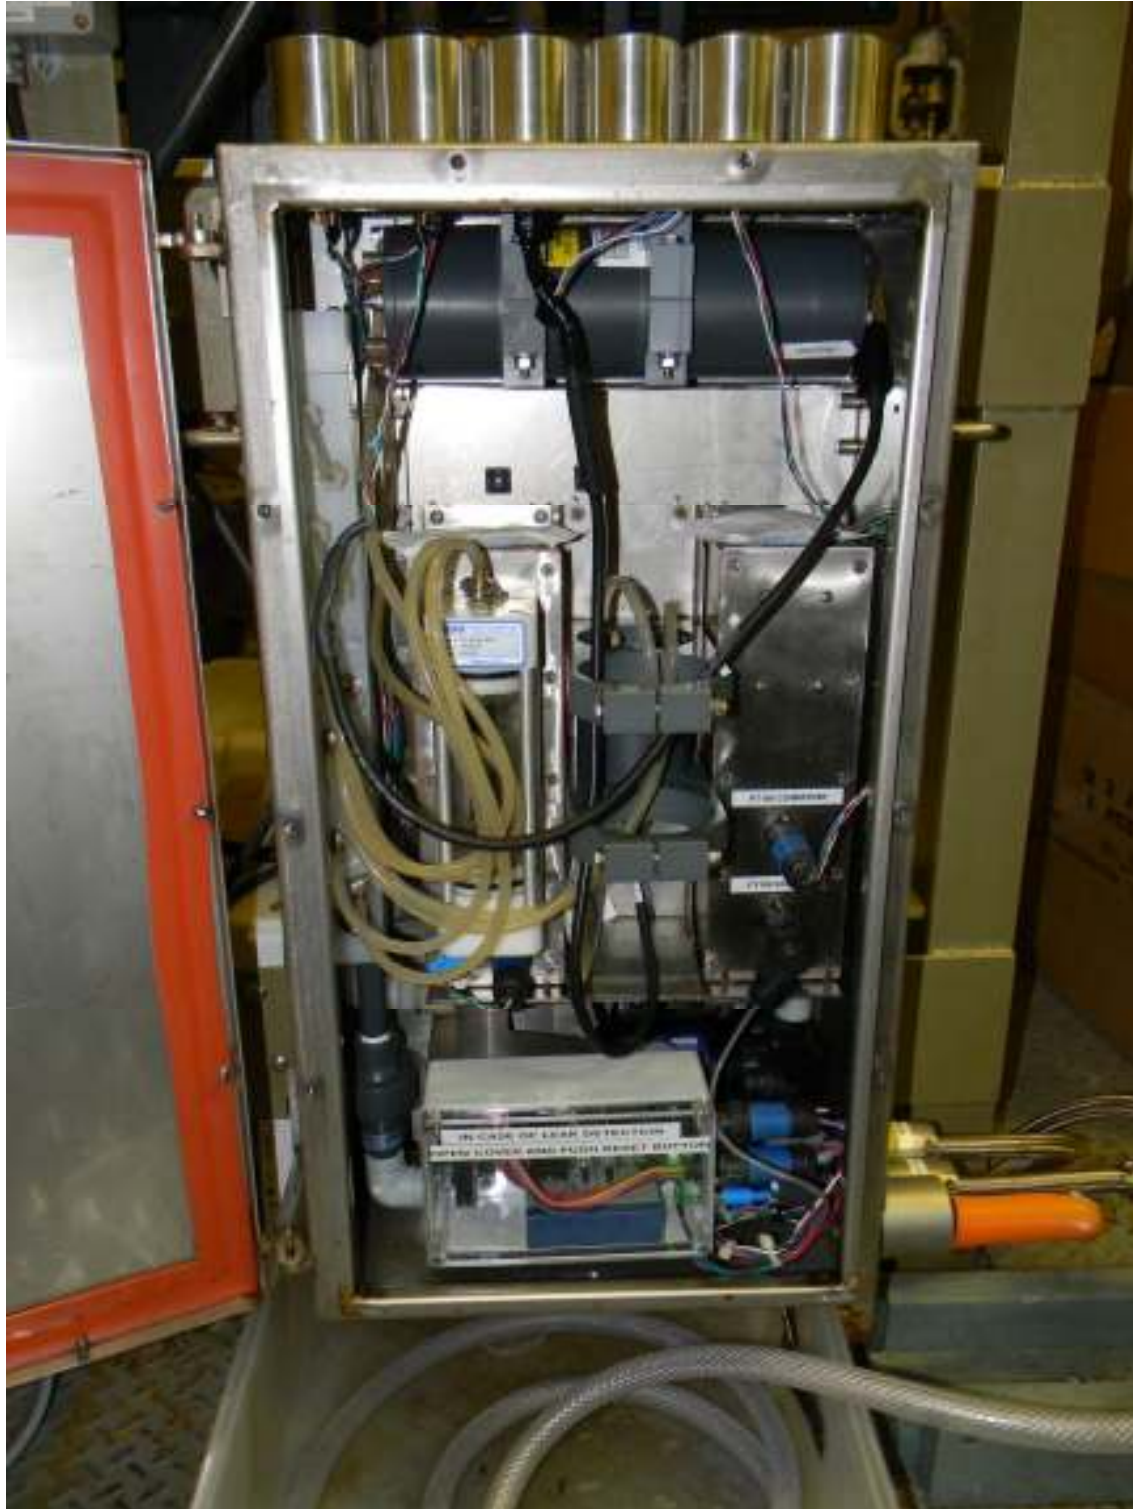
Figure 1: System upon arrival

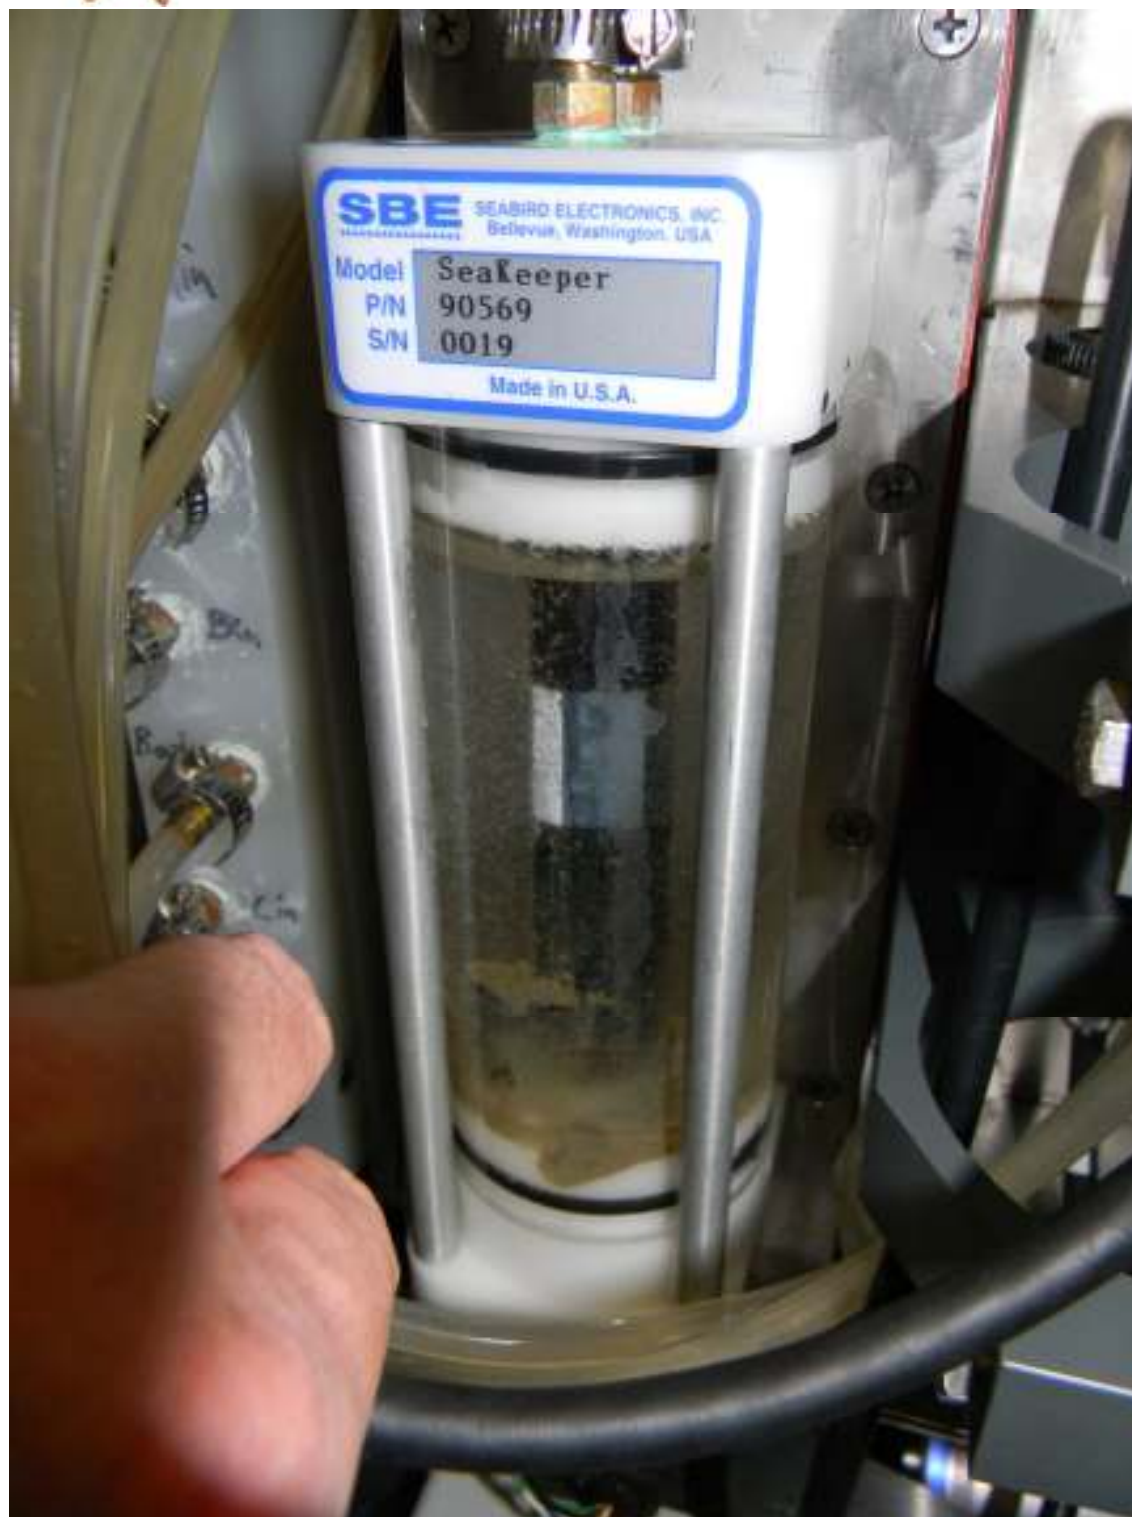
Figure 2: Sediment and biofouling within CT sensor

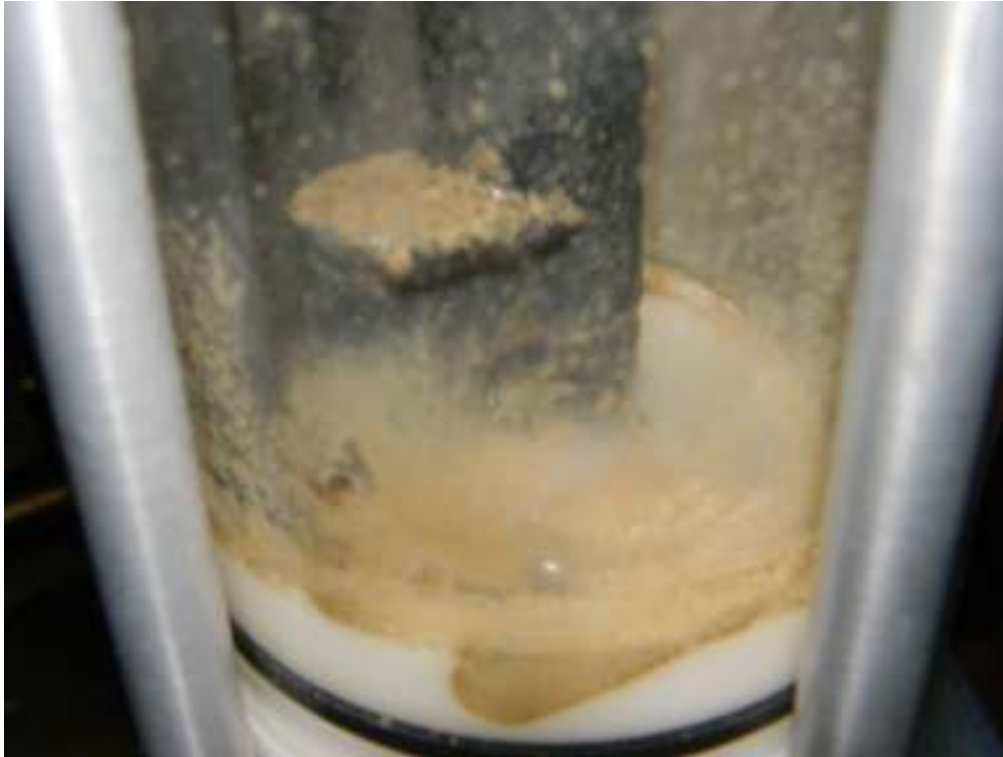
Figure 3: Biofouling within CT sensor

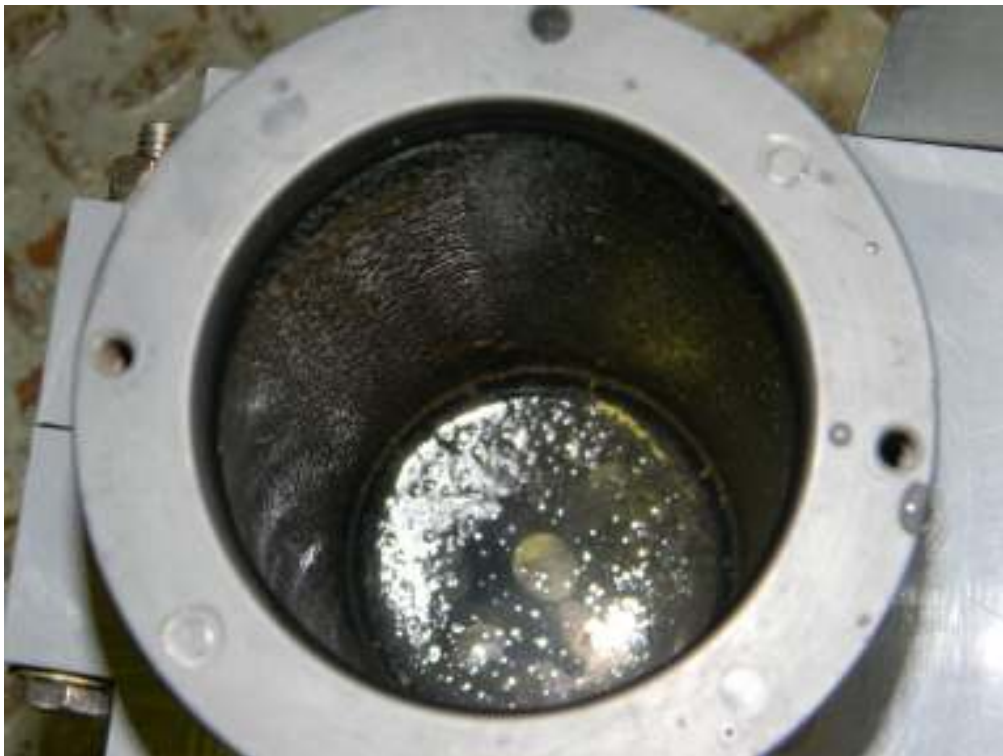
Figure 4: Biofouling within BBFL2 sensor

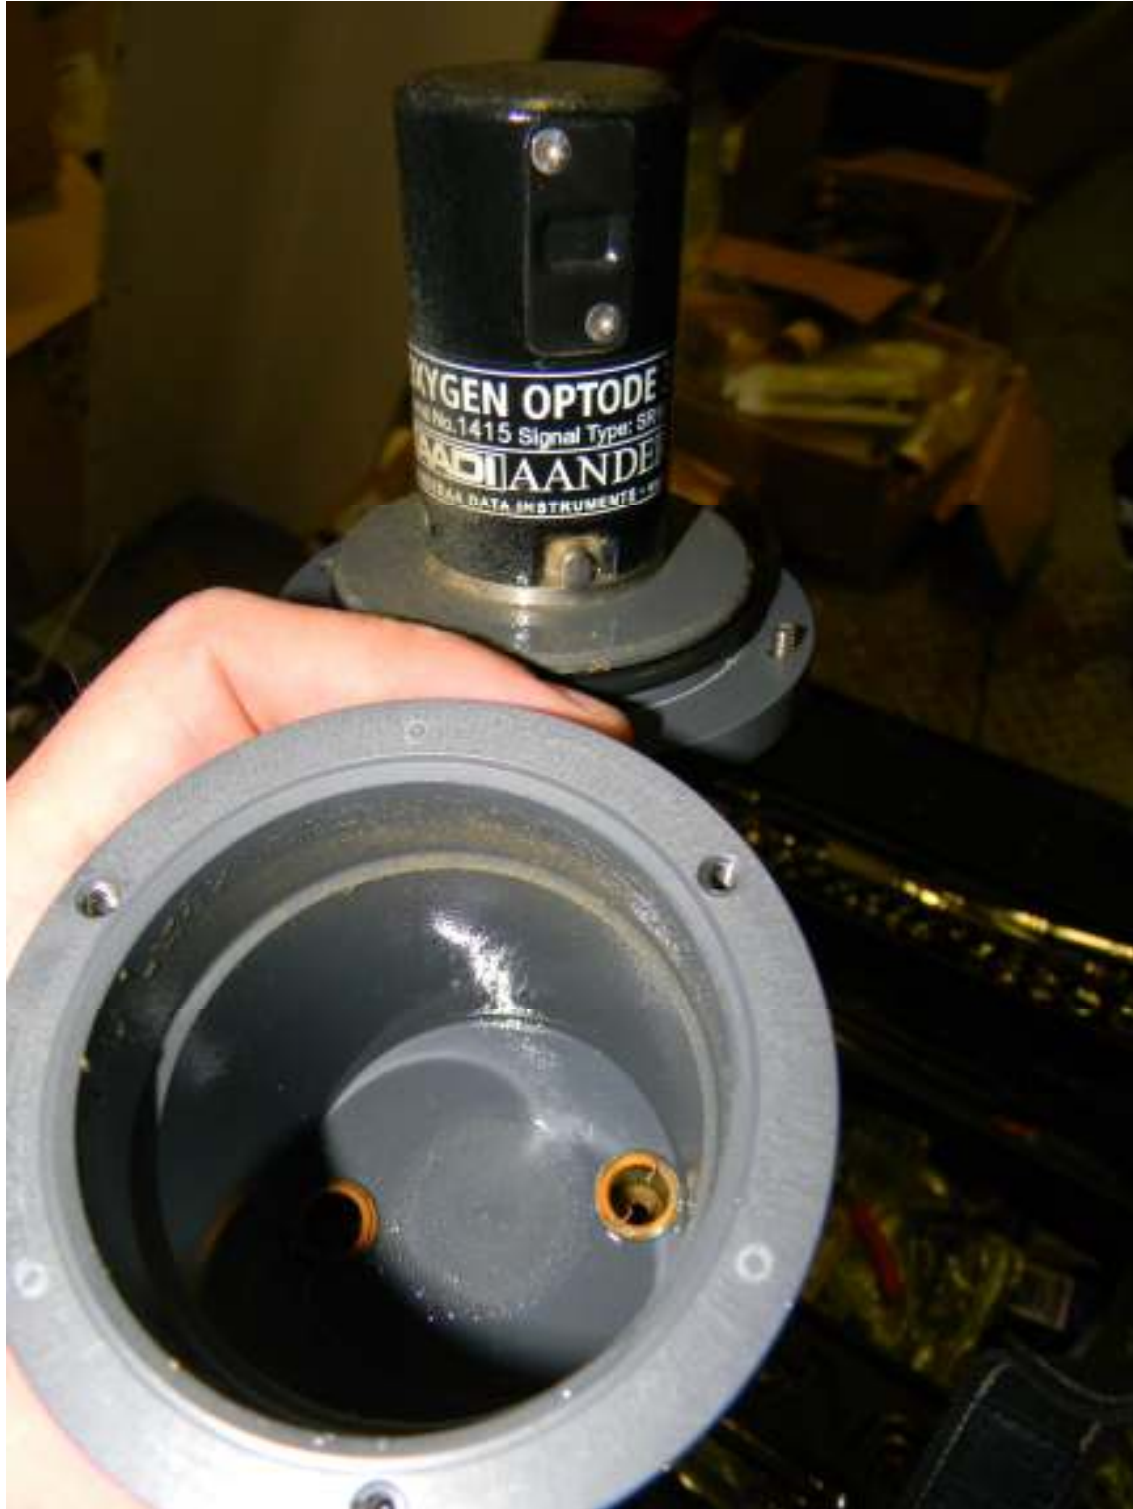
Figure 5: Biofouling within Optode sensor

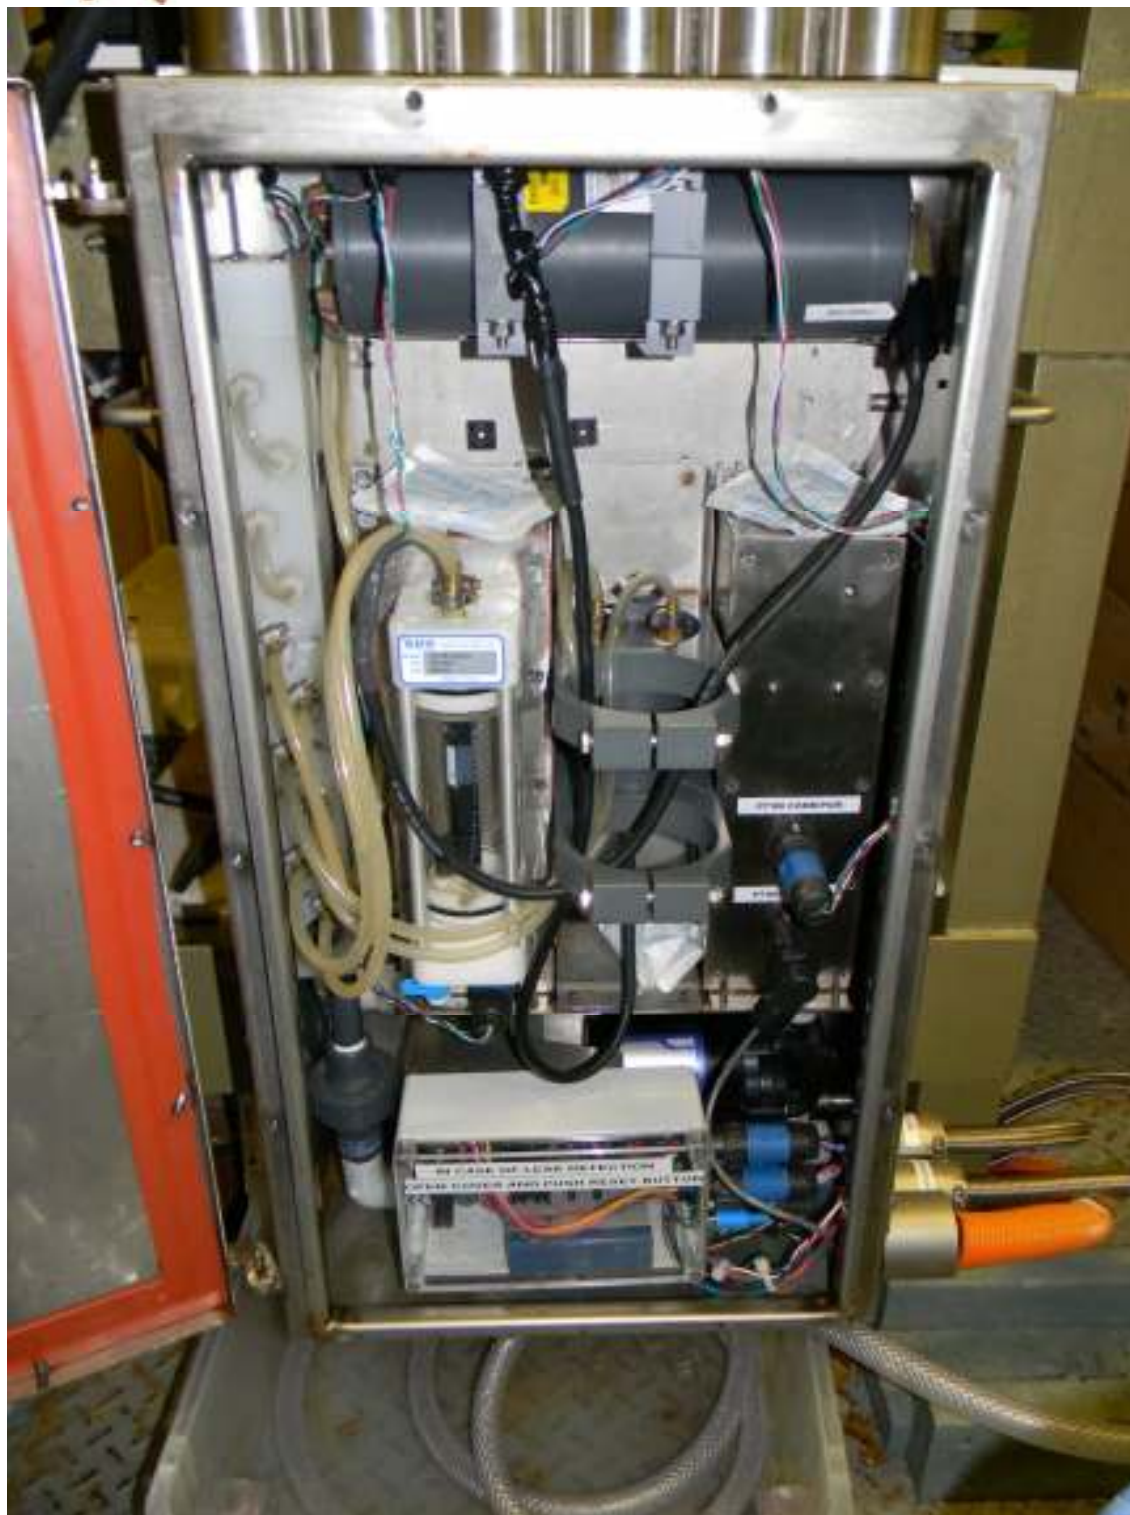
Figure 6: System upon reassembly

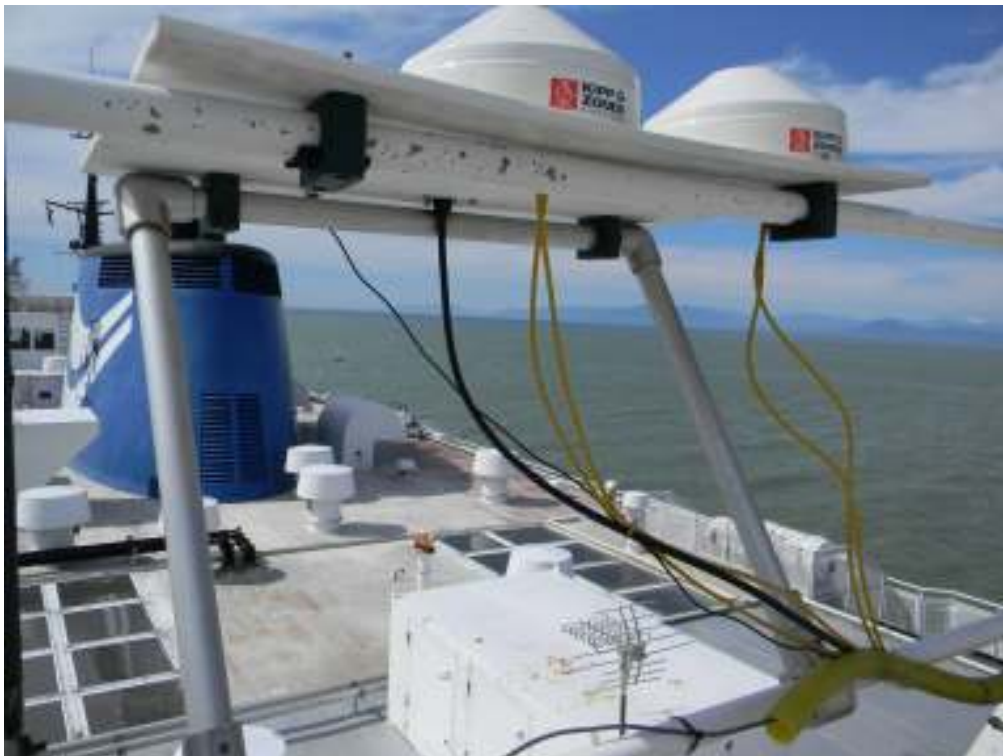
Figure 9: Connector view

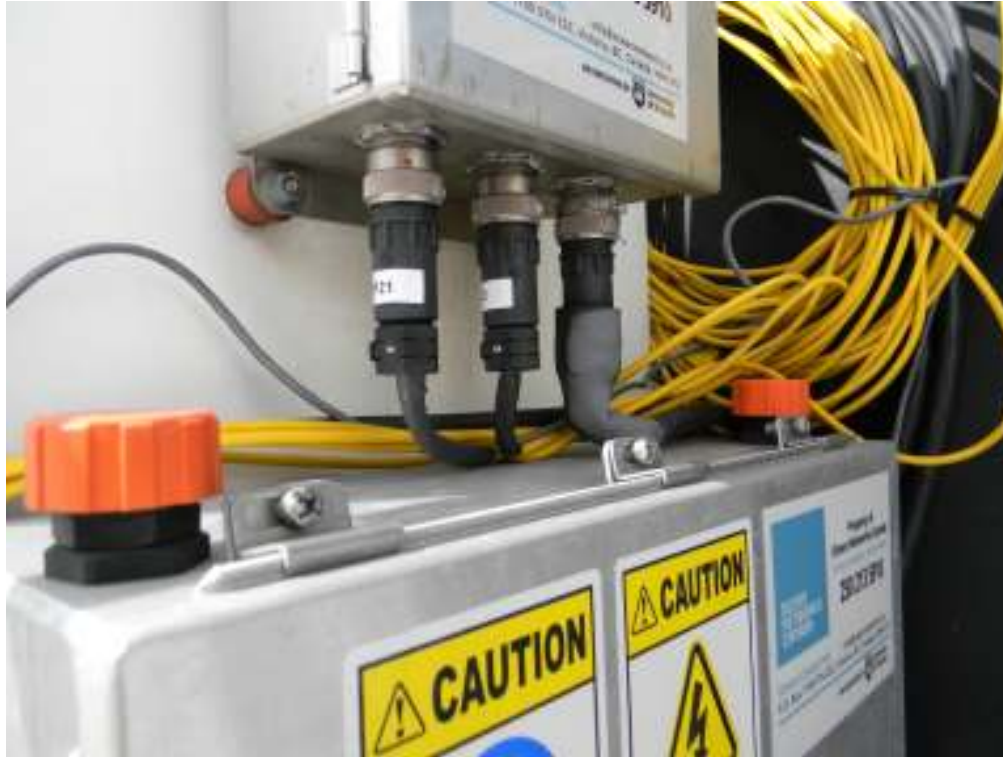
Figure 11: Corrosion on connectors (upper box)

1. Potentially replace CT connector (shipboard connector will need to be re-soldered).
2. Monitor growth of Mussels within the system.
3. Purchase new #2 Philips Screwdriver (missing from toolkit). Purchase longer Slot screwdriver to make installation of panel screw for BBFL2 easier and less time consuming.
4. November refit, replace all metallic connectors on upper boxes with plastic glands.

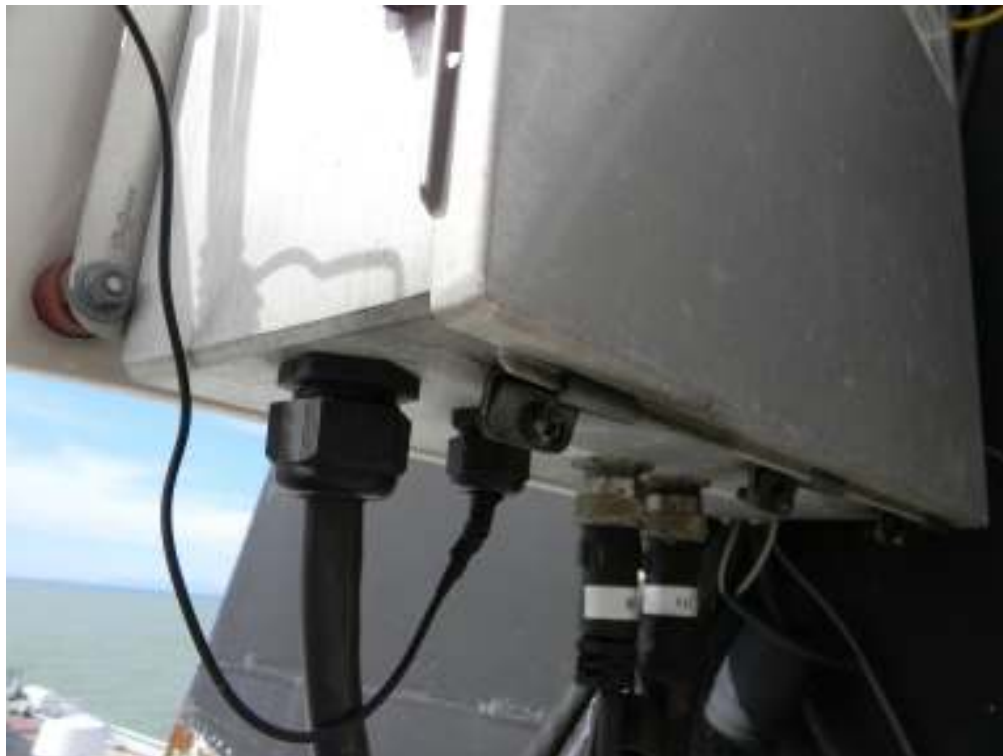
Figure 12: Corrosion on connectors (lower box)
