Ocean Networks Canada

Ferry Maintenance Report – Queen of Alberni

Date: October 3rd, 2014

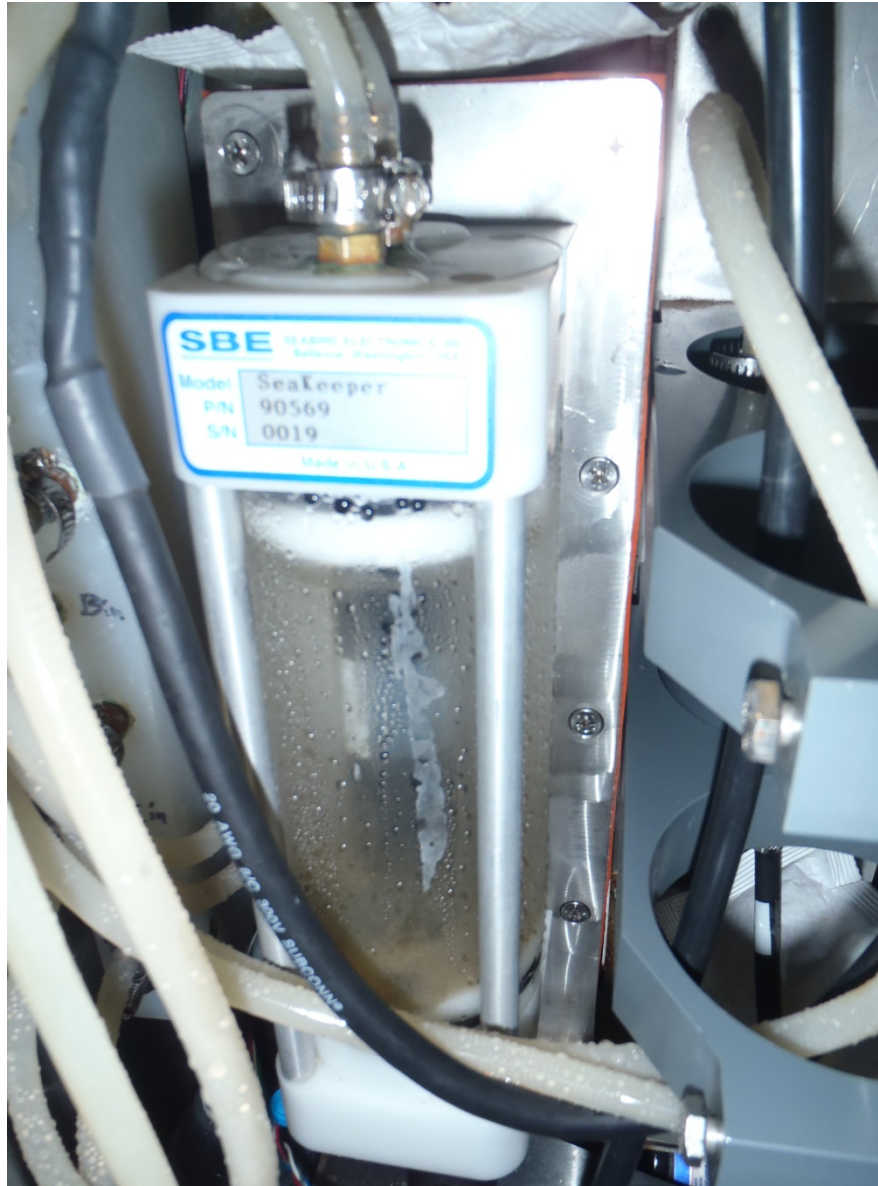
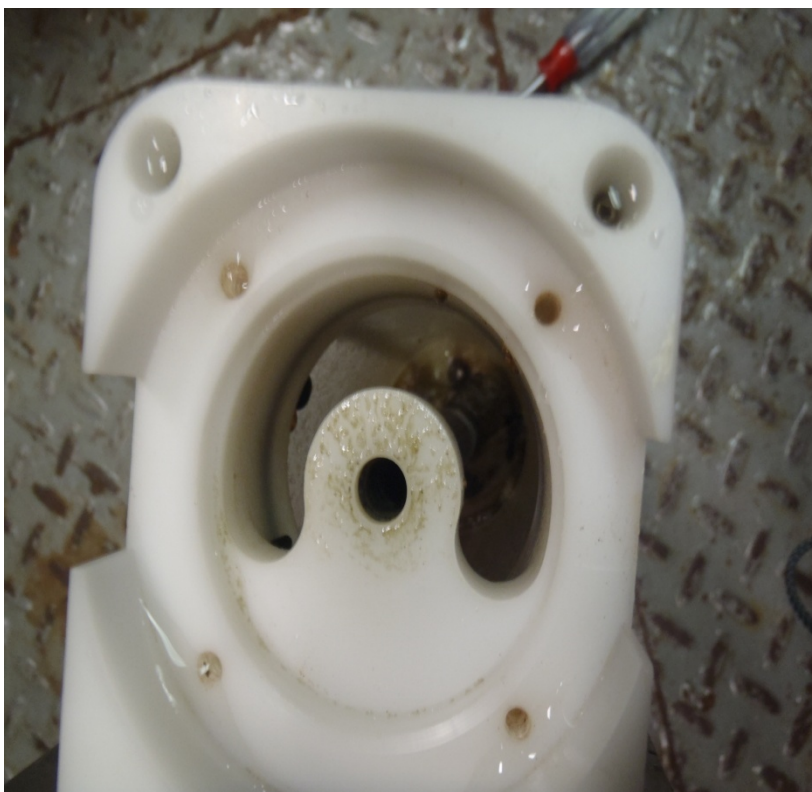
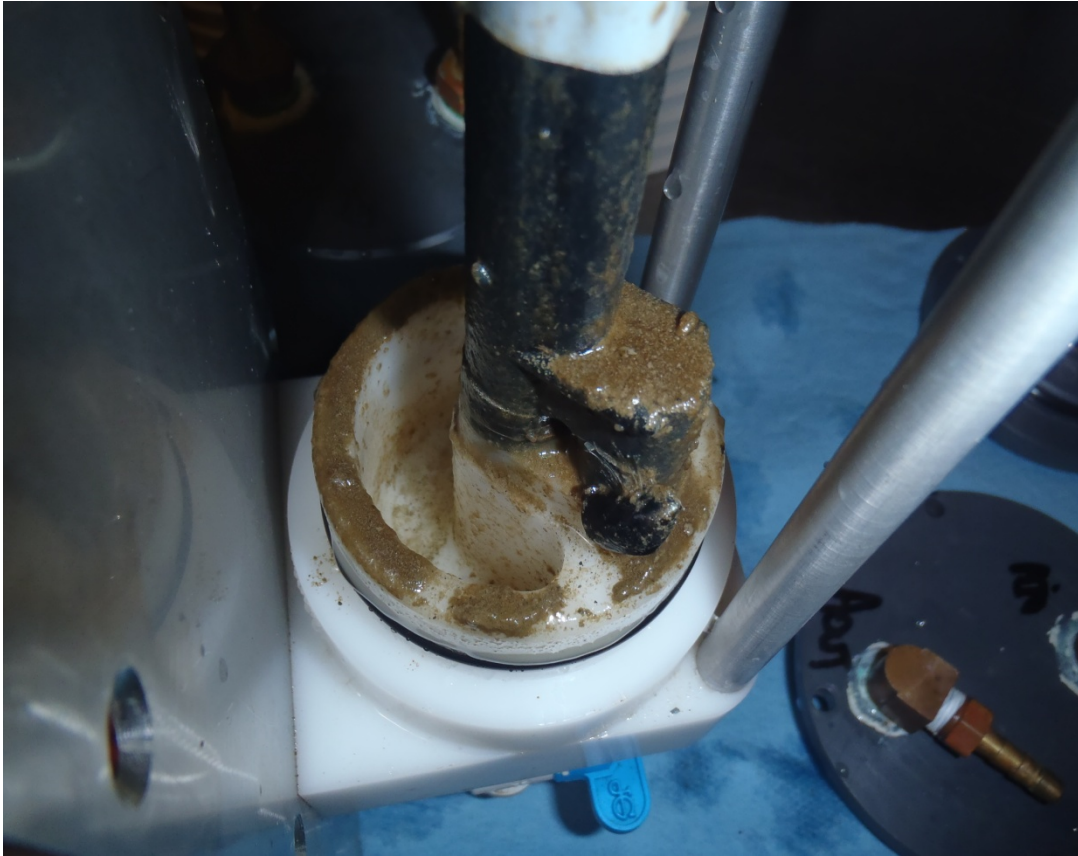
4. The Seabird 45 CT sensor very dirty, with to mussels approximately 3/8” long found growing within the housing on the sensor outlet port and on conductivity cell.

Figure 2: CT Sensor fouling

Figure 3: CT Sensor fouling

Figure 4: CT Sensor fouling

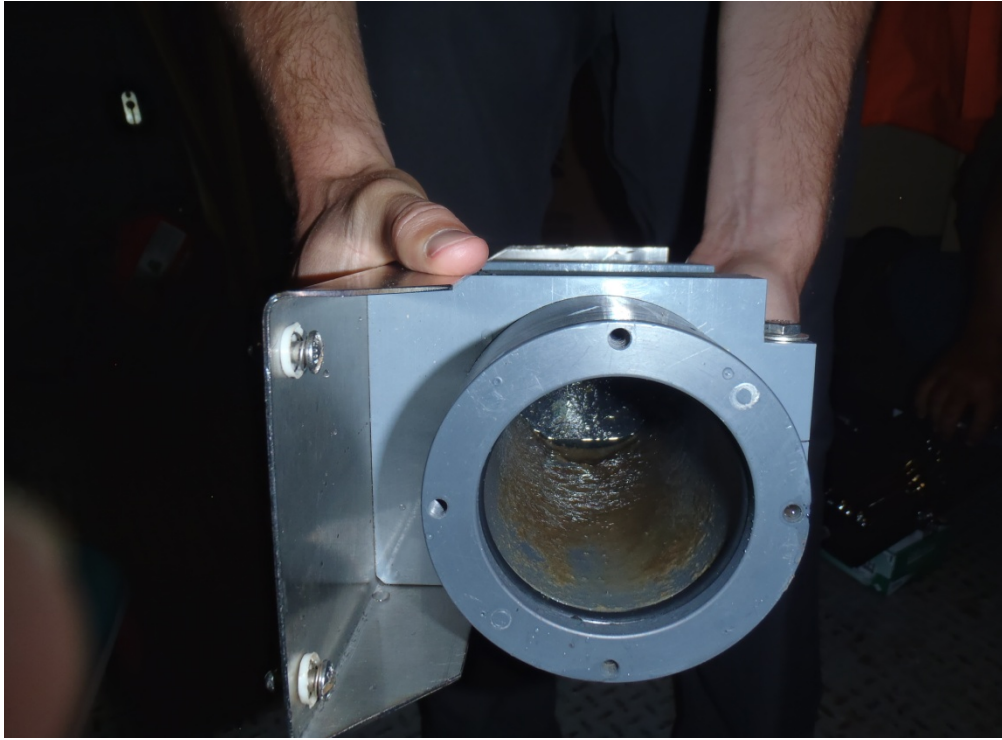
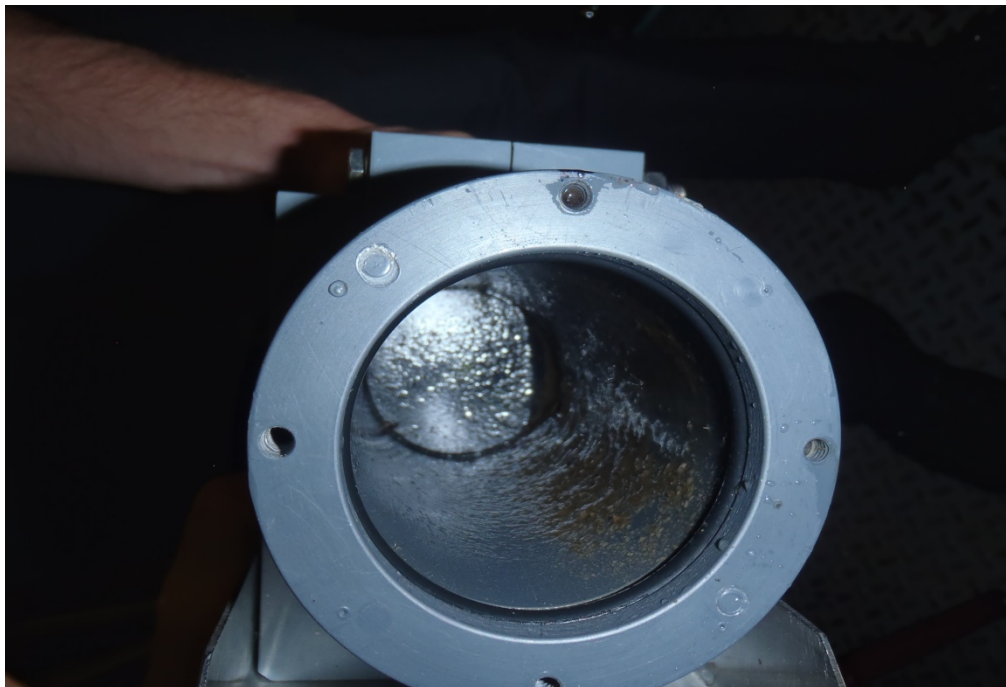
3. The BBFL2 had a partial layer of sediment in the housing and fouling on the sensing surface. Fouling was noticed on the “bottom” surface of the horizontal housing.

Figure 5: BBFL2 Fouling

Figure 6: BBFL2 Fouling

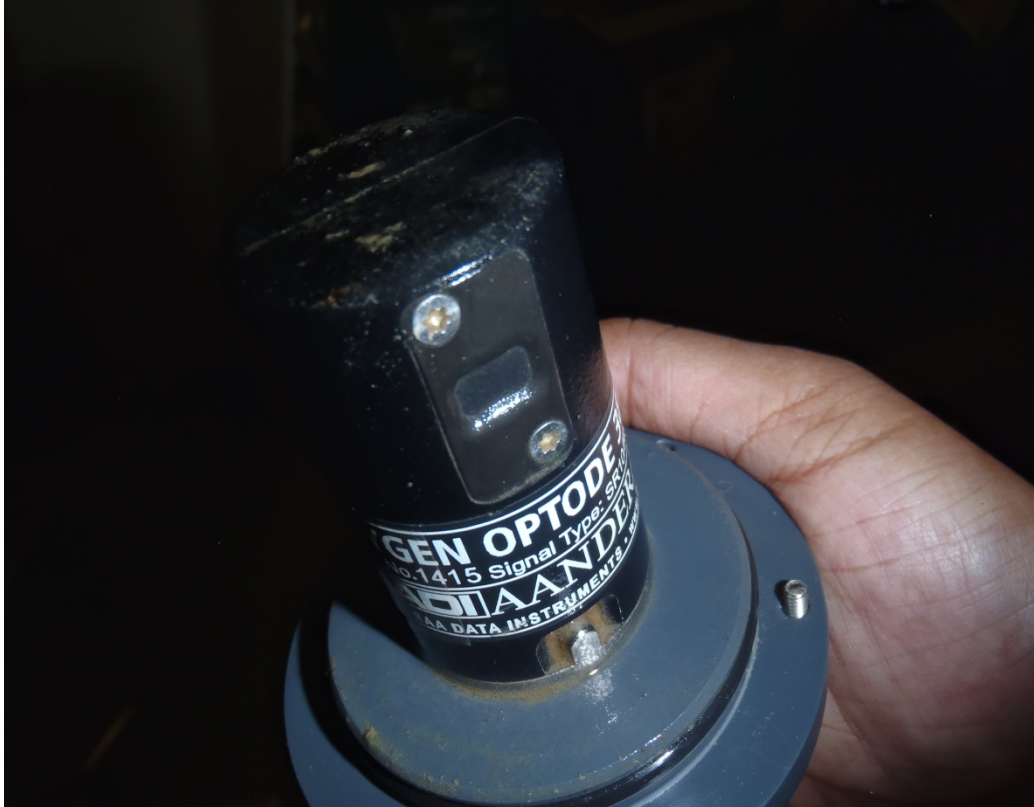
1. Signs of moisture at bottom of housing. Water manifold shows condensation.
2. The AADI optode (oxygen sensor) was slightly dirty with sediment/ bio film growth within the housing.

Figure 7: Optode fouling

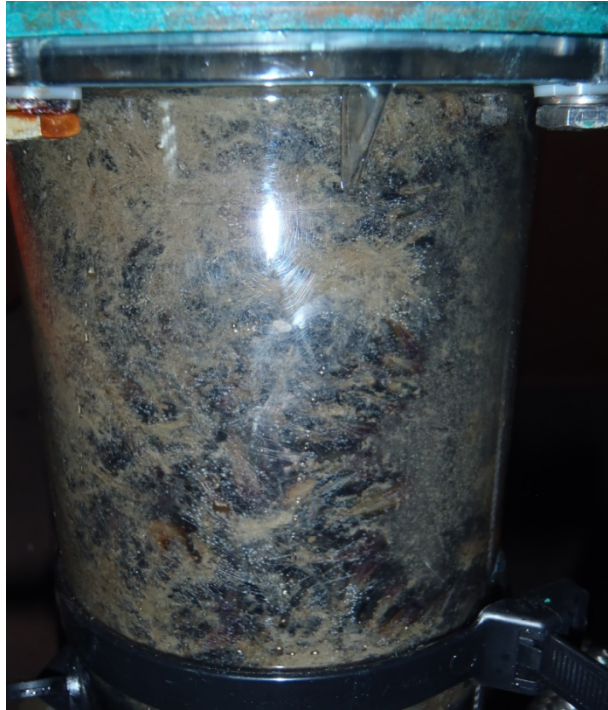
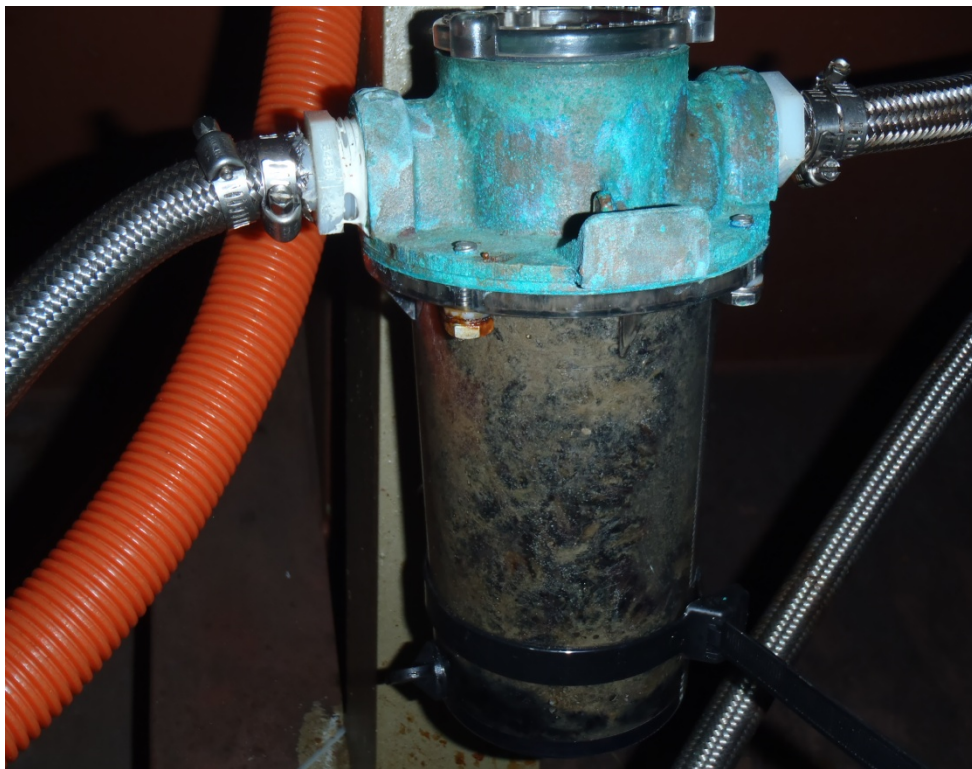
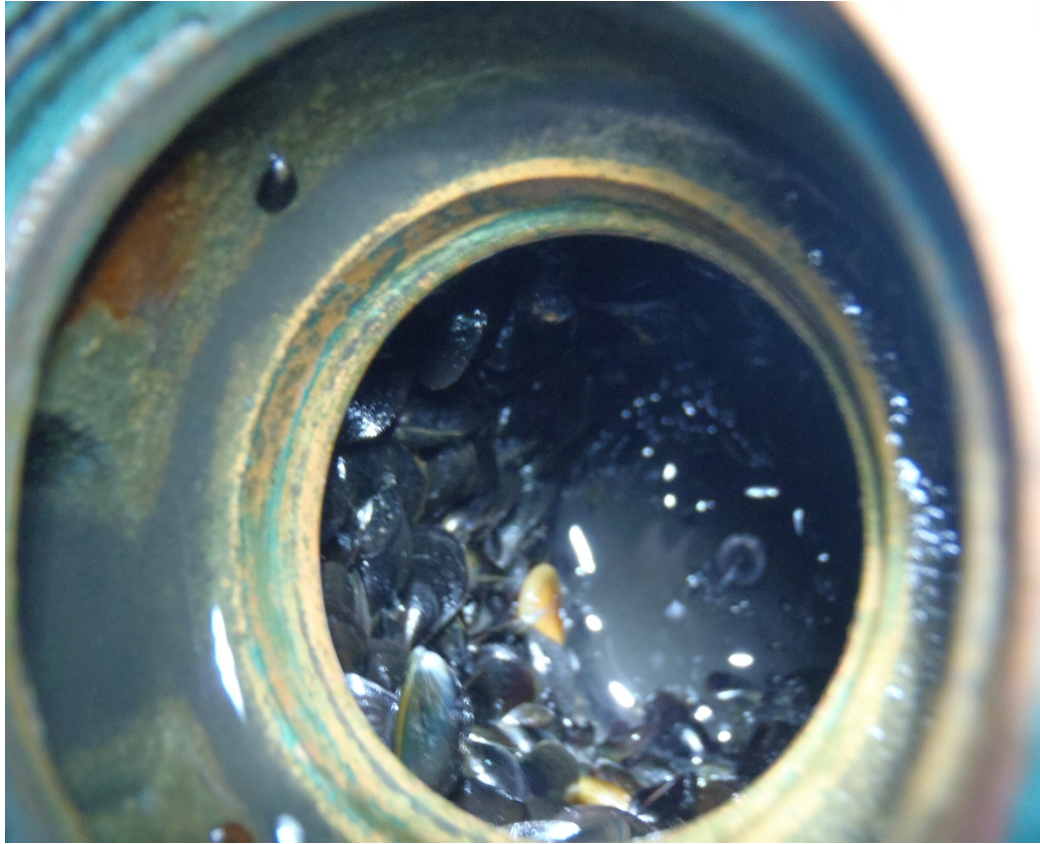
5. The flex tubing discolored. Showing sign of expanding.
6. The sea chest had couple spoons of water in housing. Due to condensation build up.
7. The inline filter (sea strainer) was checked and was found very dirty and required disassembly, and thorough cleaning. Some Mussel growth was found inside the strainer basket. A colony of mussels grew inside sea strainer outer filter area.

Figure 8: Mussel growth and fouling in Sea Strainer

Figure 9: Mussel growth in sea strainer

Figure 10: Sea strainer mussel growth in external housing area

7. Checked and cleaned the sea strainer. Removed many mussels, bio film and sediment fouling from the external area of strainer. Mussel growth was significant.
