Ocean Networks Canada

Ferry Maintenance Report – Queen of Alberni

Date: Nov 4 and 5th, 2014

Service(s) to SeaKeeper system. Ship at Richmond BC Ferries DEAS docks for re-fit.

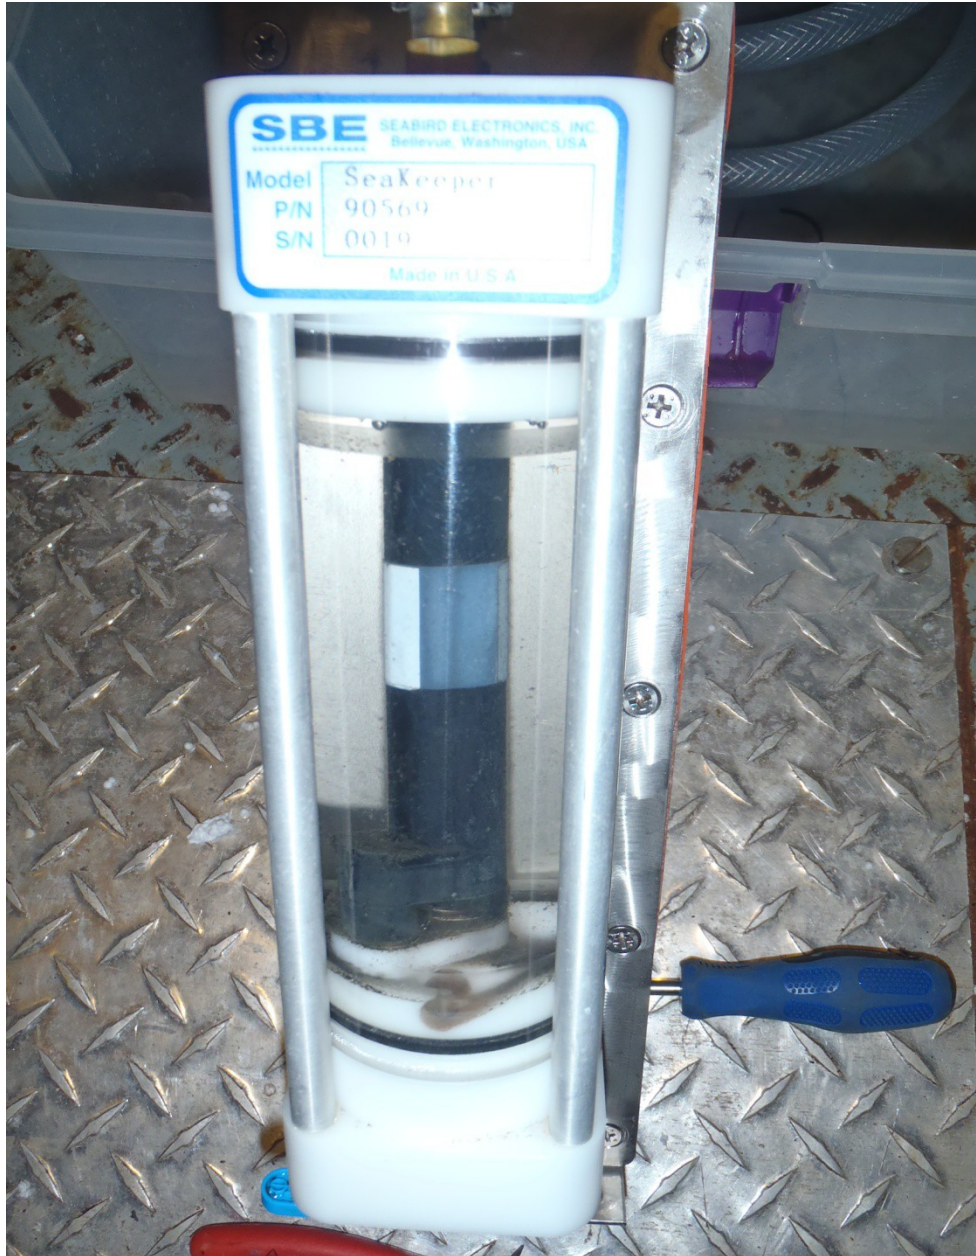
Figure 2: CT Sensor fouling

- ~~3.~~ The BBFL2 had a slight partial layer of sediment in the housing and had minimal fouling on the sensing surface.
- ~~4.~~ The Seabird 45 CT sensor slightly dirty. Blackish sediment at bottom visual through housing.
Seems like Coal dust ?

- ~~7.~~ Cleaned and checked over instruments in engineering room. Cleaned CT sensor connector to remove sediment and biofouling growth. Take whole CTD apart. Wash clean.

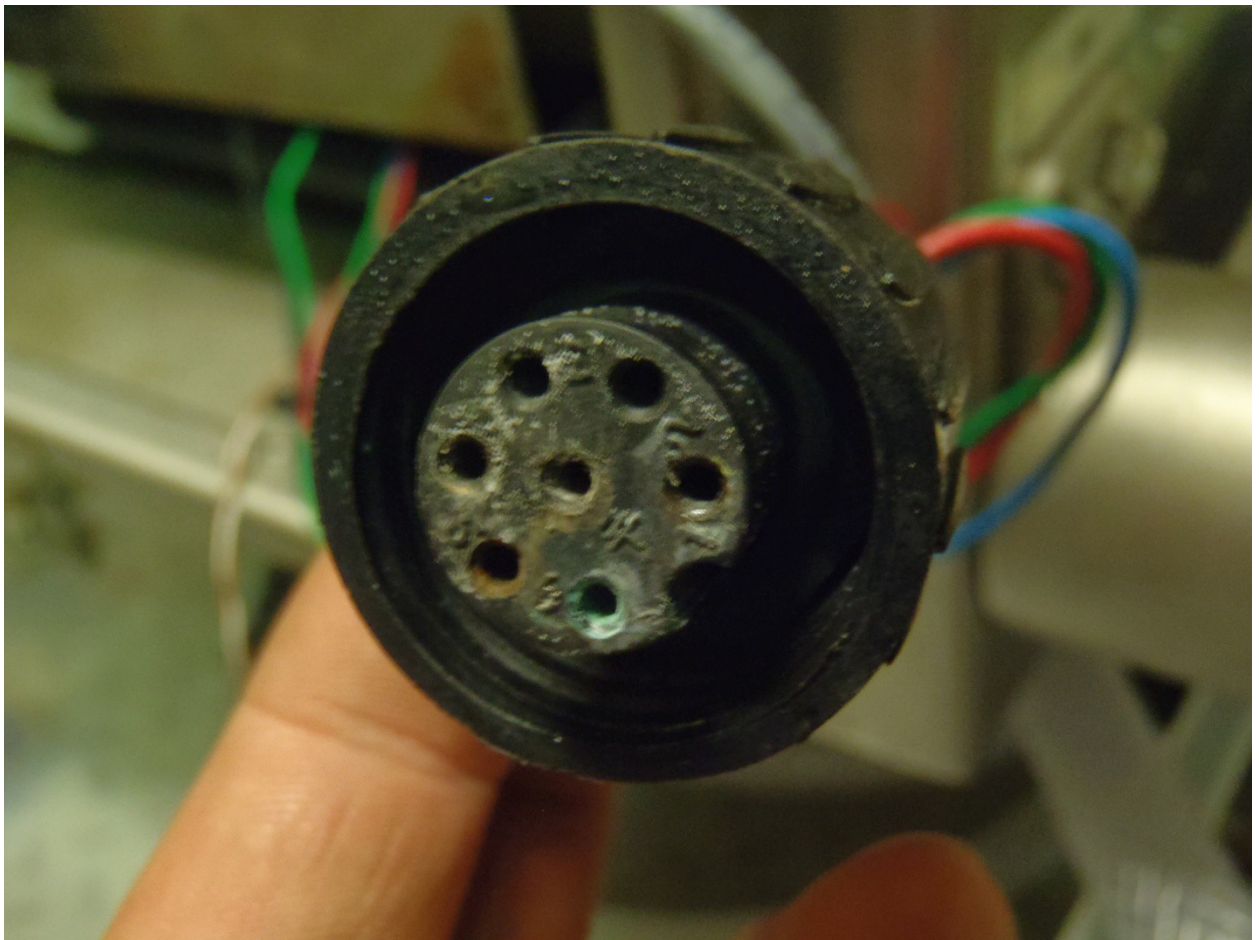
Figure 3: Pump control box connector

- ~~5.~~ Remove and Disassemble pump control box. Replace leak sensor RCA jack, and cable plug. Clean connectors at RHS. Lower plug (one with Pump) corroded pins. Found pins are corroding from outside of the connector and affecting connector pins internally. Condensation leaks down wire and into and past the gland fitting into the pins of the connector. Gland fitting does not seal the connector nor the wires ! Had to scale off corrosion, and clean connector with alcohol thoroughly. This may have affected pump control. Applied silicon grease to end of gland fitting to protect water seepage into connector. Measured battery voltage =13.3Vdc (did not replace). Pump control b/h with pins had corrosion, mainly pins 6 and 7.

1. Board ship when back in operations to check for leaks, and operations of instruments on Nov 15th 2014.
2. Replace Amphenol CT bulkhead connector and its plug (shipboard connector will need to be re-soldered).
3. Replace Amphenol plug going into pump control box. (need to order all Amphenol connectors for future replacement and have spares on hand).
4. Possibly replace all metallic connectors on upper boxes with plastic glands.
5. Provide training and certify particular staff for confined space, and fall protection. Paul, Denis and Ian.B
6. Complete documentation prior to arrival - Risk management assessment sheet
7. BBFL2 end cap one screw is stripped. Need to re-tap all holes in housing to next size up.
8. Purchase our own electrical panel lockouts

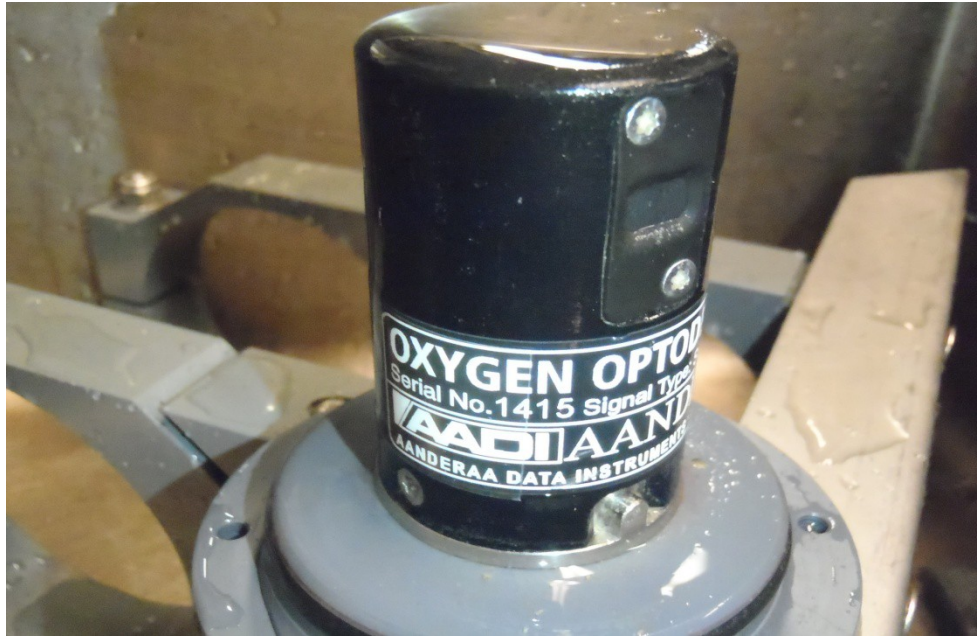
Figure 5: AADI Dissolved oxygen sensor

- ~~1.~~ No signs moisture at bottom of housing. Ship was not in service for 3 weeks.
- ~~2.~~ The AADI optode (oxygen sensor) was slightly dirty with sediment/ bio film growth within the housing.

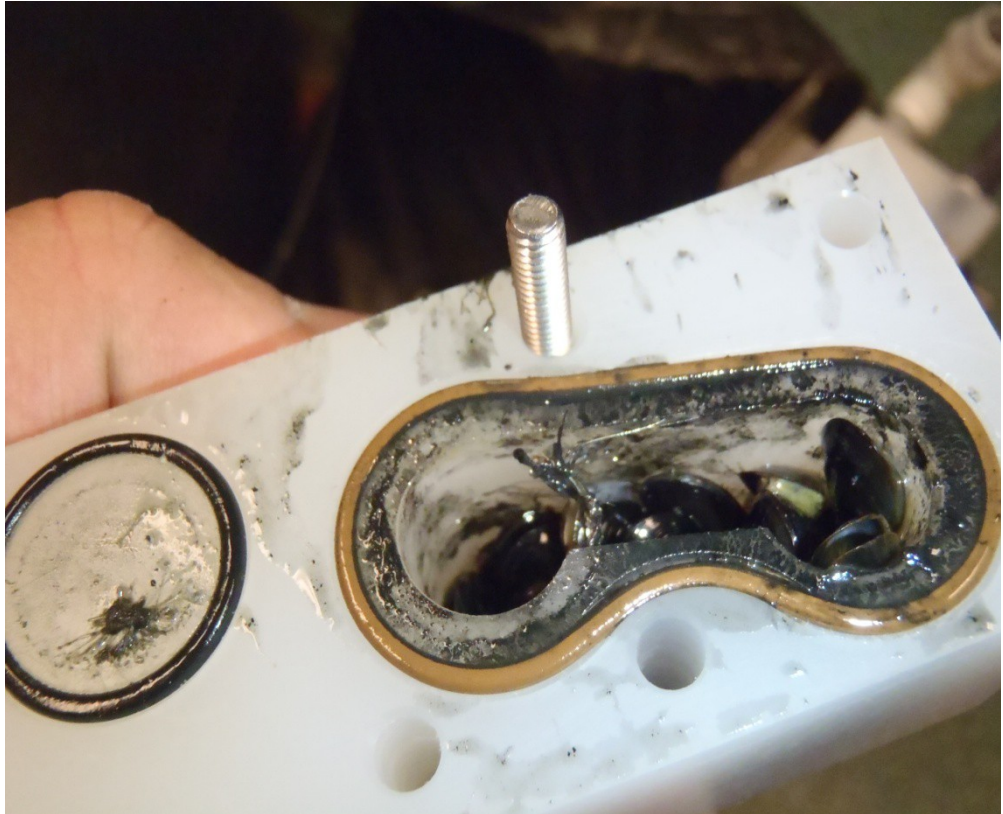
Figure 6: Top part of inlet outlet manifold

- ~~8.~~ Remove input/ output PVC manifold. Remove top end of manifold. Two o-rings are apparent. There are three pipes bored into the manifold. Each pipe was loaded with mussels. Washed out manifold in engineering room. A spring loaded stopper installed on the side of manifold jammed piping with mussels possibly restricting flow. Spent much time cleaning this unit. I recommend that we purchase two more of these manifolds for in field easy swapping for future.

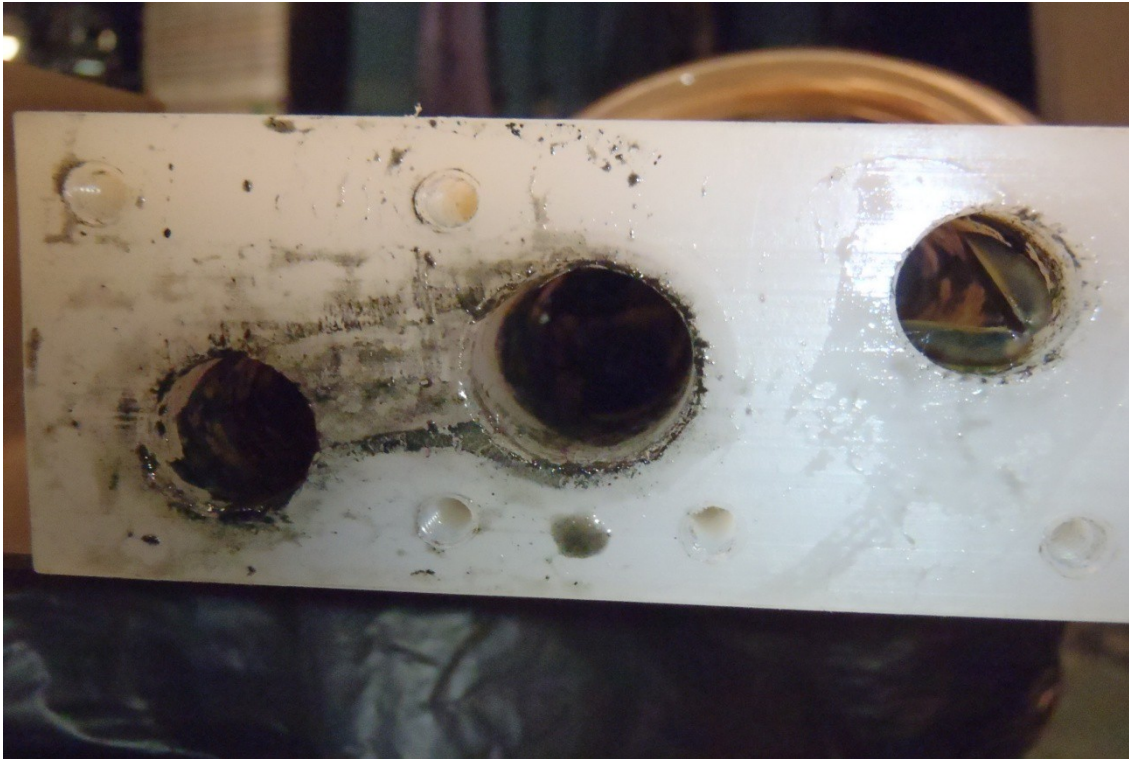
Figure 7: Manifold inlet, and outlet. Internal mussel growth.

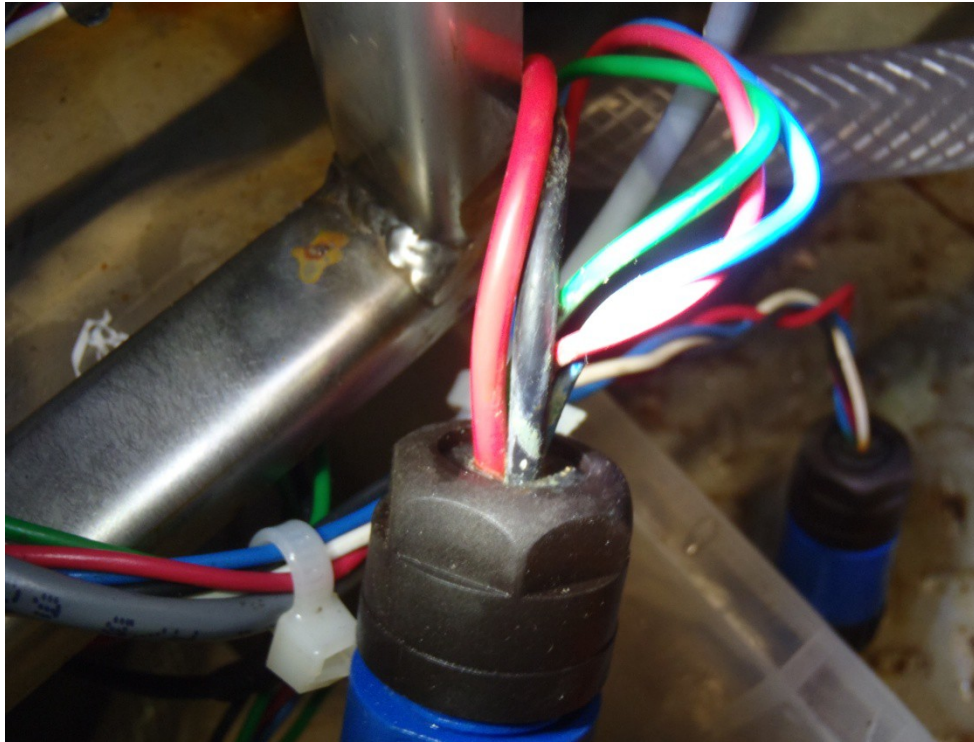
Figure 9: Pump control box plug to pump. Water seeps pass these wires. Gland fitting does not seal water out. This may have caused issue with pump. Red and Black wires are pump power wires.
