Ocean Networks Canada

Ferry Maintenance Report – Queen of Alberni

Date: December 5, 2014

Regular instrument servicing + Calibration/comparison of Optode Instruments measurements

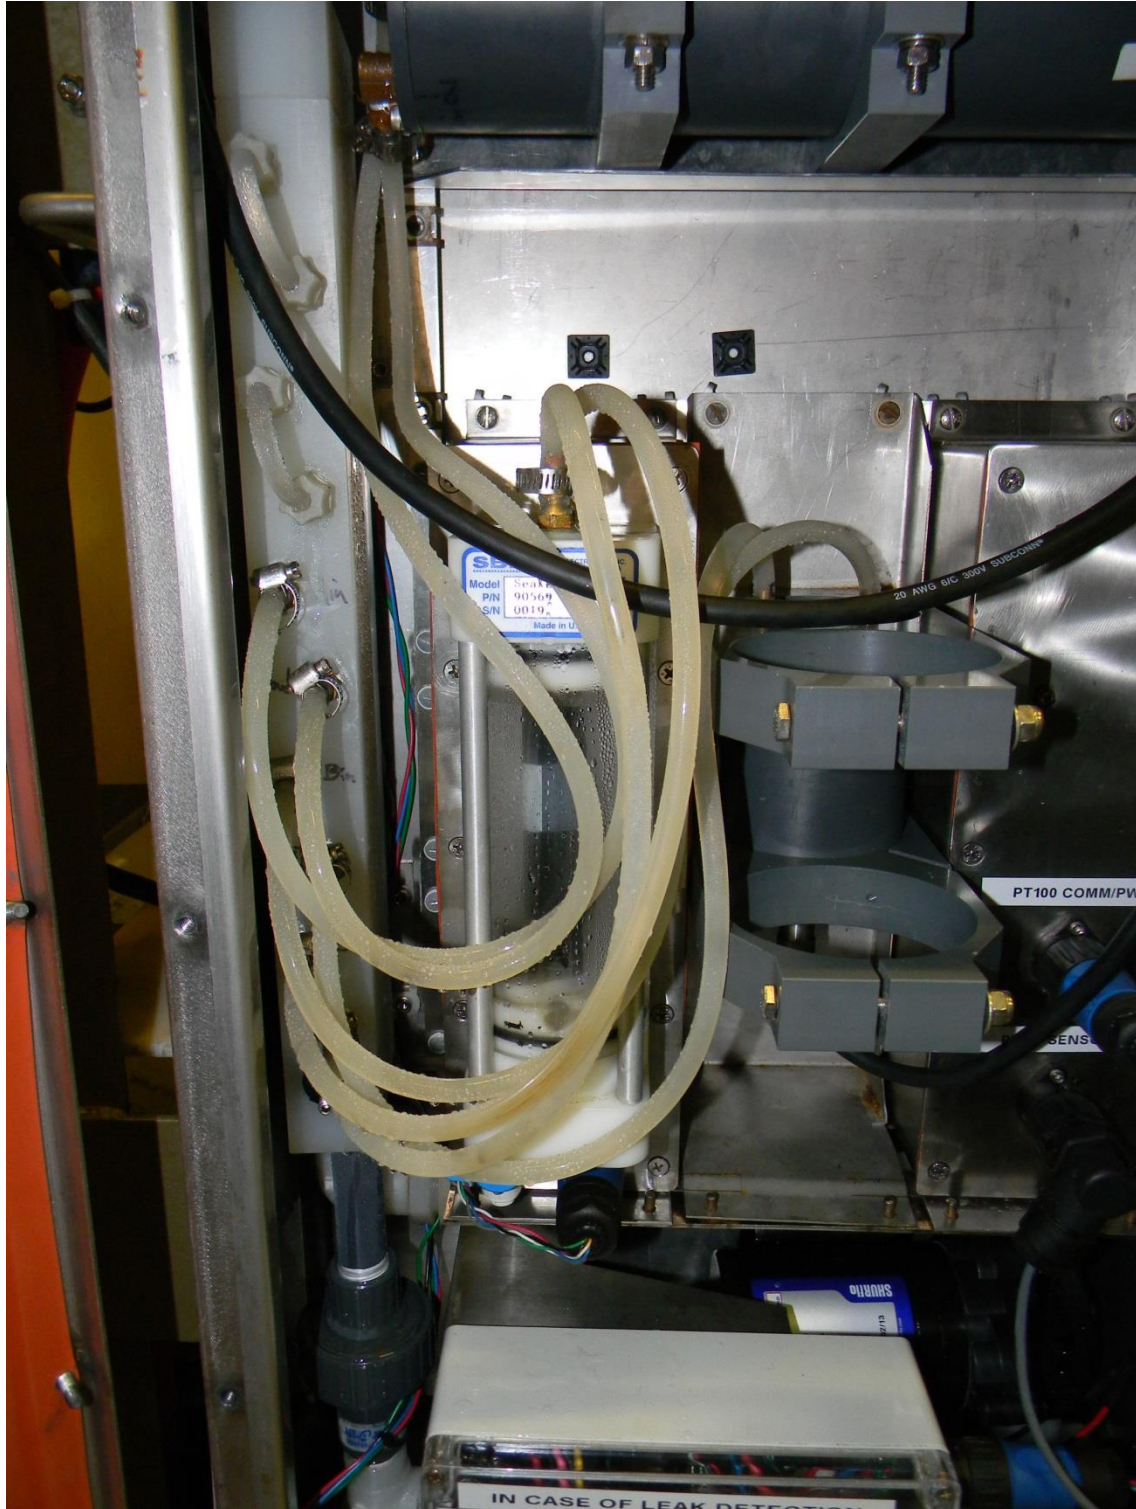
1. There was moisture and/or leaks In the Instrument Box. The overall impression of the moisture was that it primarily came from condensation, but smelling of the fluid indicated a low level of salinity, suggesting very small (drip-level) leaking as well.

Figure 1: Evidence of leaks within the housing. Note how the water is primarily confined to the outside of tubing, or logical (gravity) drip locations.

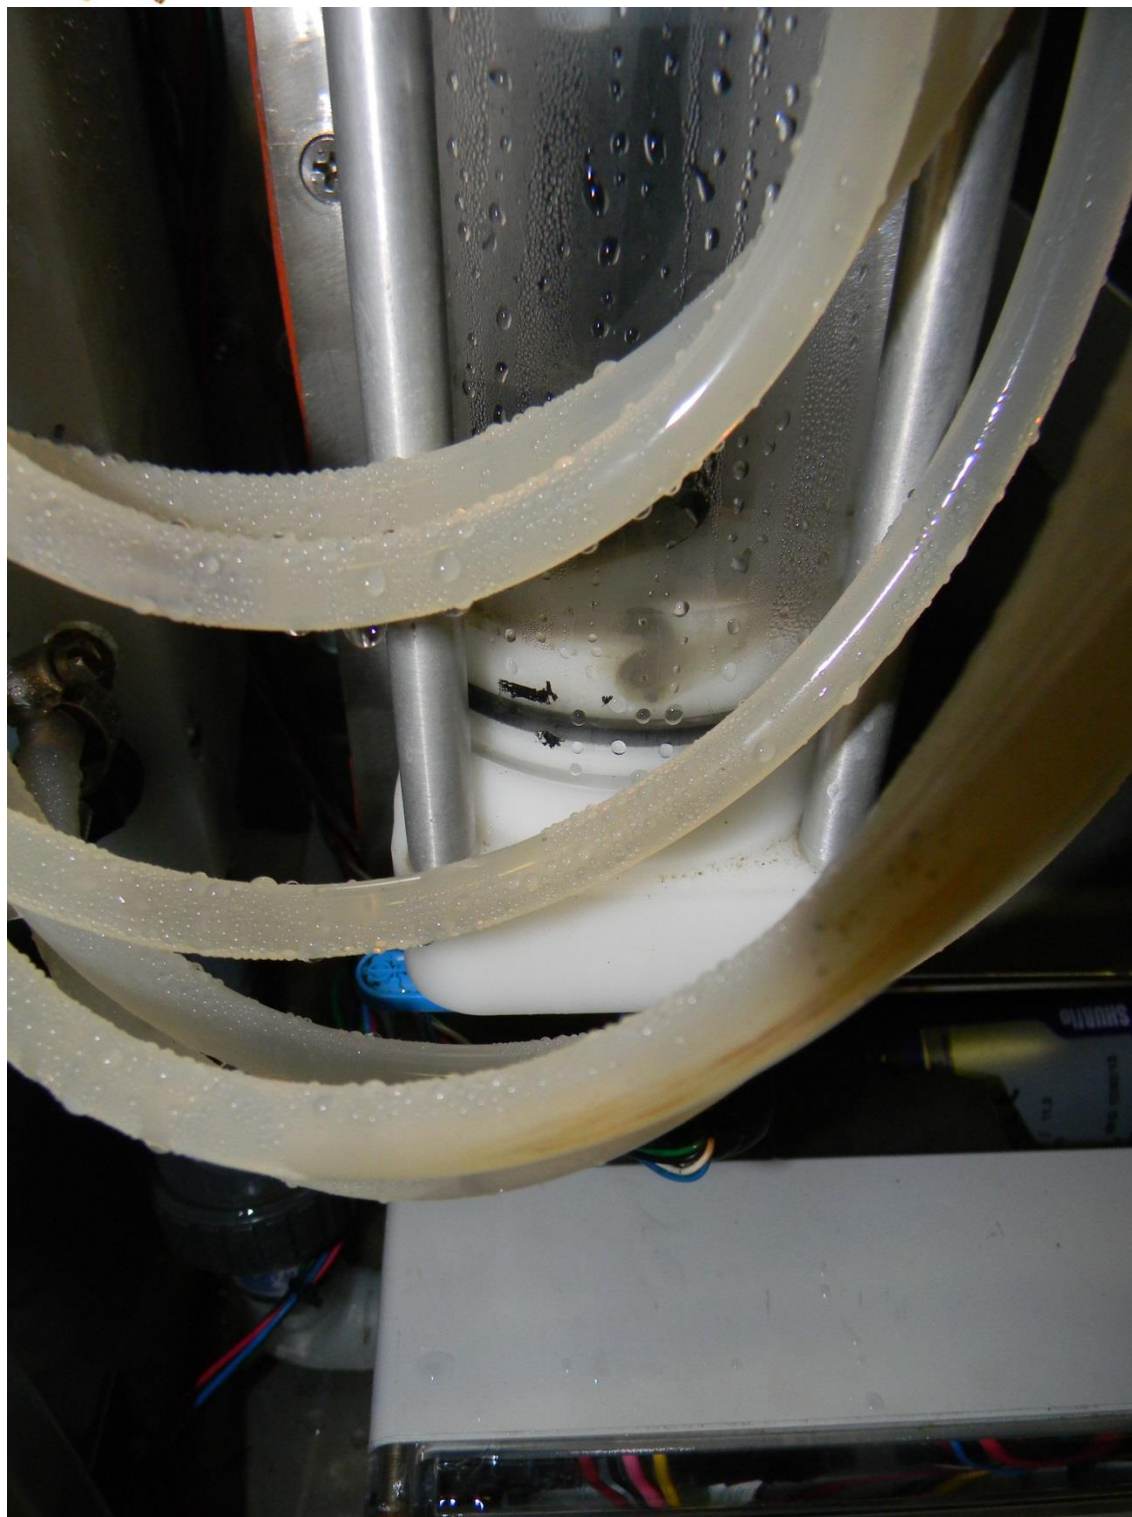
Figure 2: Close-up of water on tubing.

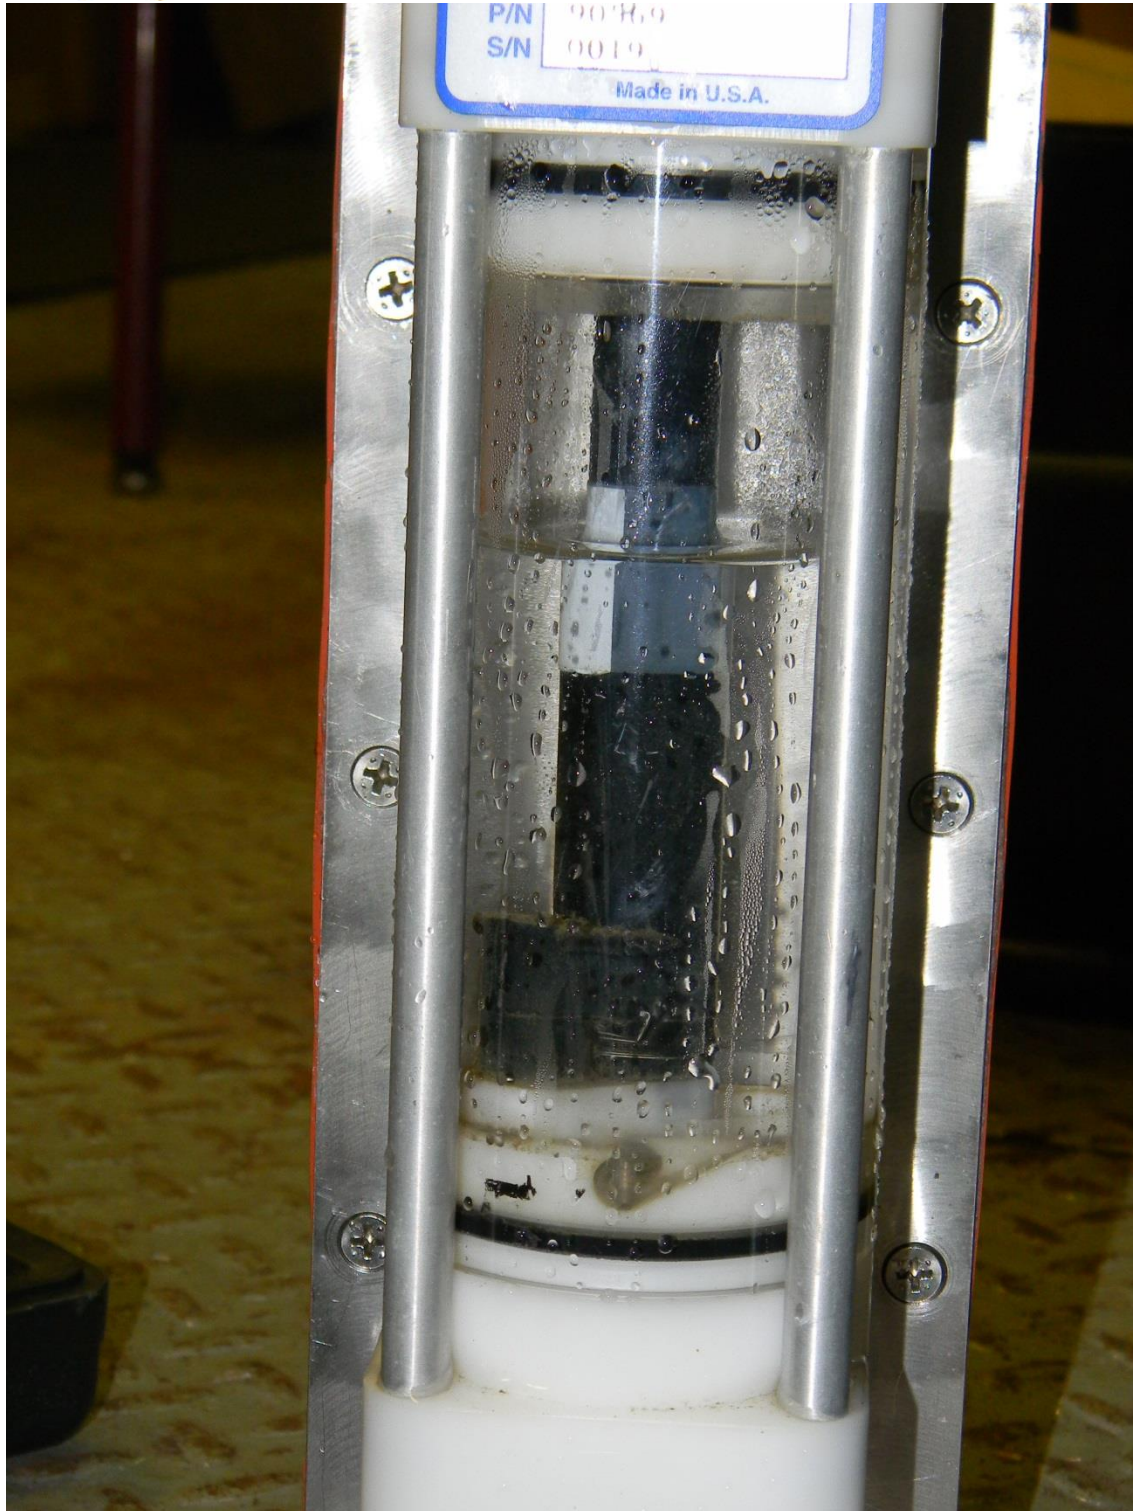
4. The Seabird 45 CT sensor was mildly dirty, with no mussels found growing within the housing on the sensor outlet port.
5. The flex tubing was in good shape, having been replaced recently. ALL of the barb fittings were, however, installed incorrectly, potentially causing one or more small micro-leaks and risking blowout of the piping.

Figure 3: Fouling just starting to be apparent in the CT unit.

2. Powered down and disassembled instruments in lower assembly.
3. Cleaned and checked over instruments in Engineering room. Cleaned CT sensor connector to remove sediment and biofouling growth.

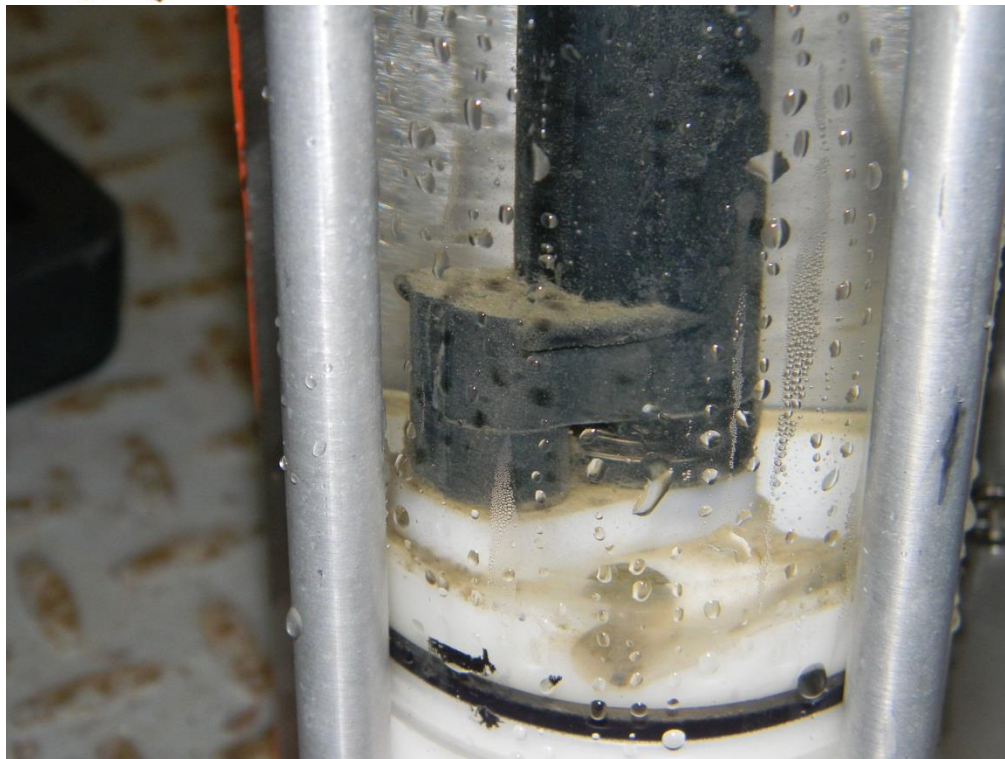
Figure 4: Fouling in the CT unit.

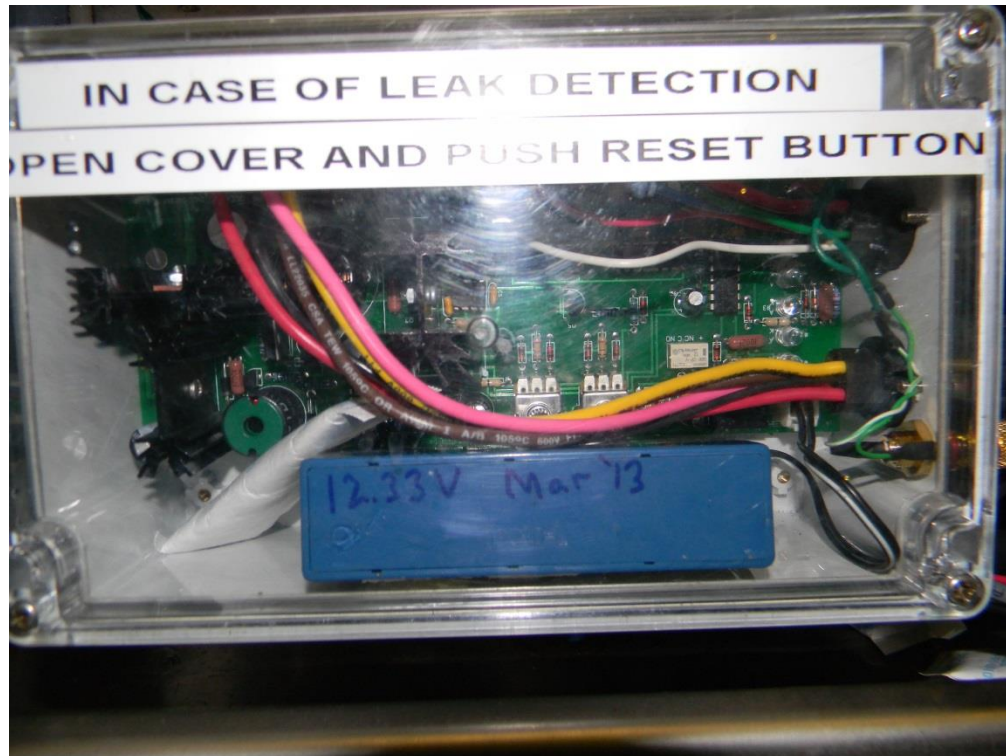
Figure 5: Note: pump was off upon arrival.

1. Opened both boxes and observed function. The system was off upon arrival; reset the breaker (off-on) and the system started up cleanly. Unknown why the system turned itself off.

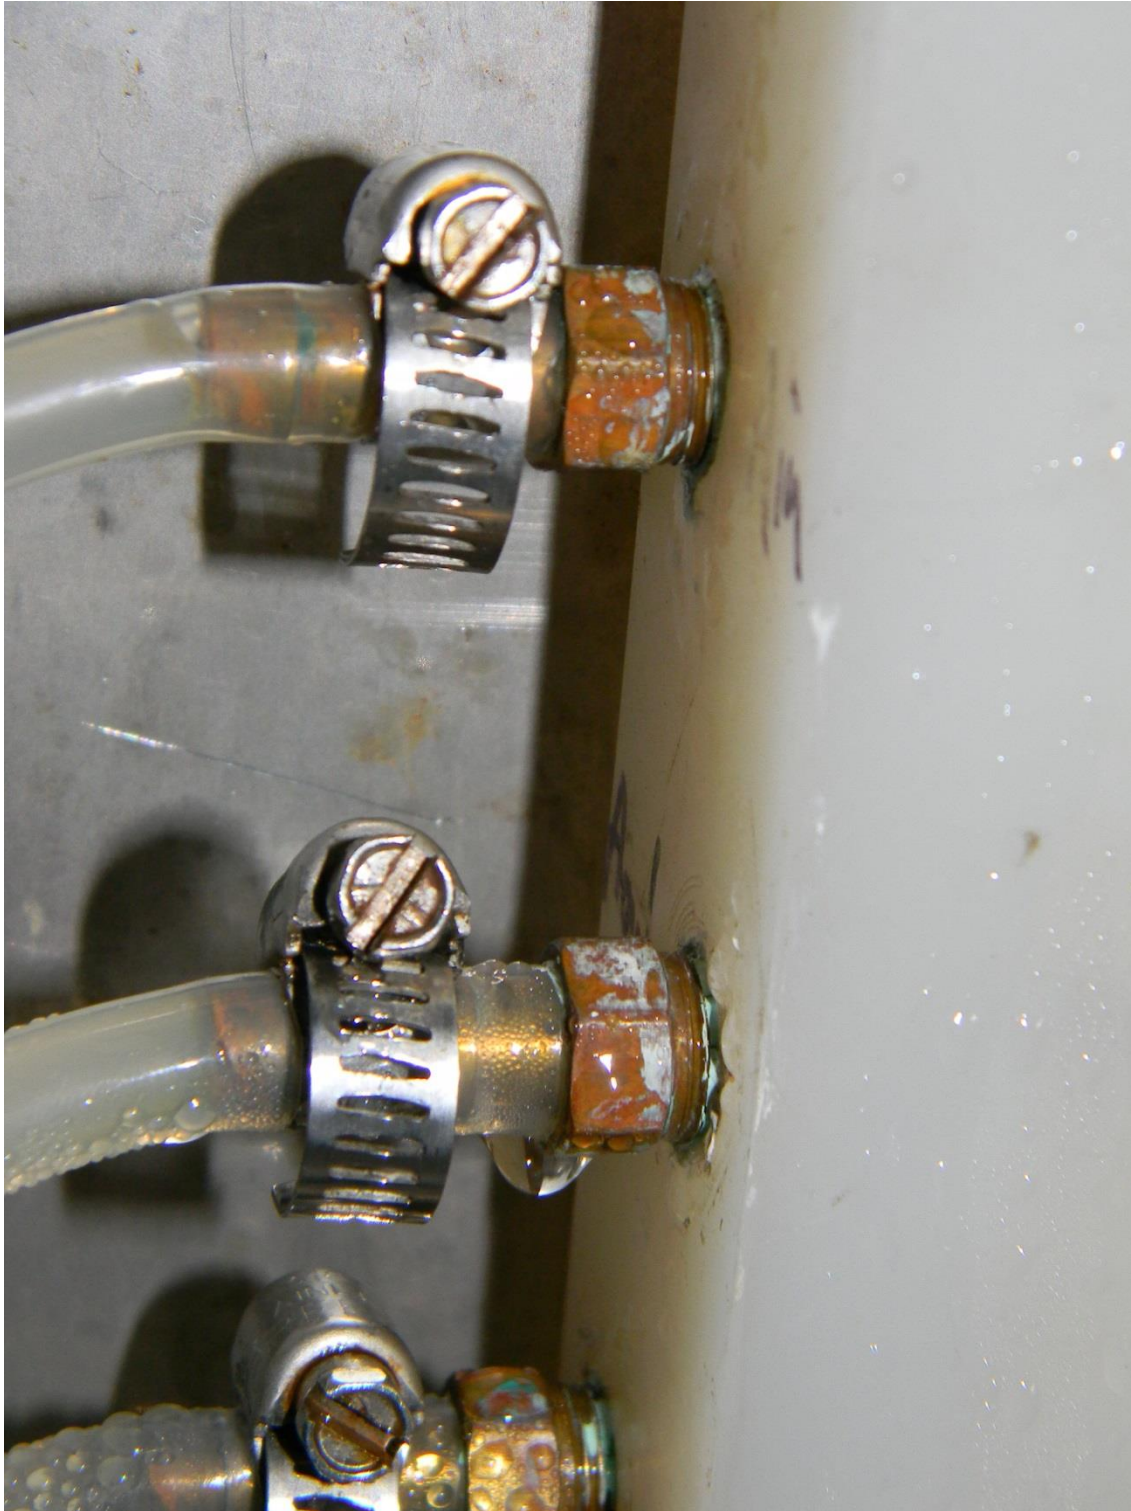
Figure 6: Correctly and incorrectly install hose clamps. The top clamp has been reinstalled correctly (set as close to the base of the barb as possible, snug without serious deformation of the rubber). The bottom clamp is set too far toward the end of the barb.

4. Ran pre- and post- calibration with standard solutions and with Orange test stick and blue test stick for CDOM fluorescence and Chl fluorescence.
5. Re-assembled the instruments in the lower box. ALL hose connections were re-done properly to assure no leakage occurs from this source. Replaced the leak sensor with a longer flexible unit and installed correctly.

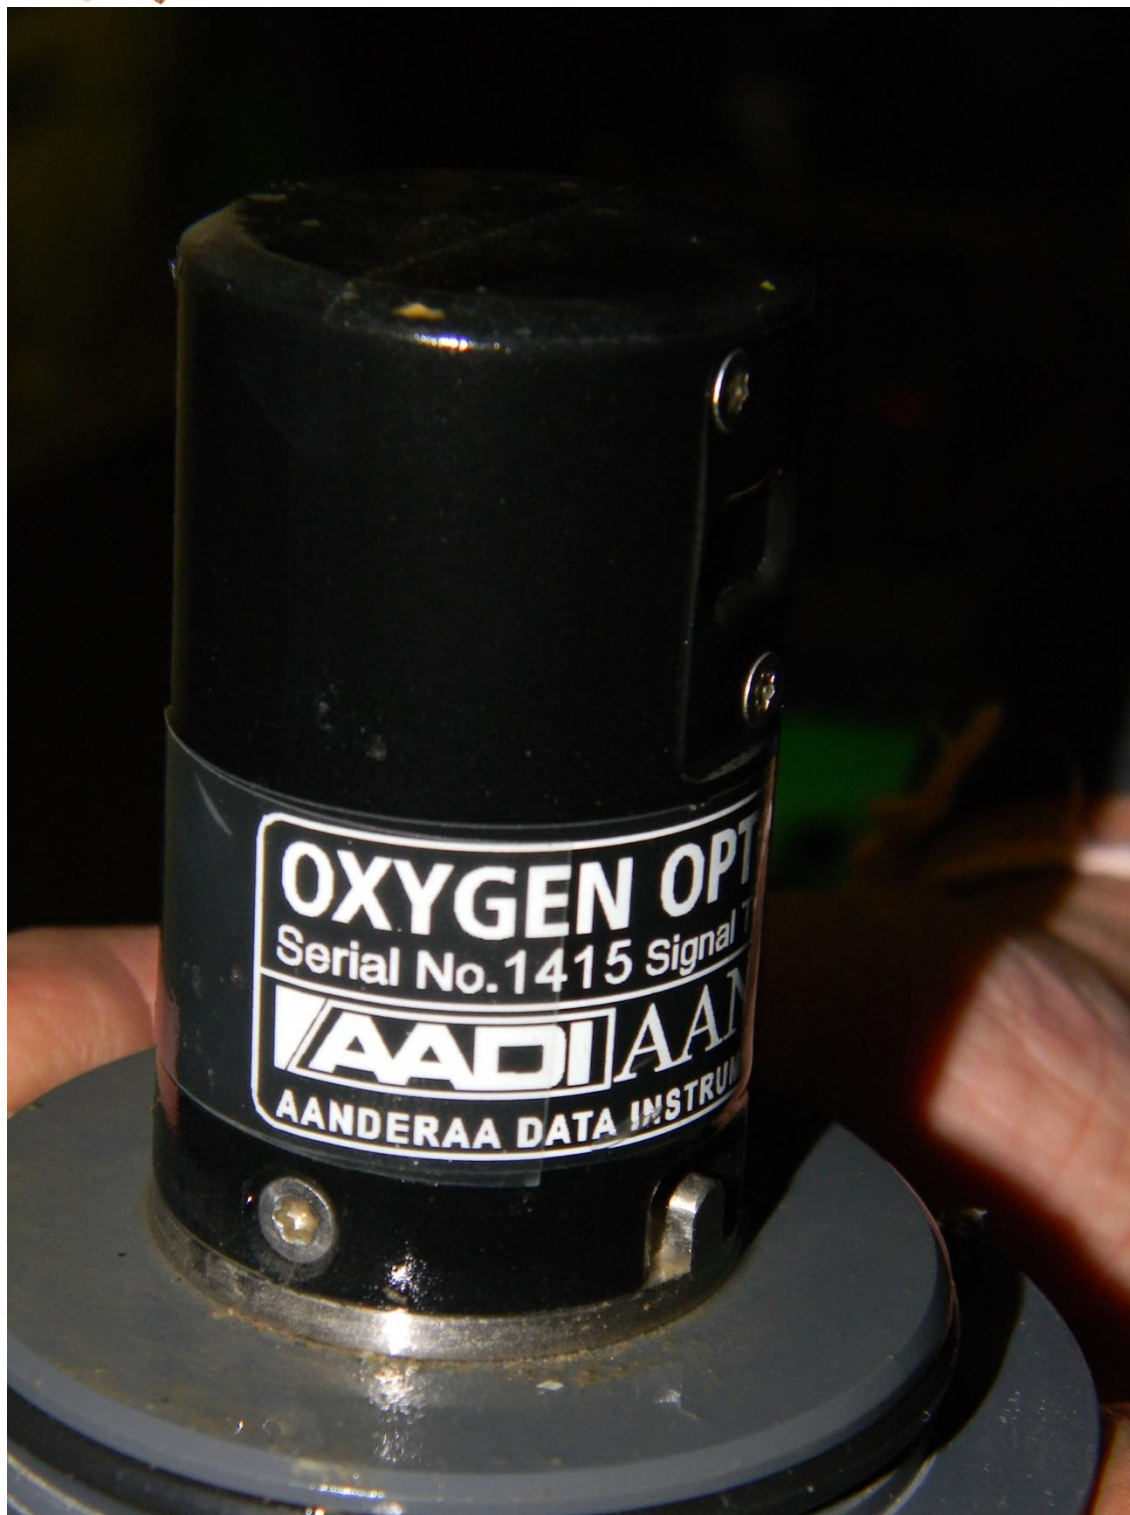
2. The AADI optode was slightly dirty with some limited sediment/biofilm growth within the housing.
3. The BBFL2 had a partial layer of sediment in the housing and some minor fouling on the sensing surface. Fouling was noticed on the “bottom” surface of the horizontal housing.

Figure 7: Some minor fouling and sediment within the OPTODE housing.

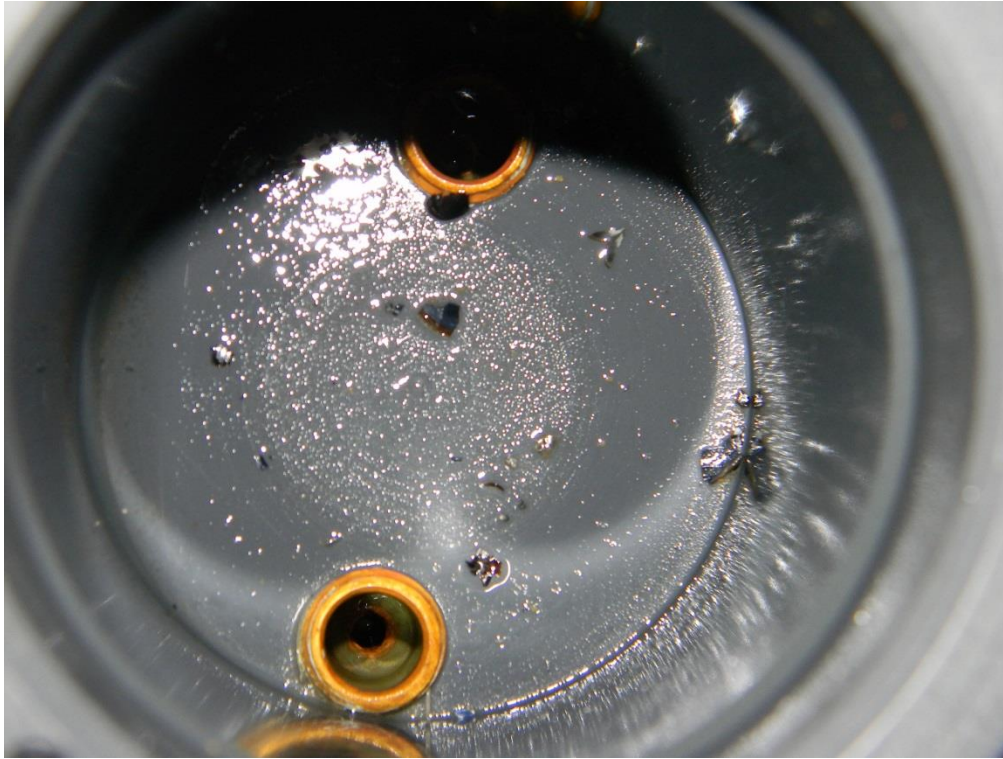
Figure 8: Sediment within the OPTODE housing.

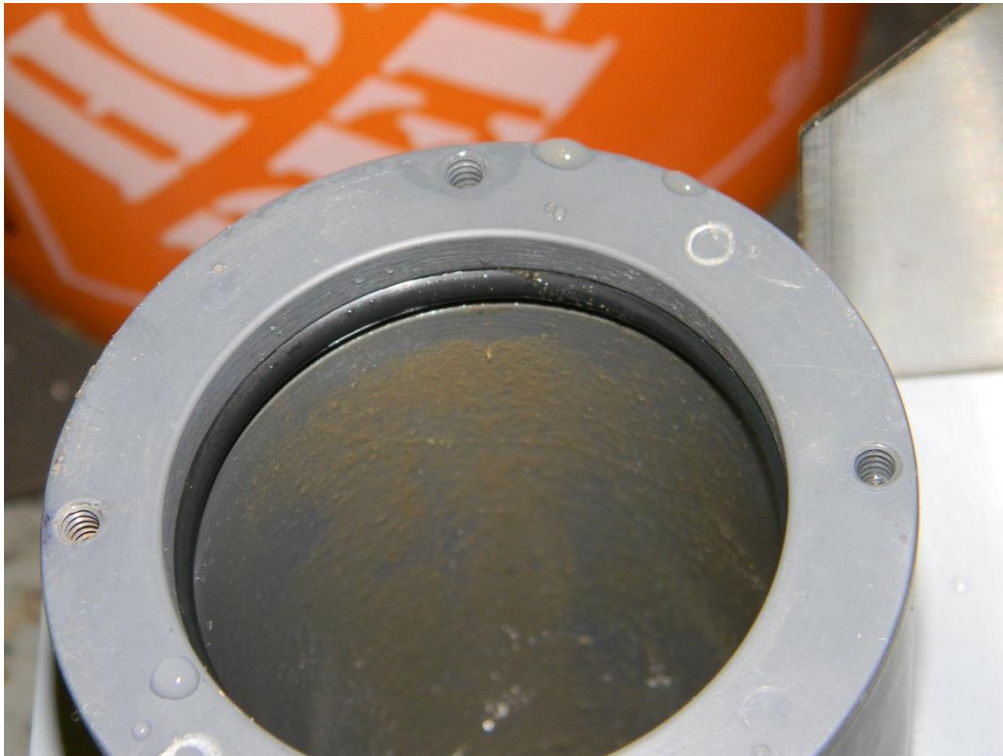
Figure 9: Sediment and fouling within the BBFL2 housing.

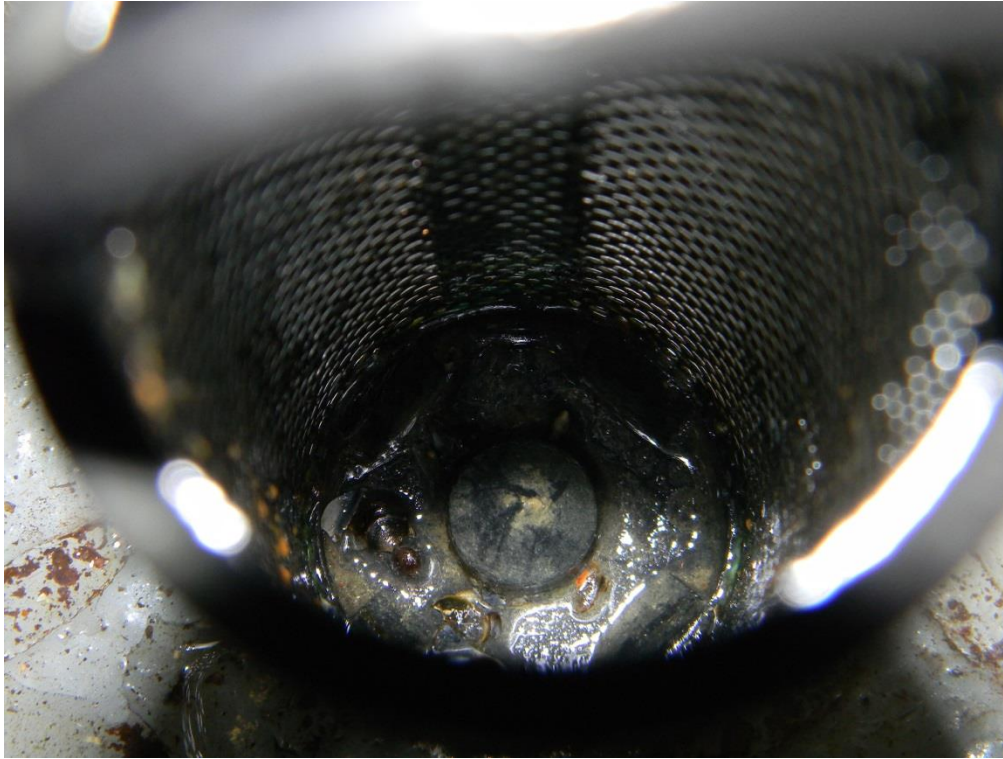
6. The sea chest showed no signs of leaks.
7. The inline filter (sea strainer) was checked and was found to be slightly dirty and required cleaning.
8. The leak sensor was incorrectly installed and incorrectly manufactured.

Figure 13: Sea Strainer interior.

6. Checked over Sea chest and valves, no leaks apparent.
7. Checked and cleaned the sea strainer. Removed biofilm and sediment fouling from the strainer.

1. Monitor growth of Mussels within the system. There were indications of possible mussel growth starting in the Sea Strainer system.
2. Educate all personnel as to proper installation procedures for leak sensor and hose clamps.

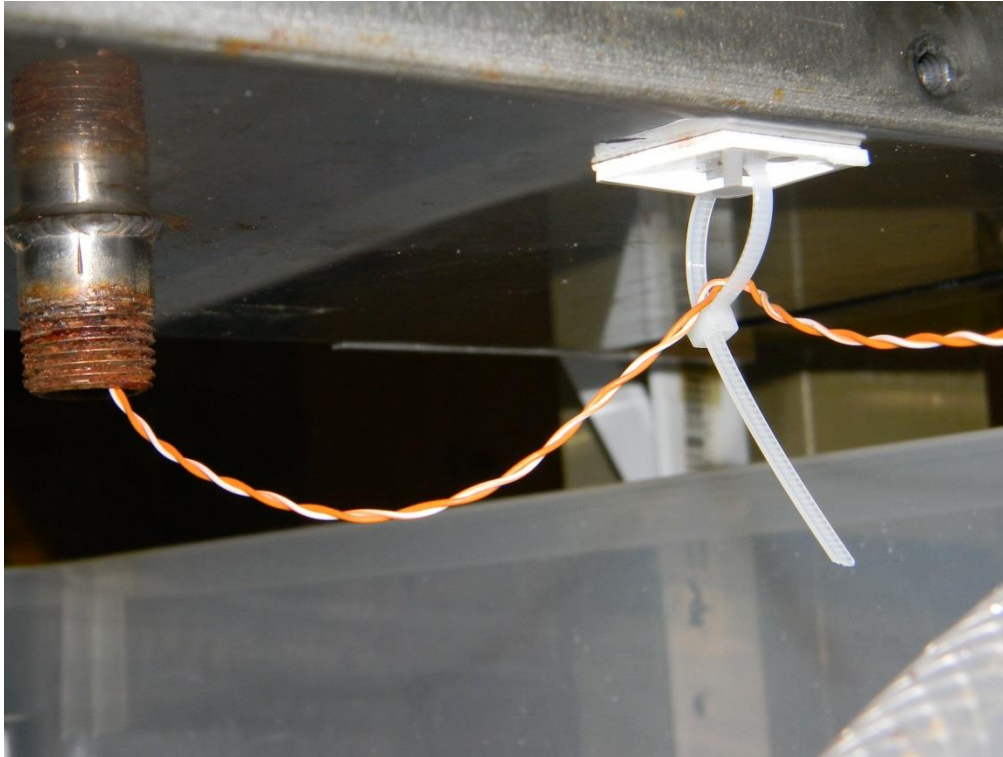
Figure 15: Correct installation of leak sensor. Note the drip loop before the sensor (which extends downward to right of image).

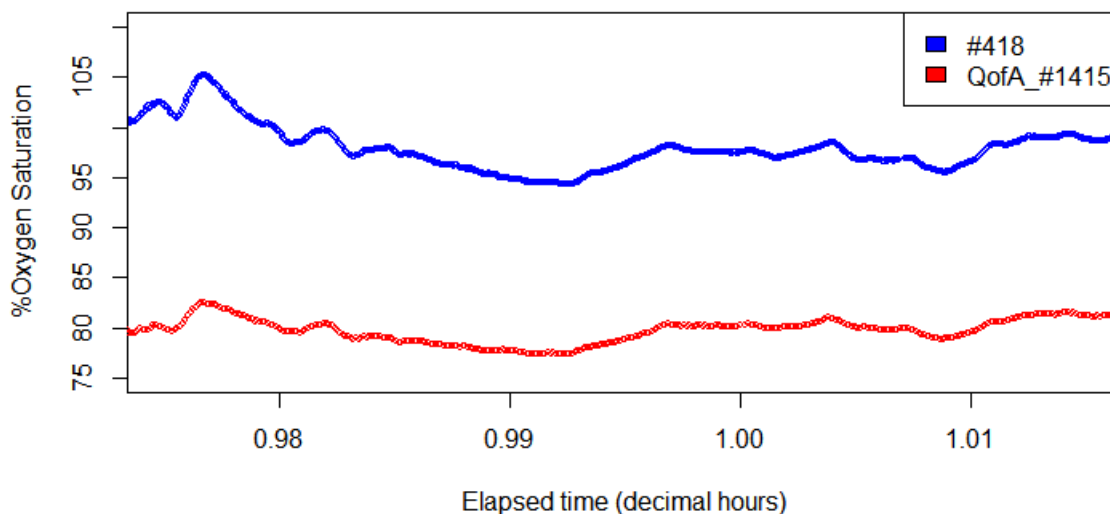
Figure 3. A suspected underestimation of oxygen saturation measured by the Queen of Alberni was identified by Chuning Wang (UBC) following his comparison of oxygen saturation values between the Queen of Alberni and Spirit of Vancouver Island, (October 3-11, 2014) in the vicinity of Tsawwassen. This figure represents a preliminary assessment of this potential under-estimate. The red symbols represent O_2 saturation values measured en route departing from Tsawwassen at ~15:15 on December 5, 2014. A second optode (Aanderra #418) calibrated in the lab (2-point zero/saturated) was placed in line (see photos above) with the resident instrument (#1415). Blue symbols represent #418 measurements. Note; no corrections for salinity have been made here (i.e. optode #418 calibrated assuming salinity of 0); nevertheless, both optodes capture a very similar spatial-temporal pattern with a significant offset indicating instrument #1415 is significantly underestimating. Chuning Wang also collected discrete water samples for Winkler titrations alongside these optode measurements and will present a more detailed comparison shortly.
