Ocean Networks Canada

Ferry Maintenance Report – Queen of Alberni

Date: January 23, 2015

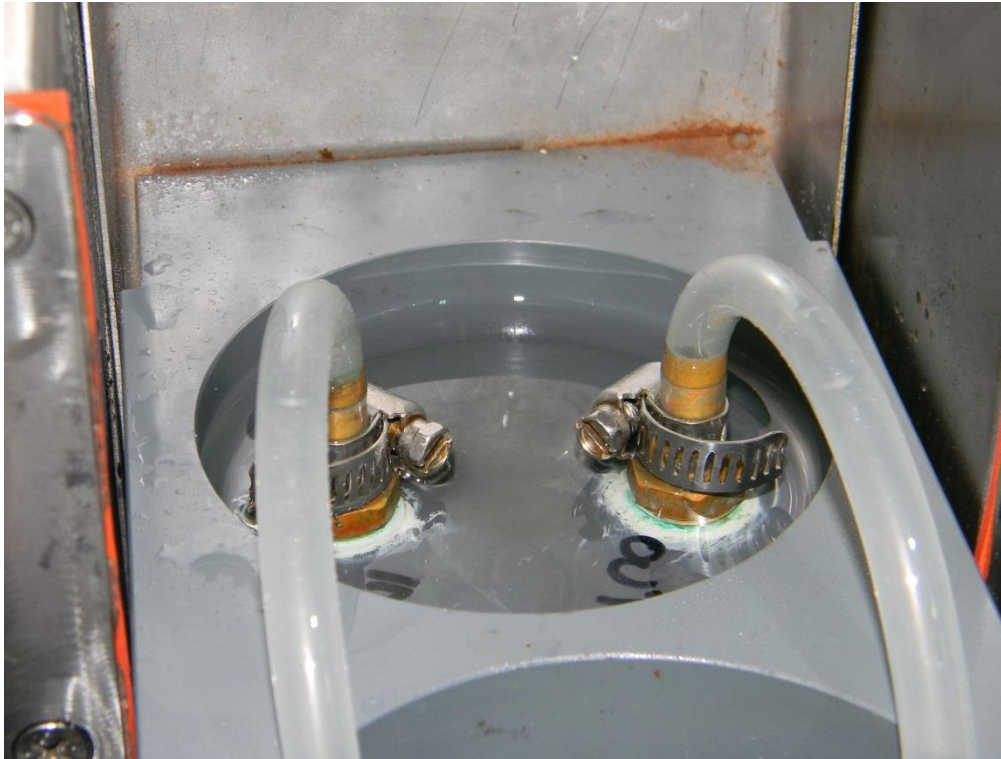
4. Disassembled system instruments, checking tubing and connections. No apparent leaks or failures in the instrument tubing. No signs of damage to any connectors. Water had sprayed high enough to pool on the Optode and CT housings, but the BBFL2 was perfectly dry, and there were no signs of spray reaching that level.

Figure 1: Water pooled in top recess of Optode

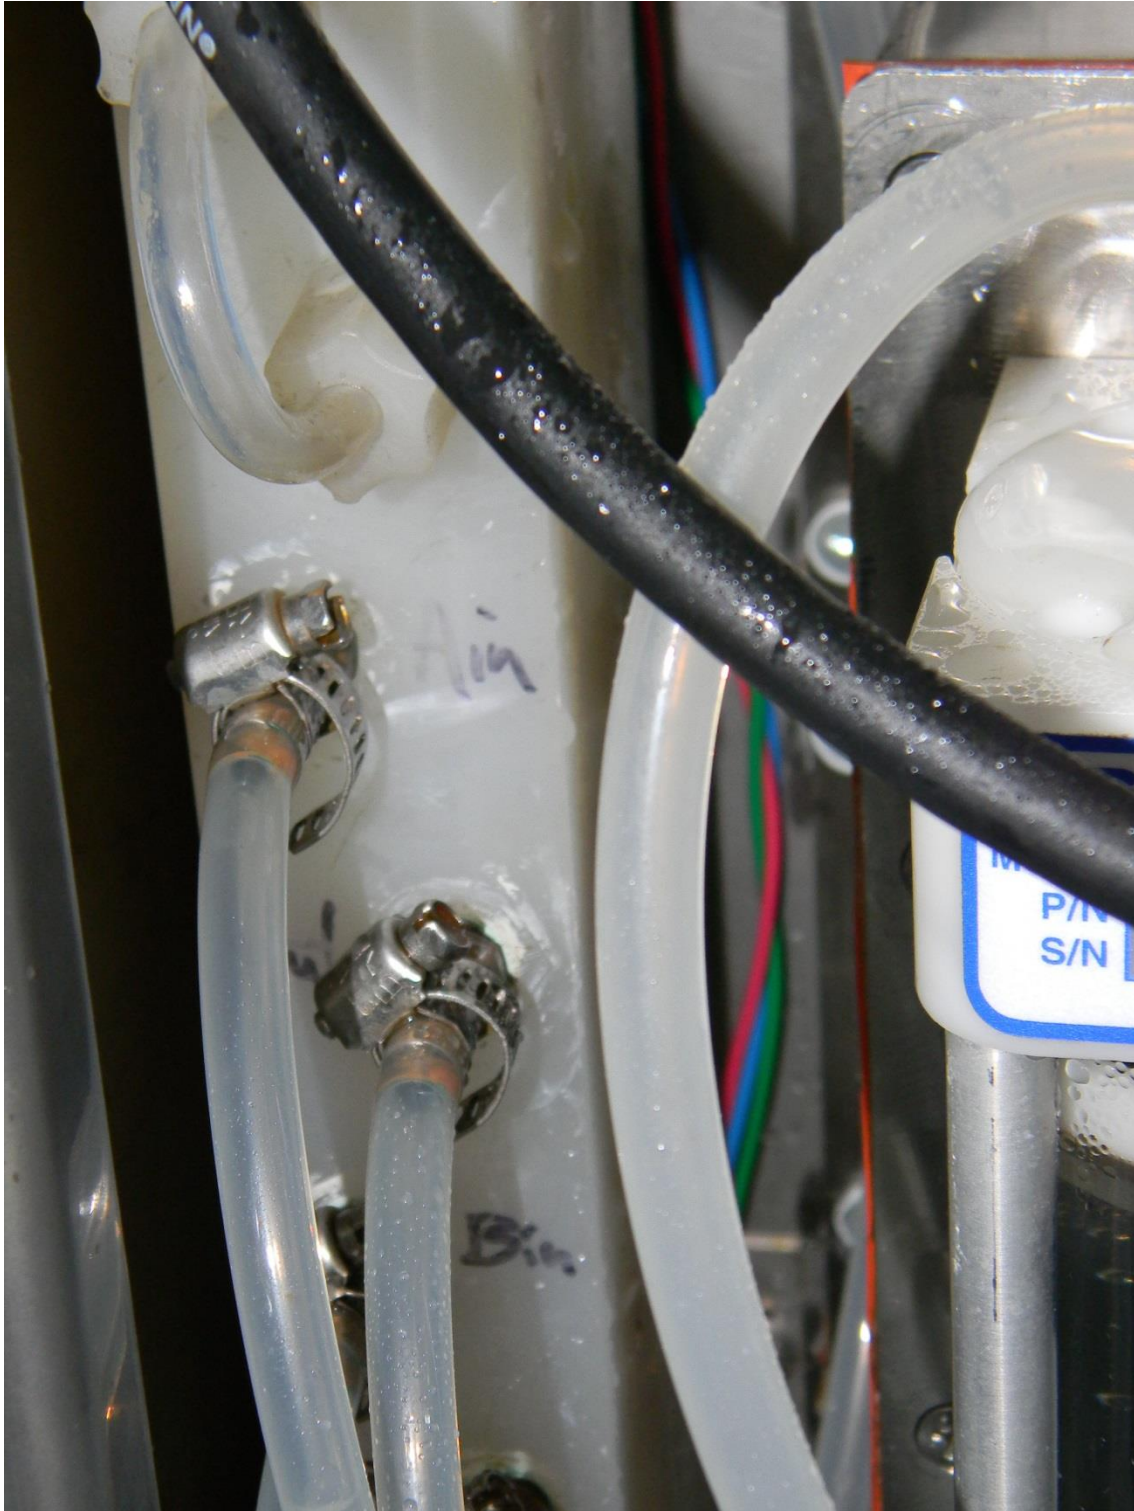
Figure 2: Water Spray on Manifold

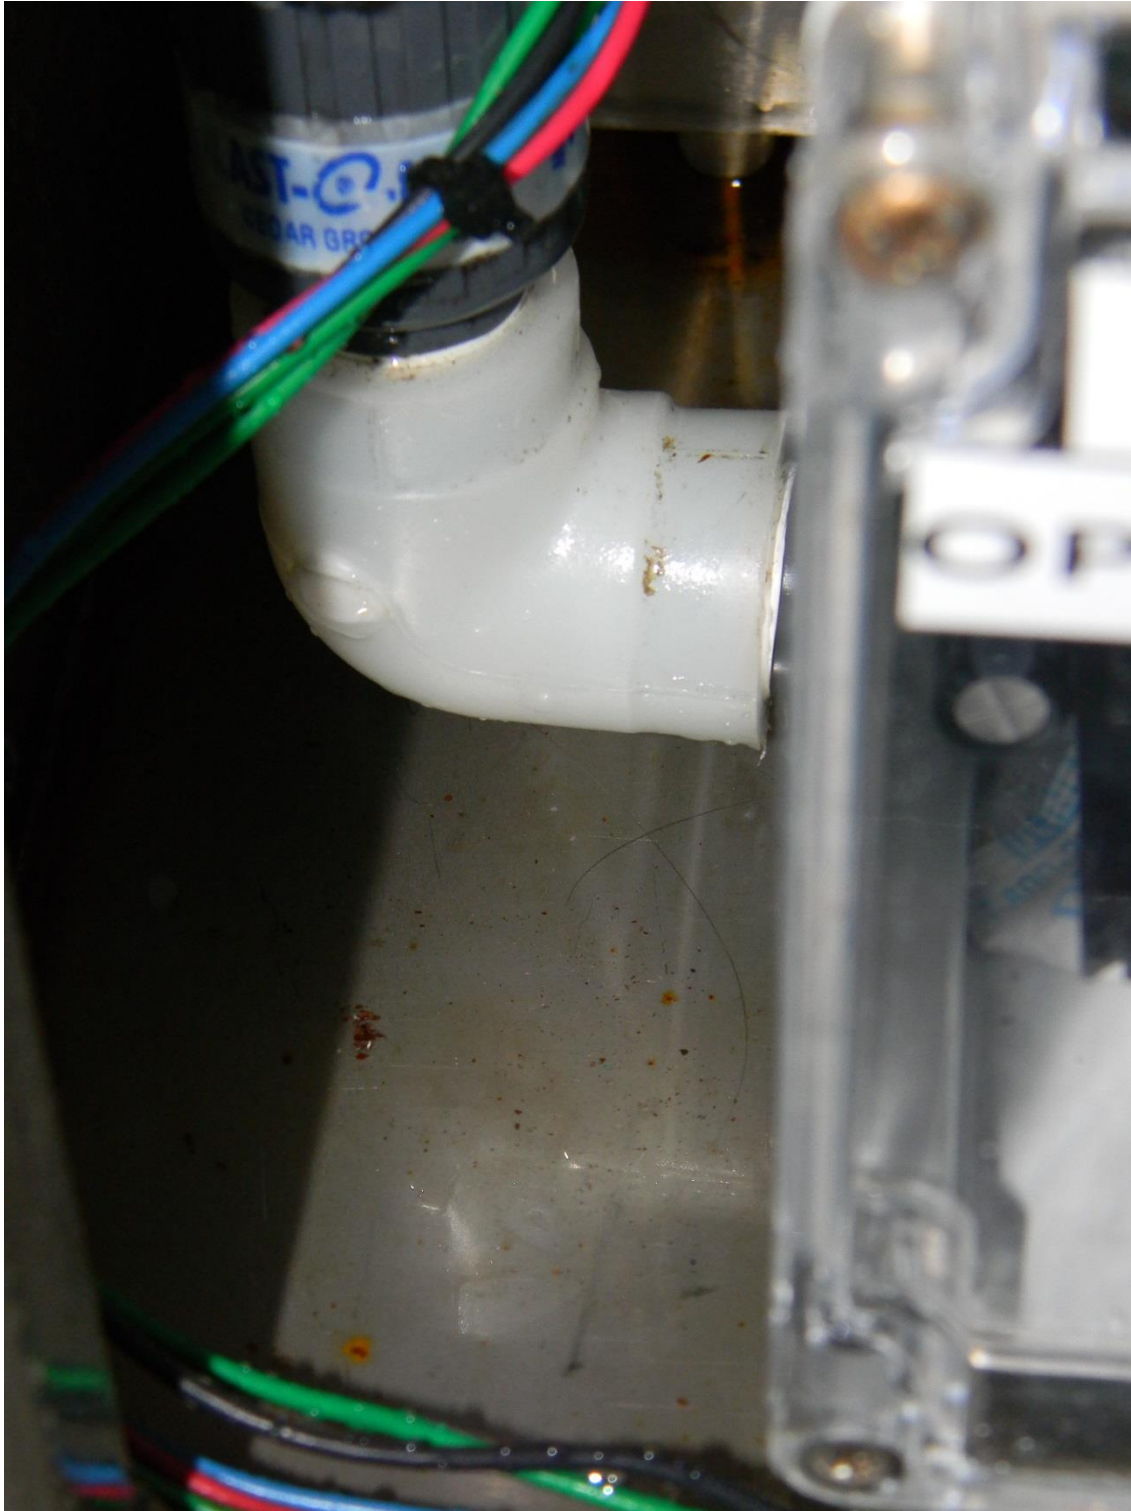
1. There was extreme moisture in the Instrument Box. The entire lower box was coated in water spray and 3-4 gallons of water were in the catchment box.
2. The AADI optode was slightly dirty with some limited sediment/biofilm growth within the housing. The water inside was stagnant.
3. The BBFL2 was essentially clean, as the housing was mostly dry inside from lack of pressure. Only a little water remained due to an inability to drain this remnant volume due to system geometry.
4. The Seabird 45 CT sensor was mildly dirty, with no mussels found growing within the housing. The water inside was stagnant.
5. The flex tubing was newly replaced and showed little to no signs of sediment or biofilm growth.
6. The sea chest showed no signs of leaks.
7. The inline filter (sea strainer) was checked and was found to be slightly dirty and required cleaning.

Figure 3: Water pooled in the bottom of the housing

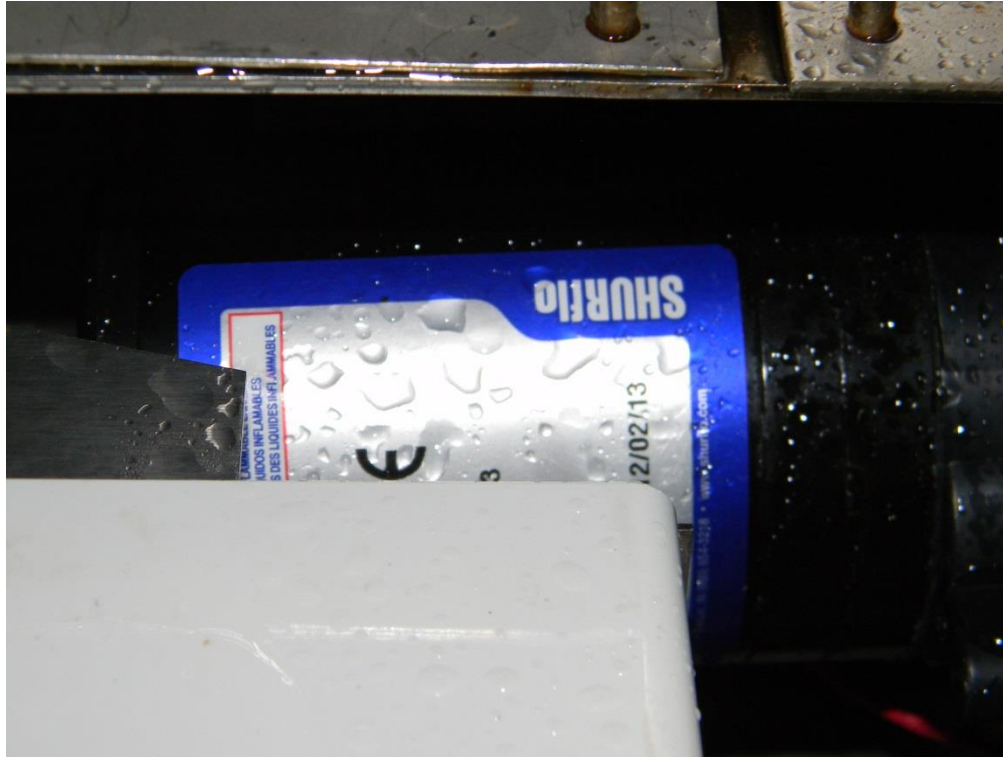
6. Removed and replaced pump unit. No immediately obvious signs of damage to the unit, but spray patterns indicated failure in the pump region of the housing. Slight indications of a leak between the motor and pump head.

Figure 4: Water spray on pump housing

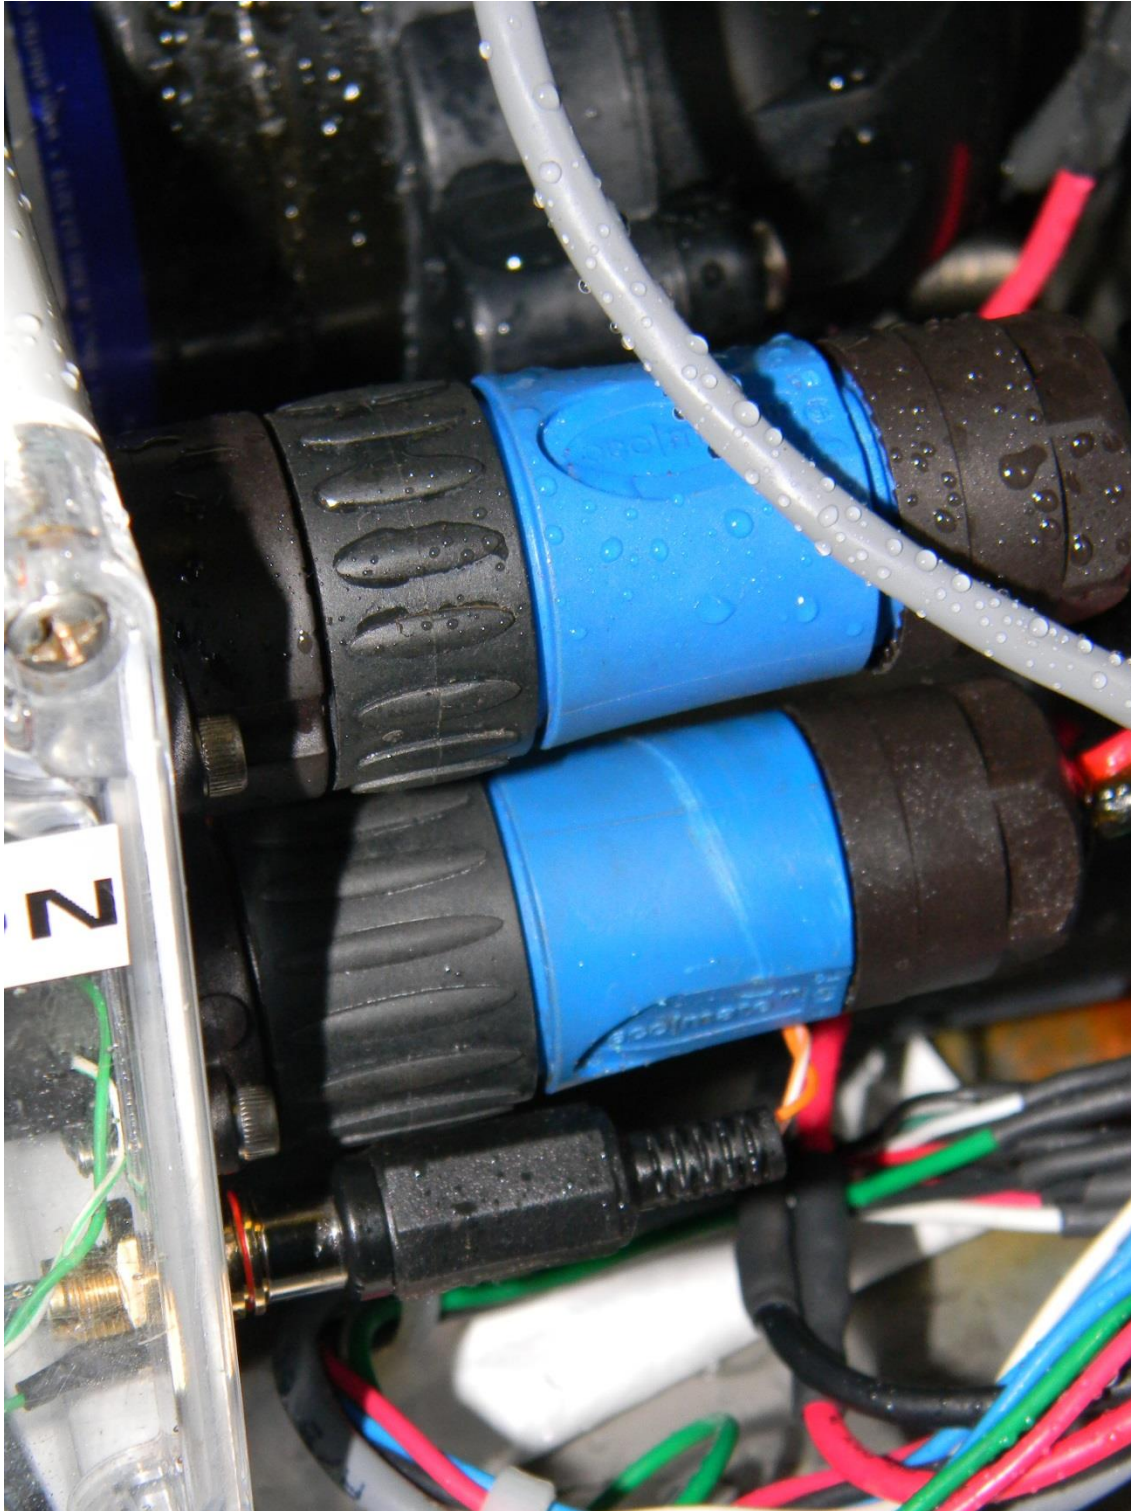
Figure 5: Water Spray on connectors

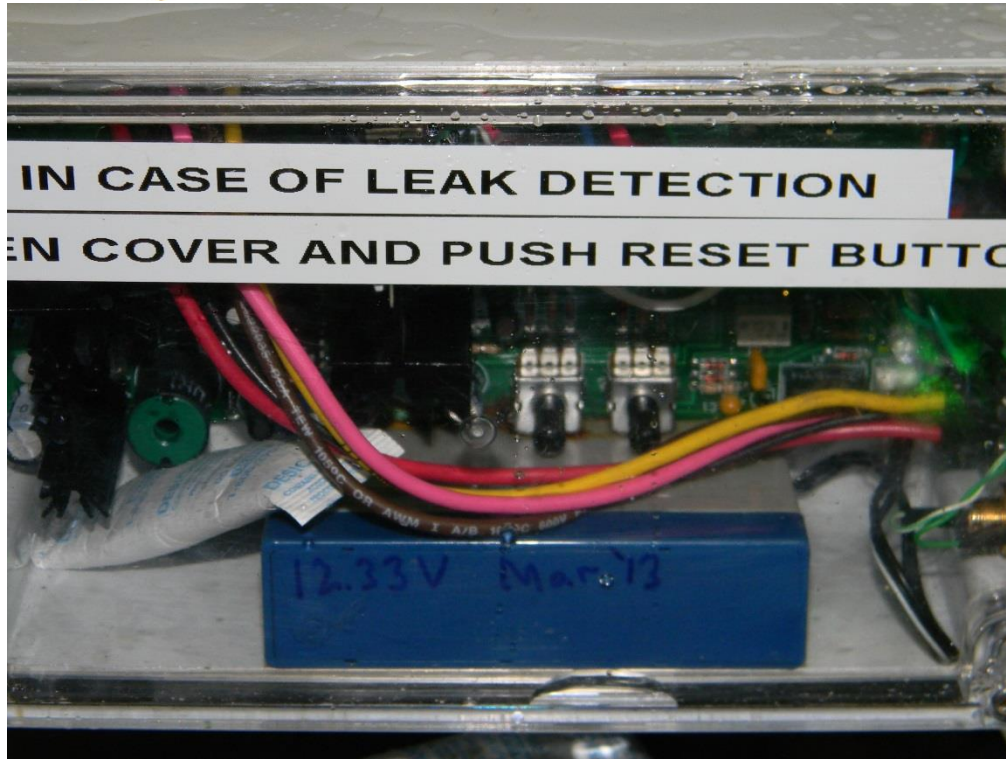
5. Removed and inspected the pump control box. Water noted inside the housing and corrosion was found on the bottom edge. Examination showed that the battery had not been fully seated into the housing, possibly because it was slightly large, and this caused the lid to bow away from the seal in the middle. Under extreme leak conditions enough water built up on the top surface of the box for some to find its way into the failed seal, thence dripping onto the battery which was pressed tight against the bottom edge of the circuit board. This caused corrosion on several components on the board. Note that the failure only happened because of extreme leak conditions, combined with a battery that didn’t fit right, combined with the battery being pressed against the board, combined with a lack of conformal coating on the board.

Figure 6: Pump Control Box. Note water pooled inside front edge of housing, plus visible corrosion products at junction of battery and board. Desiccant package was fully absorbed.

1. Install replacement Pump Control System. Check for leaks and test system.
2. Purchase extended length Allen keys for the Queen of Alberni. The set we have on board is too short to perform maintenance on the Pump system, and we had to borrow appropriate length Allen keys from the Engine Room (which was almost impossible – they had only a partial set in the small sizes we use).

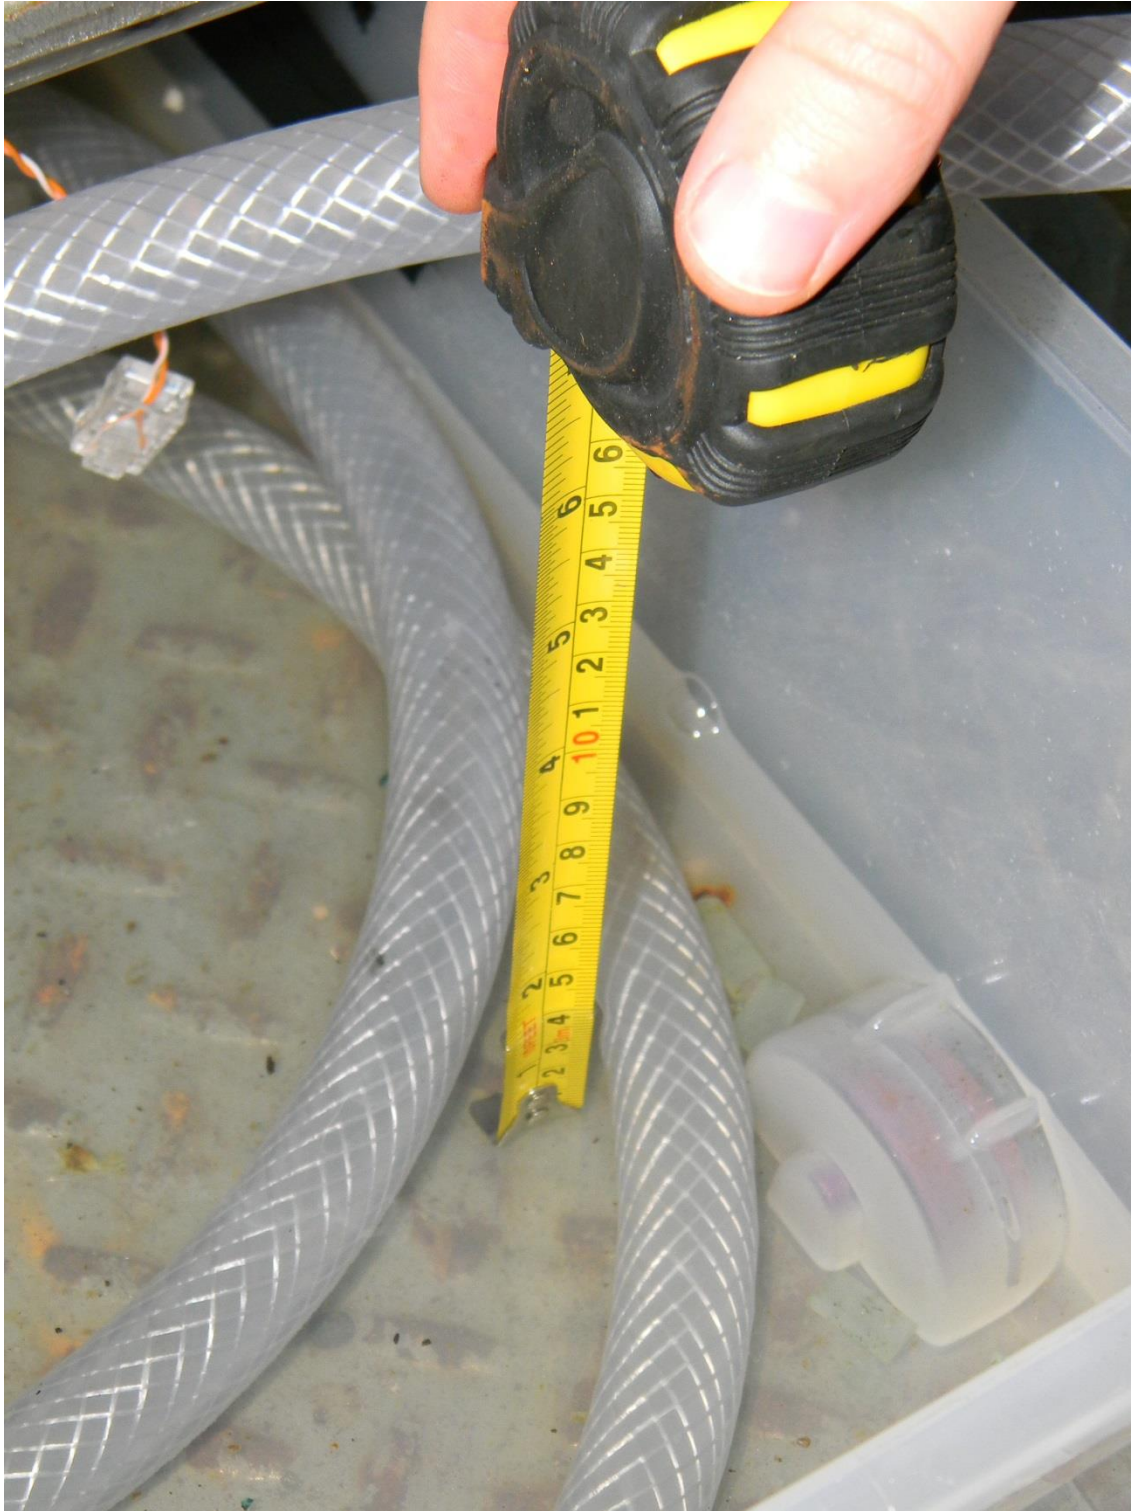
Figure 7: Depth of water within the catchment basin (approximately 4 cm)

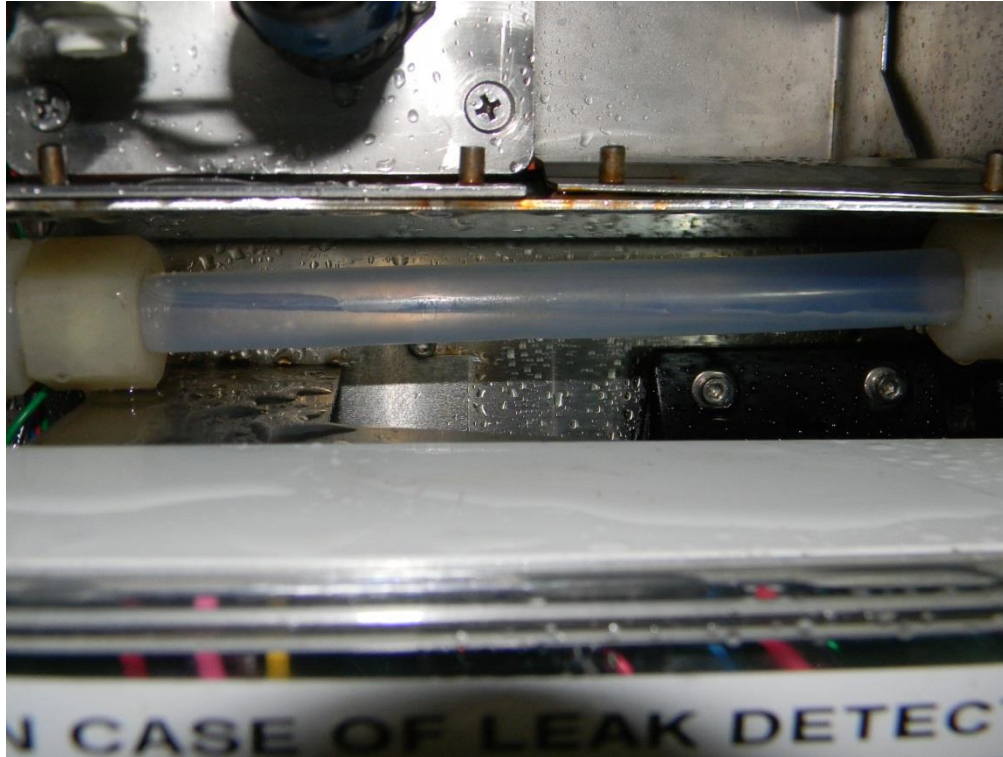
1. Opened both boxes and observed function. The system was not functioning normally upon arrival. The pump was not operating, although the pump control board showed a green light. No flow was seen and the flow tubes were empty except for pooled water in the low points.

Figure 8: No flow visible within main supply tube. Spray pattern indicates leak within the pump section of the system.

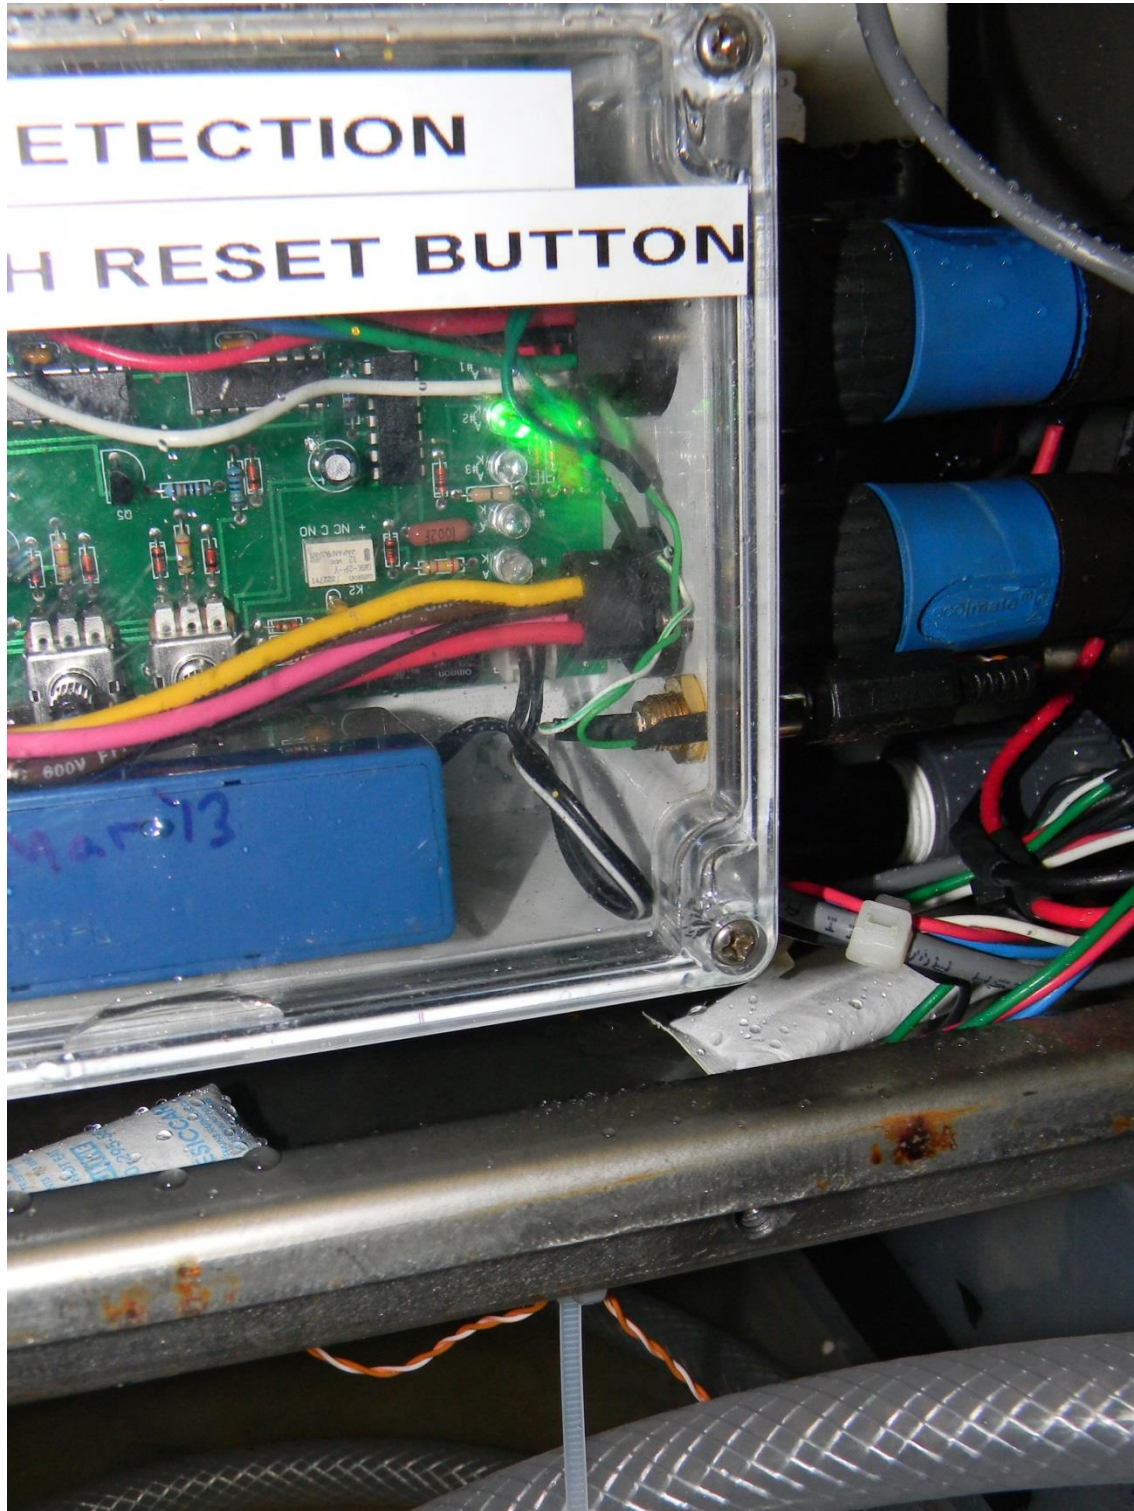
Figure 9: Note Pump Control Box light is on, no pump function

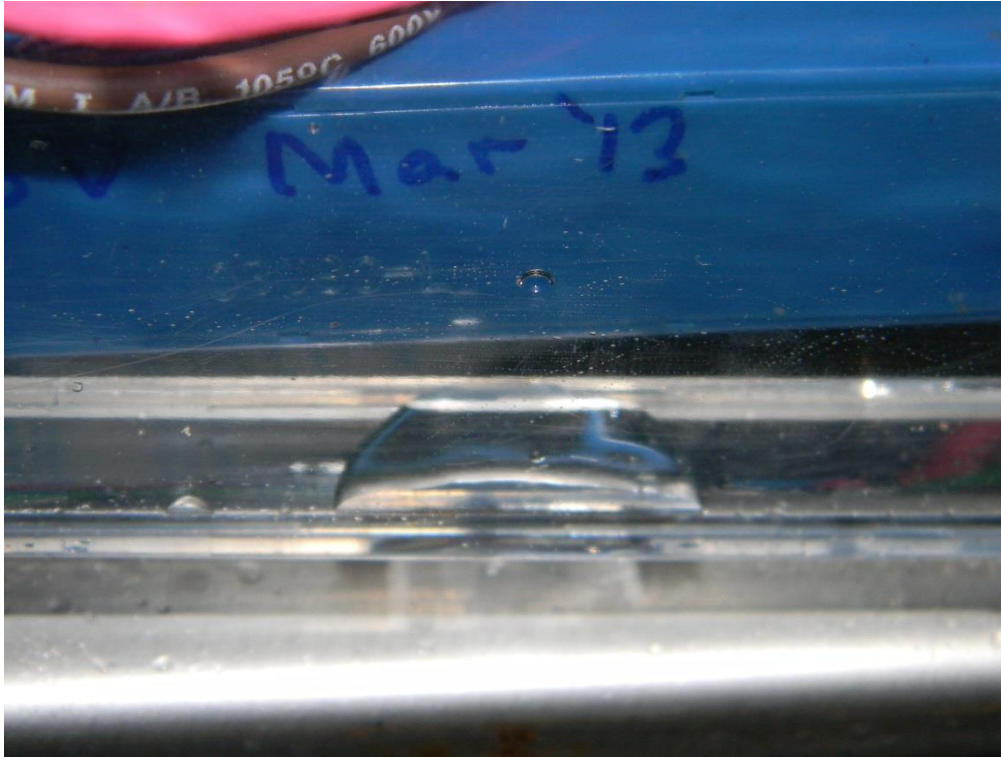
Figure 10: Water inside Pump Control Box

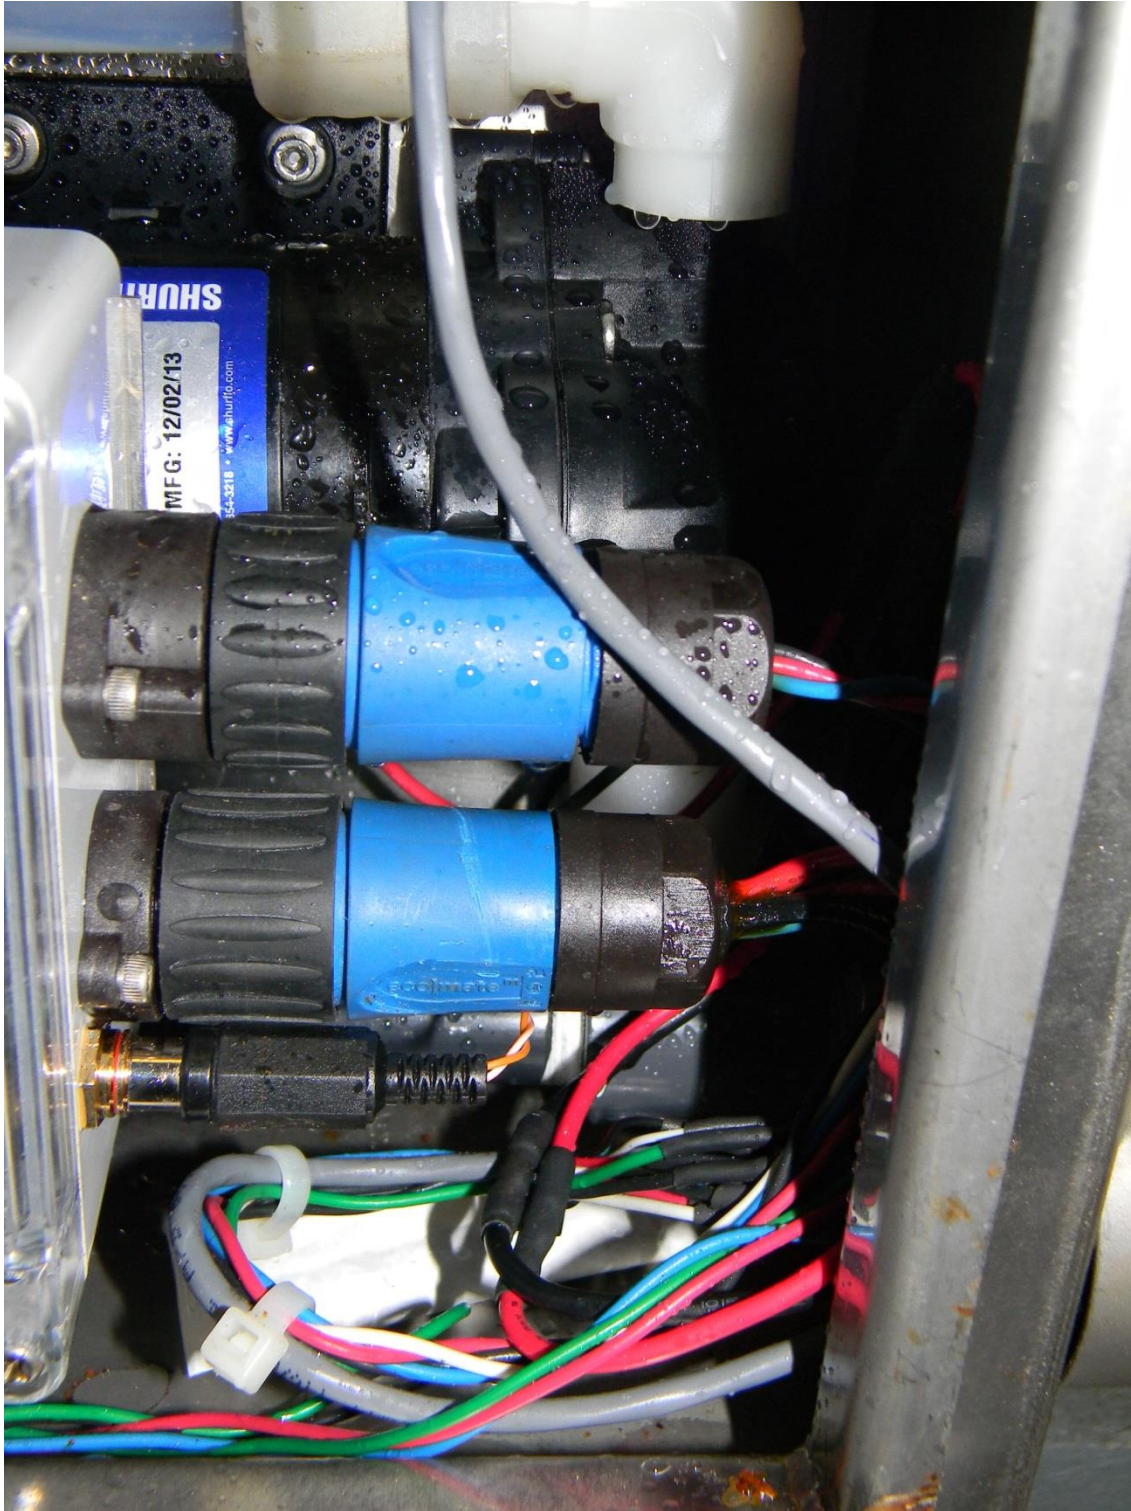
Figure 11: Water Spray within pump region

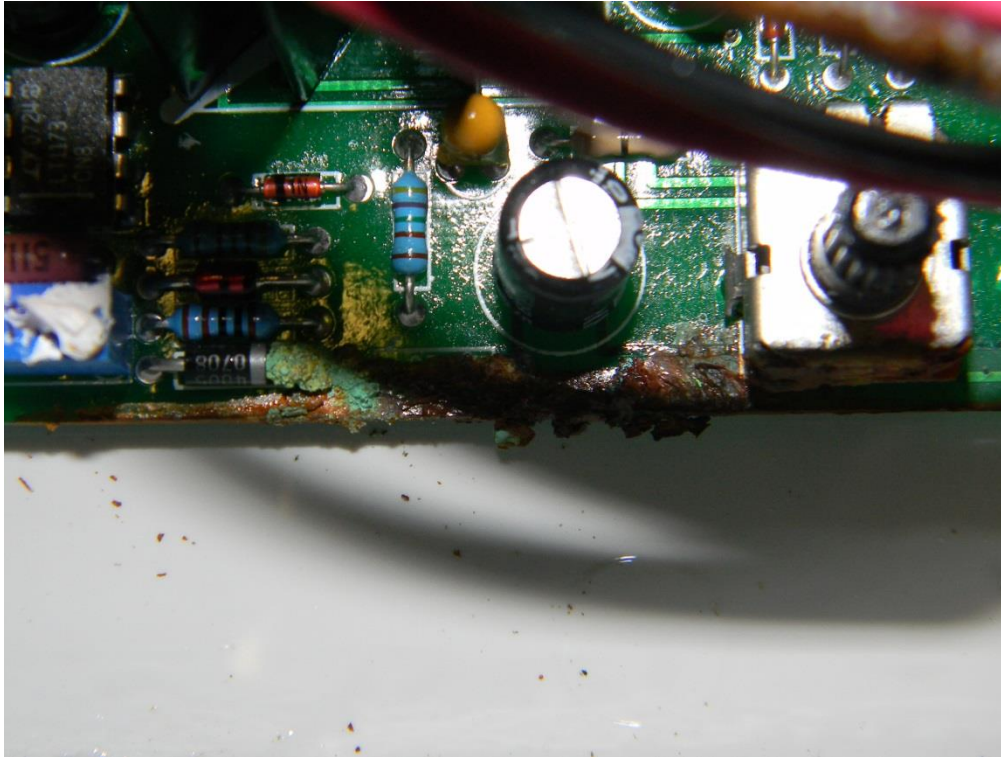
Figure 12: Corrosion on lower edge of board

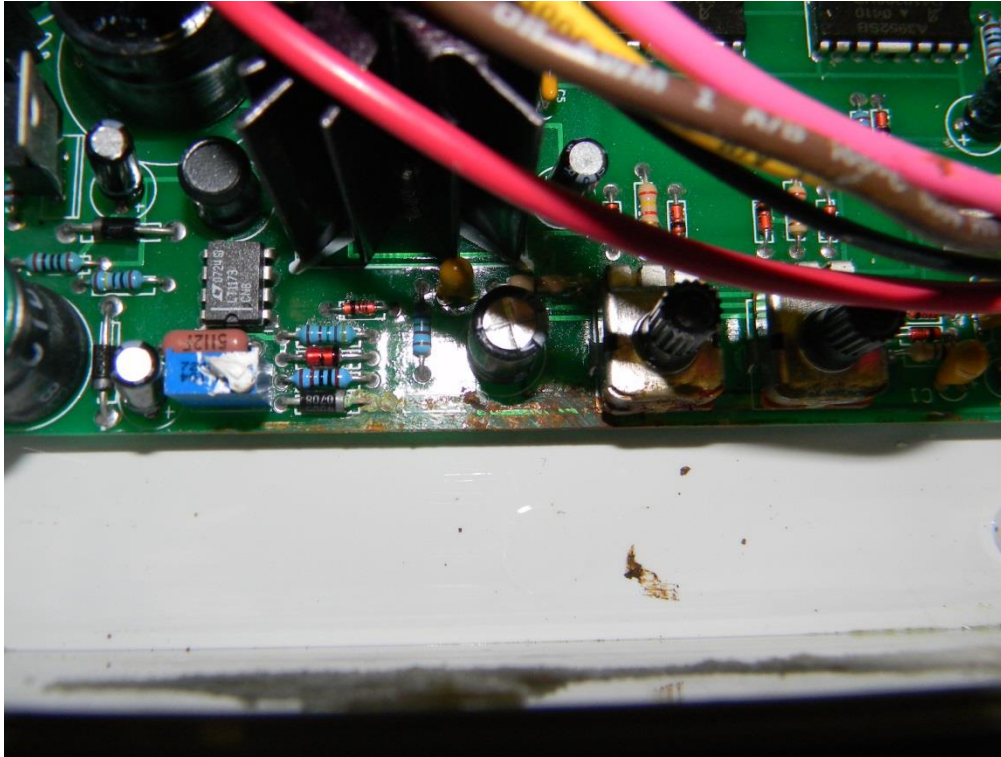
Figure 14: Pump Control board corrosion after rudimentary cleaning

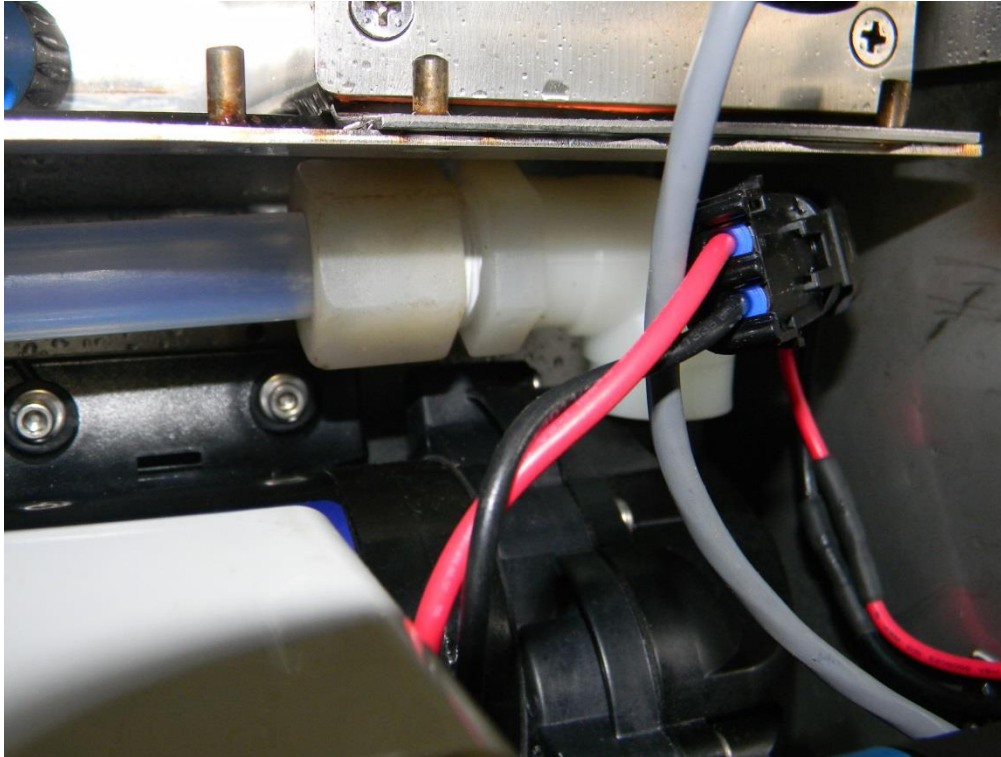
Figure 16: Pump system after reassembly

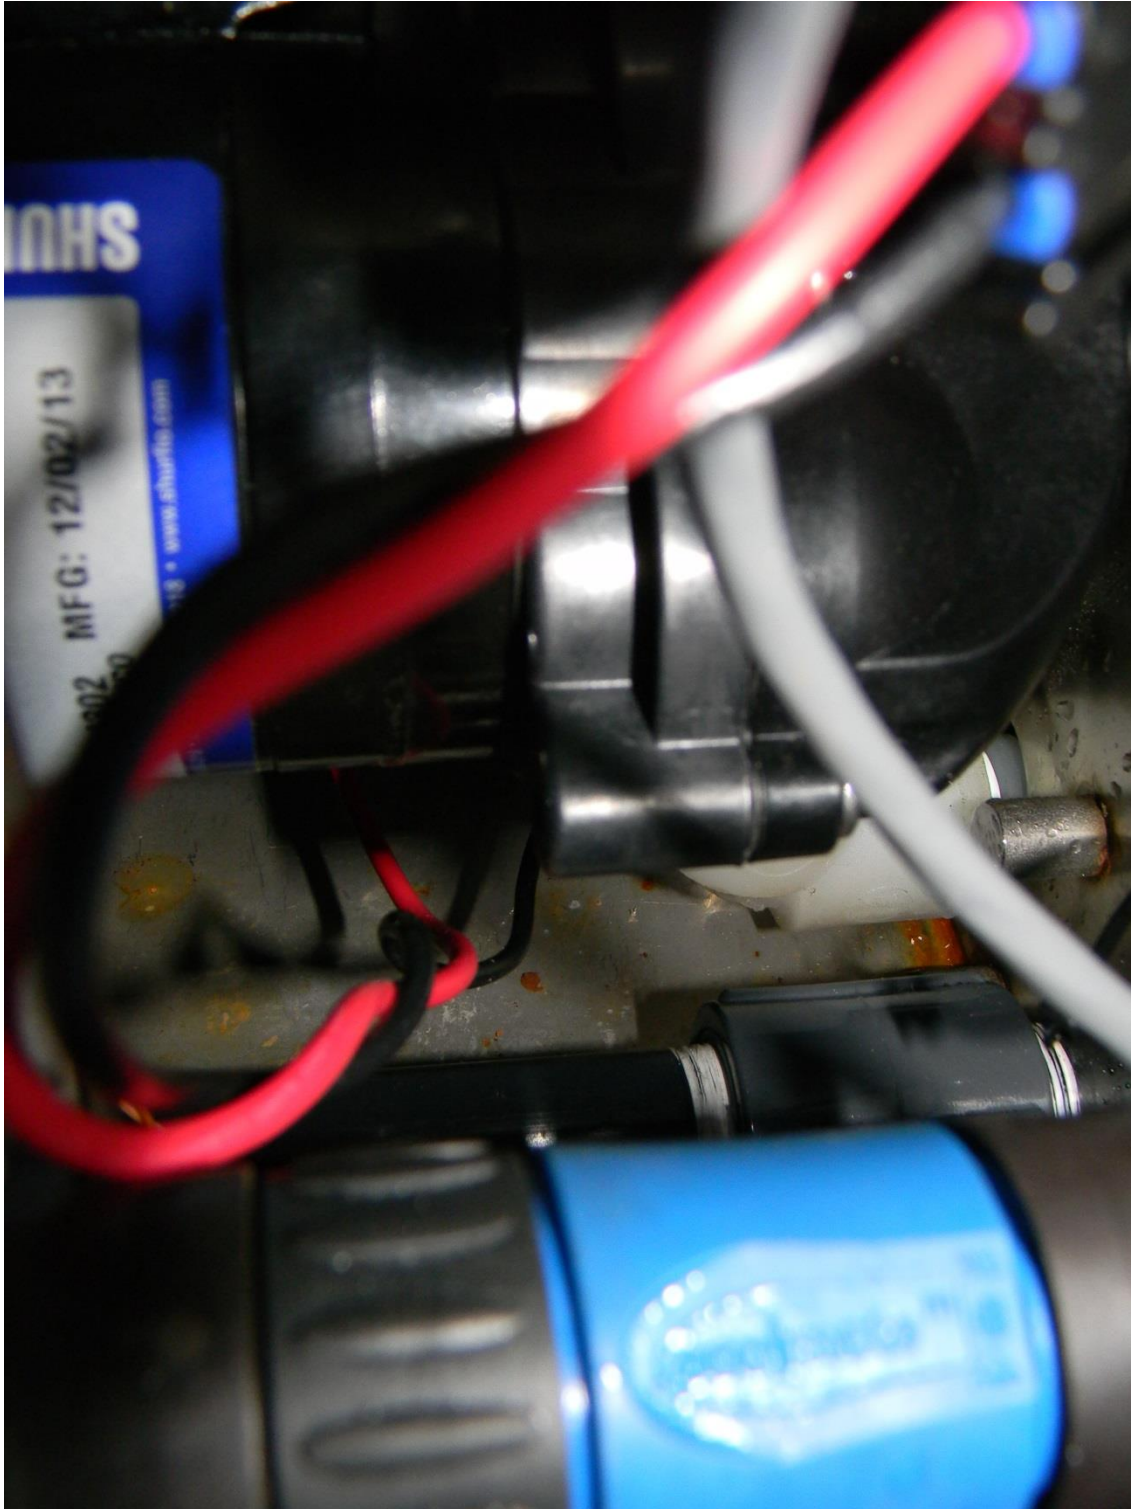
Figure 17: Pump after reassembly
