Ocean Networks Canada

Ferry Maintenance Report – Queen of Alberni

Date: Feb 12, 2015

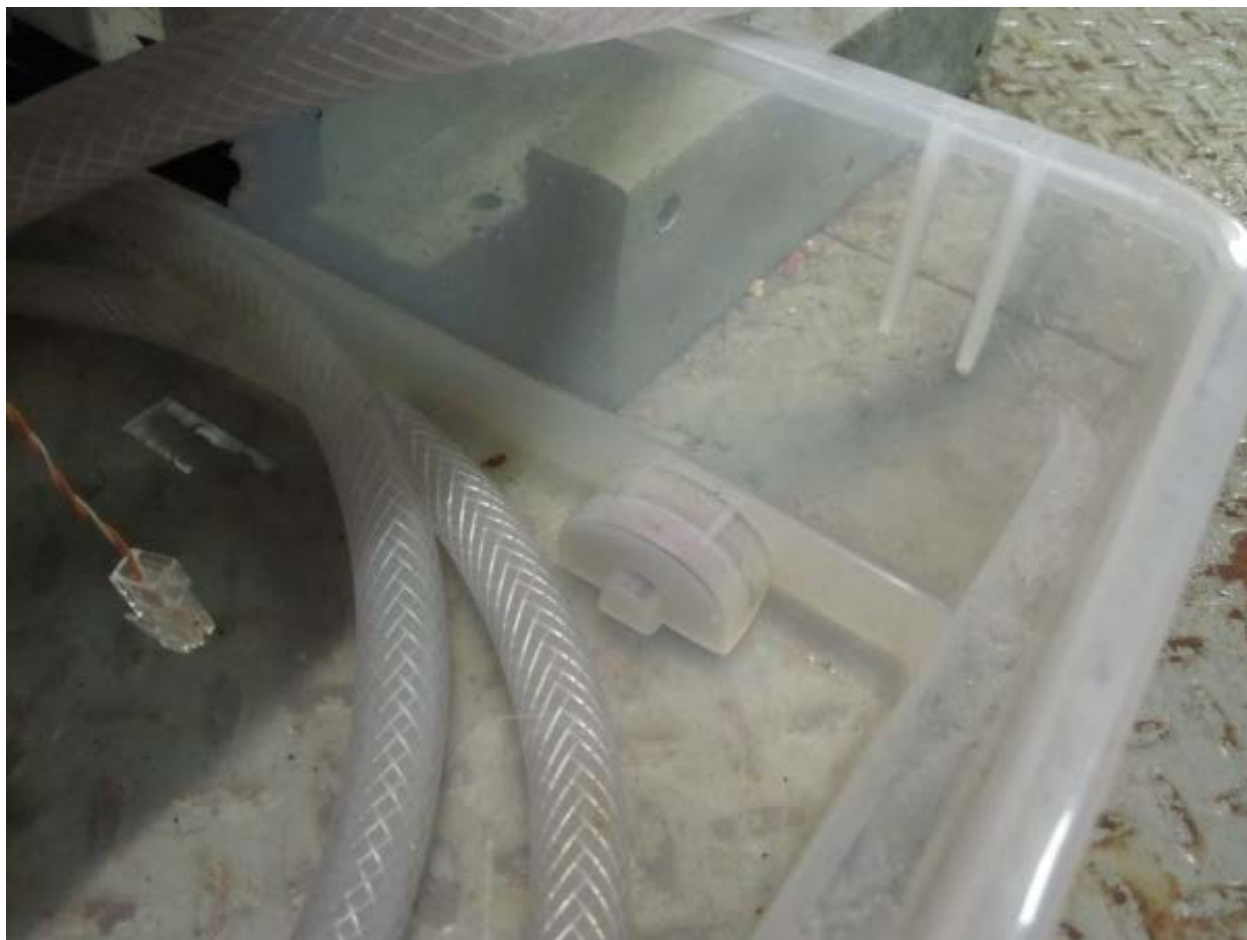
The instrument box drain pan was filled just up past the wheel (about 2 inches). Leak detector was not submersed. Opened the PC box, the PC and other network gear were running, nothing unusual seen. Opened the instrument box and it had water droplets, mainly in the bottom half as well as some pooling. Some water had pooled on top of the optode housing, up higher. The pump control box had no lights on.

Figure 1 - water level in overflow bin

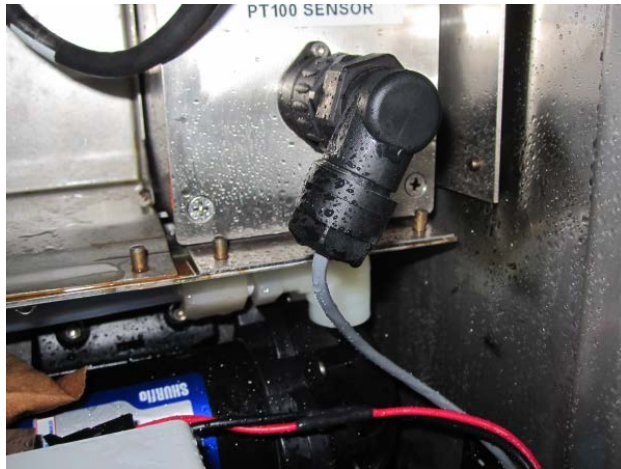
Figure 2 - water spray

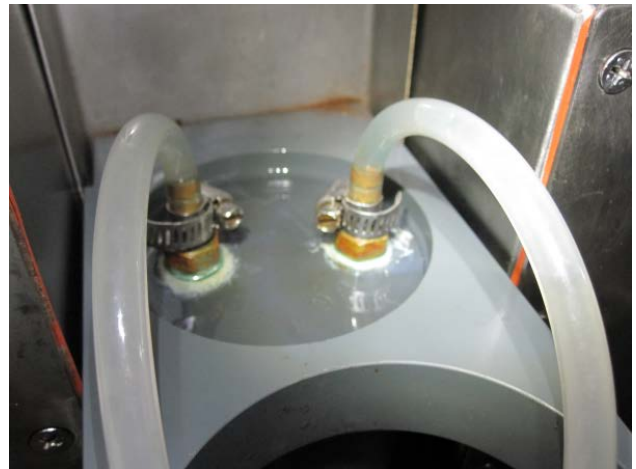
Figure 3 - water pooling on optode

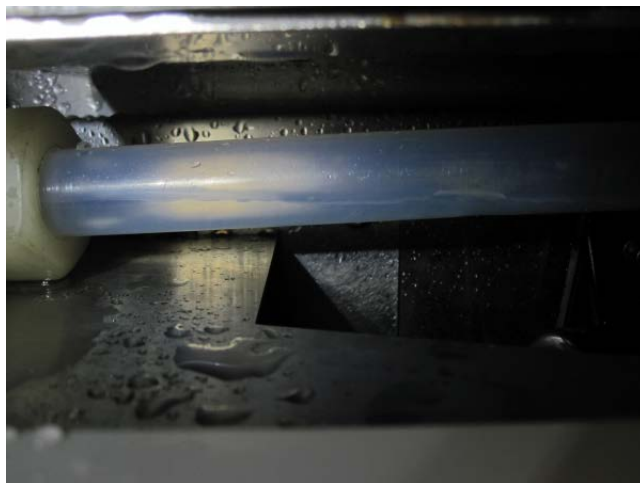
4. It is thought that the dramatic current pull on the pump may be due to the fact the instruments were riding above the waterline, causing the pump to work harder. The resulting higher pressure in the line may be causing a weak link in the plumbing to leak. This seems to be an intermittent problem, maybe due to weather conditions and/or ship loading. The compression fittings/rigid line run are a likely culprit for the weak link. New clear rigid FEP pipe has been cut to replace the existing one on the pump outlet. Action item 5 is probably a better alternative though...

Figure 4 - rigid line with water spray

5. It is recommended to review using flexible PVC tube (5/8 barb to ½ NPT) on the pump to manifold line. This makes pump replacement easier and avoids the need to replace unseated rigid tubing currently installed. The tubing in stock is similar to the 3/16 ID tubing used on the manifold.

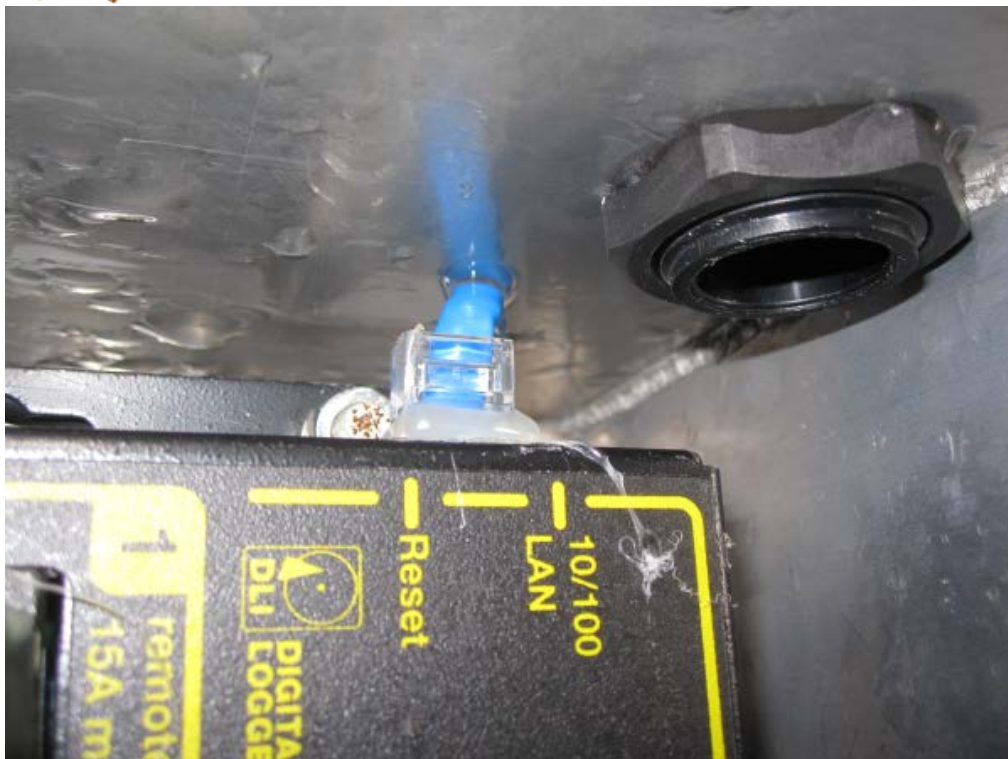
The topside box was opened and water was seen in the bottom of the box. The Web Power Bar had box symbols on the display, indicating a failure mode. The water seepage was traced to the top-vent on the right side of the box, just above the Web Power Bar Ethernet port. The left vent appeared dry. The power was shut off at the PC box breaker. Due to weather hampering further troubleshooting and multiple issues with the topside box, it was determined that the box should be removed.

Figure 5 - topside box - right side vent and ethernet port on Web Power Bar pictured

1. The web power bar in the topside box will need to be replaced.
2. The top box vent leaks need to be investigated further. It will need to be determined how the vent leaked – **it appears that water seeped in around the nut**. Fixing a gasket on the nut as well as a bead of marine sealant around the outer perimeter of the vent are two solutions to this.

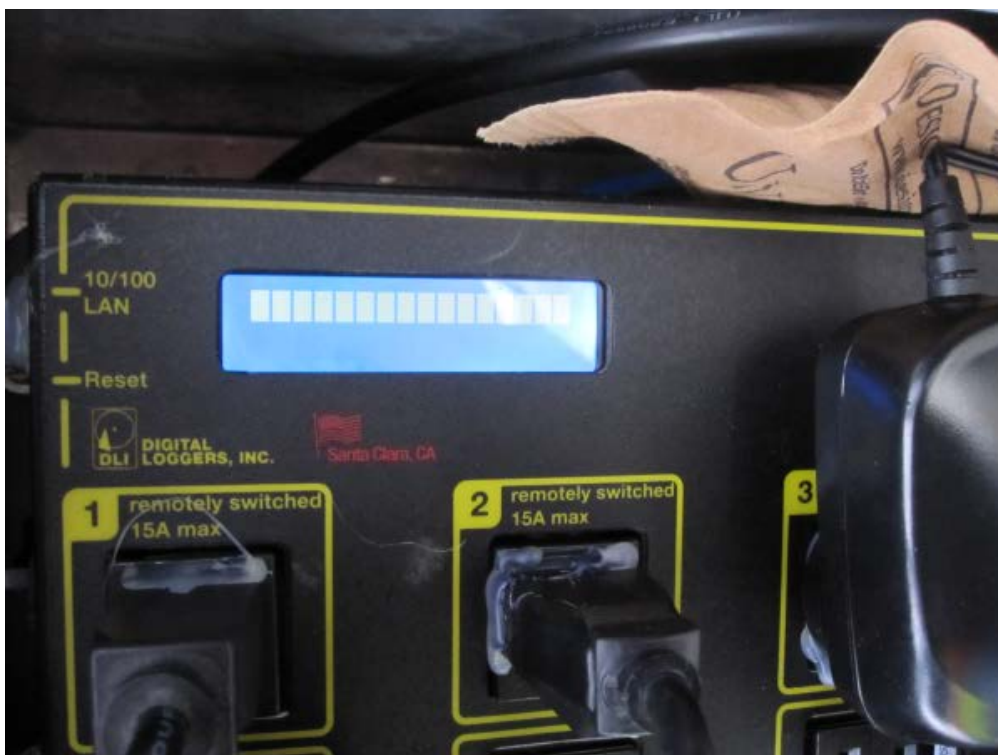
Figure 6 - Web Power Bar has entered a non-recoverable failure mode

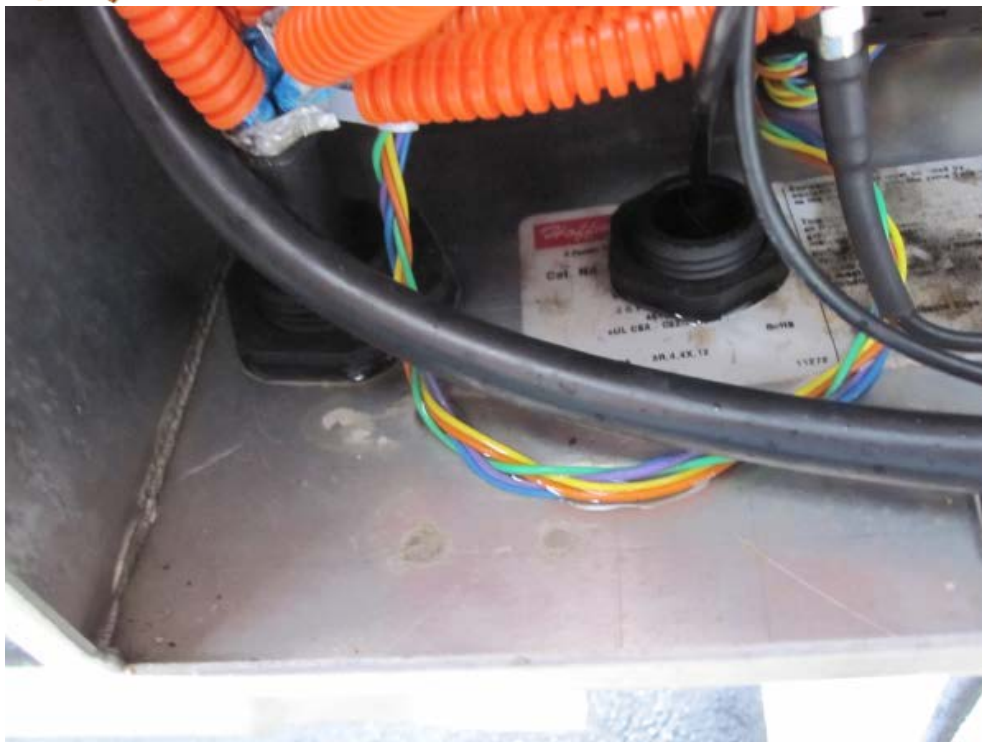
Figure 7 - pooling at bottom of topside enclosure
