Date: Feb 19, 2015

To install the new topside enclosure, including mounting it on the railing and wiring into the QoA system. To remove the radiometers, which are in need of calibration.

#### Ferry Maintenance Report – Queen of Alberni

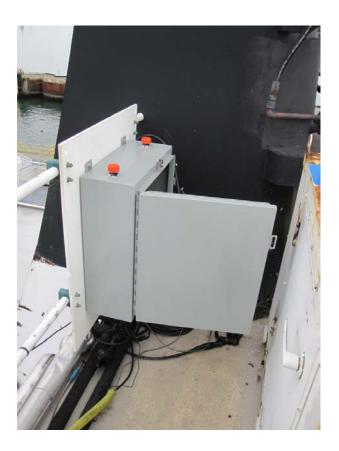
2. The new box was mounted on the railing, and the wiring completed. A separate gland fitting was used for the Met station. The cable for the CS logger/radiometers was bagged and left on deck.
