Ocean Networks Canada

Ferry Maintenance Report – Queen of Alberni

Date: March 6, 2015

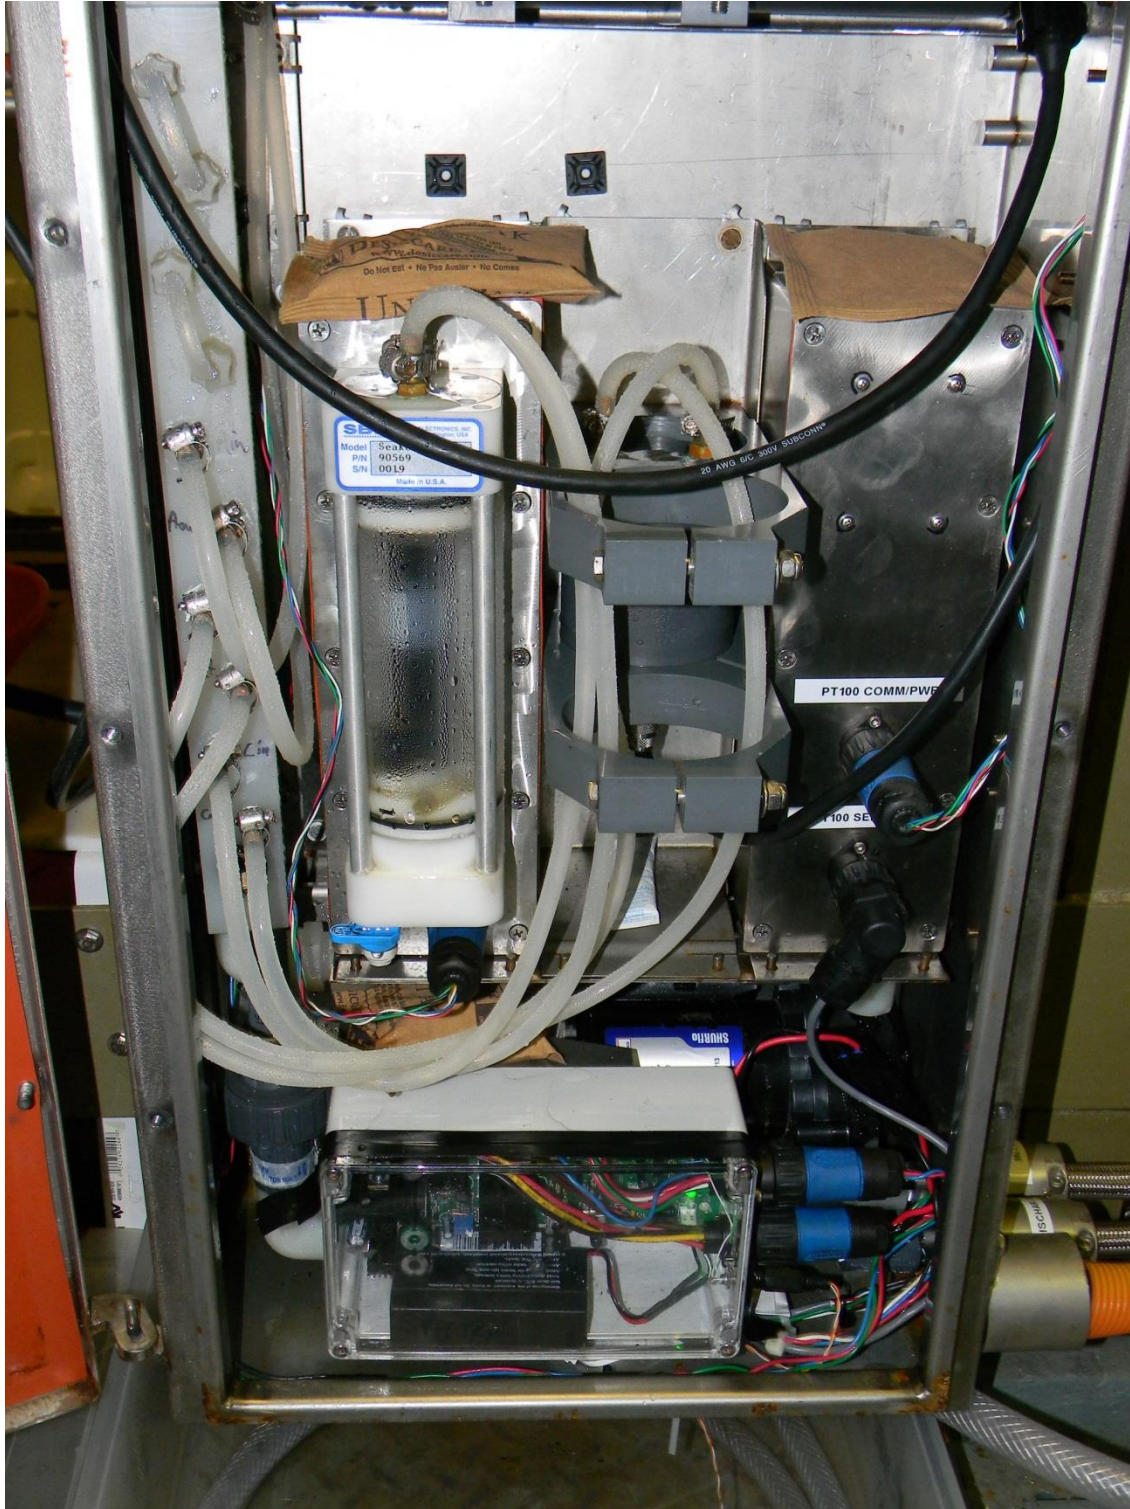
Figure 1: System upon arrival

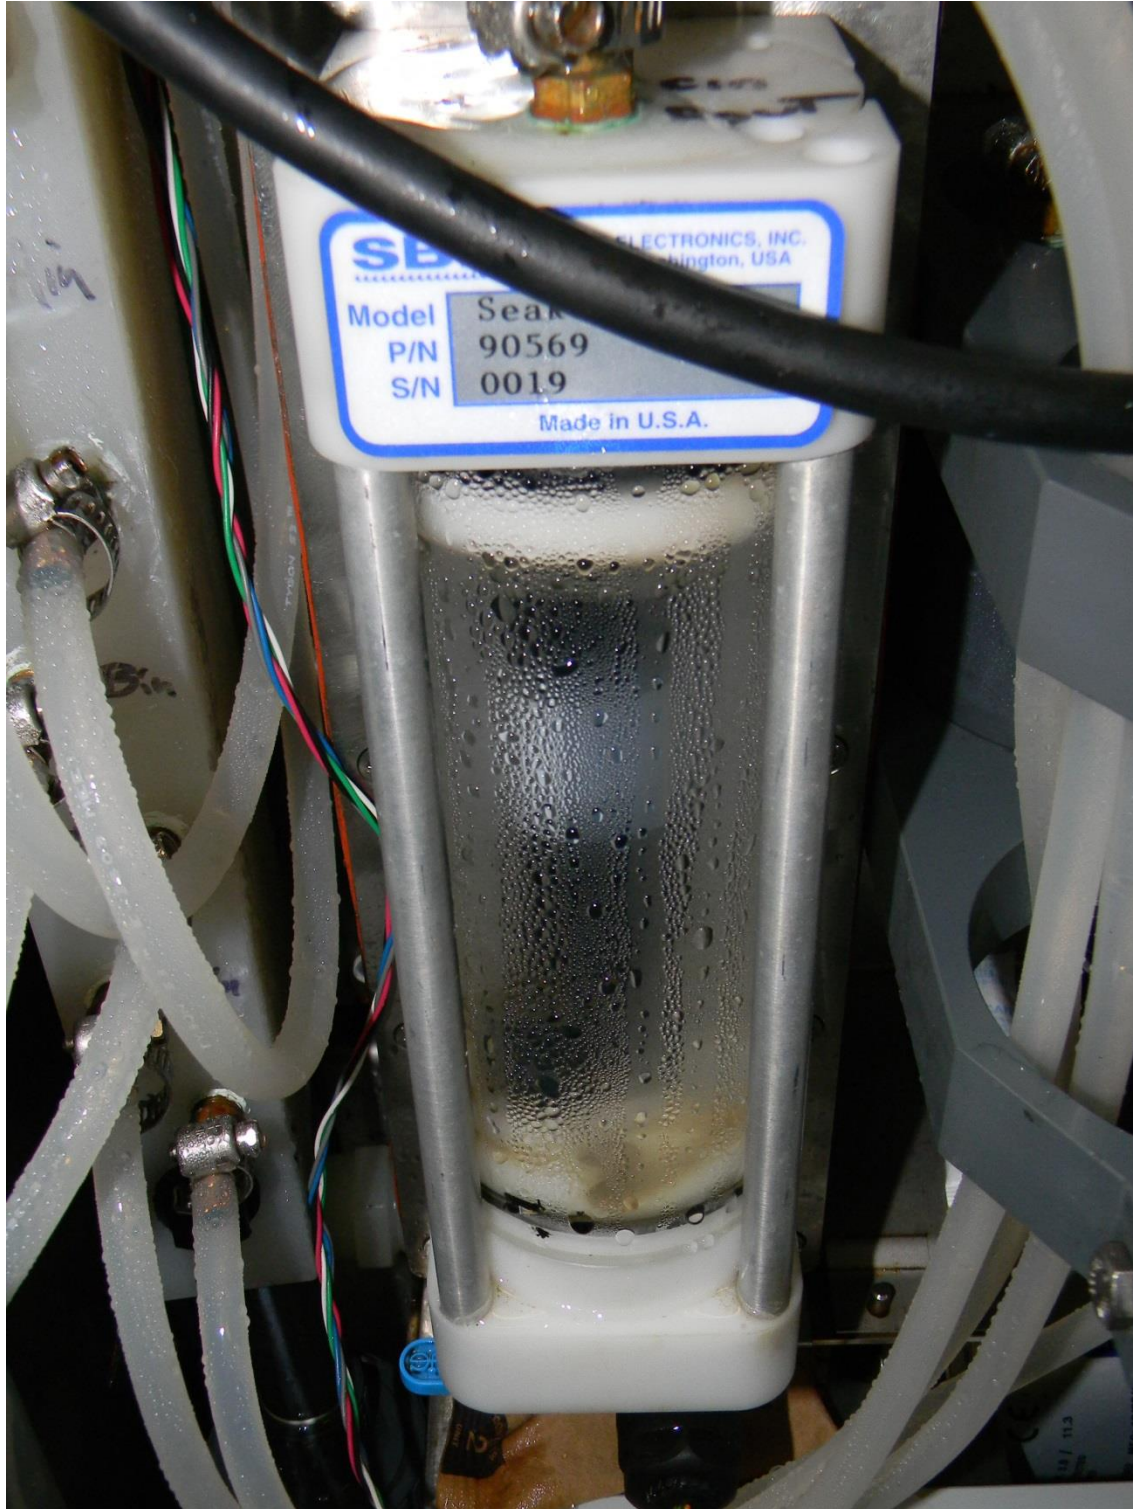
Figure 2: Moisture on CT unit

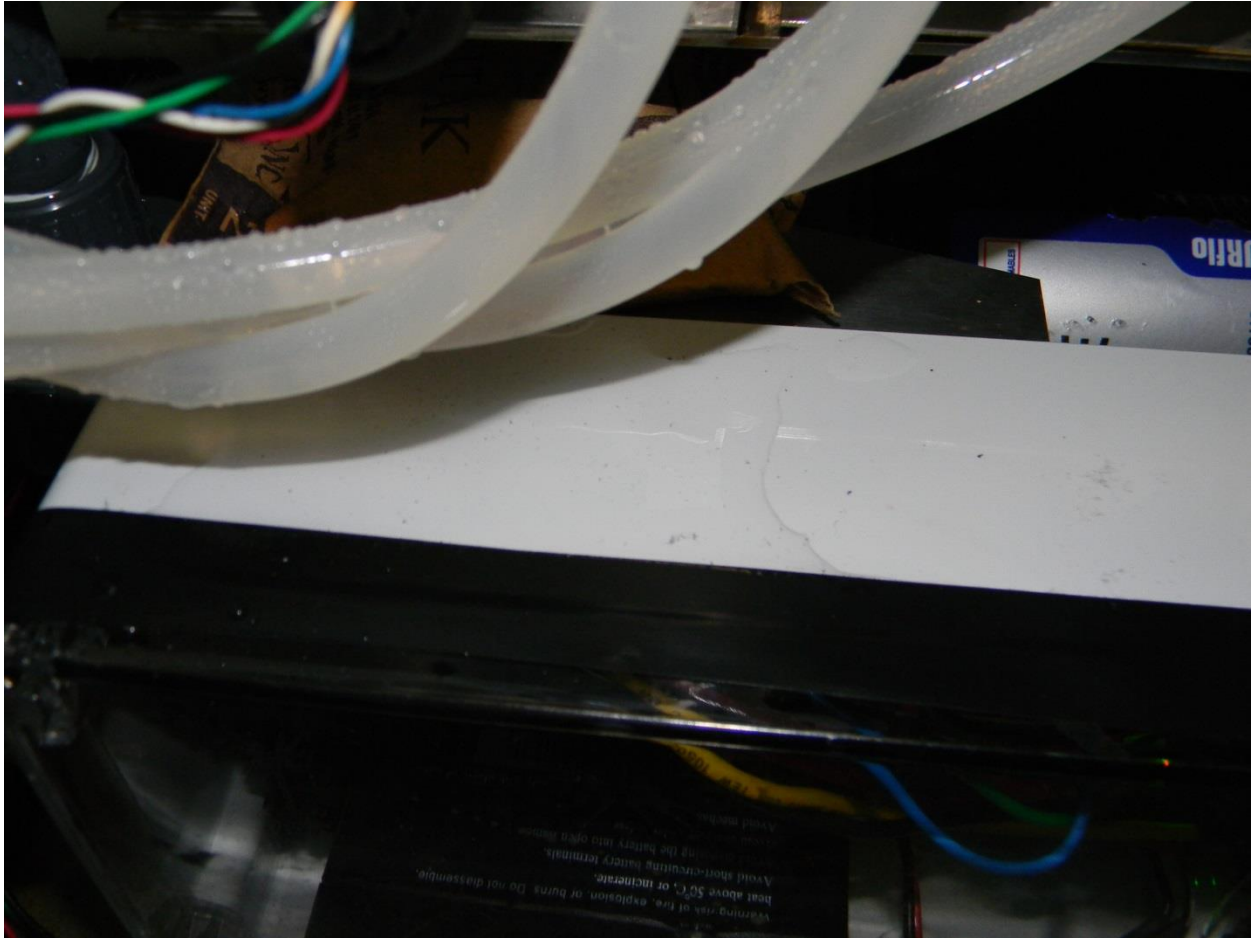
Figure 3: Moisture on top of pump control box

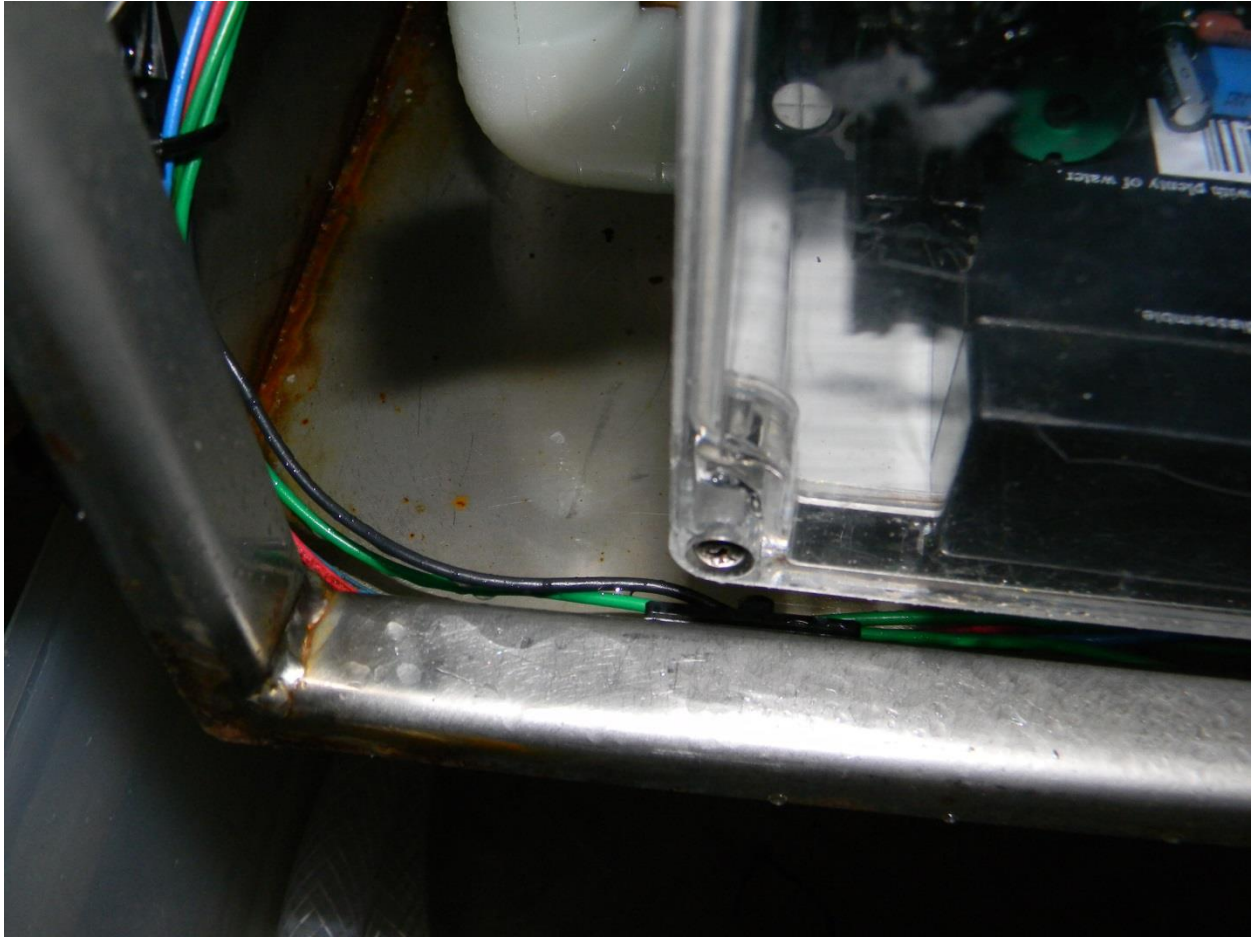
1. There was evidence of leaking within the Instrument Box. Most of the lower box was coated in water spray and approximately 8 liters of water were in the catchment box. This water was apparently from leakage in the system.
2. The BBFL2 feed water tubes had been connected backwards during the last servicing, resulting in the BBFL2 operating with minimal water in the sample volume. All data since the previous servicing is to be marked invalid.

Figure 4: Moisture in bottom of instrument box

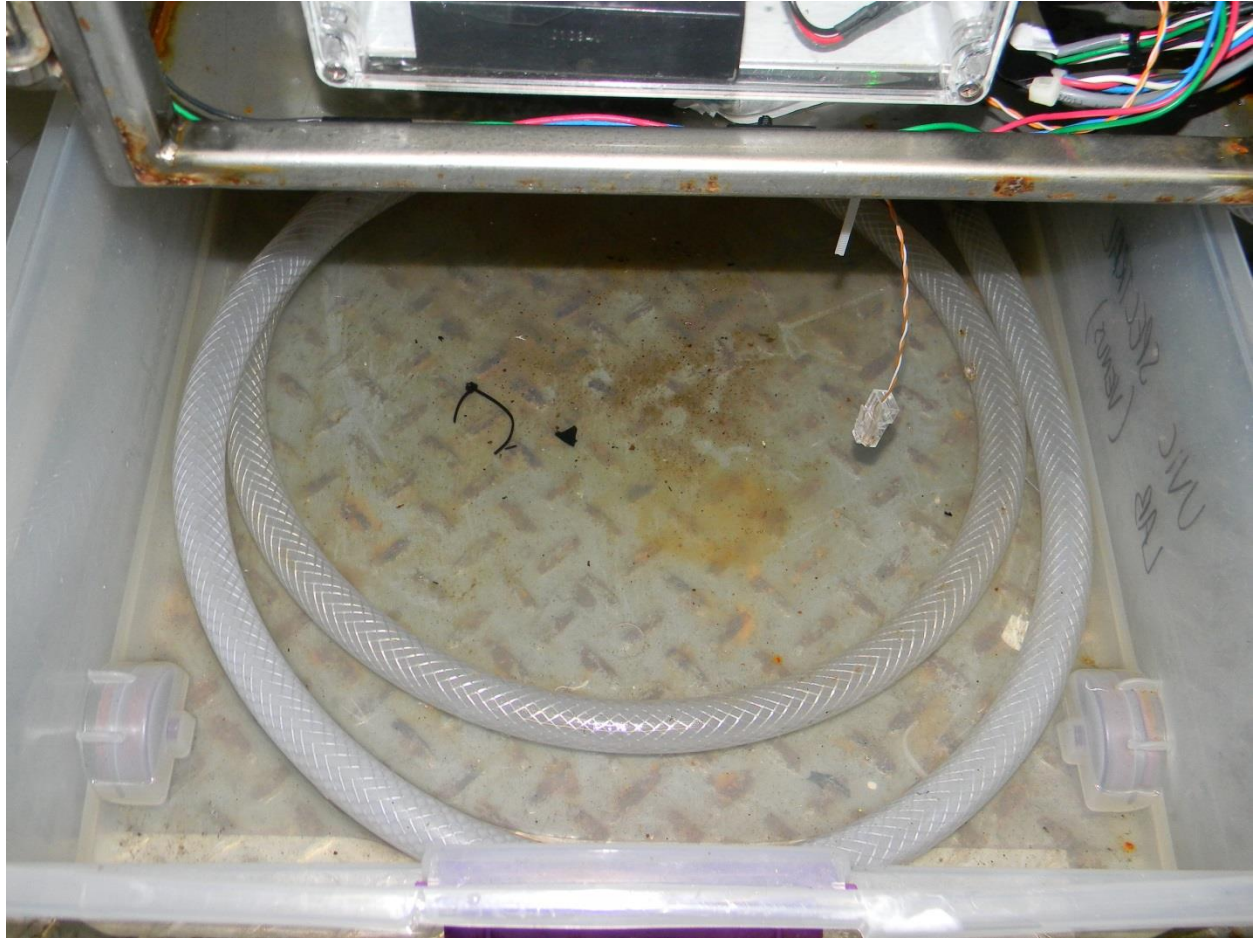
Figure 5: Collected water in catchment basin

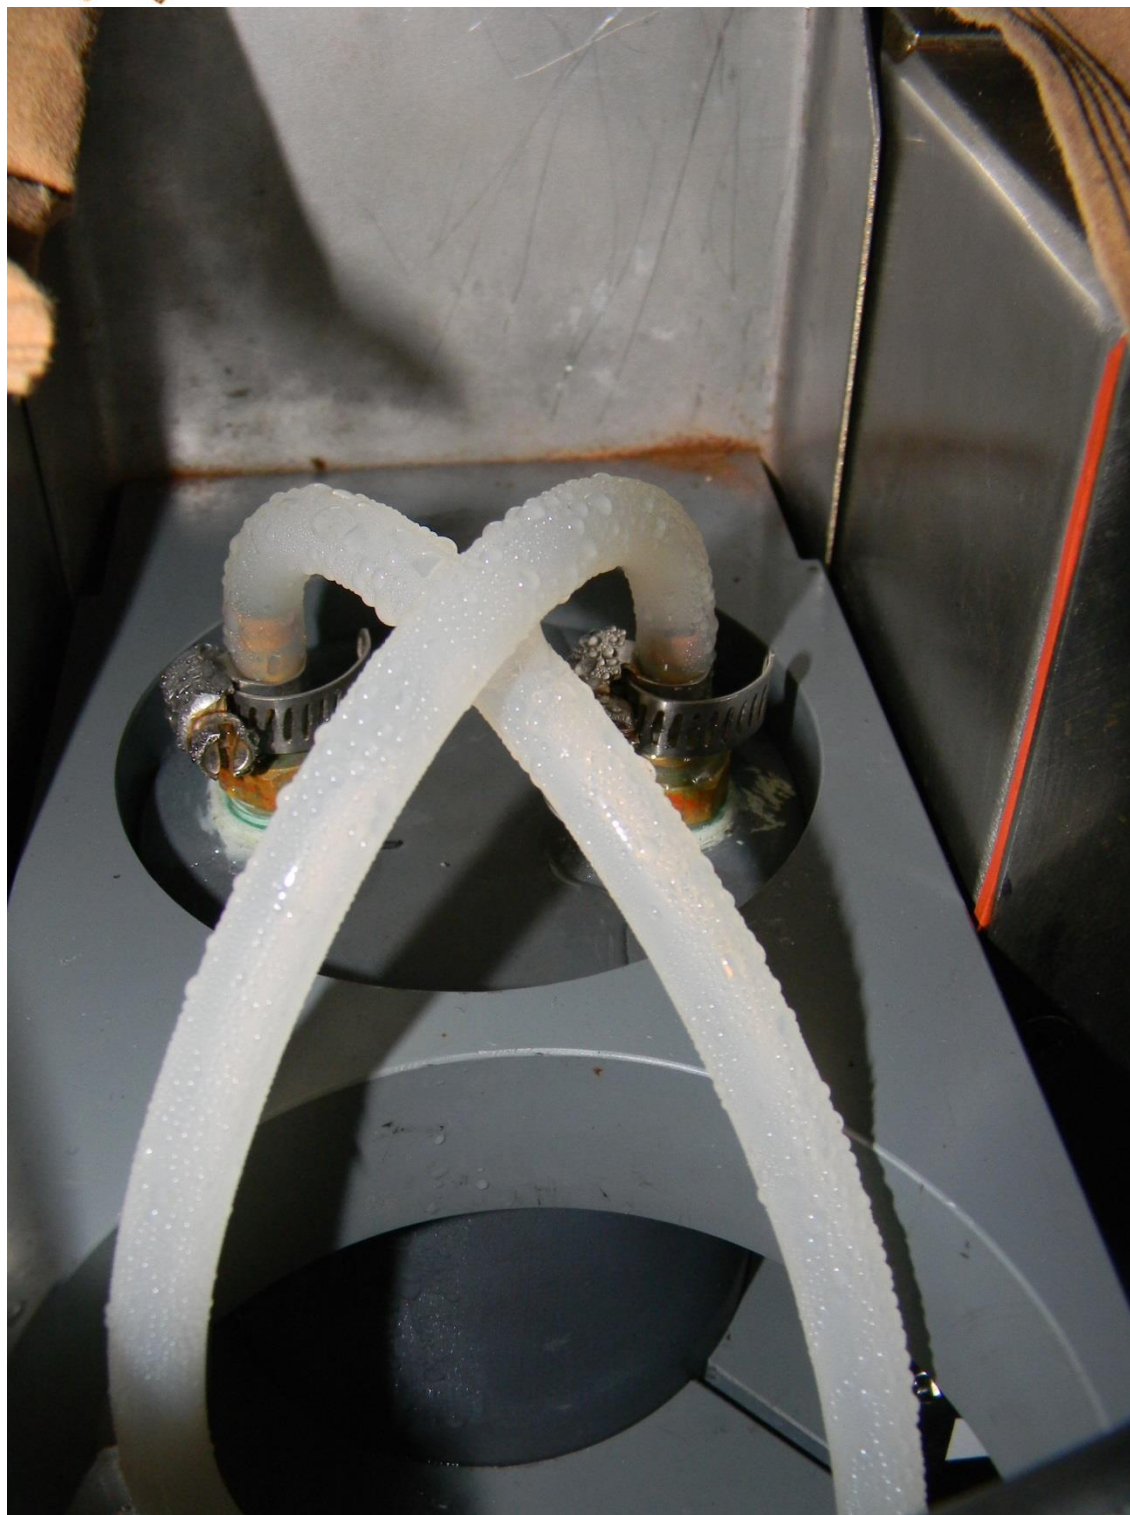
Figure 6: Moisture on top of Optode

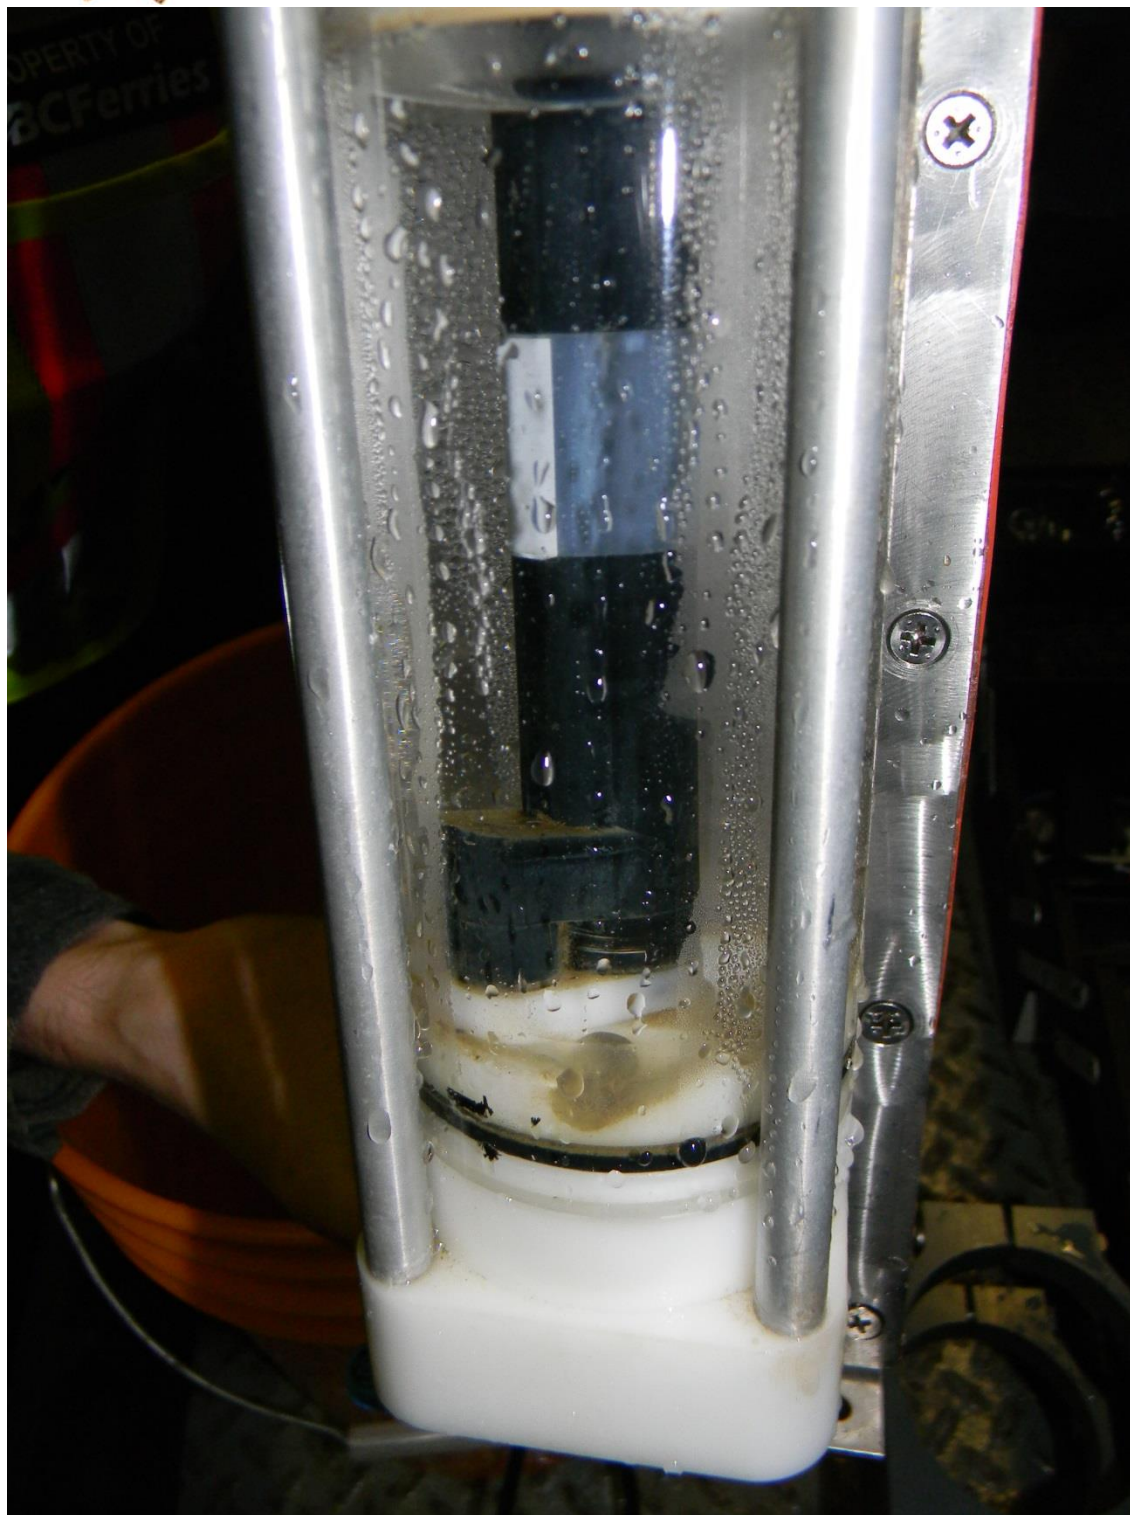
Figure 7: Minor sediment build-up within CT housing

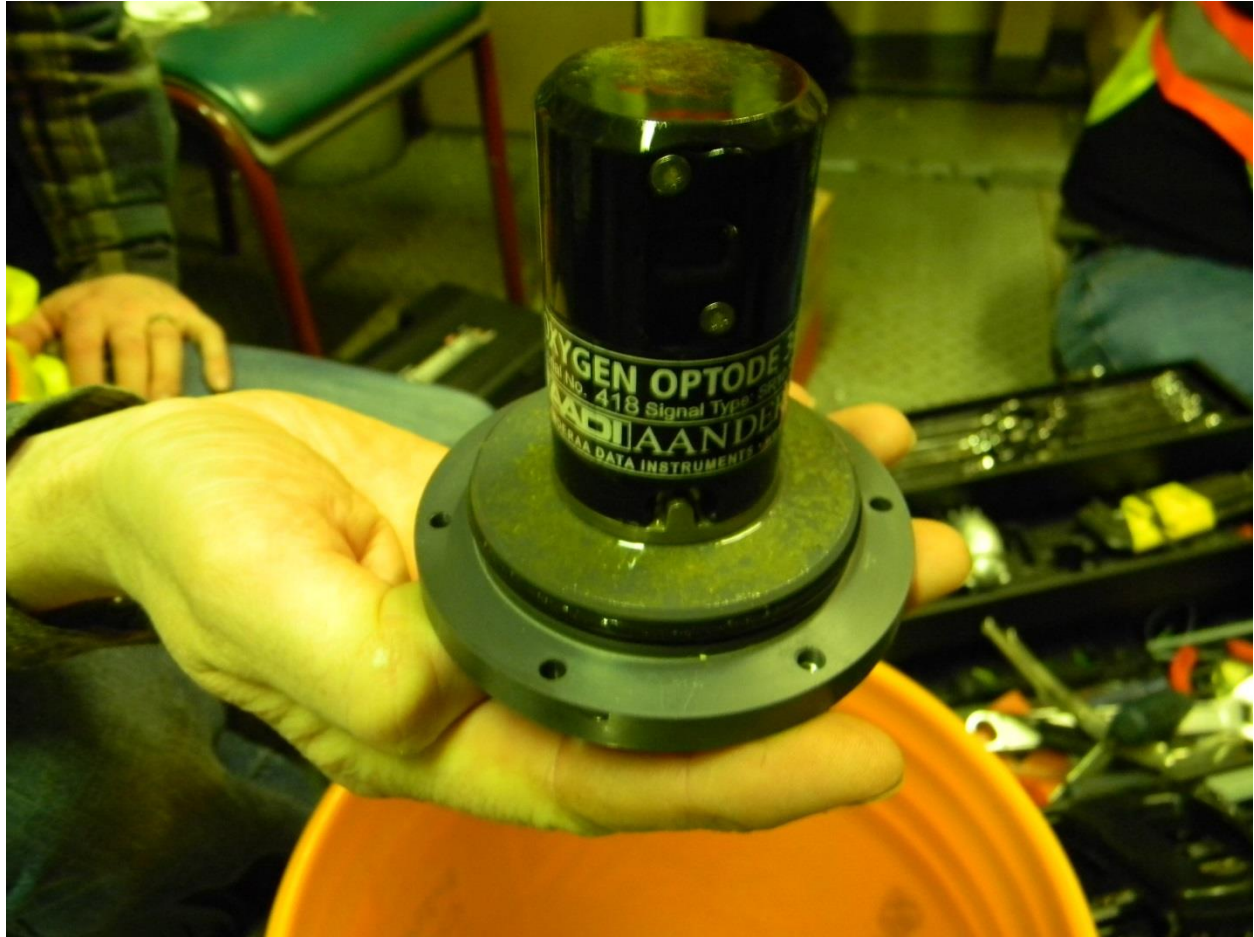
Figure 8: Minor sediment buildup within Optode housing

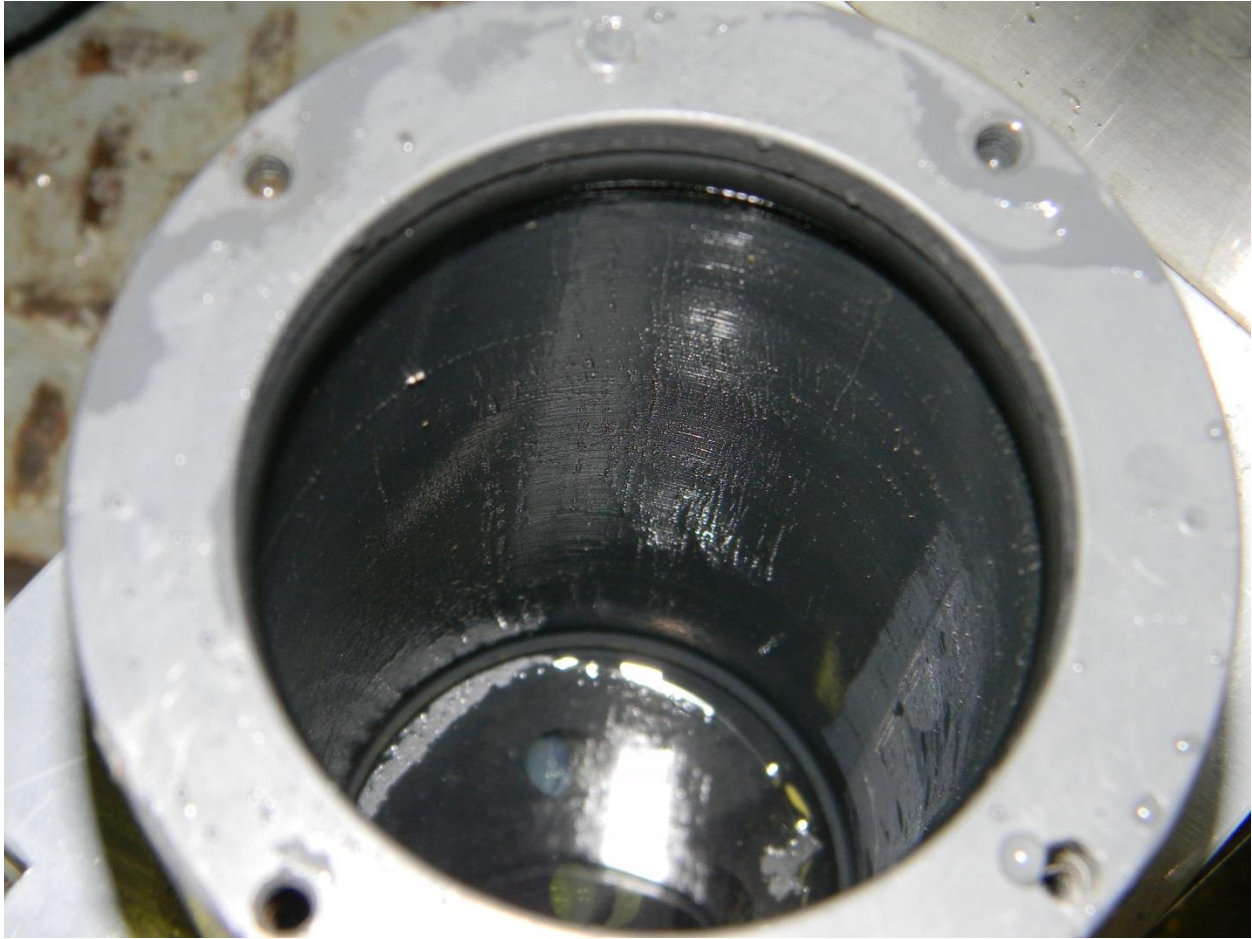
Figure 9: Minor sedimentation inside BBFL2 housing (on bottom where slight water levels were possible)

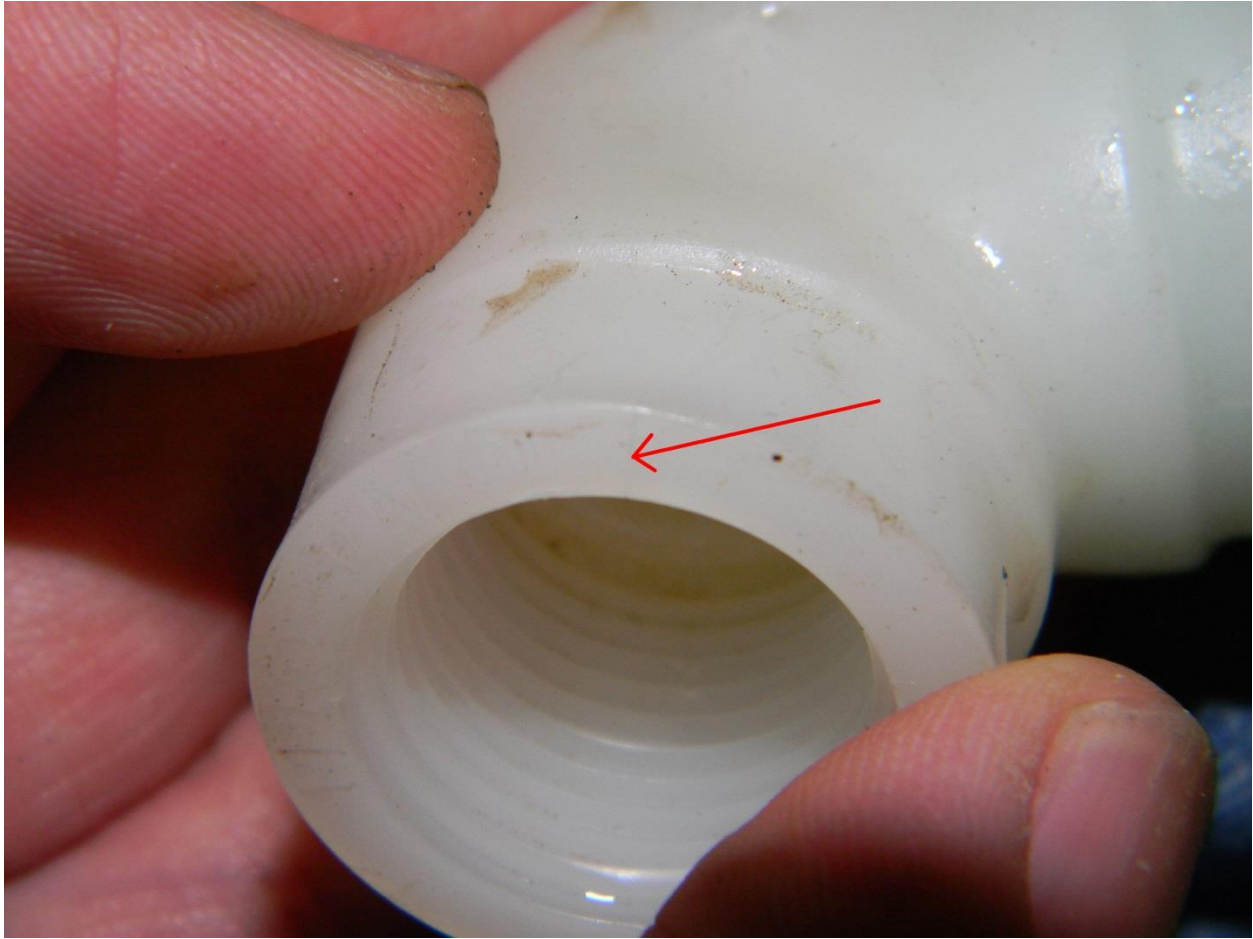
5. Examined the lower plumbing system. Removed the hard plastic tube and compression fittings to replace with barb fittings. During disassembly, noted crack in elbow joint below the manifold which became evident only under certain lighting conditions.

Figure 10: Cracked elbow joint (arrow indicated faint crack line). The crack extended past the threaded region to the unthreaded region.

6. Replaced the lower plumbing system between the pump and the manifold with two barb fittings and flex tubing.
7. Reassembled system.
8. Turned system on, pump would not start, orange LED lit. Checked manual, determined with multimeter that the leak sensor was corroded, replaced leak sensor.

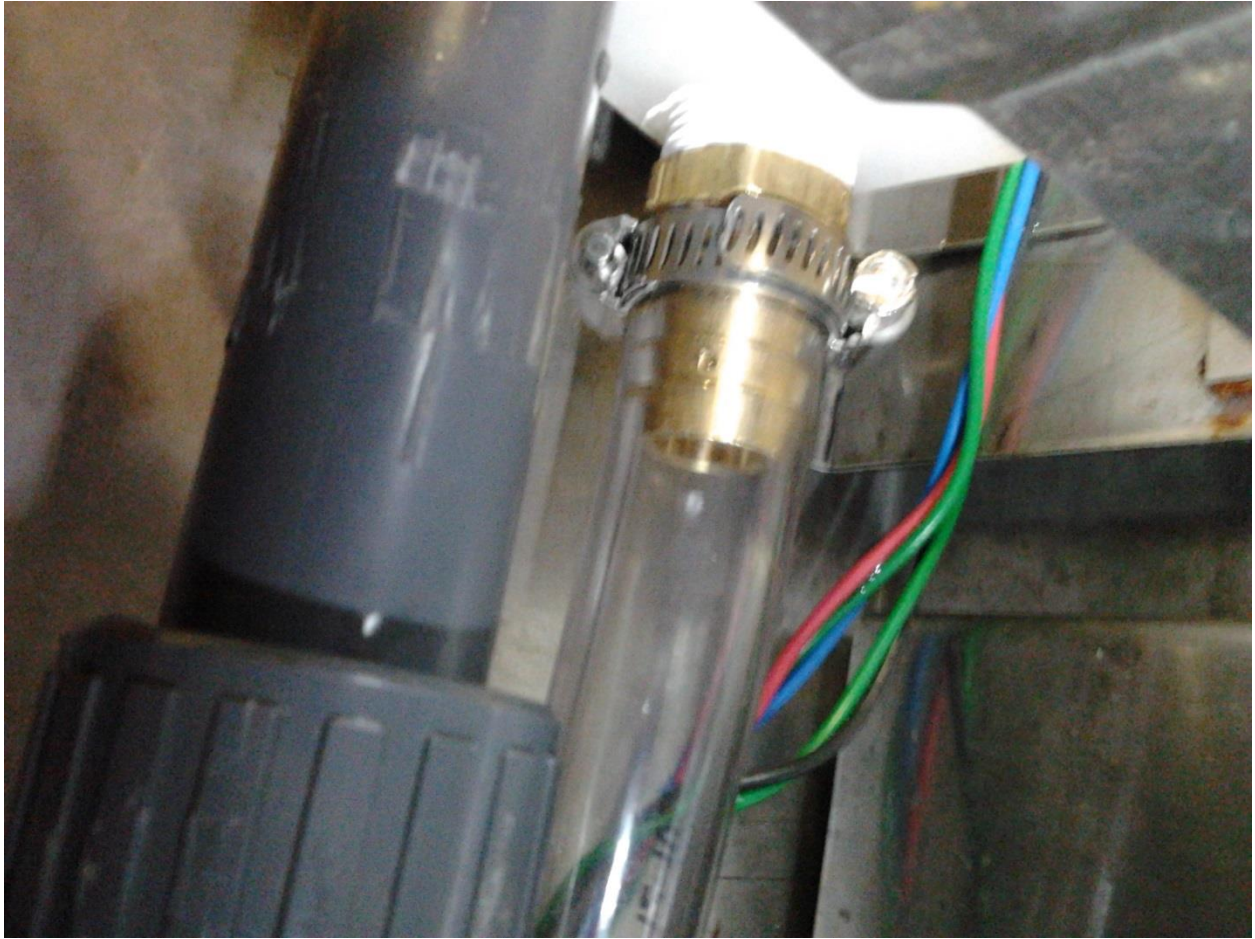
Figure 11: Replacement barb fitting and flex tubing (manifold end)

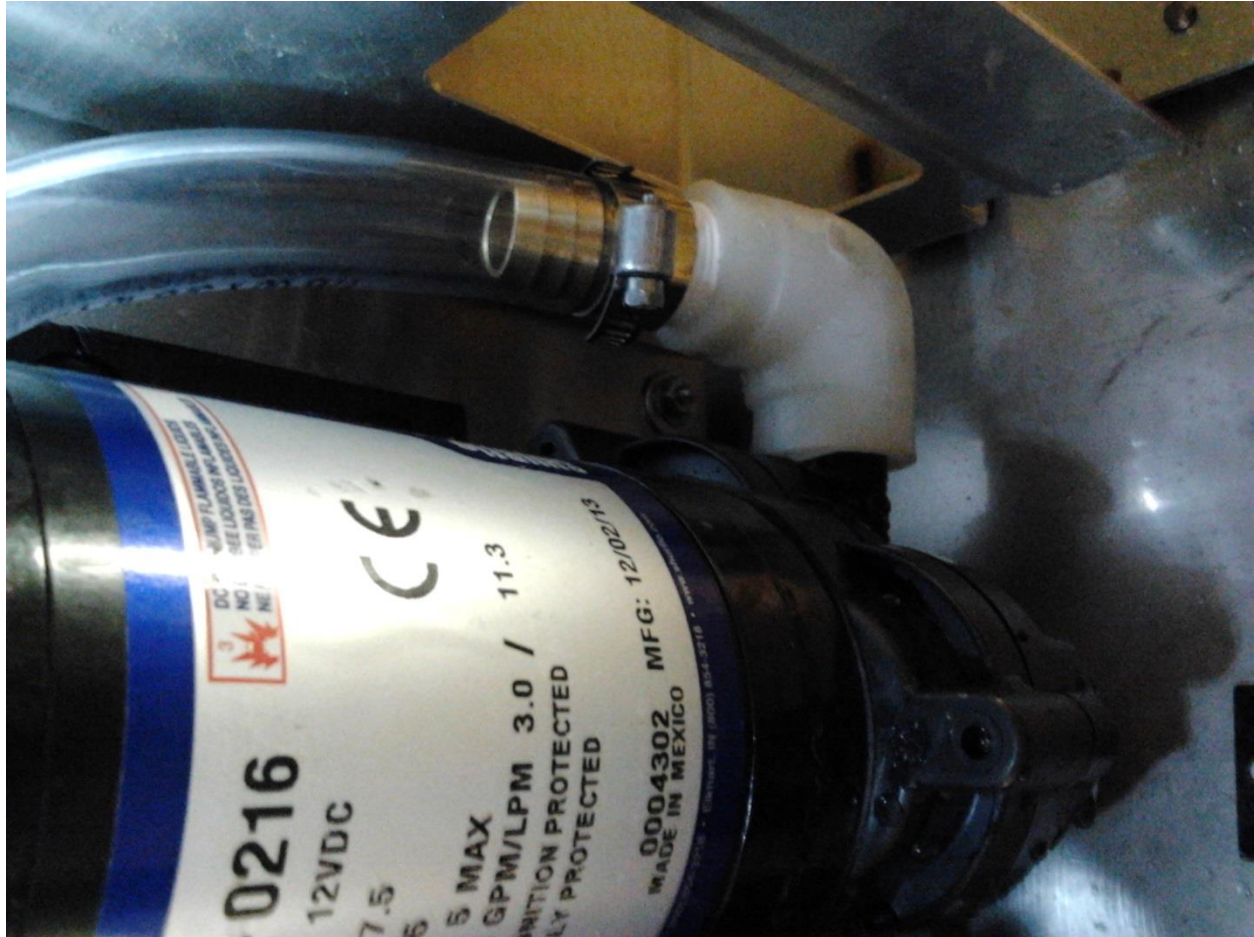
Figure 12: Replacement barb fitting and flex tubing (pump end)

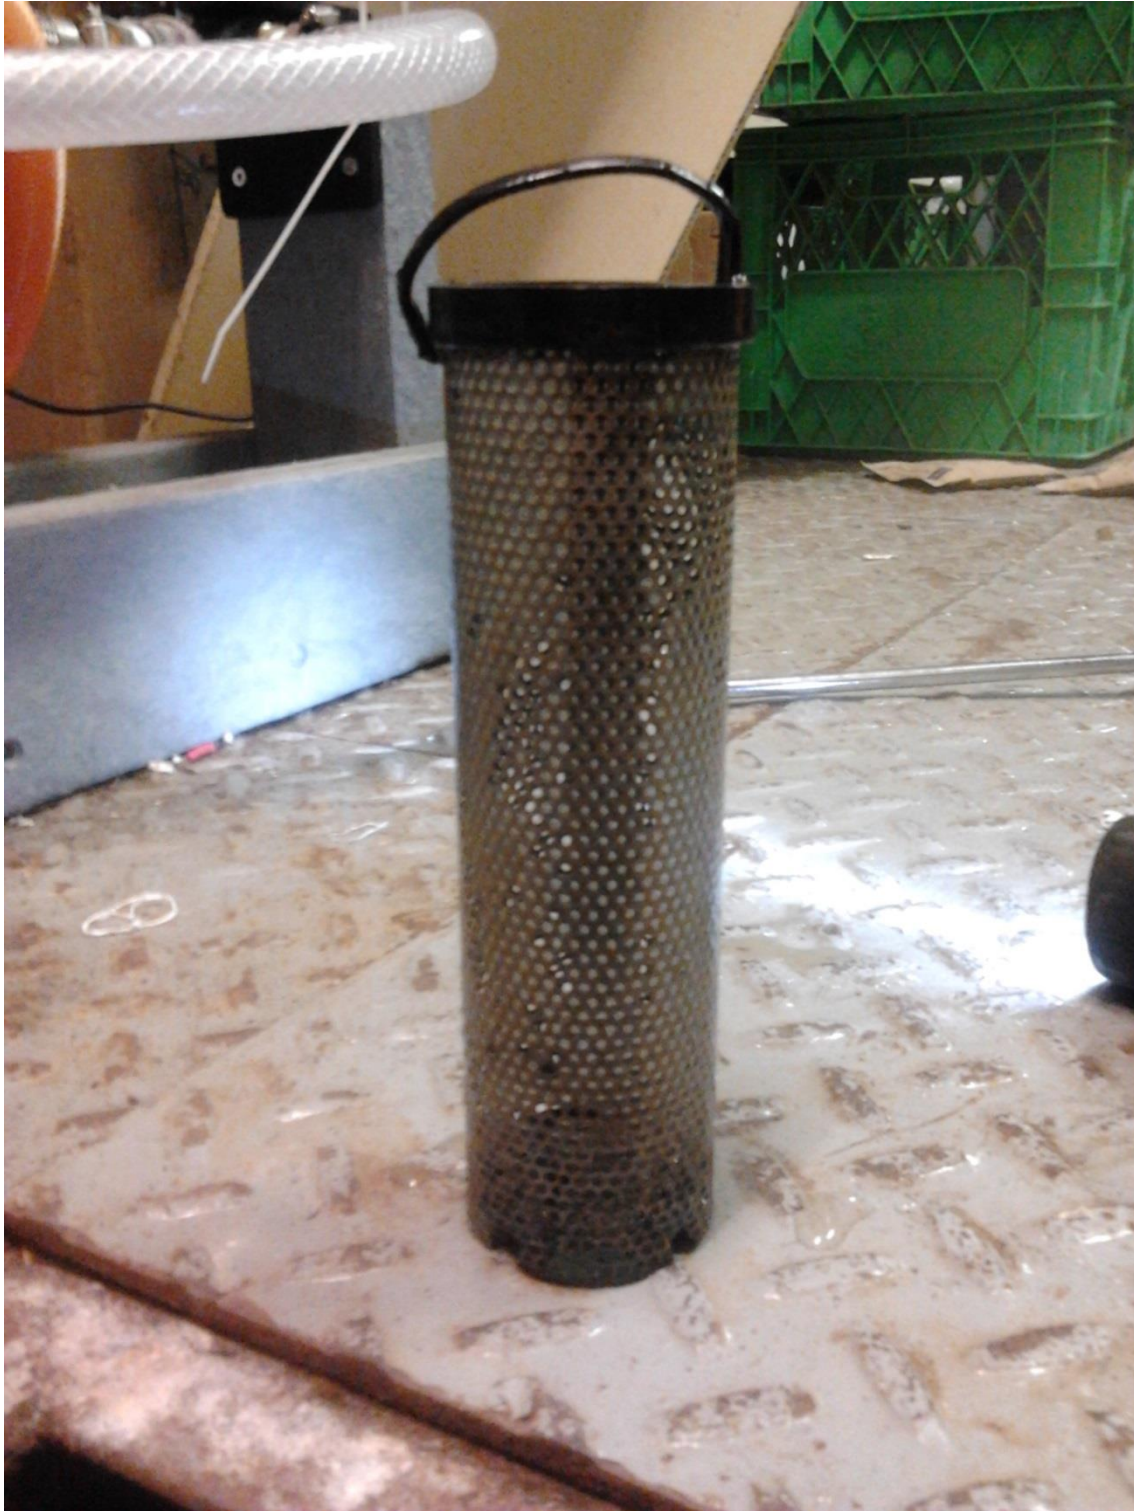
Figure 13: Sea Strainer

9. Turned system on and operation was noted as normal. No leaks immediately evident.
10. Checked and cleaned the Sea Strainer unit.
11. Proceeded to upper deck (monkey's island, 2nd bridge).

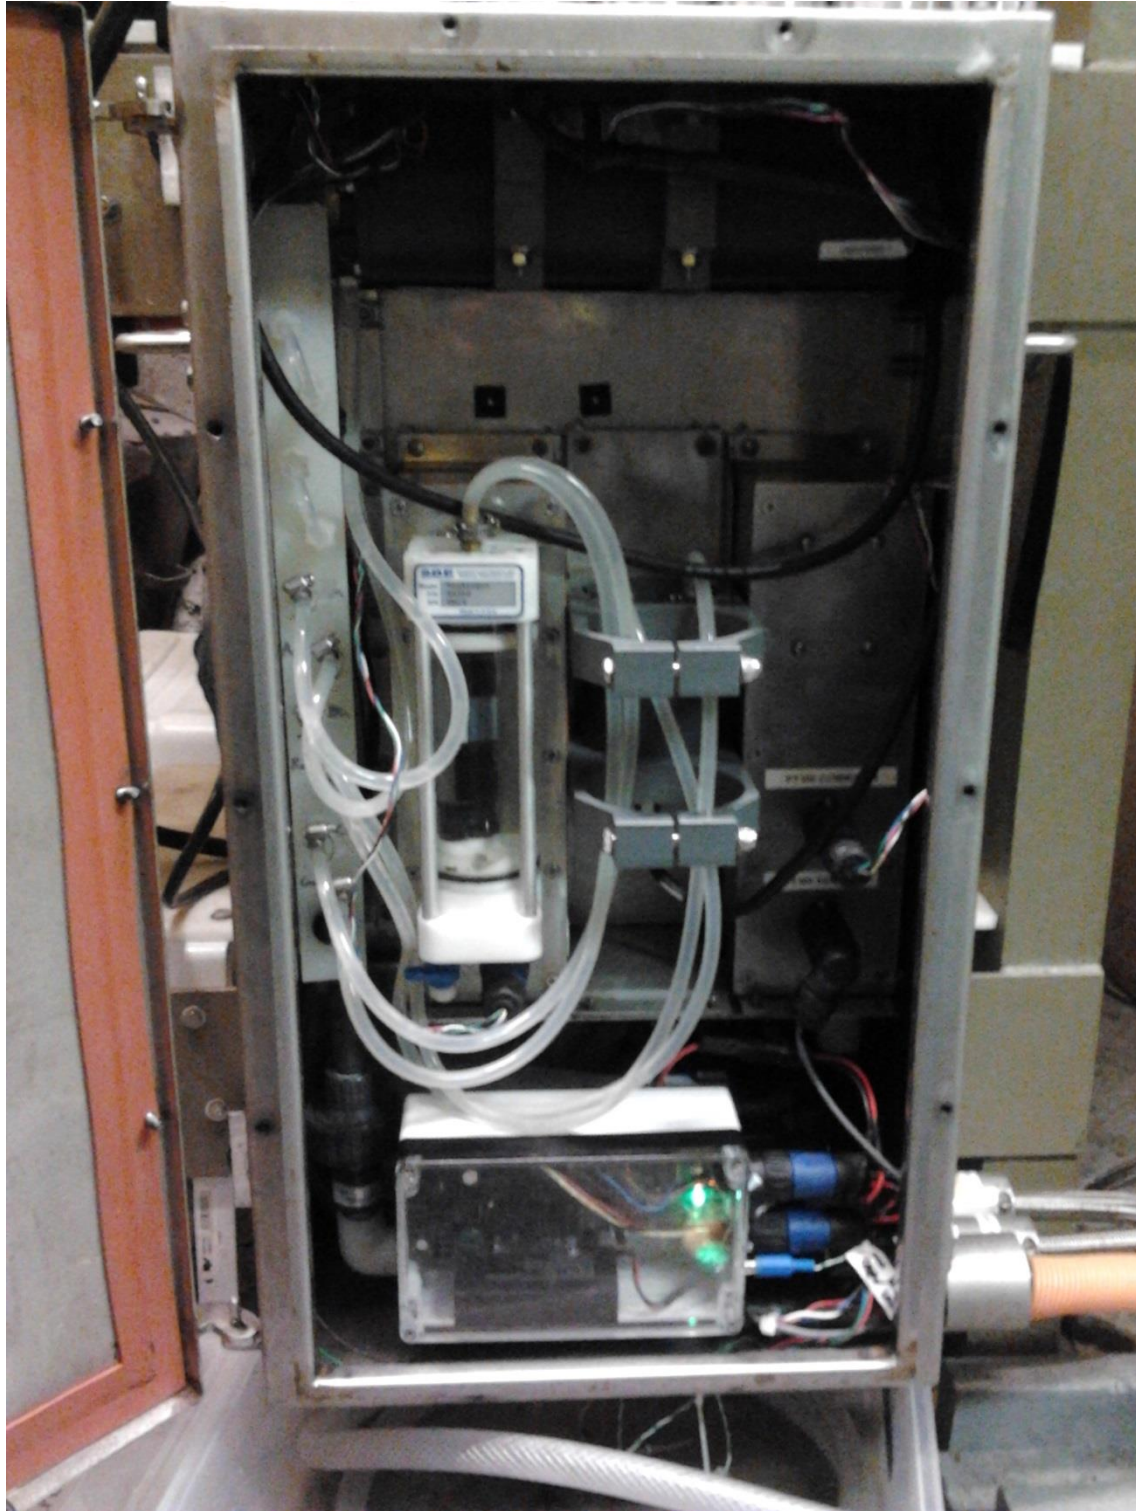
Figure 14: Instrument box upon completion
