Ocean Networks Canada

Ferry Maintenance Report – Queen of Alberni

Date: April 10, 2015

Poor sea water circulation in Seakeeper system which was affecting Oceanographic Data

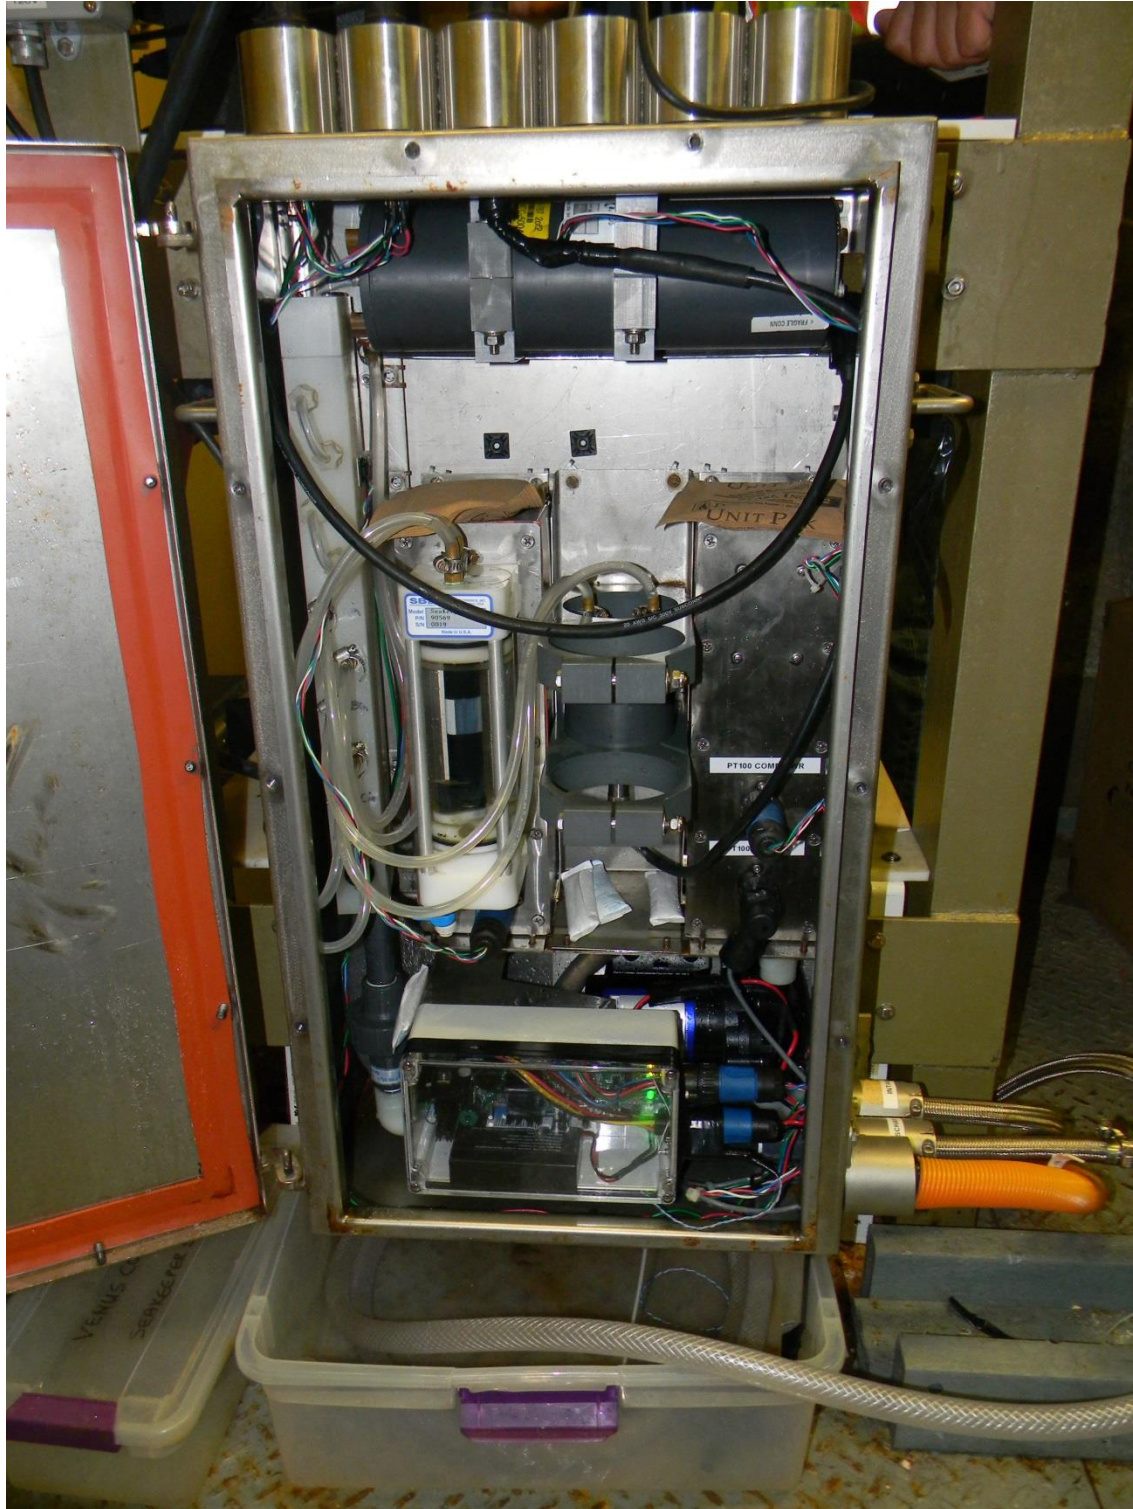
Figure 1: System upon arrival

1. Opened both boxes and observed function. Pump was in the leak-detected mode although pump control GUI stated it was on. Reset pump control box. Pump started to work. Observed the seawater flow. The flow was very poor.

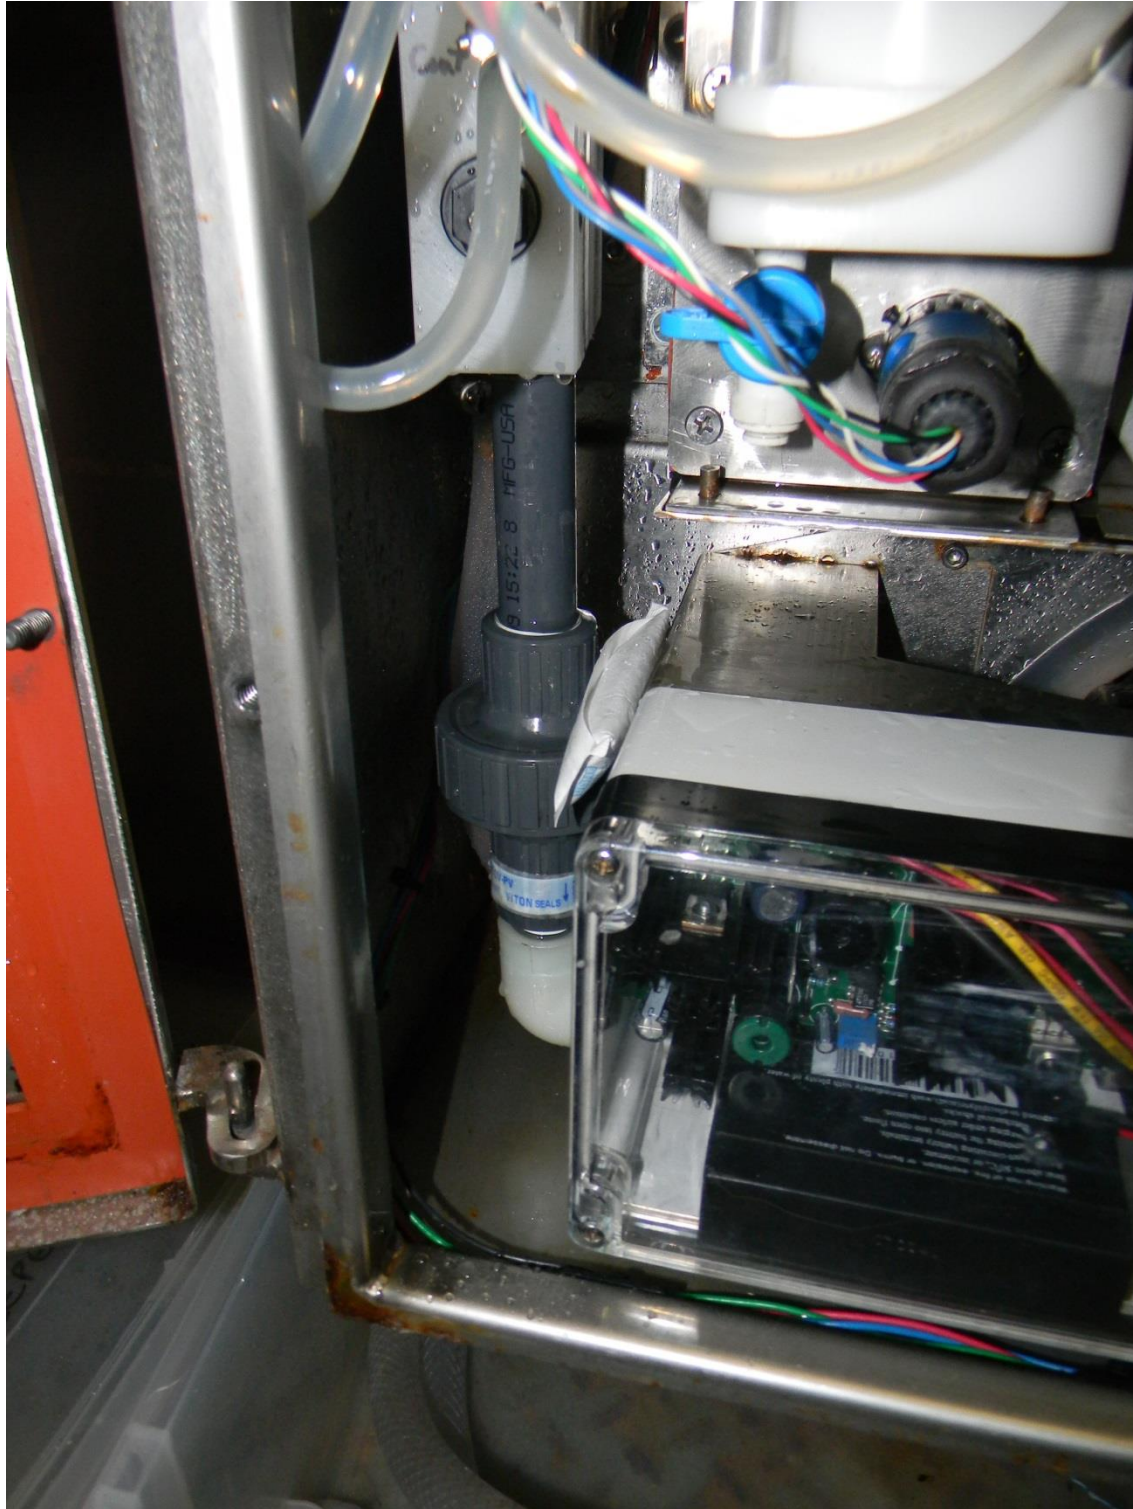
1. In the Instrument Box, there were signs of moisture, likely due to overpressure leaks.
2. The Sea Chest was dry with no evidence of leaks.
3. The Sea Strainer was mildly dirty with no debris.

Figure 2: Water leaked into the lower box, likely due to overpressure

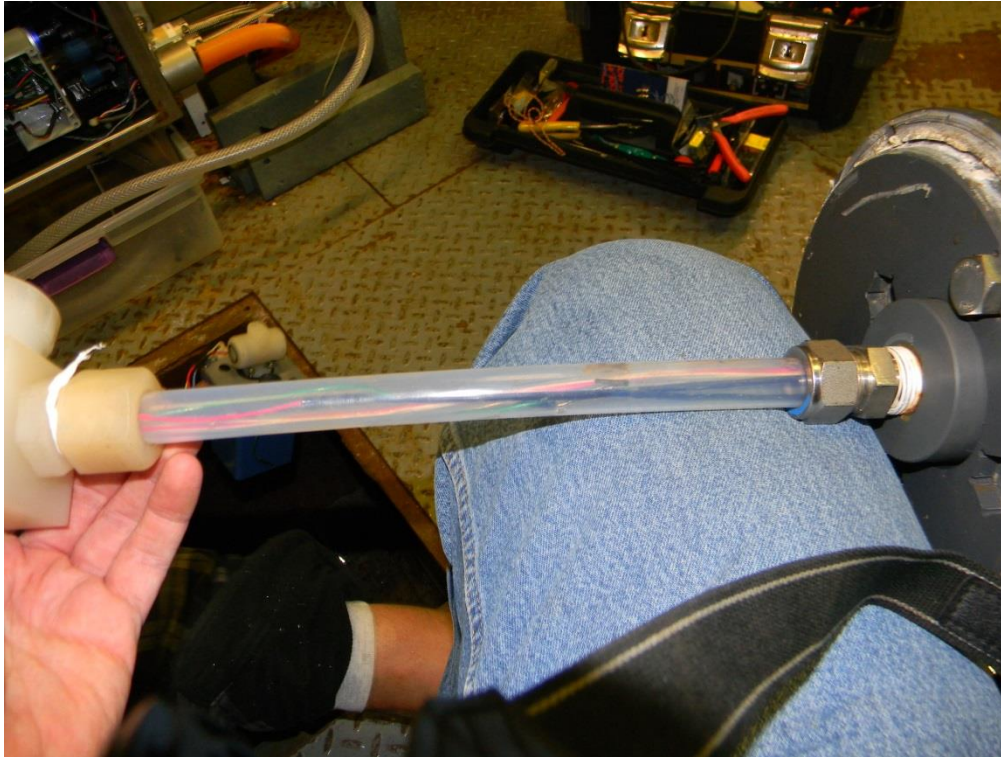
2. Powered down system.
3. Removed and disassembled the Sea Chest, pulling out the intake tube. Closed the intake and discharge valves.
4. Visually inspected the intake tube. No biofouling growth or blockage apparent.

Figure 3: Intake tube state

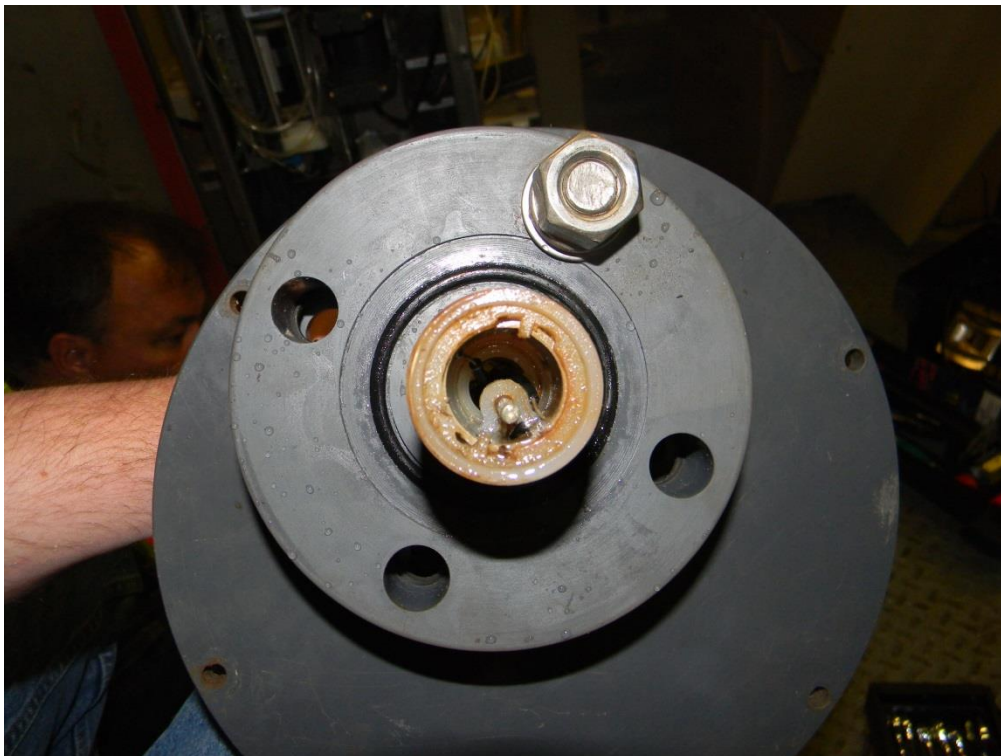
Figure 4: Intake tube seawater end

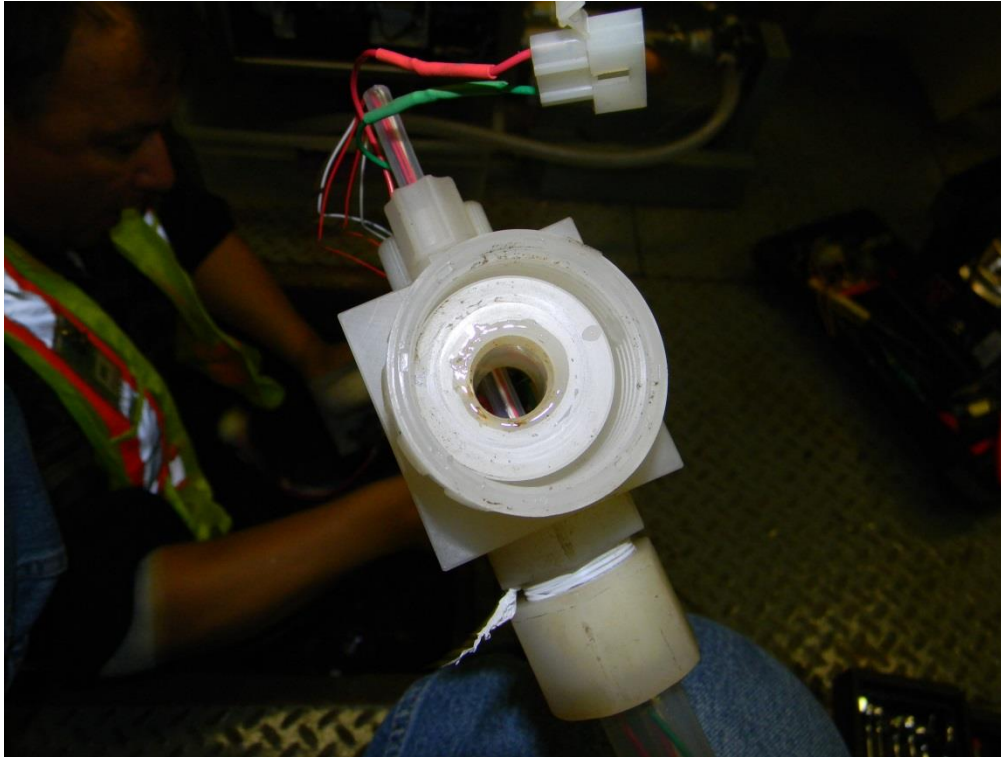
Figure 5: Intake tube ball valve end

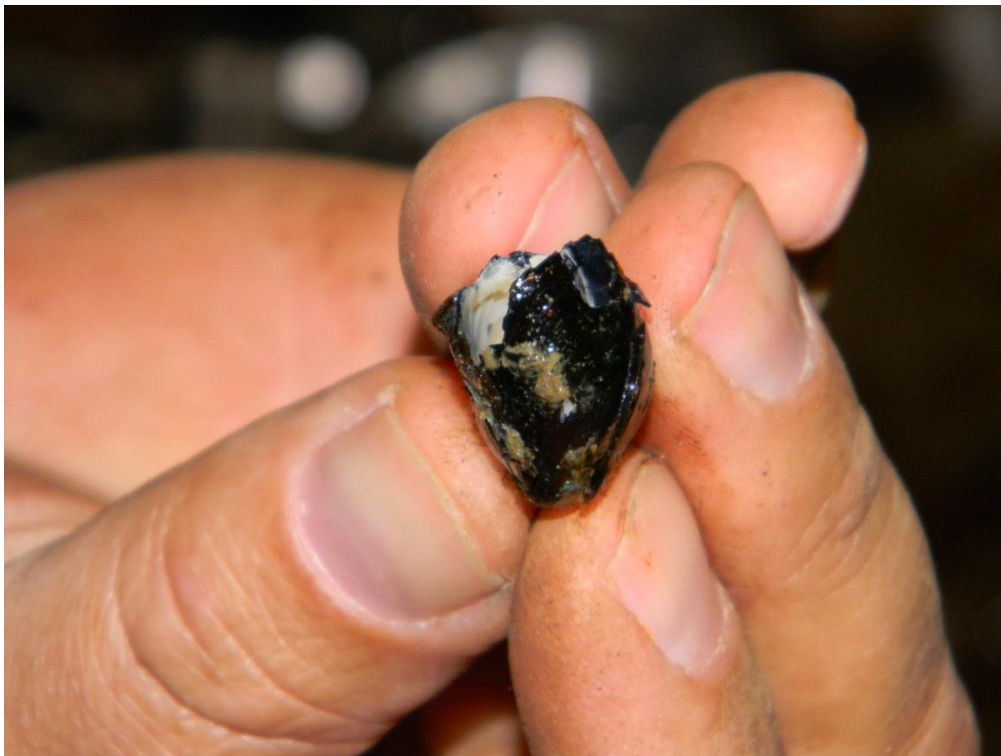
6. Dissassembled the intake/discharge tubing.
7. When disconnecting the discharge, back pressure within the tube shot a cork of crushed mussel shells out. The mussels formed a V shaped plug at the discharge inlet. Cleaned and inspected the discharge valve (closed) with long screw driver. No debris was apparent.

Figure 6: Cork of mussels ejected from the discharge tube

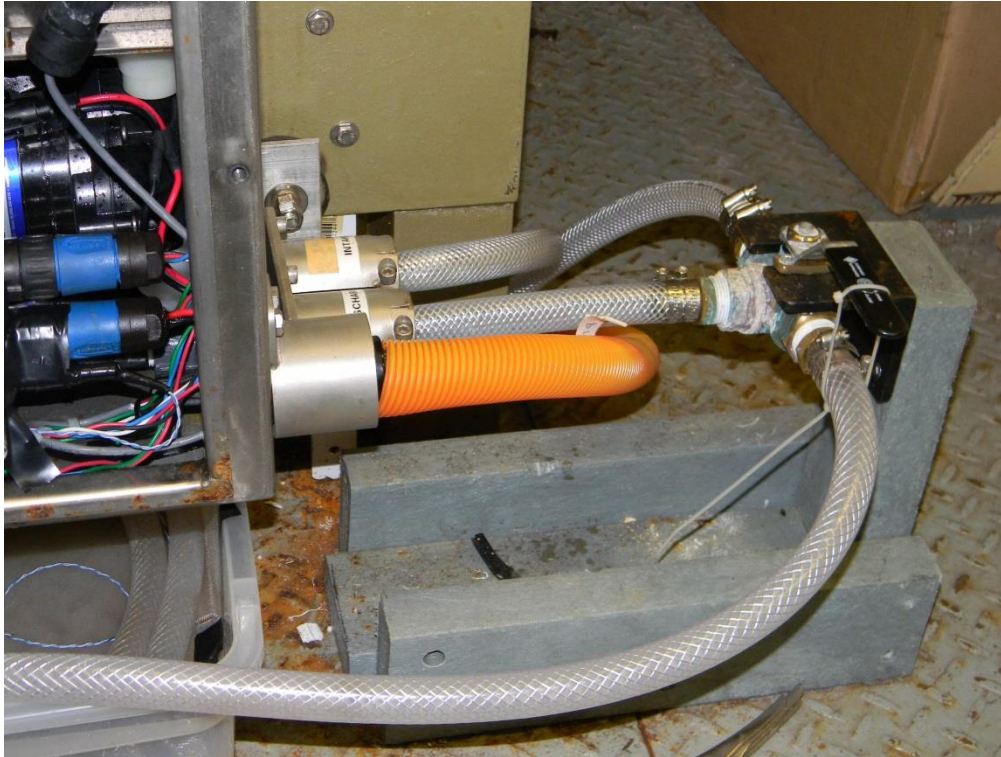
Figure 7: New fiber-reinforced TYGON tubing at the Instrument Box

9. Replaced all braided tubing to with fiber-reinforced TYGON tubing so that flow and blockages will be visible in the future.
10. Rebuilt the Seachest, and tightened fittings/bolts/screws

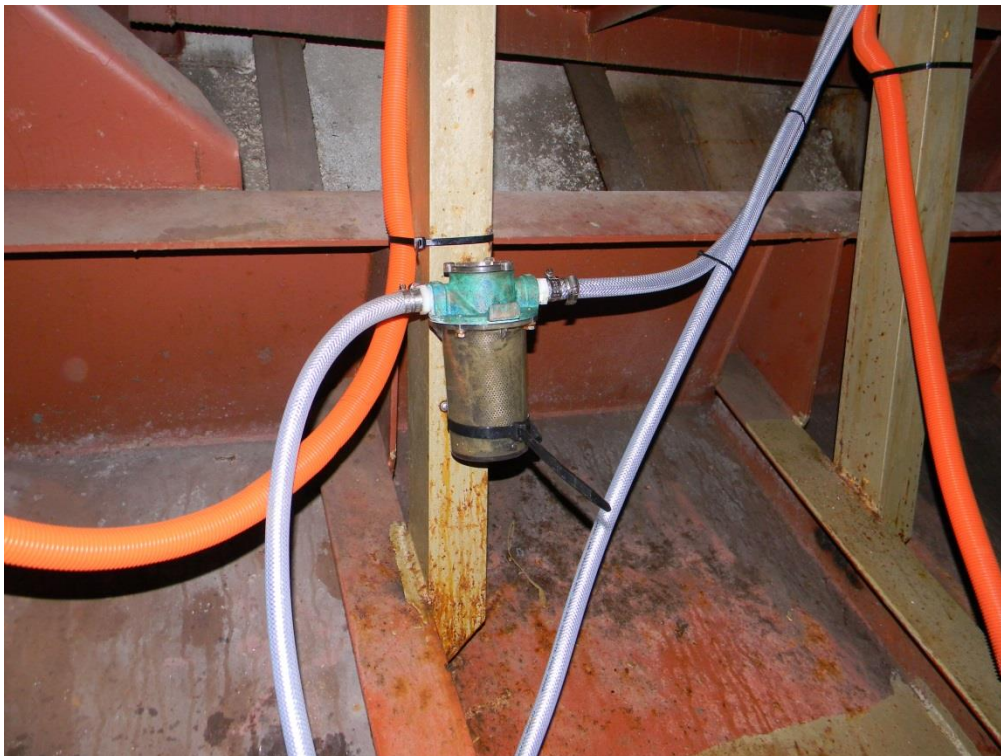
Figure 8: New tubing at the Sea Strainer

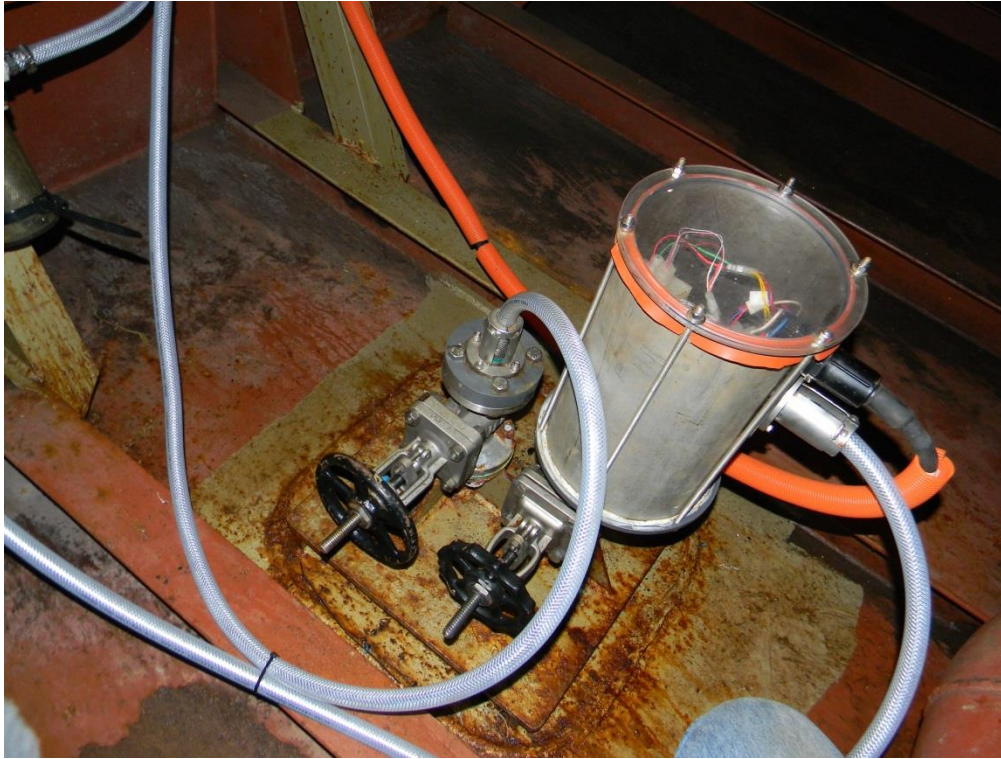
Figure 9: New tubing at the Sea Chest

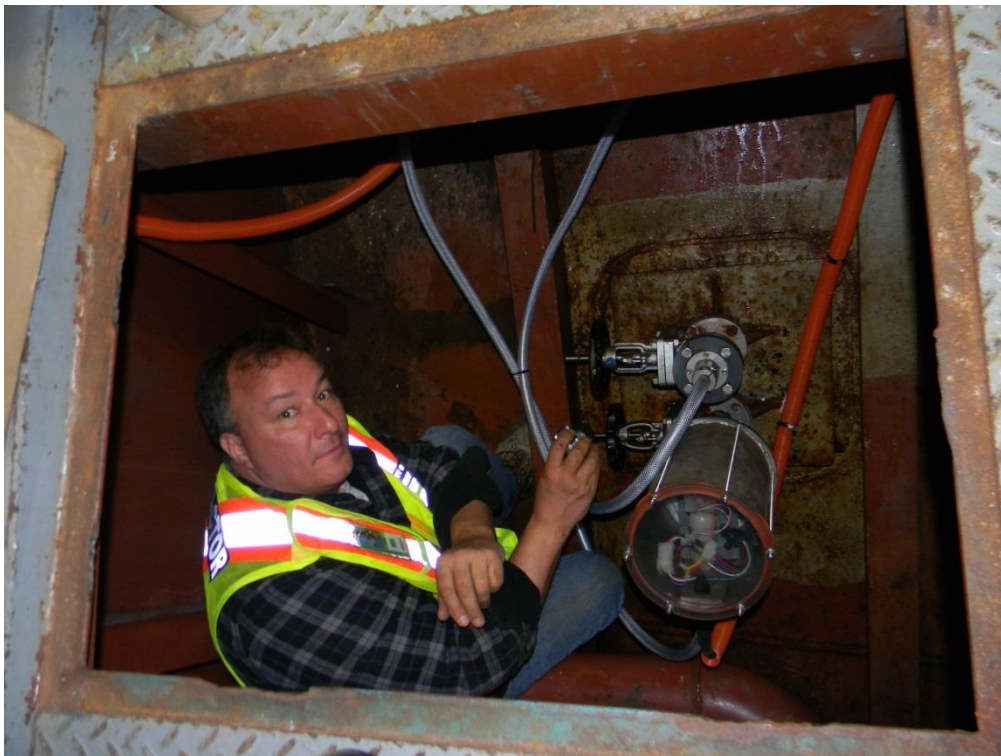
11. Powered up Seakeeper. System flow seemed much better than on arrival. Flow in both the intake and discharge lines was clearly visible through the transparent tube walls.
12. Observed the Sea chest, valves and instrument housing, with no leaks apparent
13. Signed out at Engineering room.

Figure 10: Checking for leaks after installation
