Ocean Networks Canada

Ferry Maintenance Report – Queen of Alberni

Date: April 24, 2015

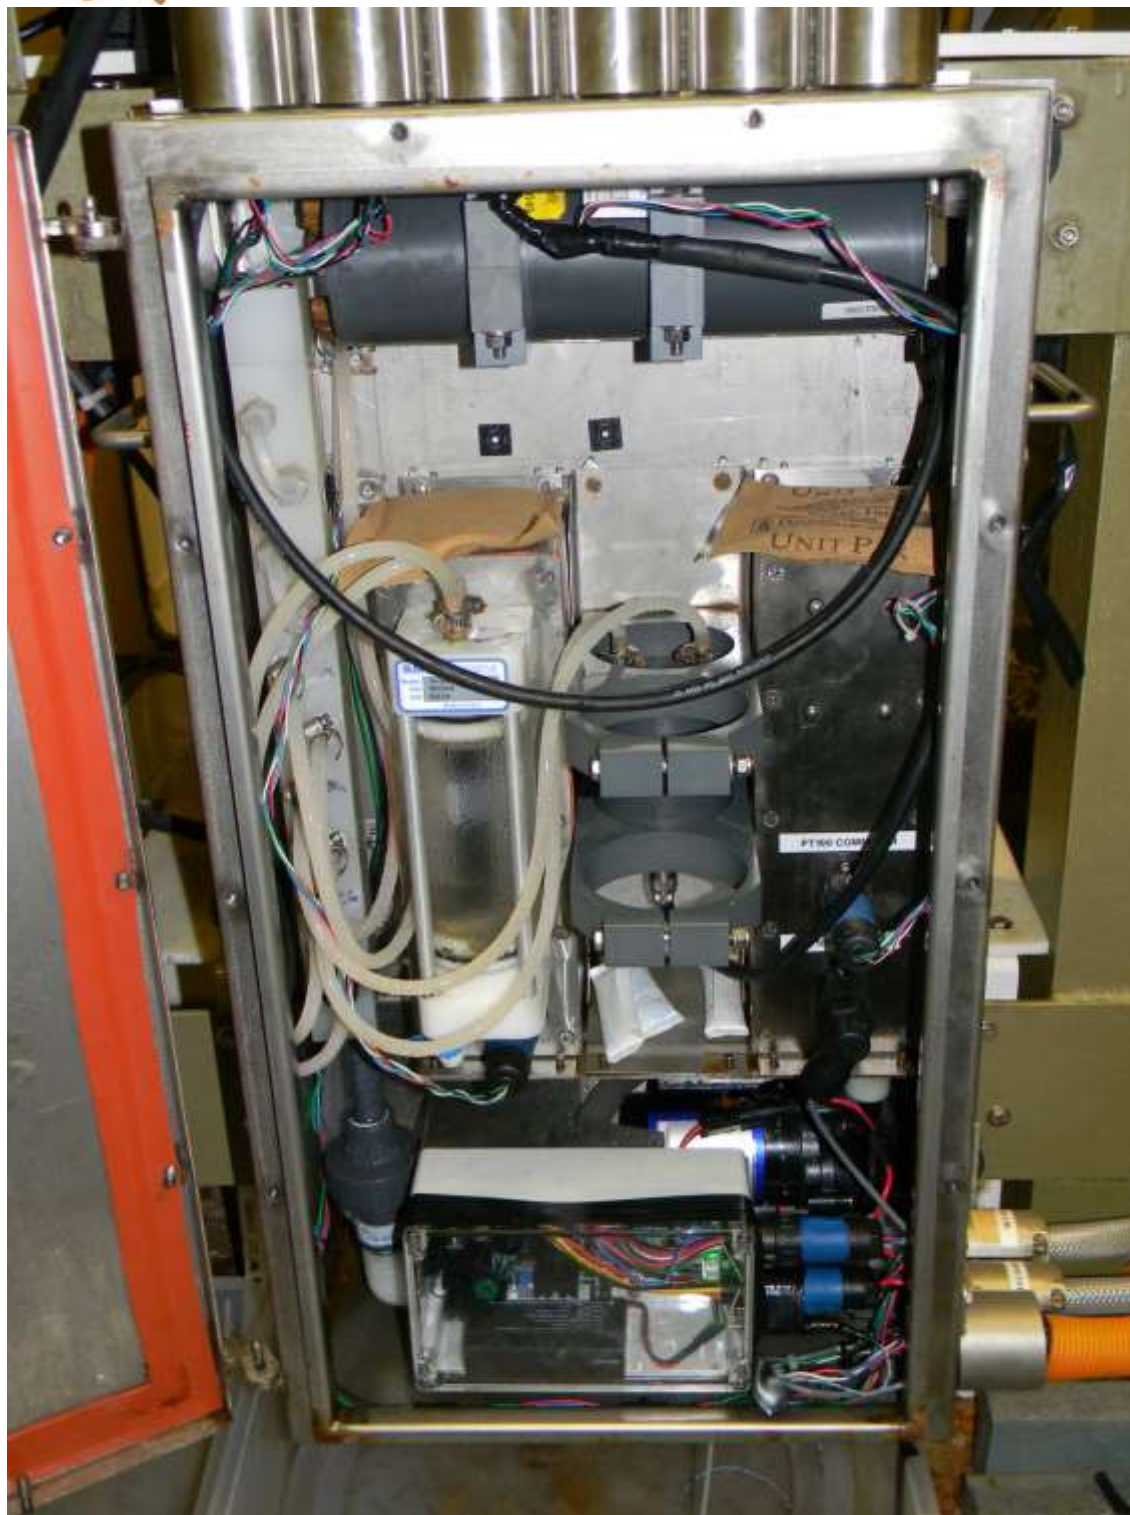
Figure 1: System upon arrival

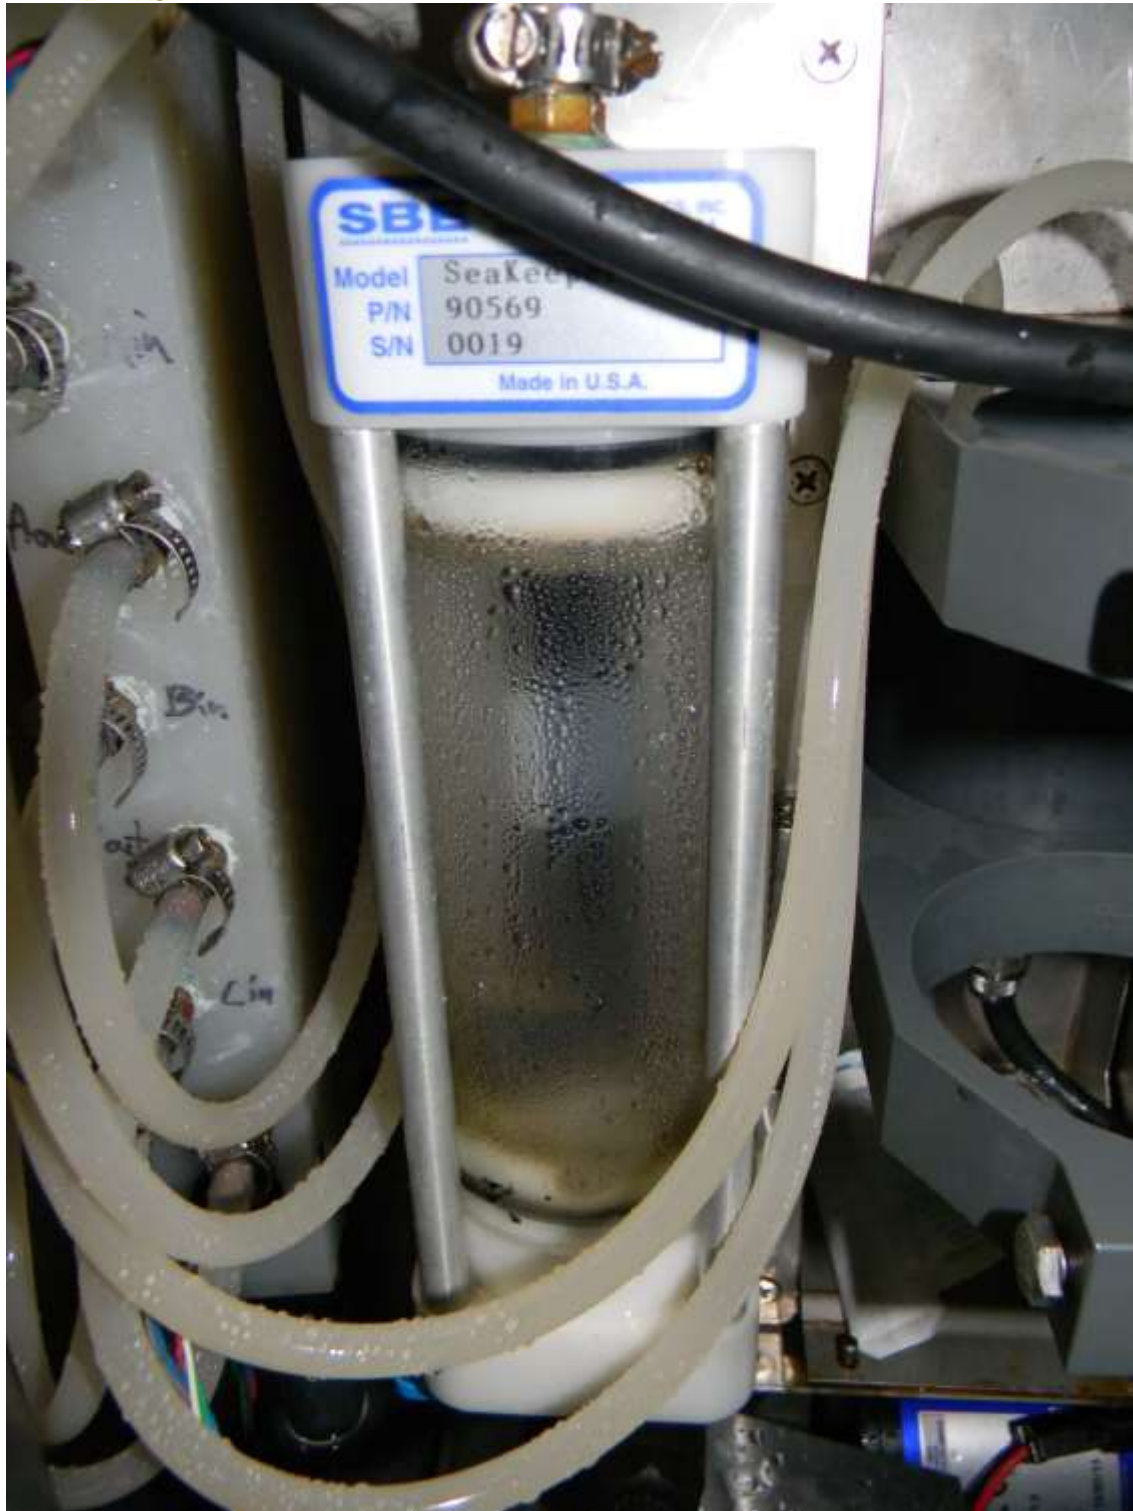
1. In the Instrument Box there were signs of moisture due to condensation only.
2. The Sea Chest was dry with no evidence of leaks.
3. The Sea Strainer was dirty with mussels growing in the region between the intake and the strainer (i.e.: blocked from entering the main system).

Figure 2: Condensation on outside of tubing and instruments

1. Bring more Desiccant bags
2. Bring AAA batteries for headlamp
3. Bring Sponges for soaking up leaks

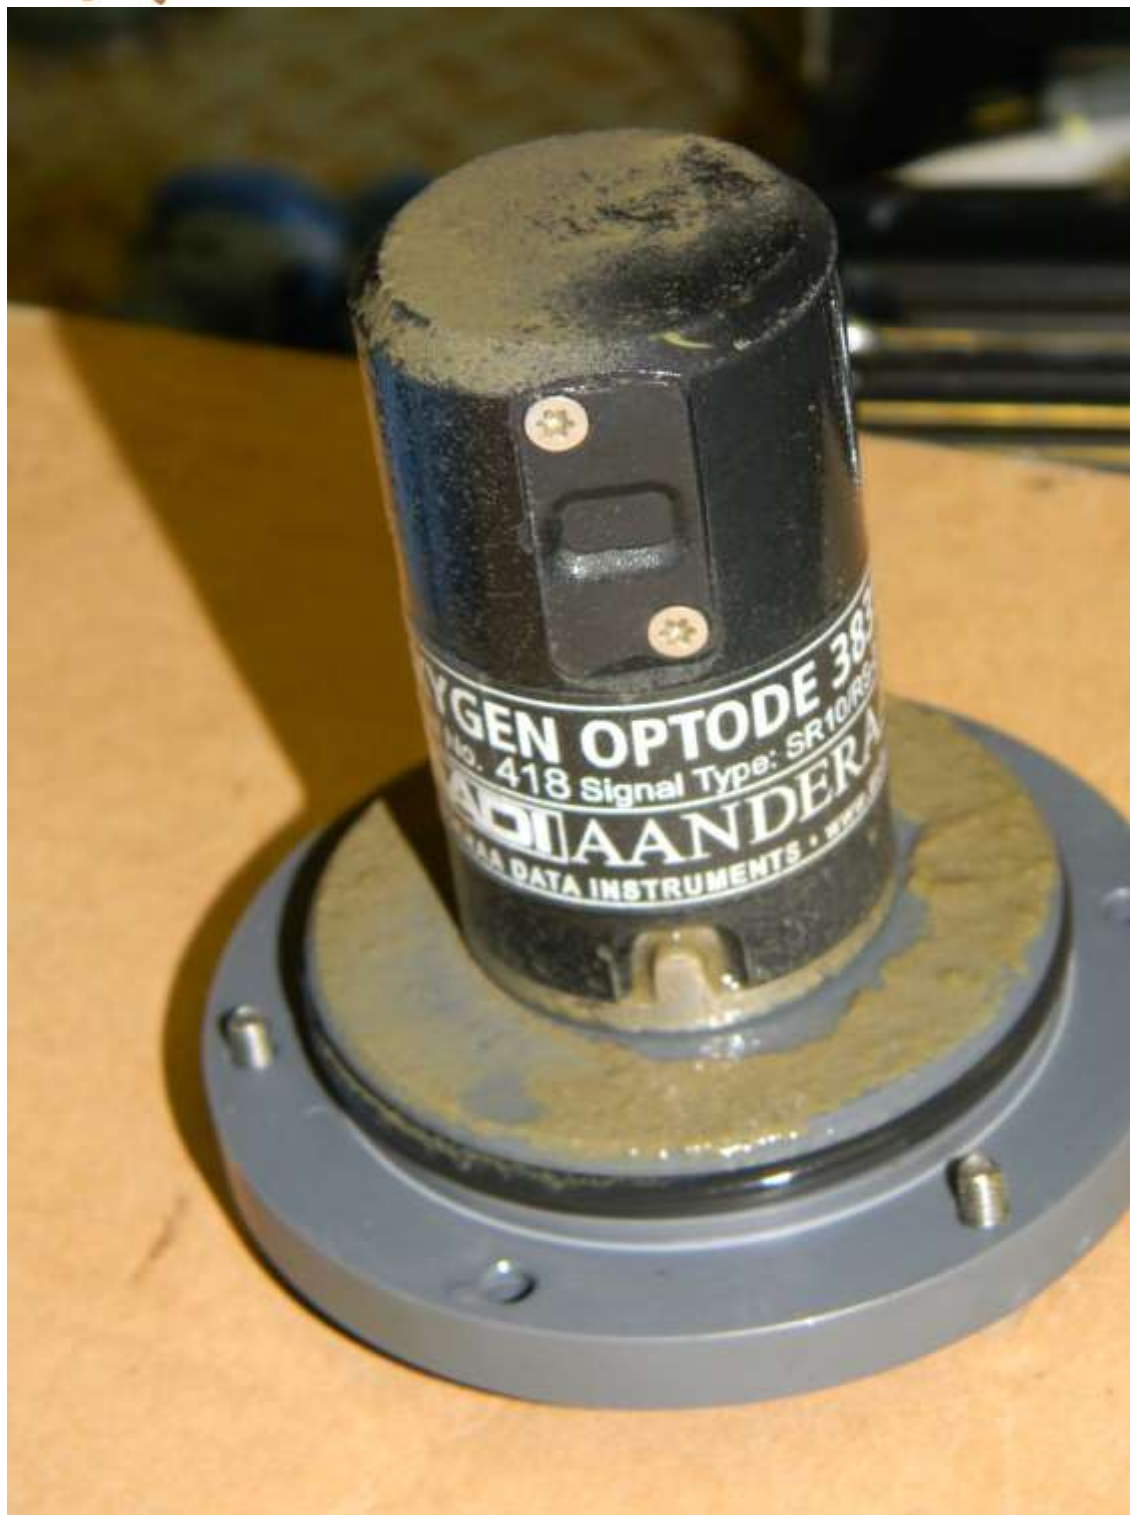
4. All instruments showed biofilm growth but not to an abnormal level.
5. Tubing was inspected; not signs of blockages or leaks in the new 5/8" intake/discharge lines. No signs of blockages and minimal fouling in the instrument lines.

Figure 3: Biofouling in Optode housing

1. Opened both boxes and observed function. The pump seemed to be operating normally and all flow seemed nominal.
2. Powered down system.
3. Removed the instruments for normal cleaning procedures.

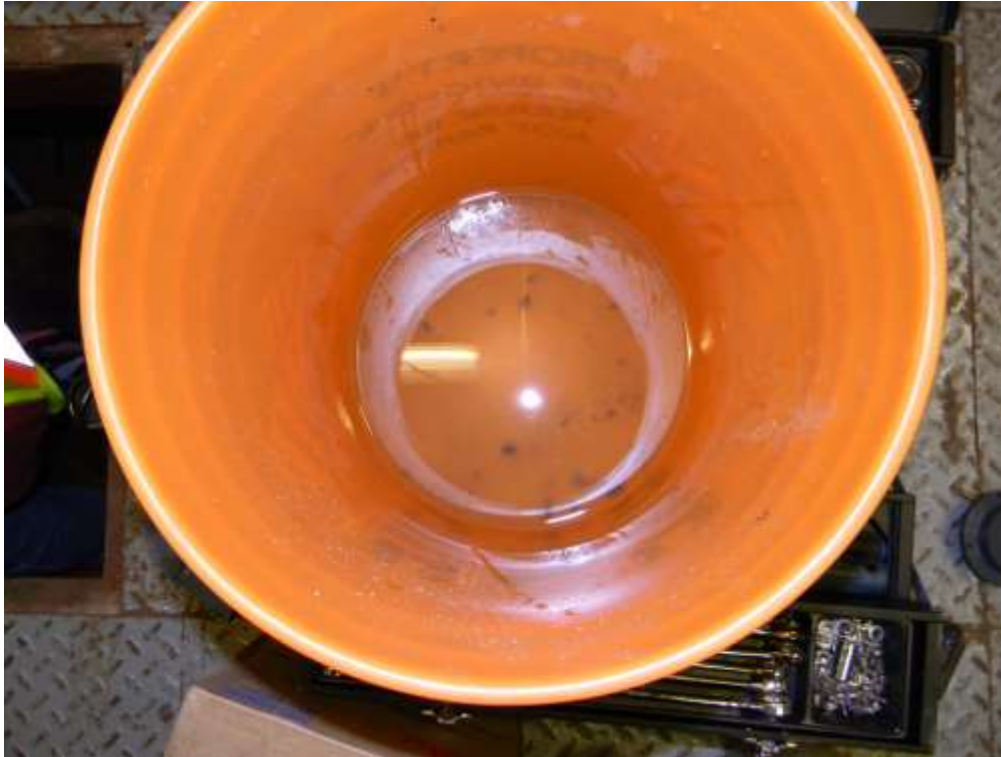
6. Sea chest was inspected. No signs of leaks.
7. Sea Strainer was inspected and cleaned. Extensive mussel growth (~10-15 mussels) was found inside the strainer between the strainer and the outer glass (i.e.: blocked by the strainer from entering the system). The glass container was cleaned as best as possible and mussels were removed as much as possible.

Figure 4: Mussels recovered from Sea Strainer

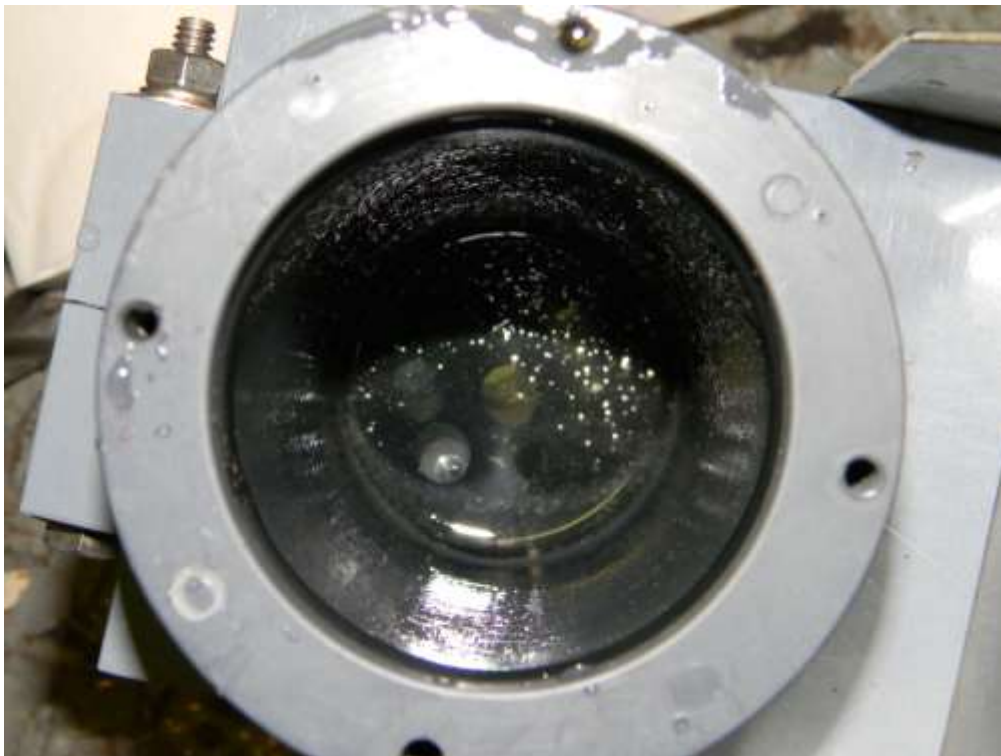
Figure 5: Biofouling of BBFL2 Surface

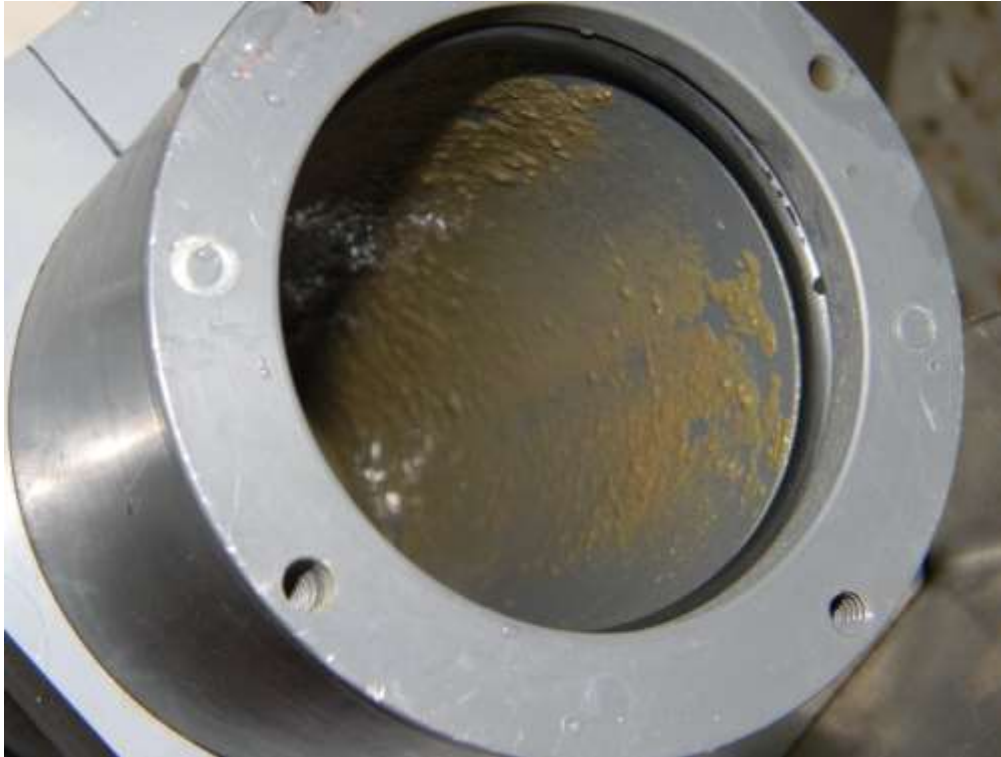
Figure 6: Biofouling within BBFL2 housing

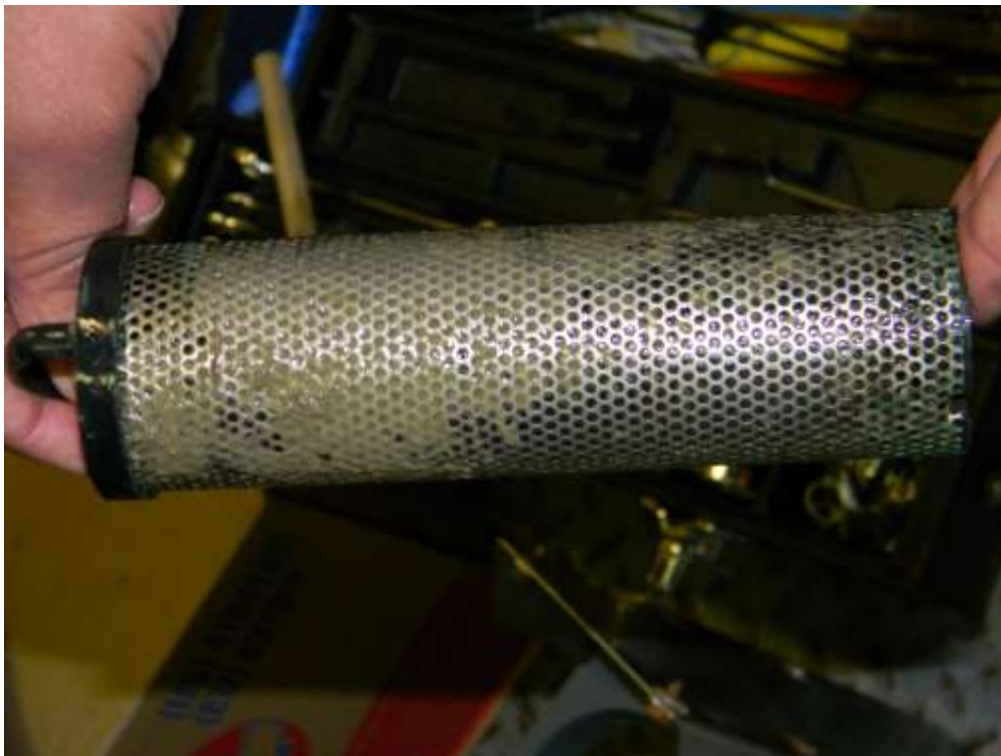
Figure 7: Sea Strainer biofouling

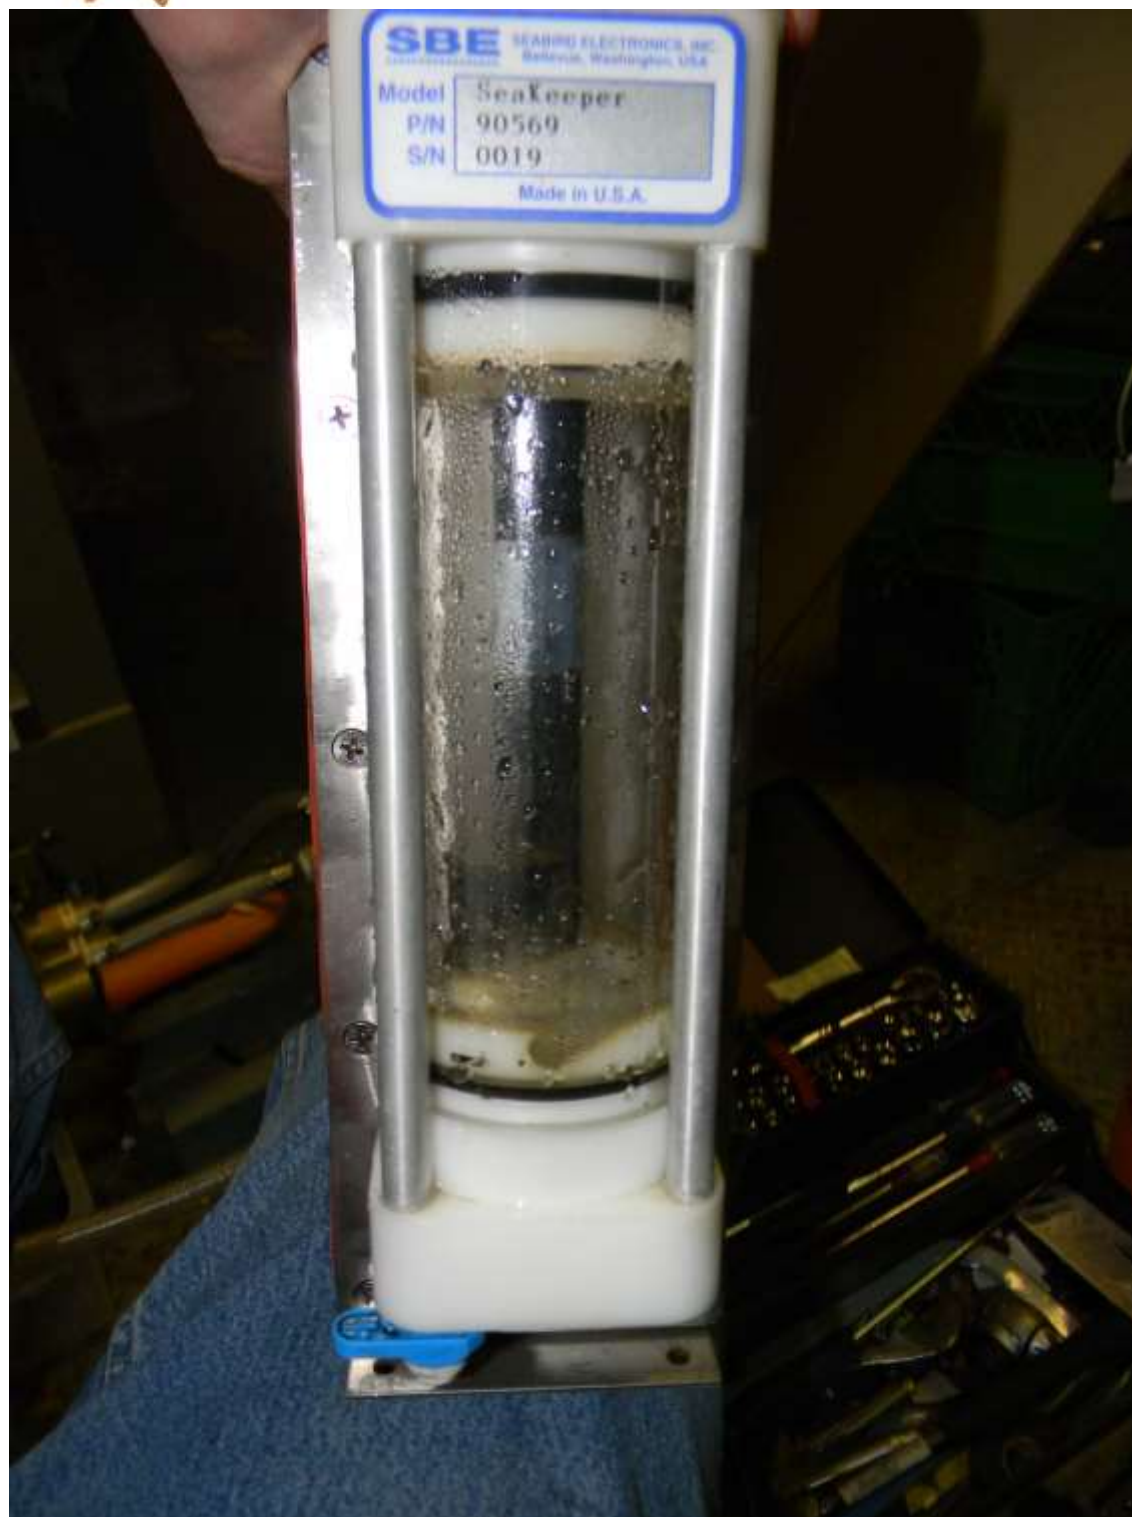
8. Instruments were re-installed into the system.
9. Pump battery replaced (old battery shows a voltage of 13.3 VDC no-load).
10. System did not restart; cause was determined to be water spilled on the leak sensor during servicing. Leak sensor replaced and the system restarted. All flow is nominal except the CT sensor was slow to fill.

Figure 8: CT sensor biofouling
