Ferry Maintenance Report – Queen of Alberni

Vessel: Queen of Alberni

Date: Nov 12, 2015

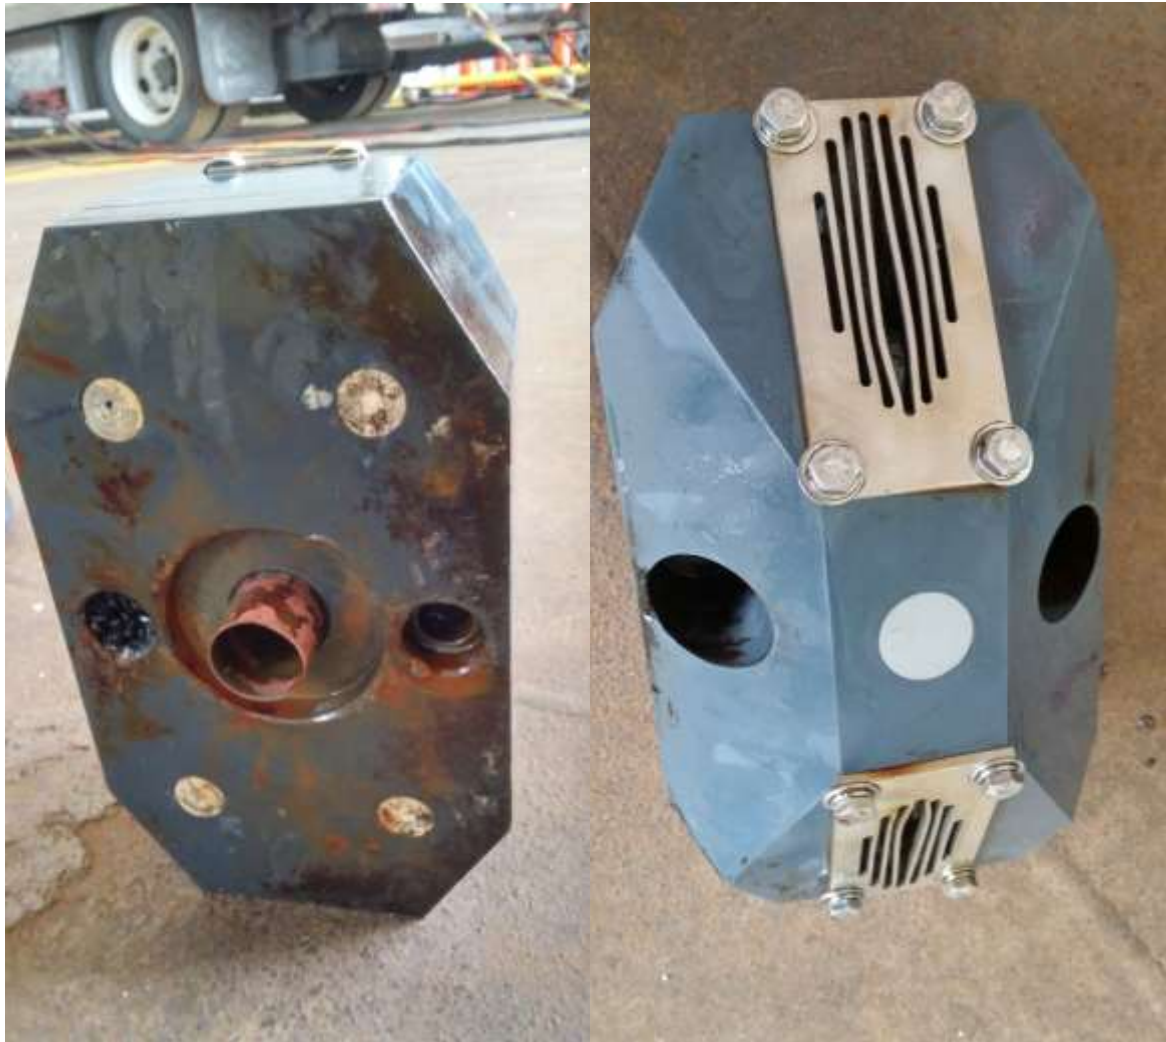
Left: top and bottom of the pod.

Found relatively little biofouling in the pod channel.

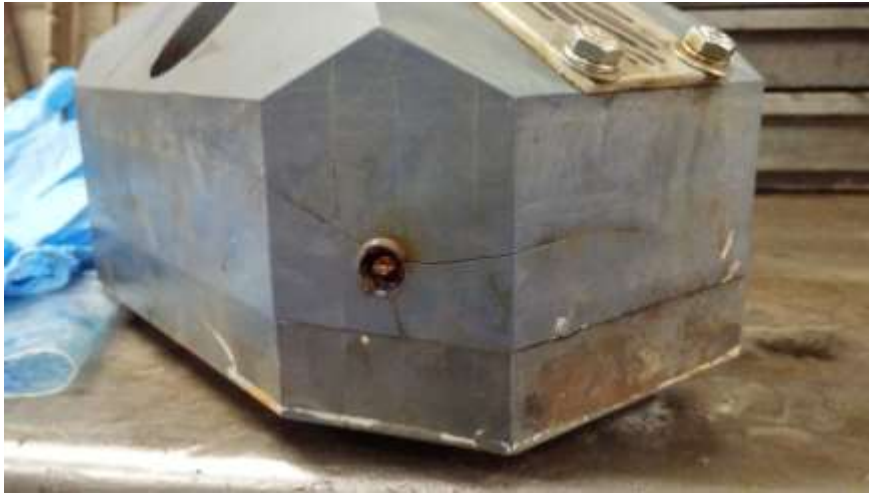
1. Instruments – contamination was not too bad on arrival. Small tubes were discoloured with bio-fouling. Large tubes showed little sign of biofouling.
2. The pod was inspected, and a crack was found on the side. The crack appeared to stem from a hole that may have possibly been made by an old bolt threaded into the side of the pod.
3. All three oceanographic instruments are out of calibration window.
4. The new BBFL2 instrument housing has a wider B/H connector that will not fit the stainless mounting plate.
5. Sea strainer plug went missing during cleaning.
6. New Optode and TSG show up as red dots in acquisition software. No time to investigate on ship.
7. No inspection of the telemetry box on the monkey's island due to time and weather constraints.

Left: crack in the upper part of the pod.

1. Pod stud repaired
2. Pod cleaned
3. Set leak sensor lower in drip tray

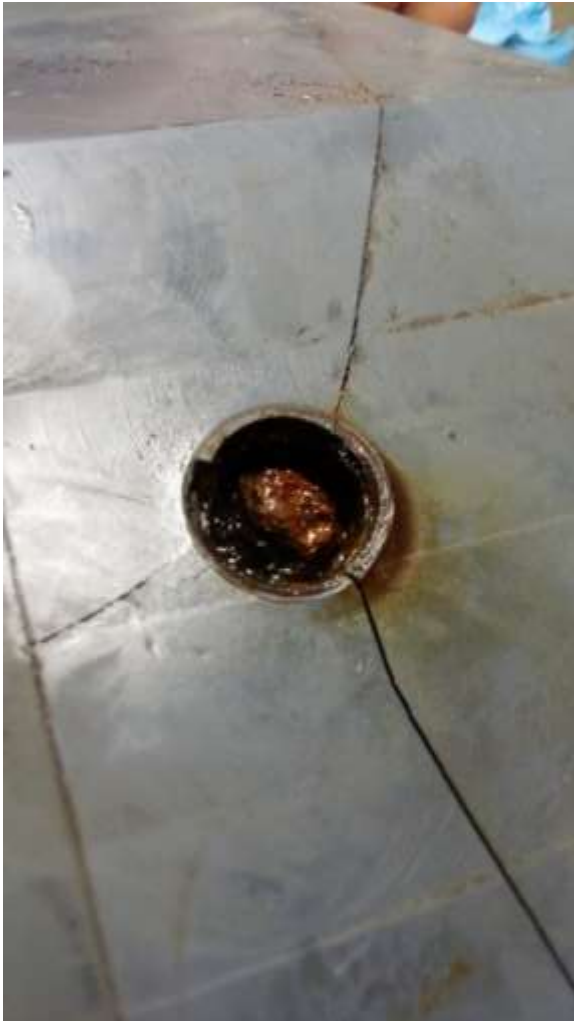
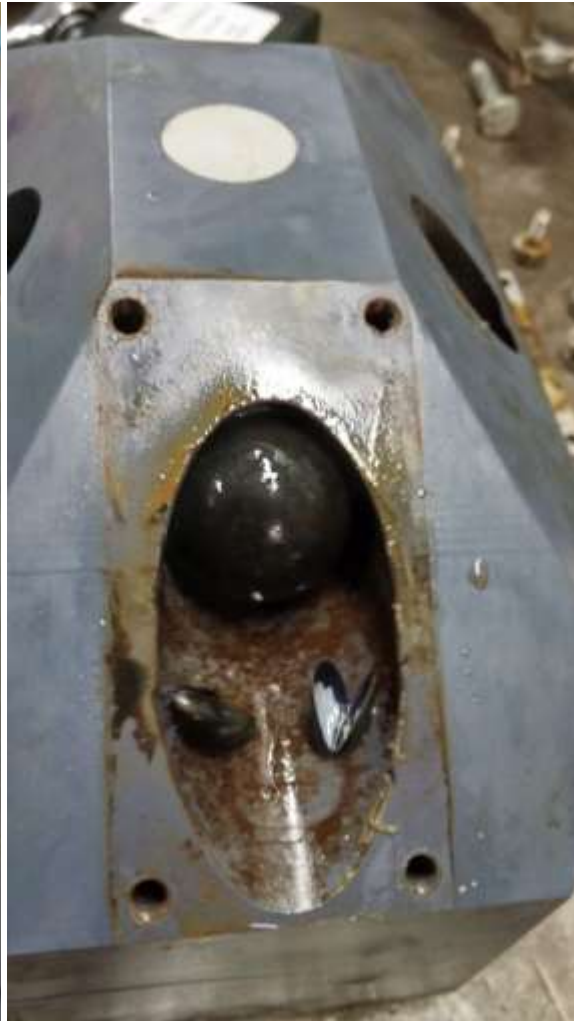
Close up of pod damage.

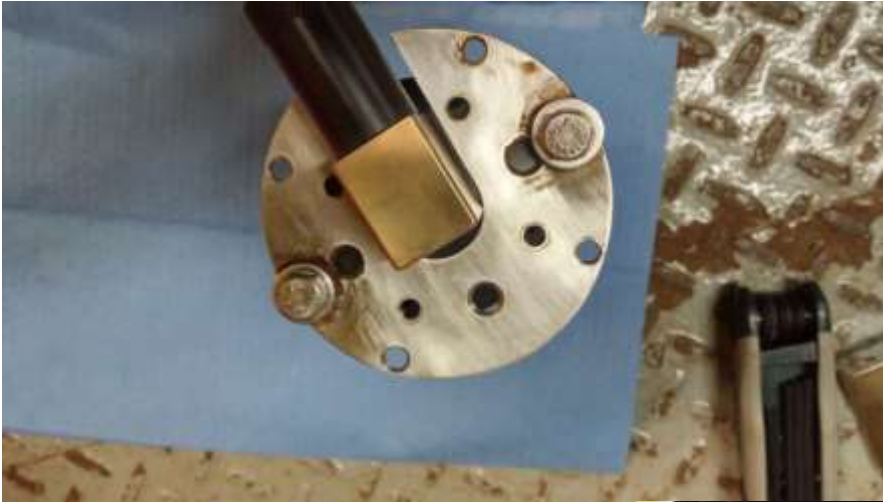
The new BBFL2 instrument connector is too wide for the mounting plate slot. This can be rectified by elongating the slot (it appears there is space to do this).

Measurements needed for new BBFL2 SS mounting plate to accept larger connector OR see if we can order some new plates from Geoff Morrison. Emailed Geoff for a quote Nov. 13th for a quote.

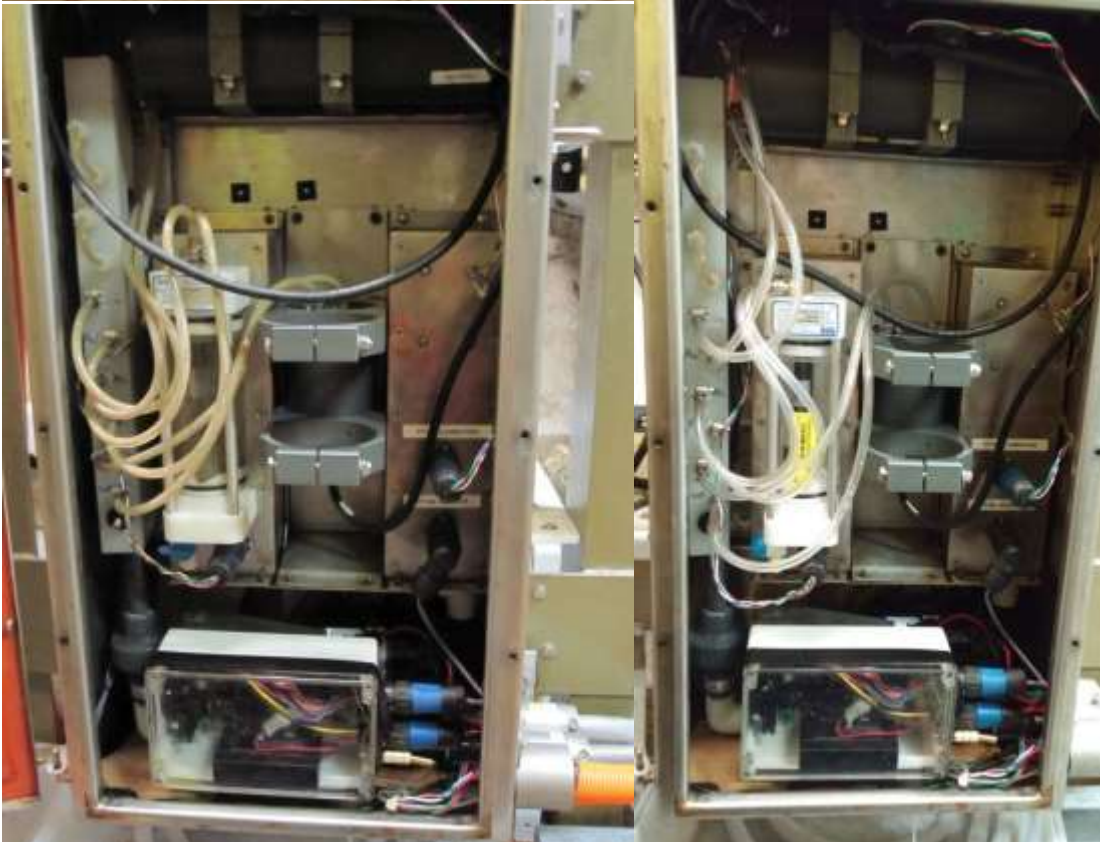
Left: before
service

Right: after
service
