Ocean Networks Canada

Ferry Maintenance Report – Queen of Alberni

Vessel: Queen of Alberni

Date: Nov 19th 2015

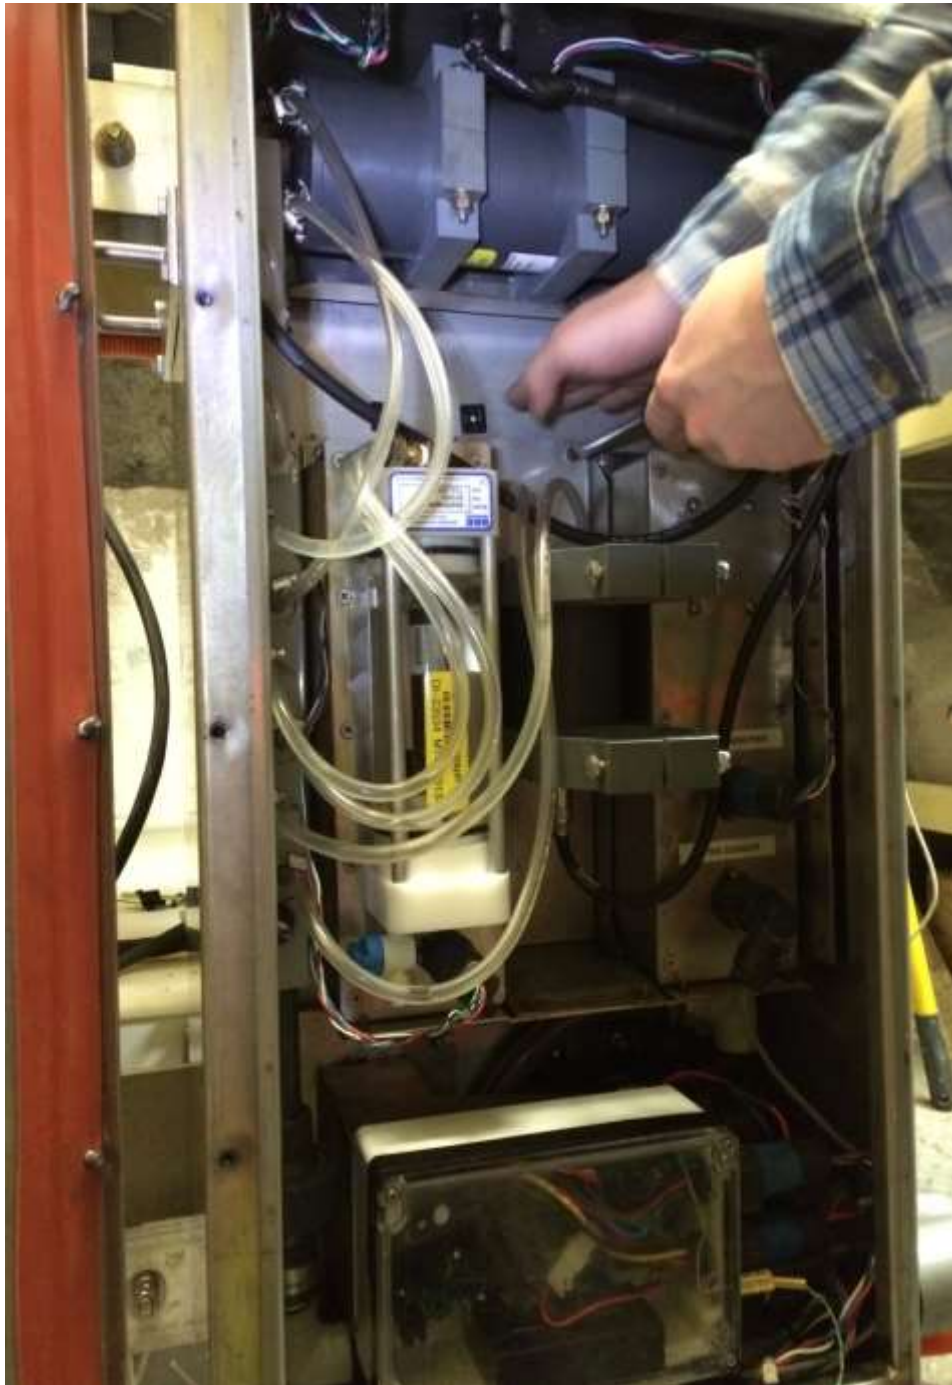
Manifold / TSG prior to power Up

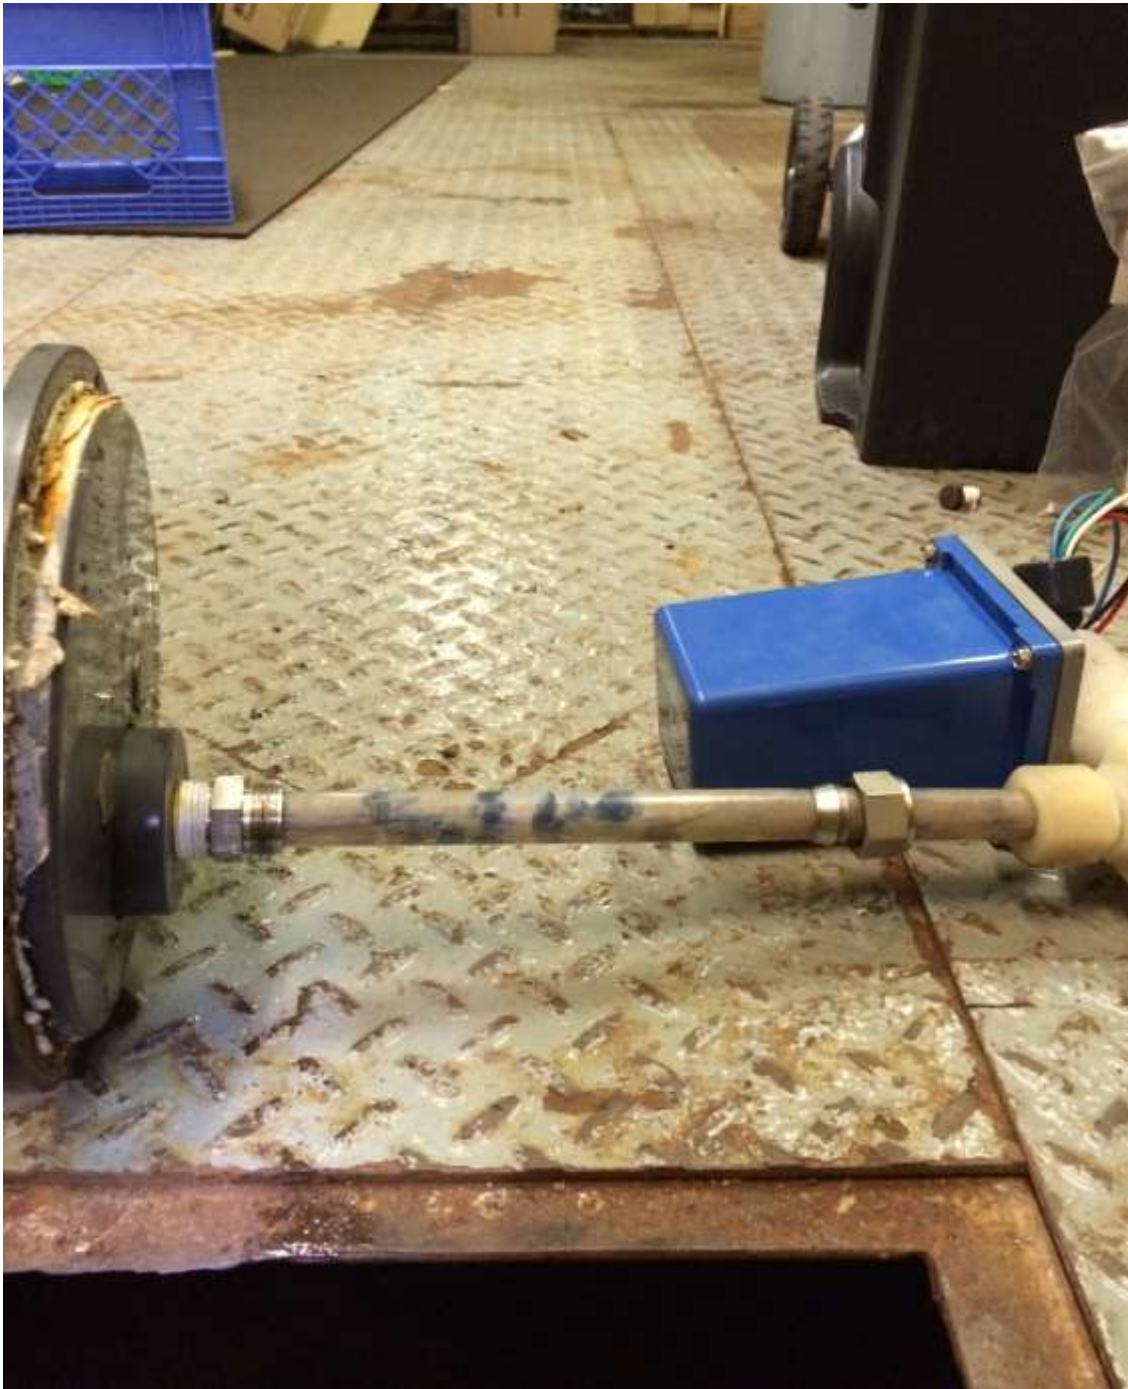
6. Power up Seakeeper system, and monitor. Noticed very poor flow. BBFL2 housing barely getting seawater into its housing
7. Shut power OFF
8. Disassemble Seachest – shutting off the Intake Valve

Seachest removed from Intake valve. Mussel growth apparent.

9. Found mussel growth inside the tube before the Ball valve. Cleaned out carefully.
10. Re-assemble Sea chest
11. Power ON sea keeper system and monitor, and check for leaks.

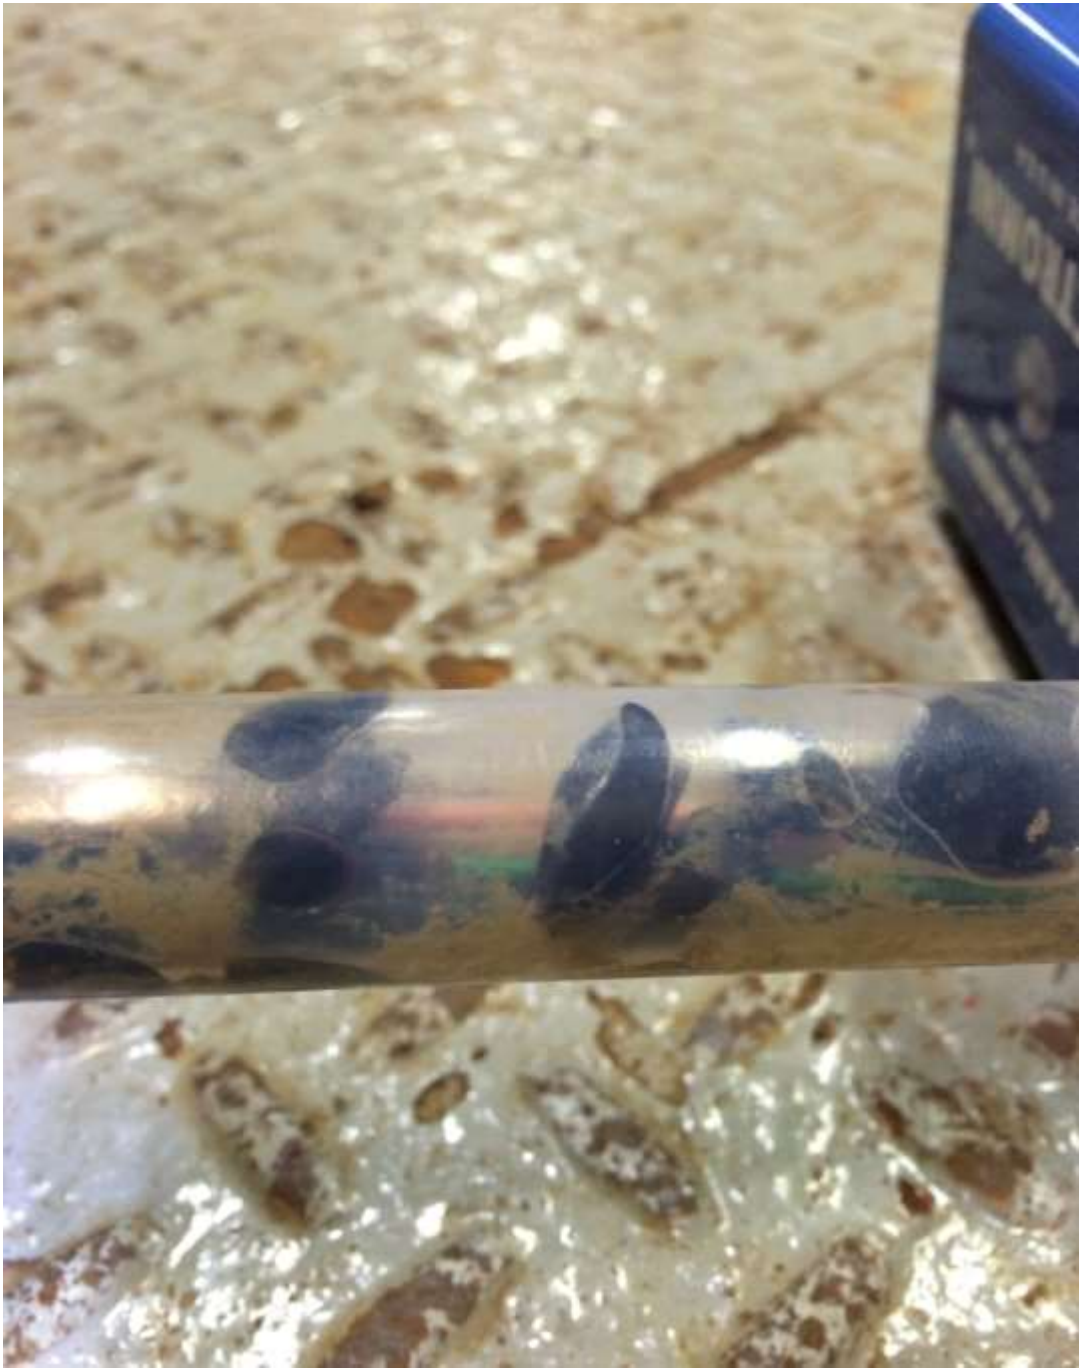
Seachest intake tube. Mussel build up which creates poor seawater flow.

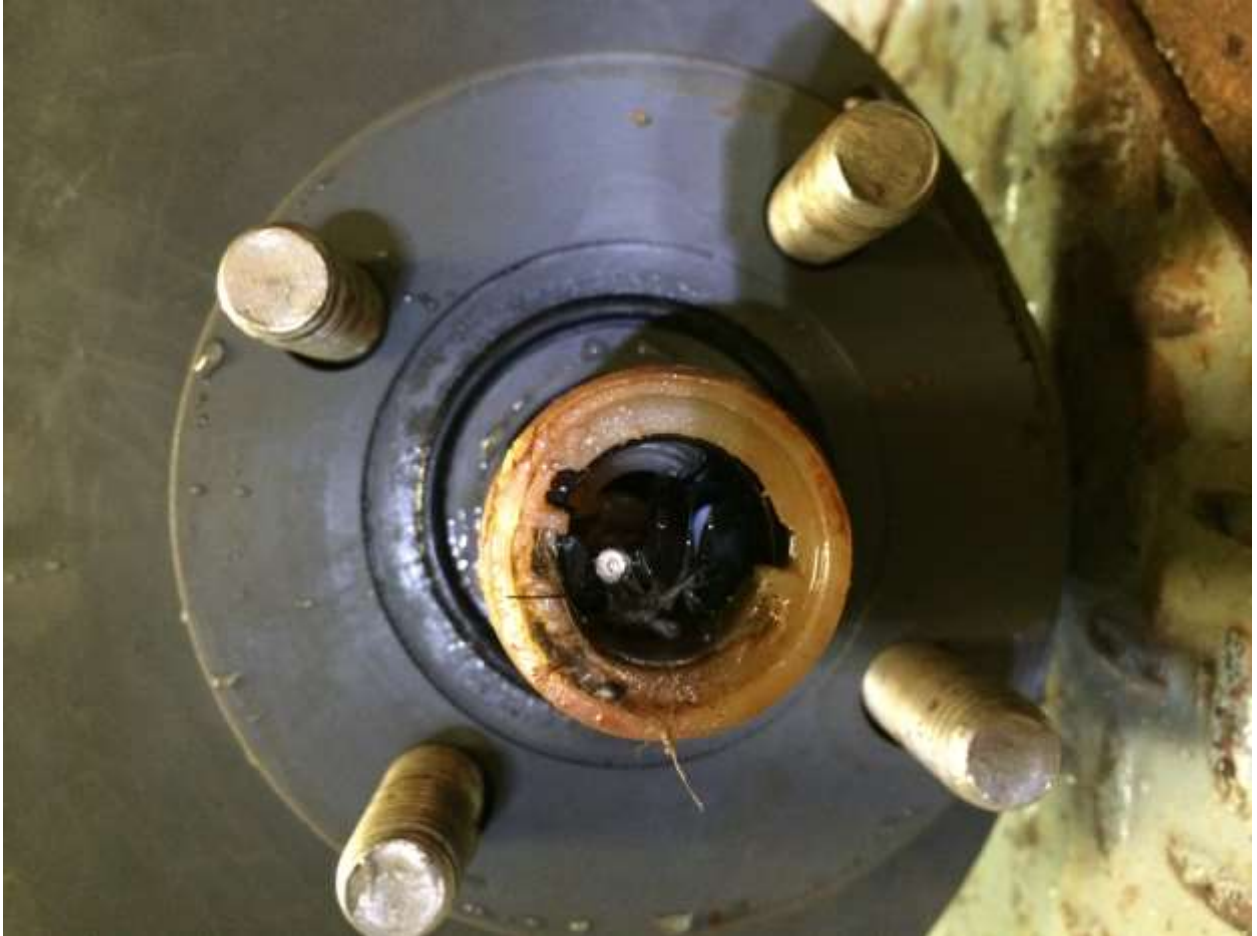
Seachest intake tube at end. Plugged with mussels.

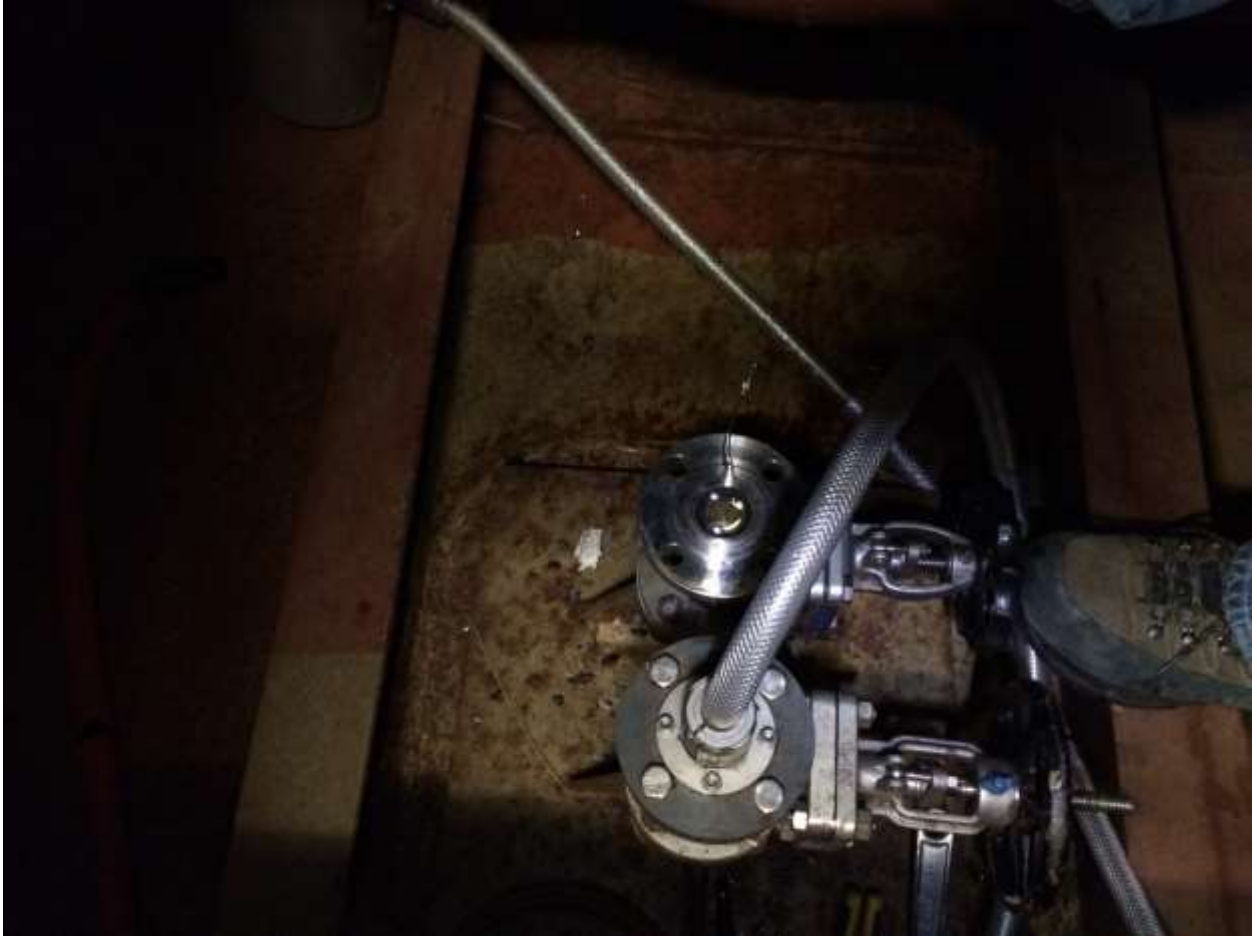
Intake(top) and Outlet valves after removing Seachest

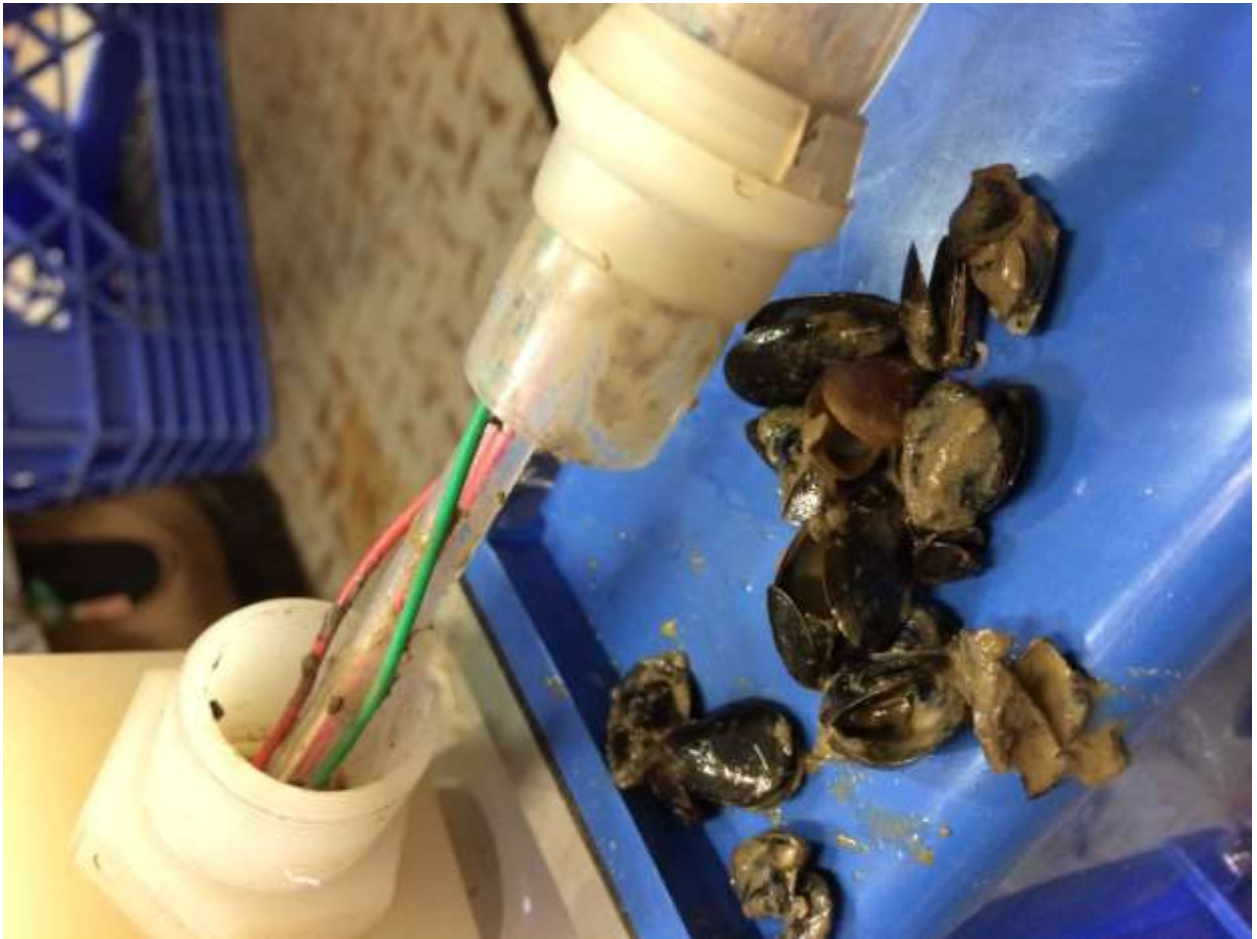
A few mussels pulled from the Sea chest intake tube before the Ball valve
