## **Ferry Maintenance Report**

#### Vessel: Queen of Alberni

Date: June 20, 2014

#### **Reason for Visit**

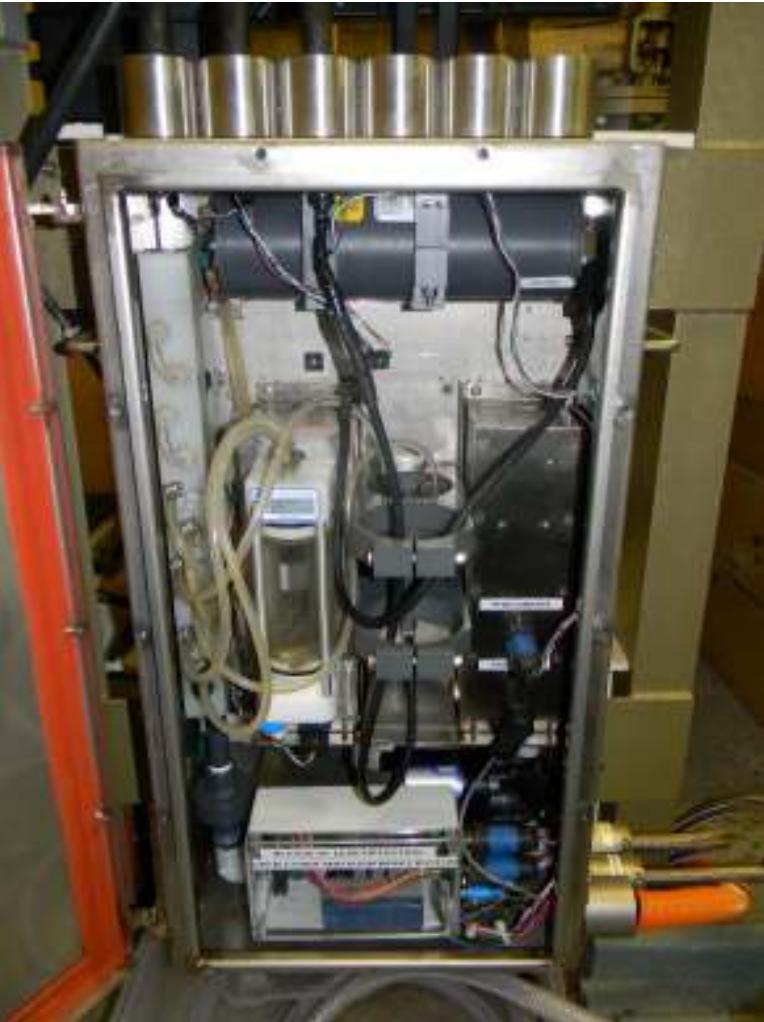
Figure 1. Lower instrument box of the seakeeper unit with each of the three instruments visible.

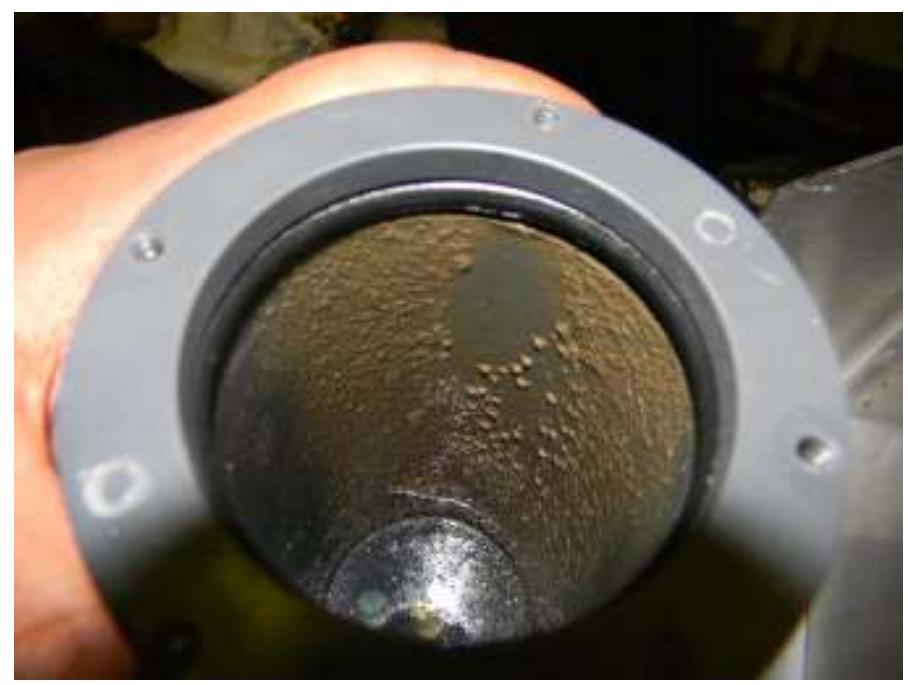
Figure 2. Accumulated biological material along the side of the BBFL2 housing. Note that the unit is positioned to sit in the horizontal and this material is therefore accumulating on the bottom of the housing.

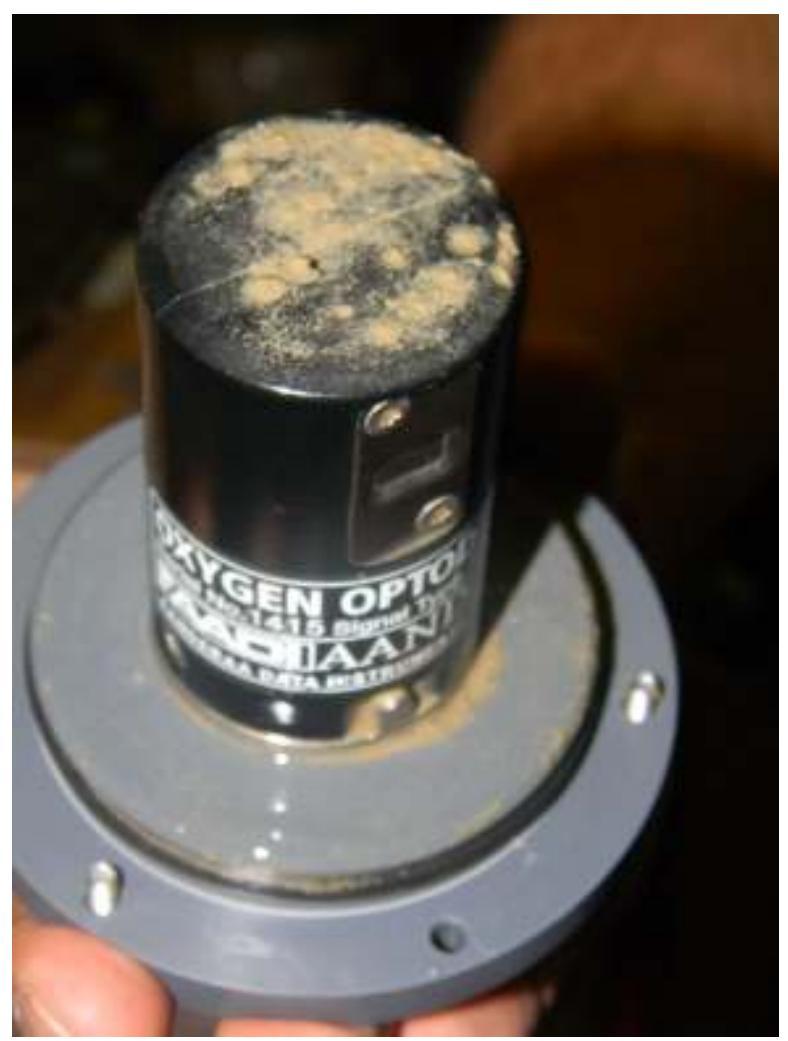
Figure 3. Moderate sedimentation on the optode.

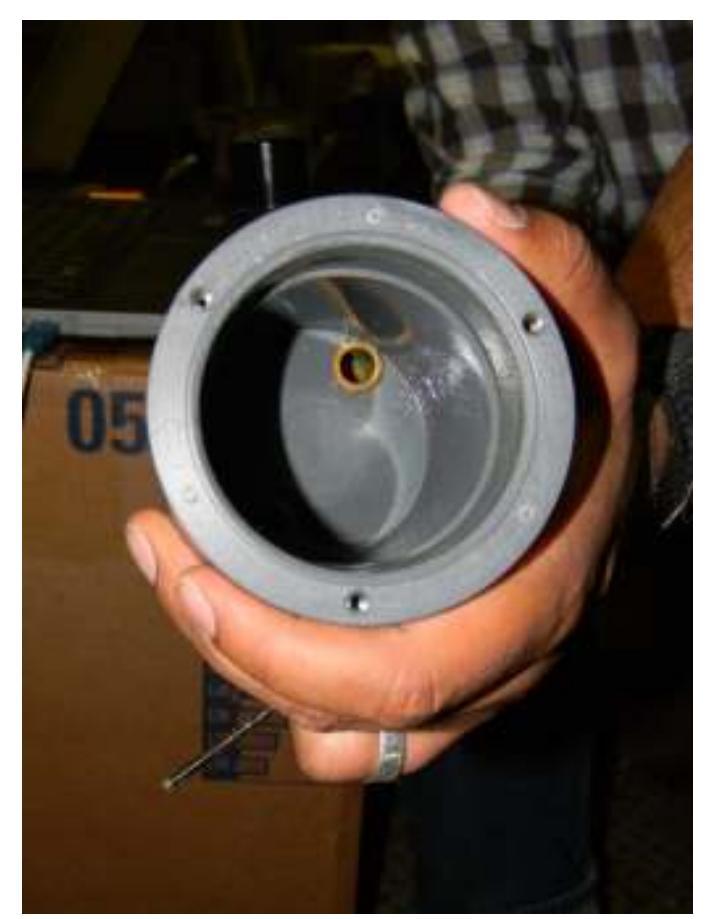
Figure 4. Optode housing relatively clean.

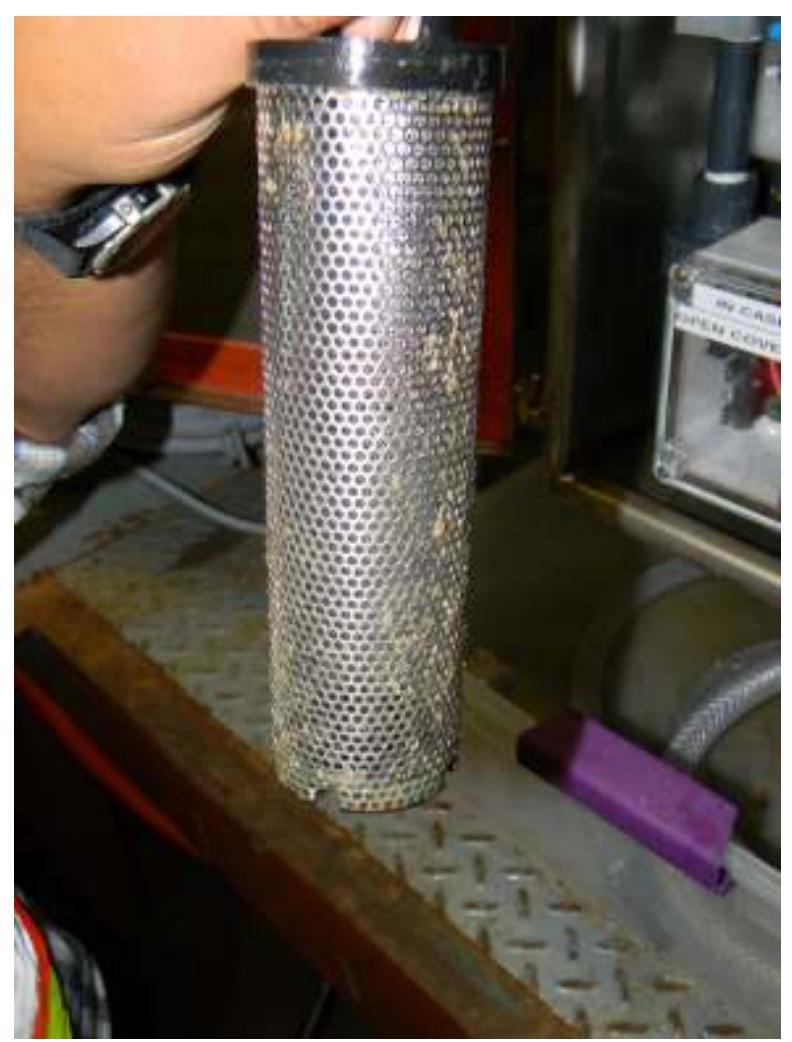
Figure 5. Sea-strainor relatively clean and free of debris.
