Ocean Networks Canada Ferry Maintenance Report – Queen of Alberni

Date: March 25, 2015

Reason for Visit

Investigate anomalous instrument readings.

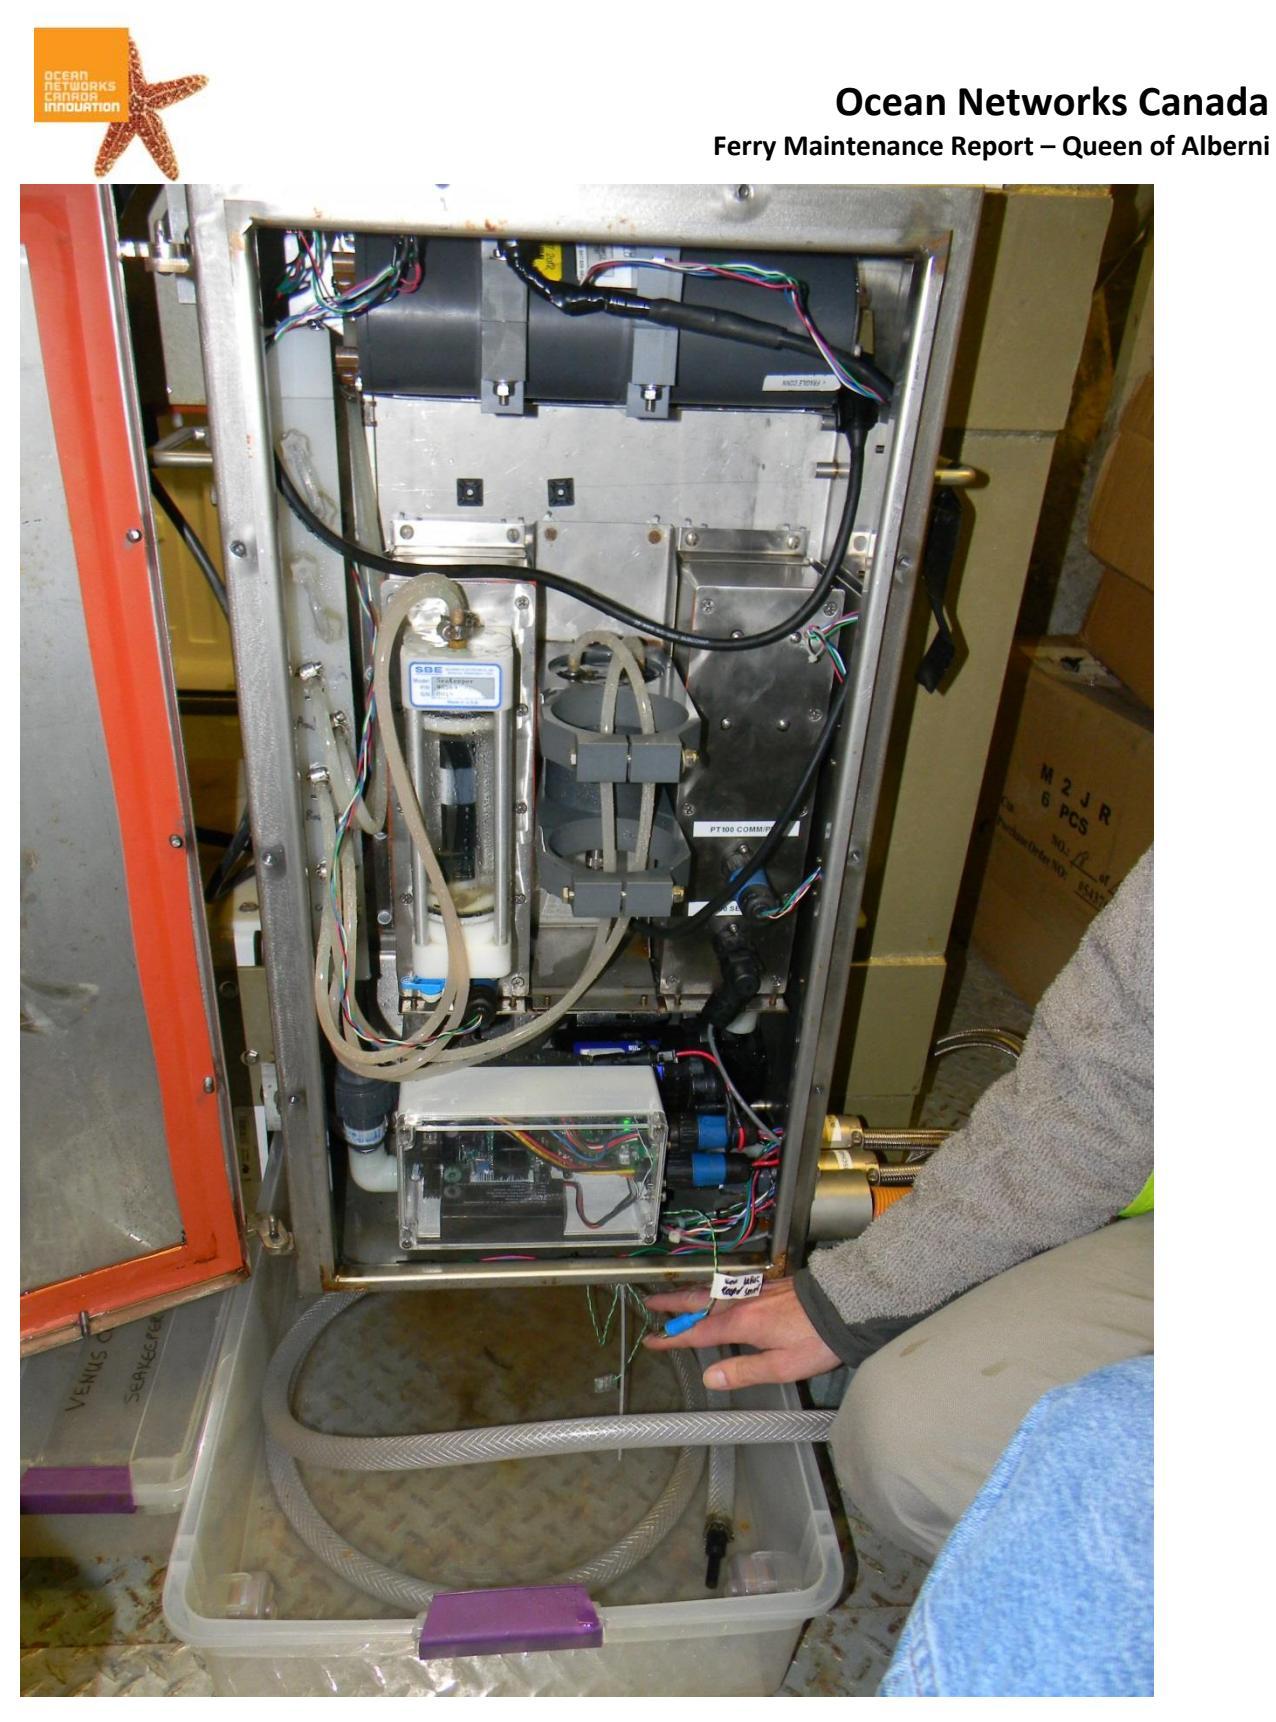
1. There was evidence of condensation and leaking within the Instrument Box. Approximately 8-10 liters of water were in the catchment basin. The pump was shut down due to a leak sensor trip.

- 1. The system was not operating upon arrival.
- 2. The upper and lower boxes were opened and system operation was observed. Water was evident within the instrument box and there was water in the catchment basin.

Figure 1: Instrument box upon arrival. Note the water in the catchment basin and throughout the instrument box.

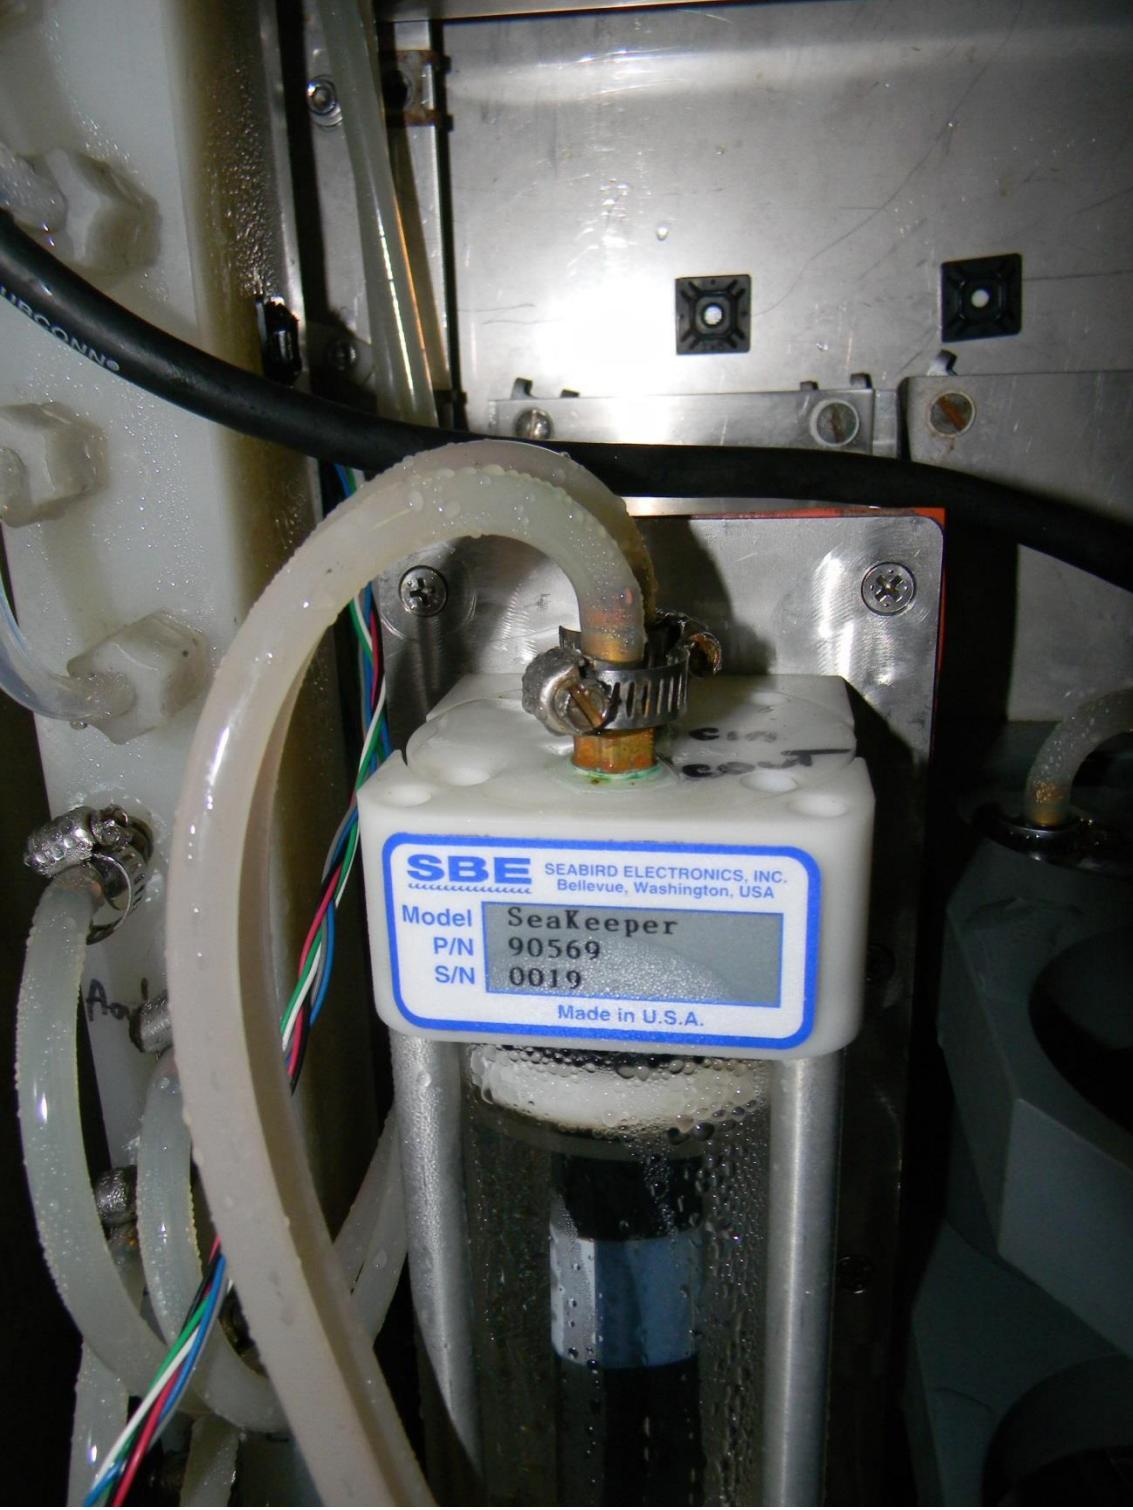
Figure 2: Water on the CT unit and manifold

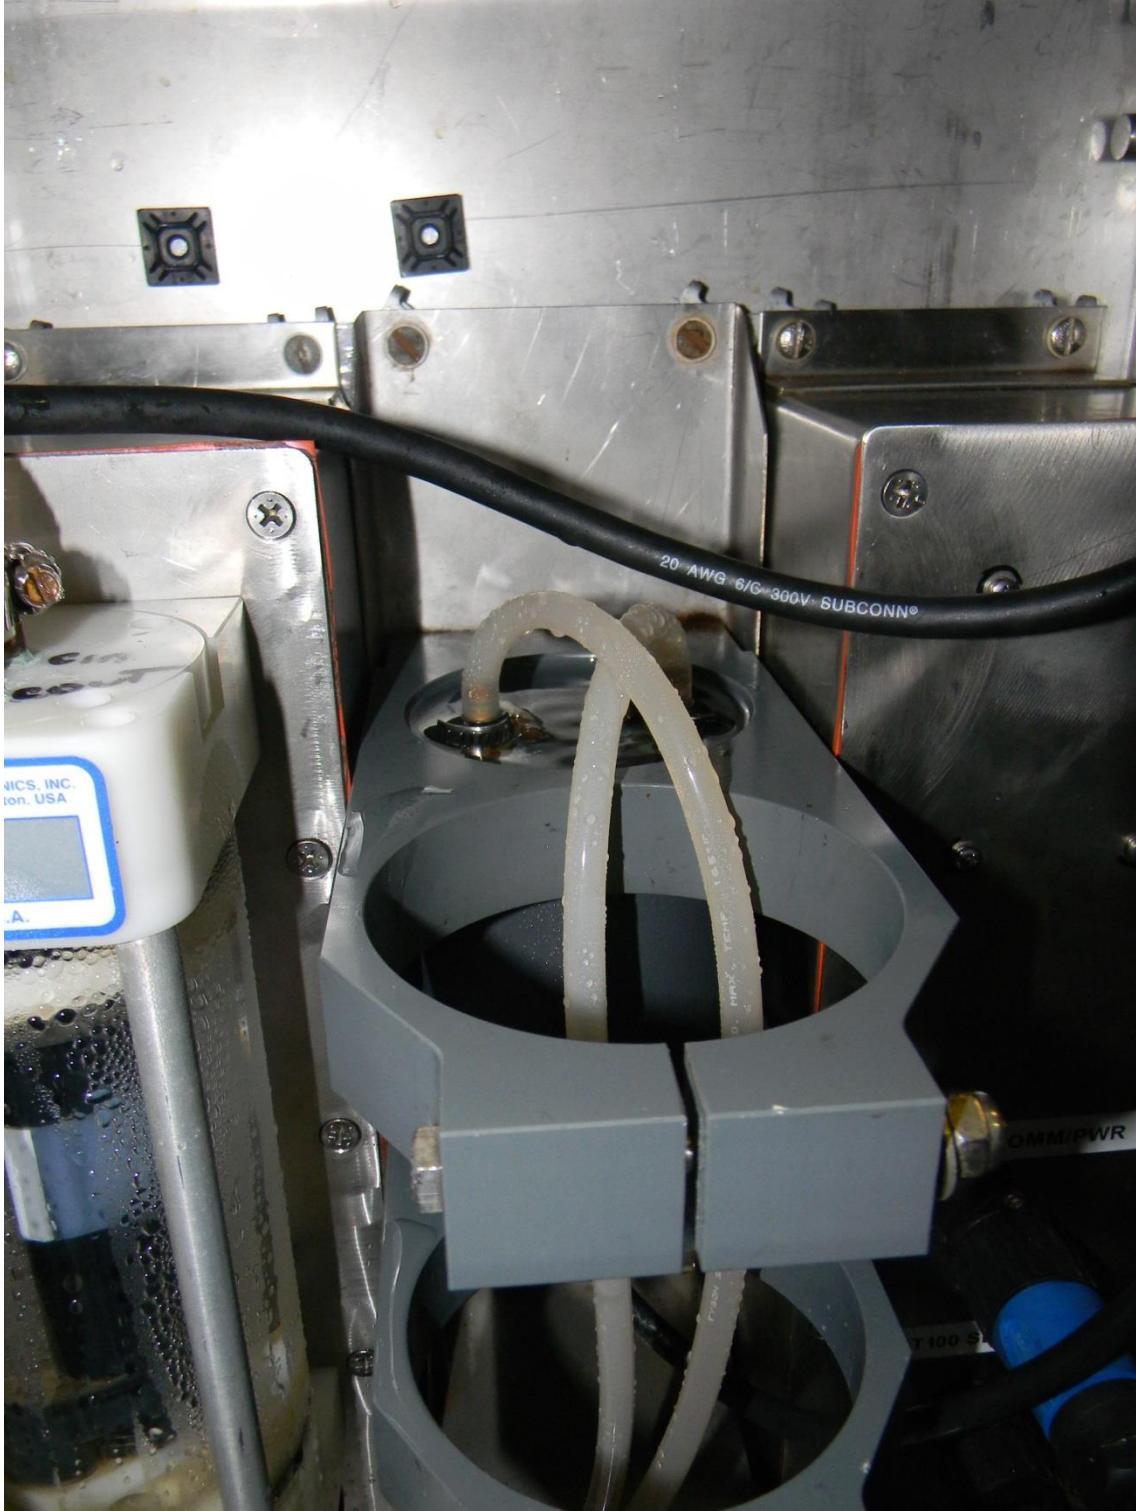
Figure 3: Water on the OPTODE sensor.

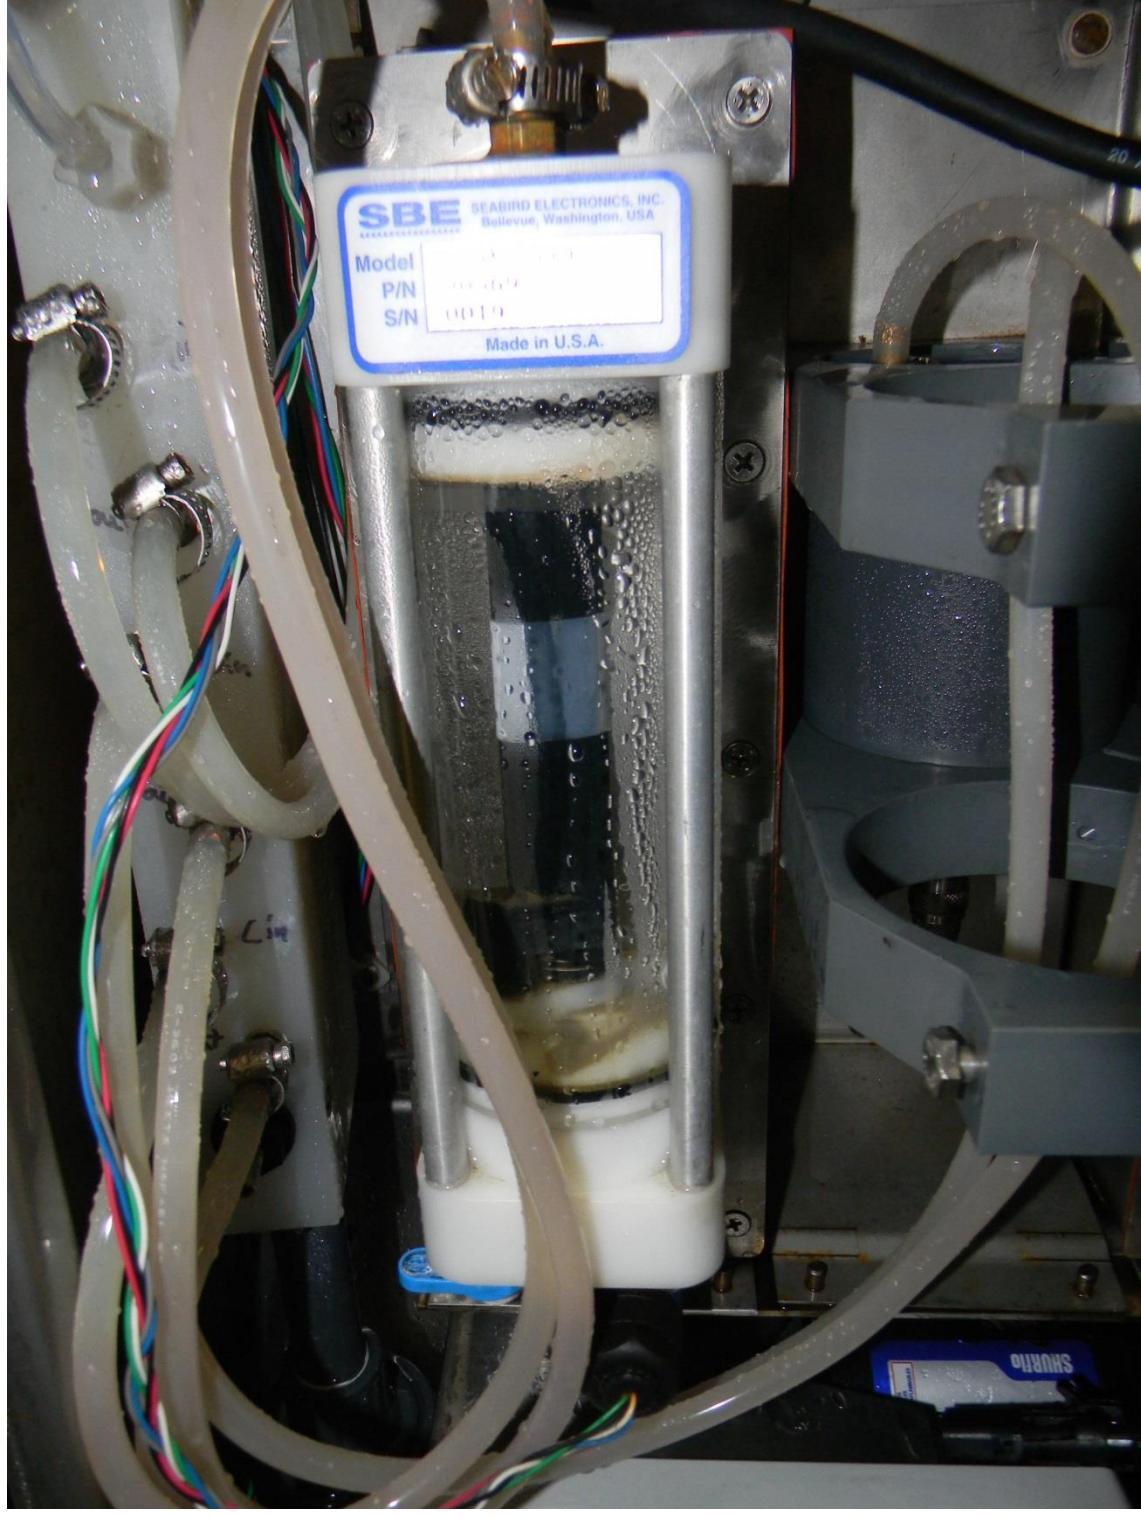
Figure 4: Water on the CT sensor.

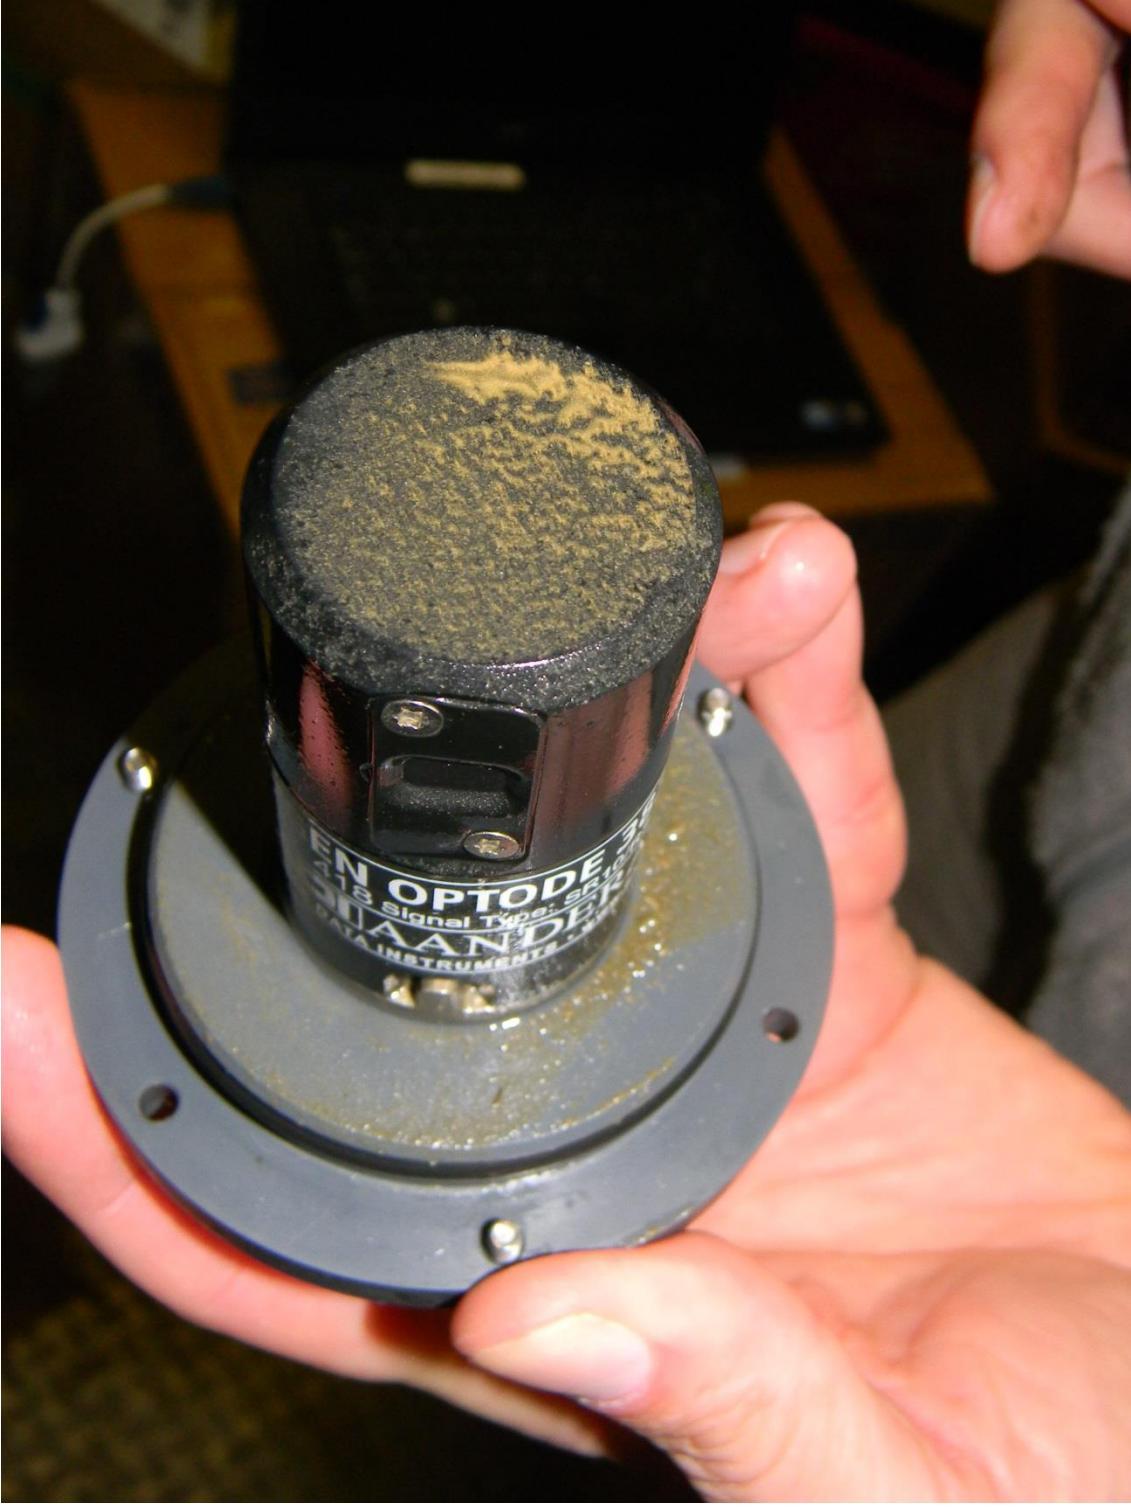
- Switched off the system and proceeded with normal instrument cleaning and calibration procedures.
- 4. Minor biofouling was observed within all instrument housings. Some indications of spring bloom were present (biological growth).

Figure 5: Biofouling on the OPTODE sensor.

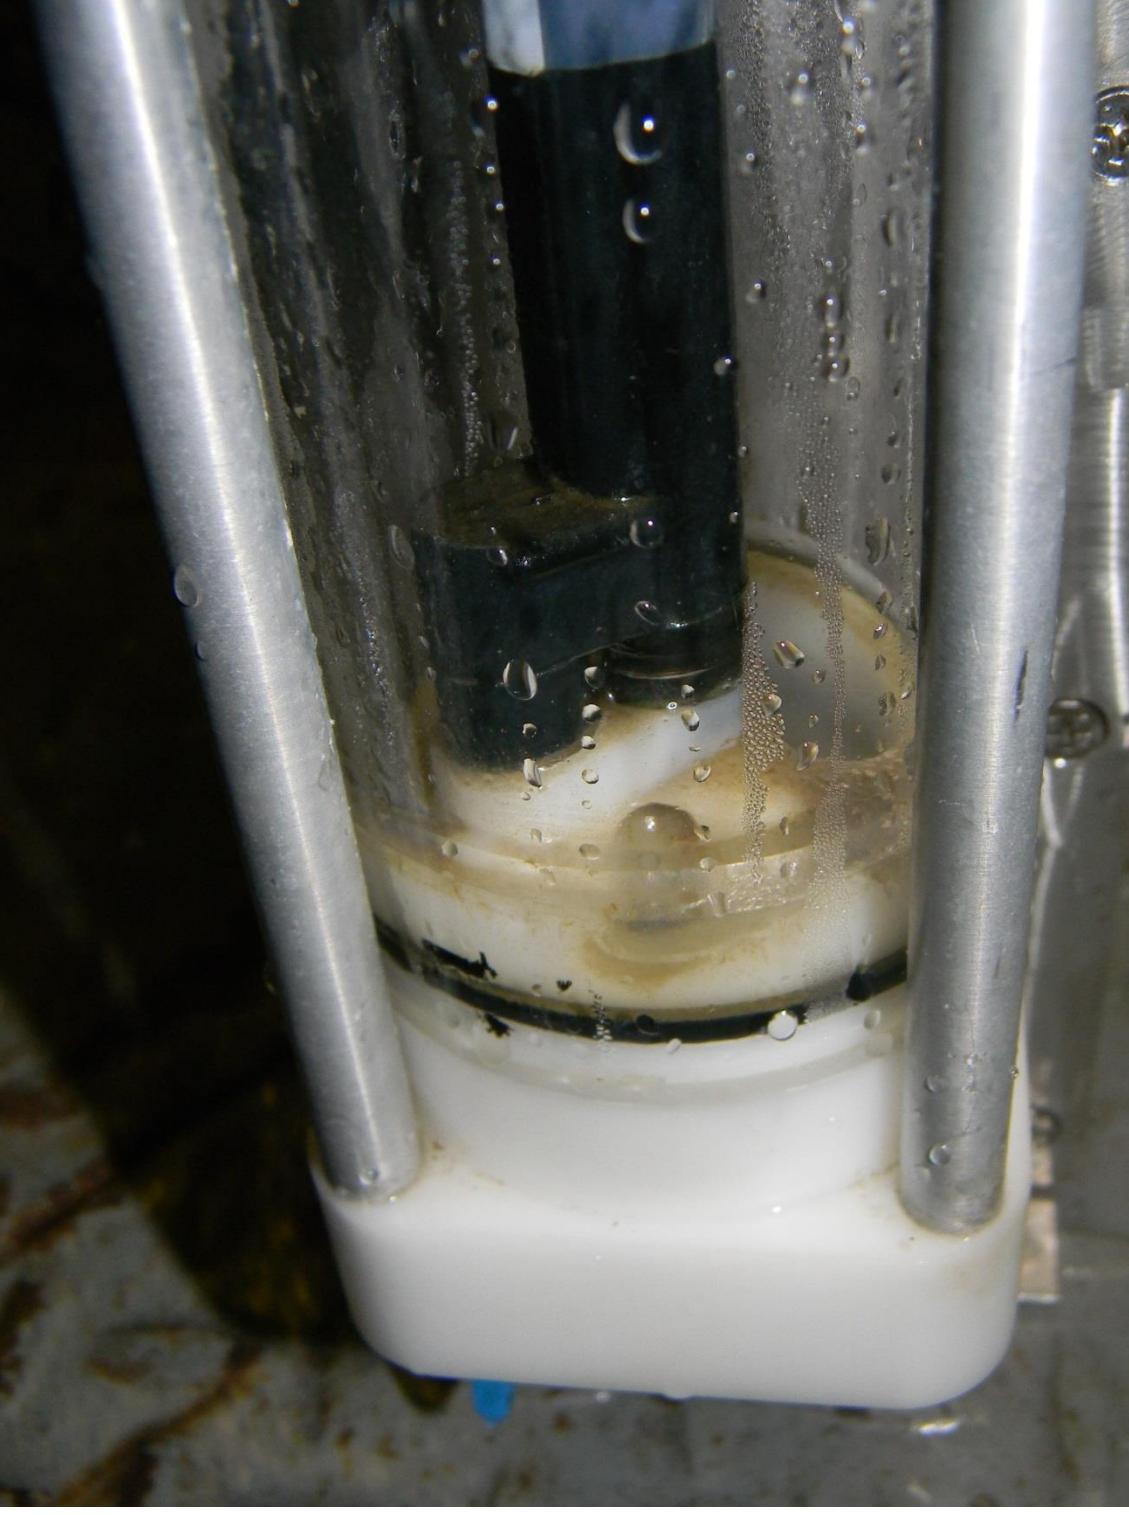
Figure 6: Biofouling within the CT sensor.

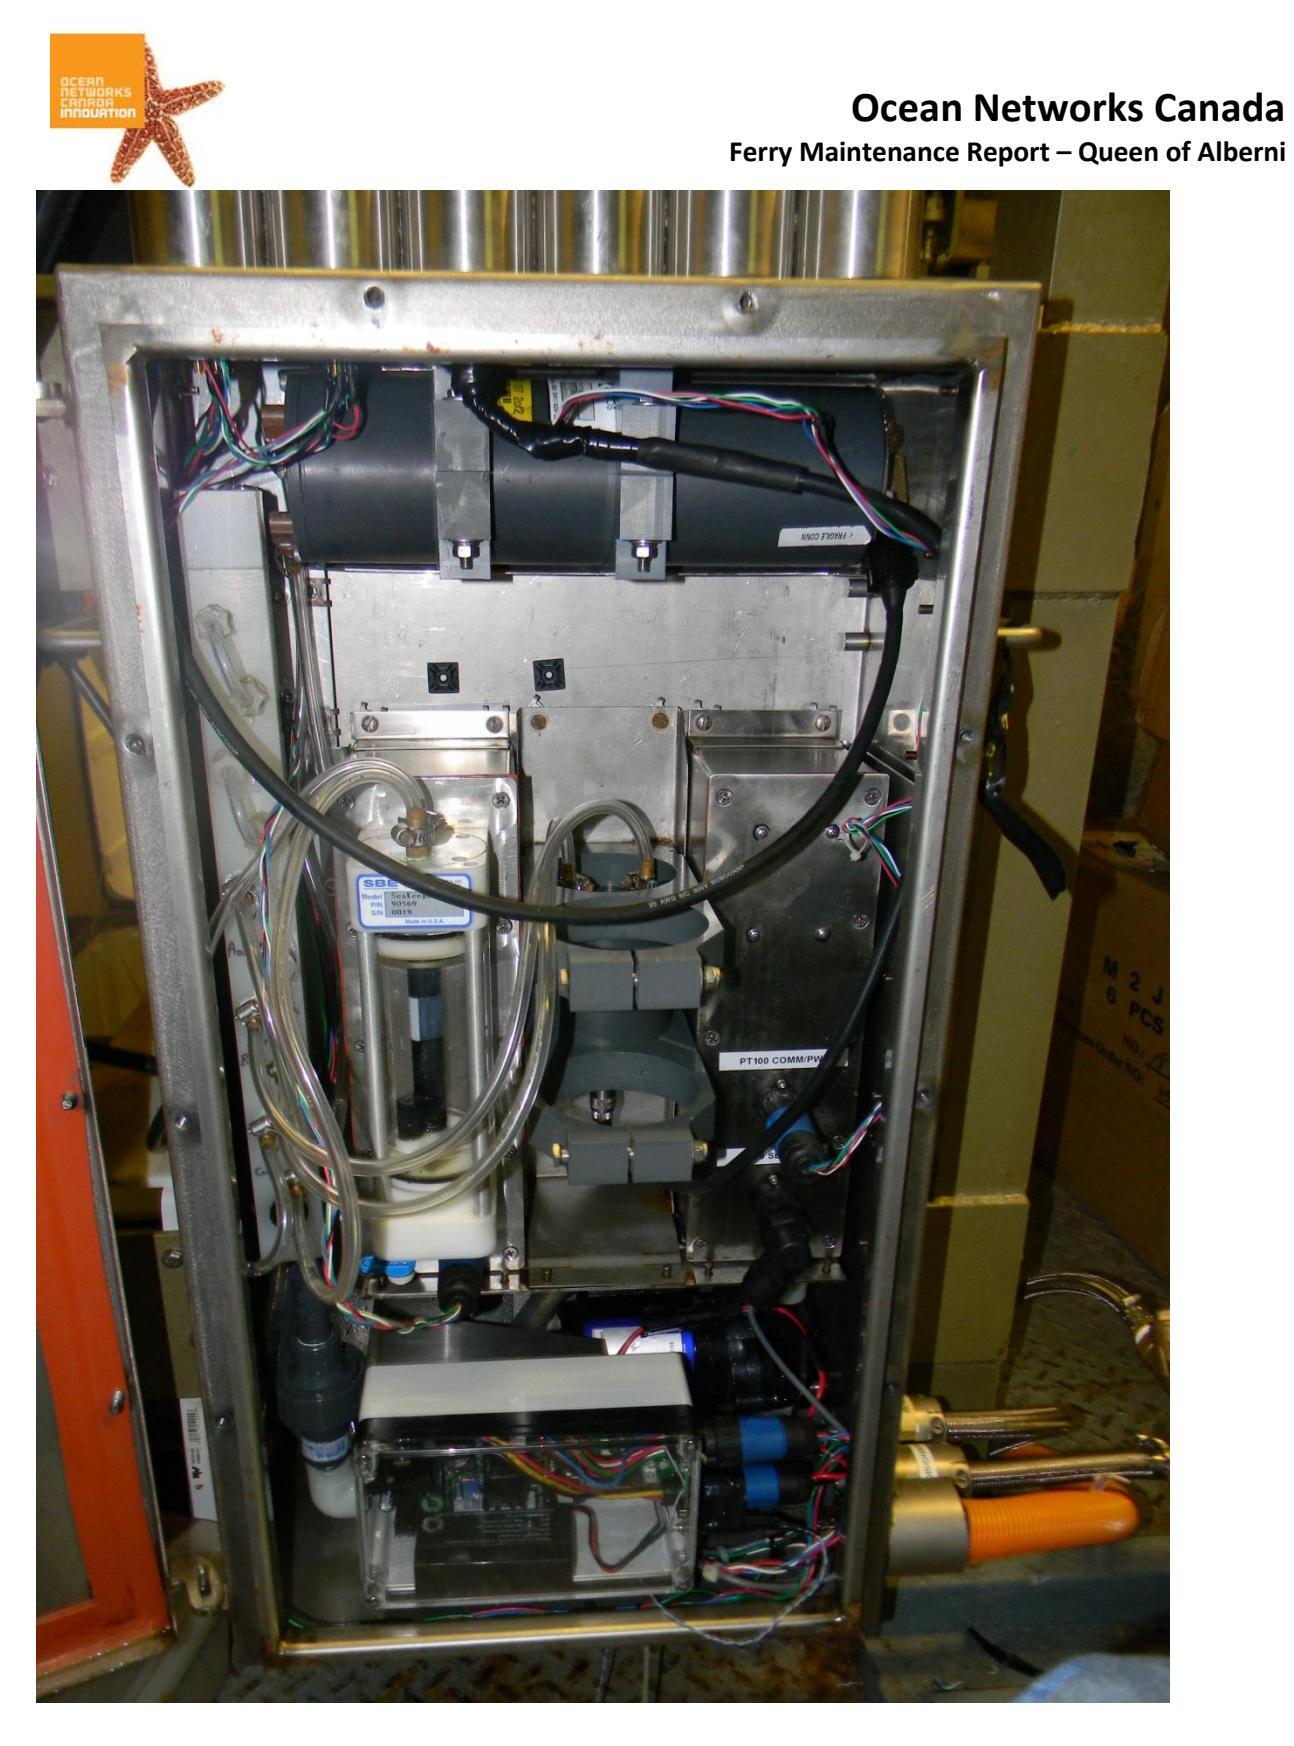
Figure 8: Instrument box post-cleaning.

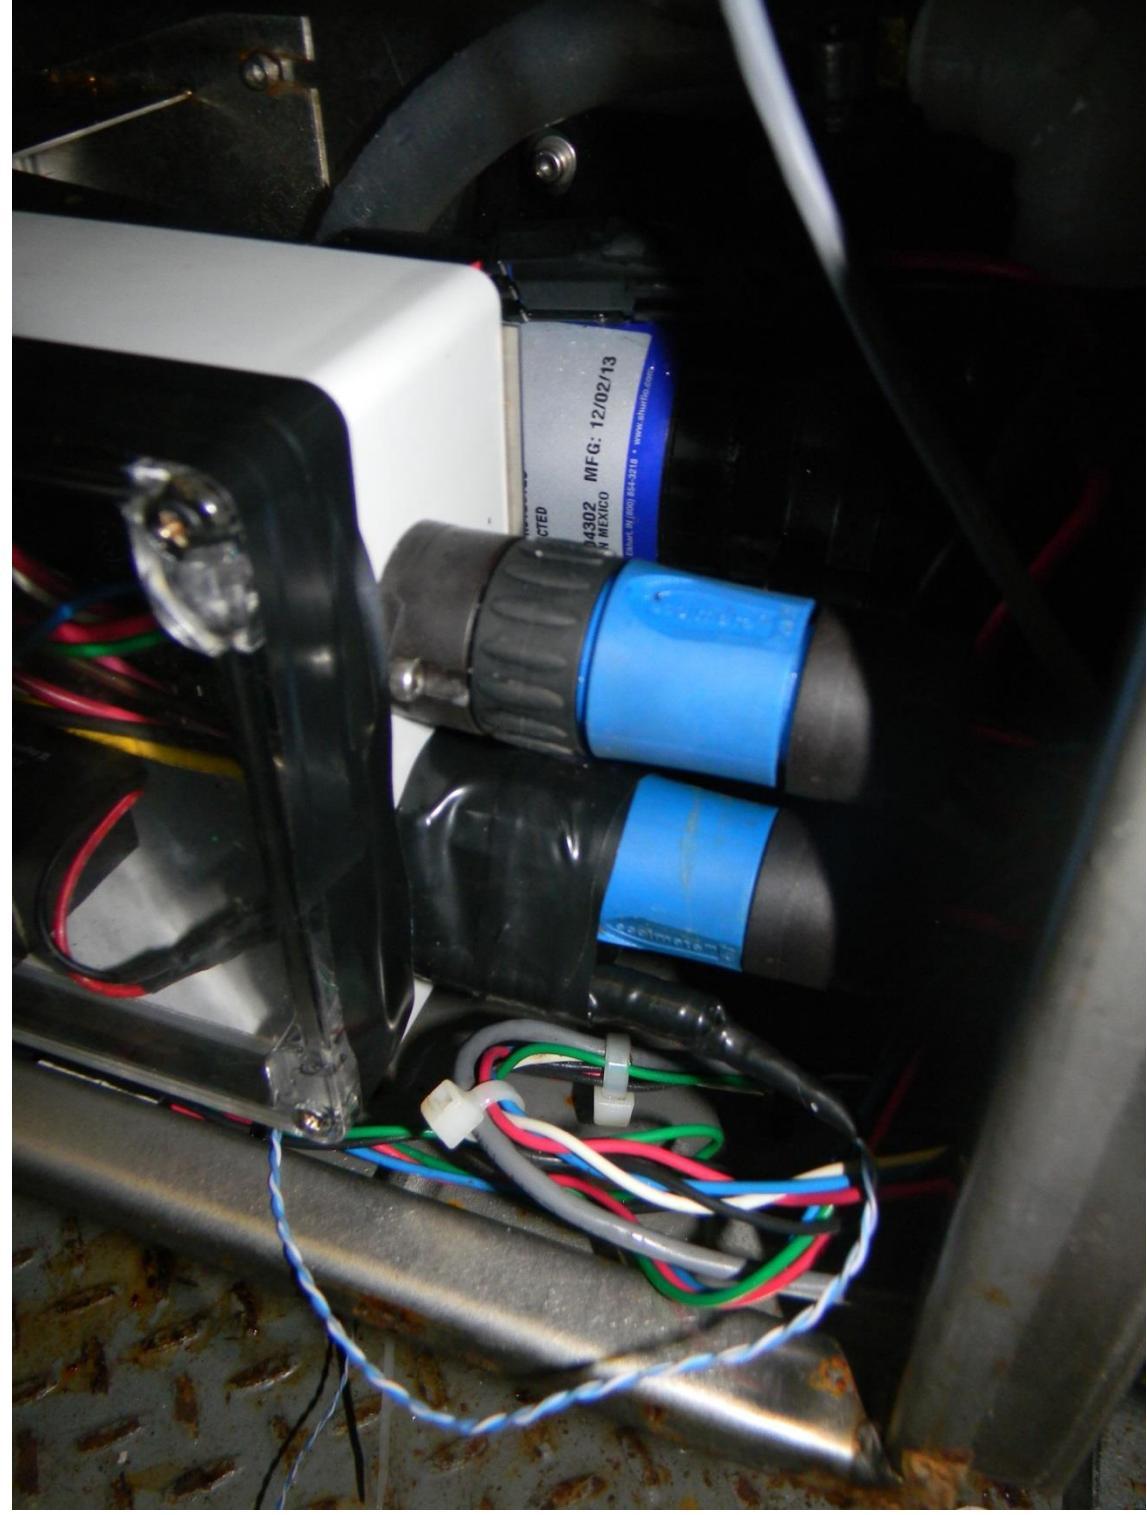
Figure 9: Additional tape waterproofing of the leak sensor input end.

- 5. Replaced all tubing with new sections to ensure that no splits or cracks in the tubing were overlooked.
- 6. Added additional tape waterproofing to the new (replacement) leak sensor to prevent false positives from condensation onto the connector.

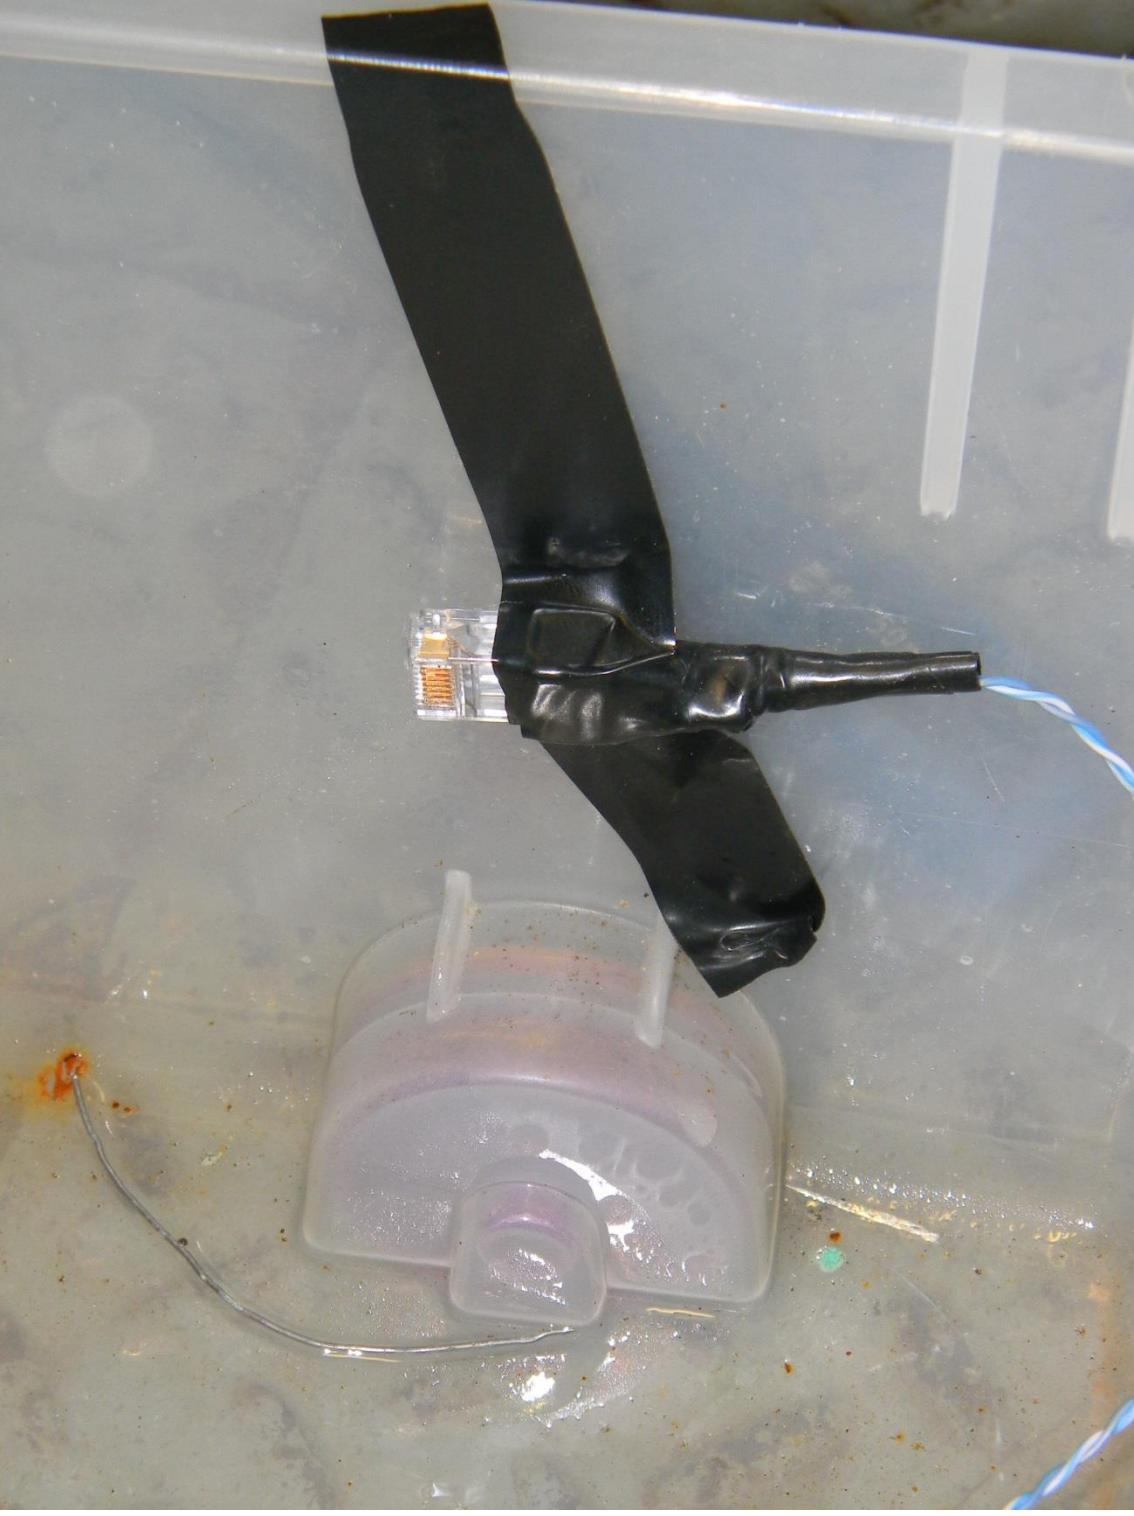
Figure 10: Taped position of the leak sensor.

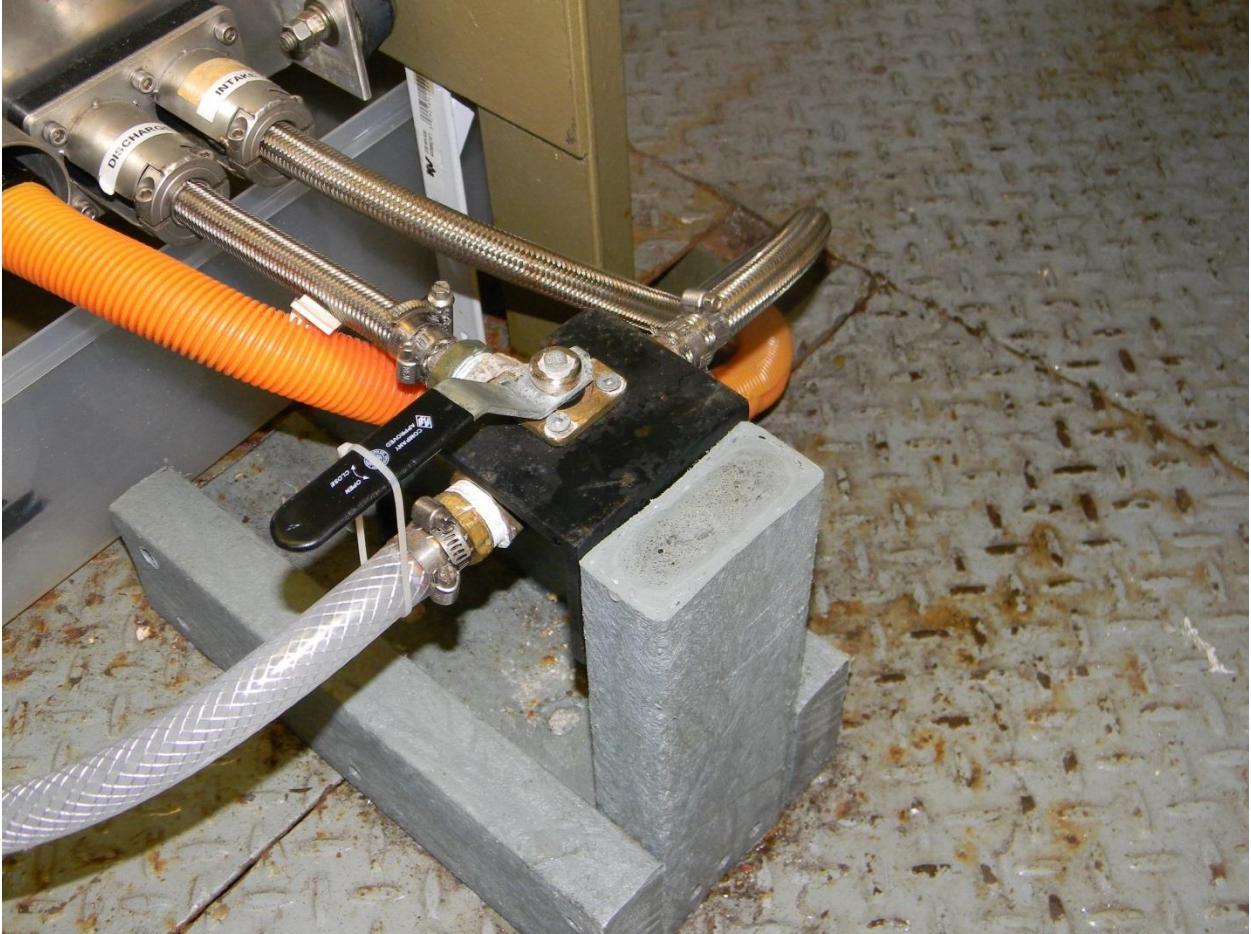
- 10. Shut the system down.
- 11. Removed the backwater check valve and reassemble system. Removal showed excessive buildup of pressure within the instrument box as reverse pressure from outside the ship was apparently high enough within the dock to prevent the check valve from cracking (only 2 psi differential is required).
- 12. Turned the system on and observed operation. Operation appeared normal without straining on the part of the pump. Closed up the system.
- 13. Signed out at Engineering room.

Figure 11: Discharge line after removal of check valve.

- 1. Inspect new plumbing for leaks.
- Replace braided stainless steel hose with transparent reinforced TYGON tubing so that flow and fouling throughout the system can be observed. Use wrap-on guard material to protect TYGON at wear points.
- 3. Add a logging pressure sensor to the discharge line to monitor the pressure along the line and check for anomalous pressure spikes.

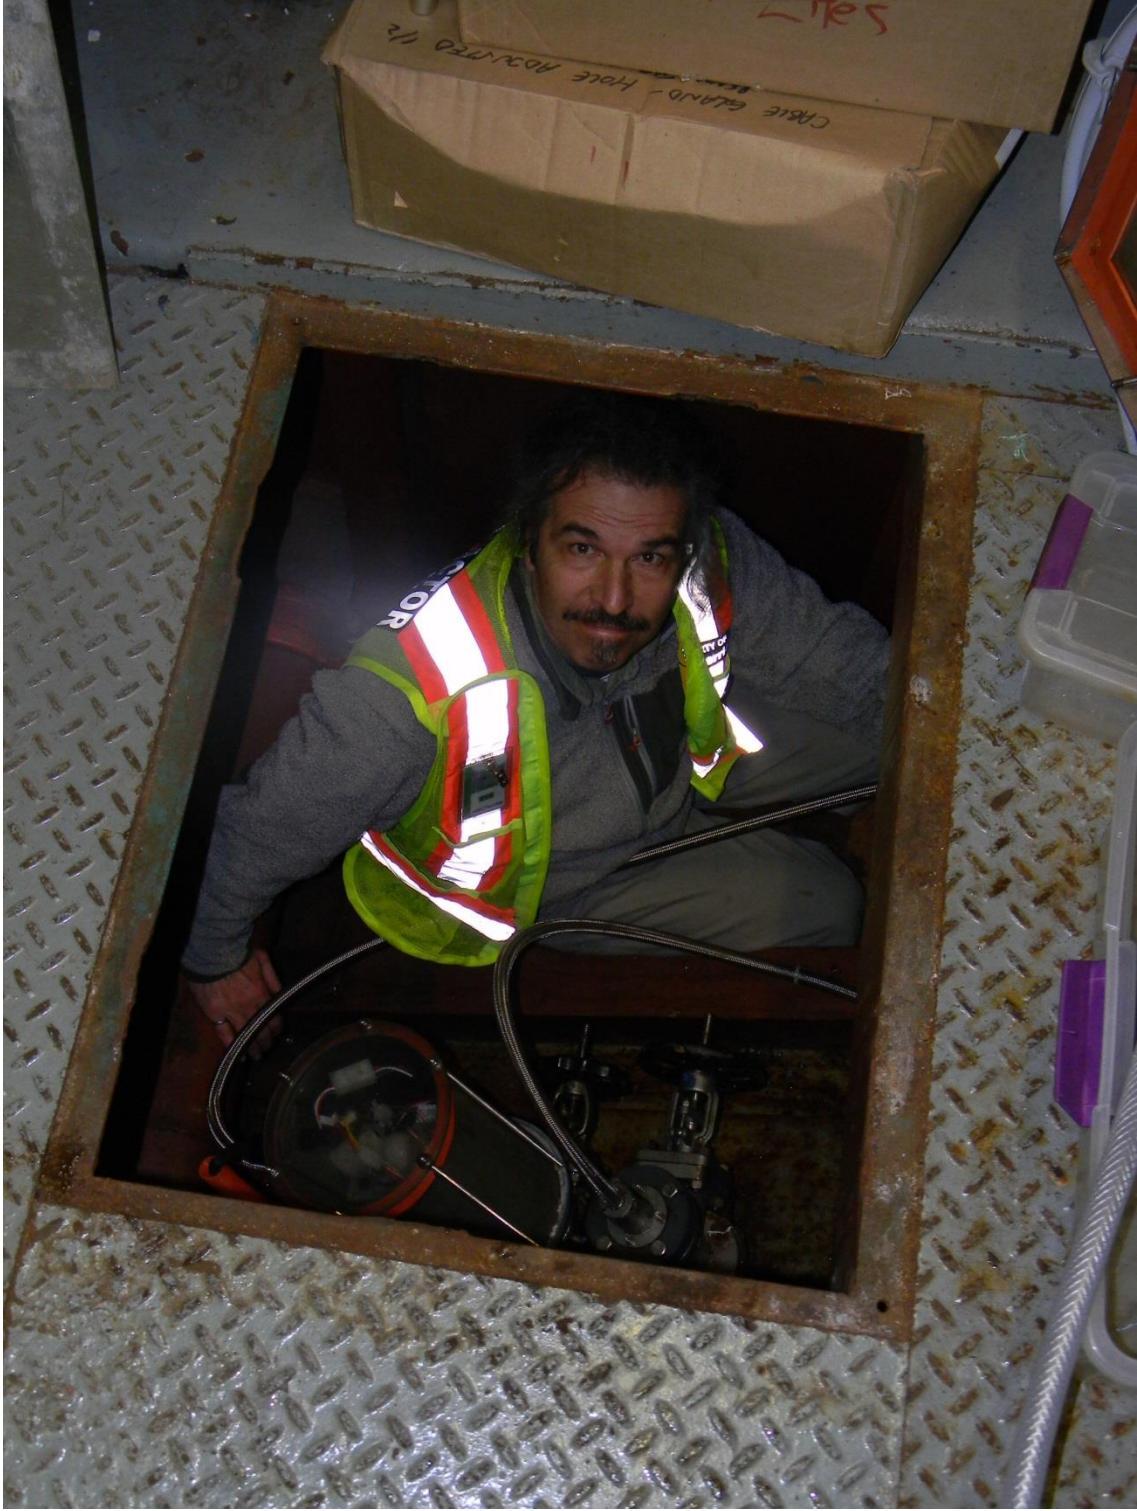
Figure 12: Cleaning the Sea Strainer.

- 7. Reassembled system.
- 8. Checked and cleaned the Sea Strainer unit.
- 9. Turned system on and operation was noted as abnormal. No leaks were immediately evident but pump noise was louder than normal and seemed strained. Opening the sample valve resulted in a large release of pressure, higher than expected.
