<mark>Vessel</mark>: Queen of Alberni

Date: Dec 16th 2015

Reason for Visit

Ferry Maintenance Report – Queen of Alberni

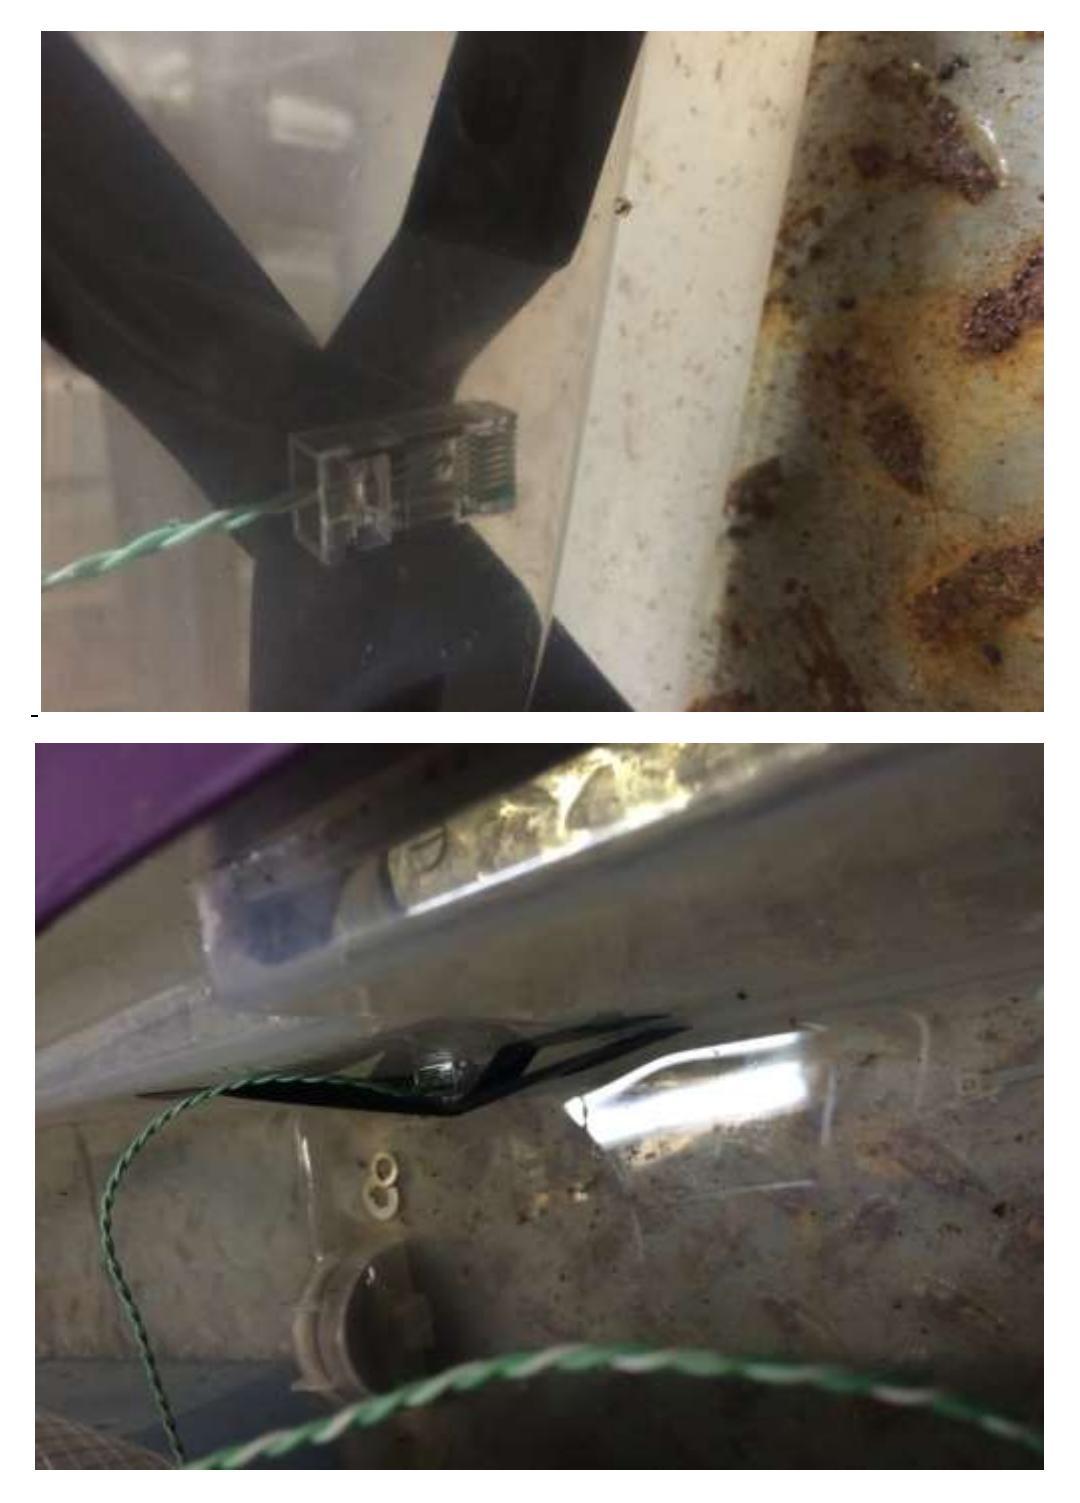
- 1. The plastic tote underneath instrument housing had seawater which reached the point of the leak sensor.
- 2. Open instrument housing. Had some sea water(drips) sitting in various spots.

Underneath Instrument housing. Water has reached to Leak sensor inside the plastic tote

- **1.** Sign in Engineering room
- 2. Open PC housing. Connect keyboard, and mouse. Still powered ON.
- **3.** Remove leak sensor, and install new one.
- **4.** Reset pump control box

- **19.** Dry areas, drain tote, and tape down leak sensor about 2" from bottom of tote. Remove old desicant, and place several fresh bags of desicant within instrument housing

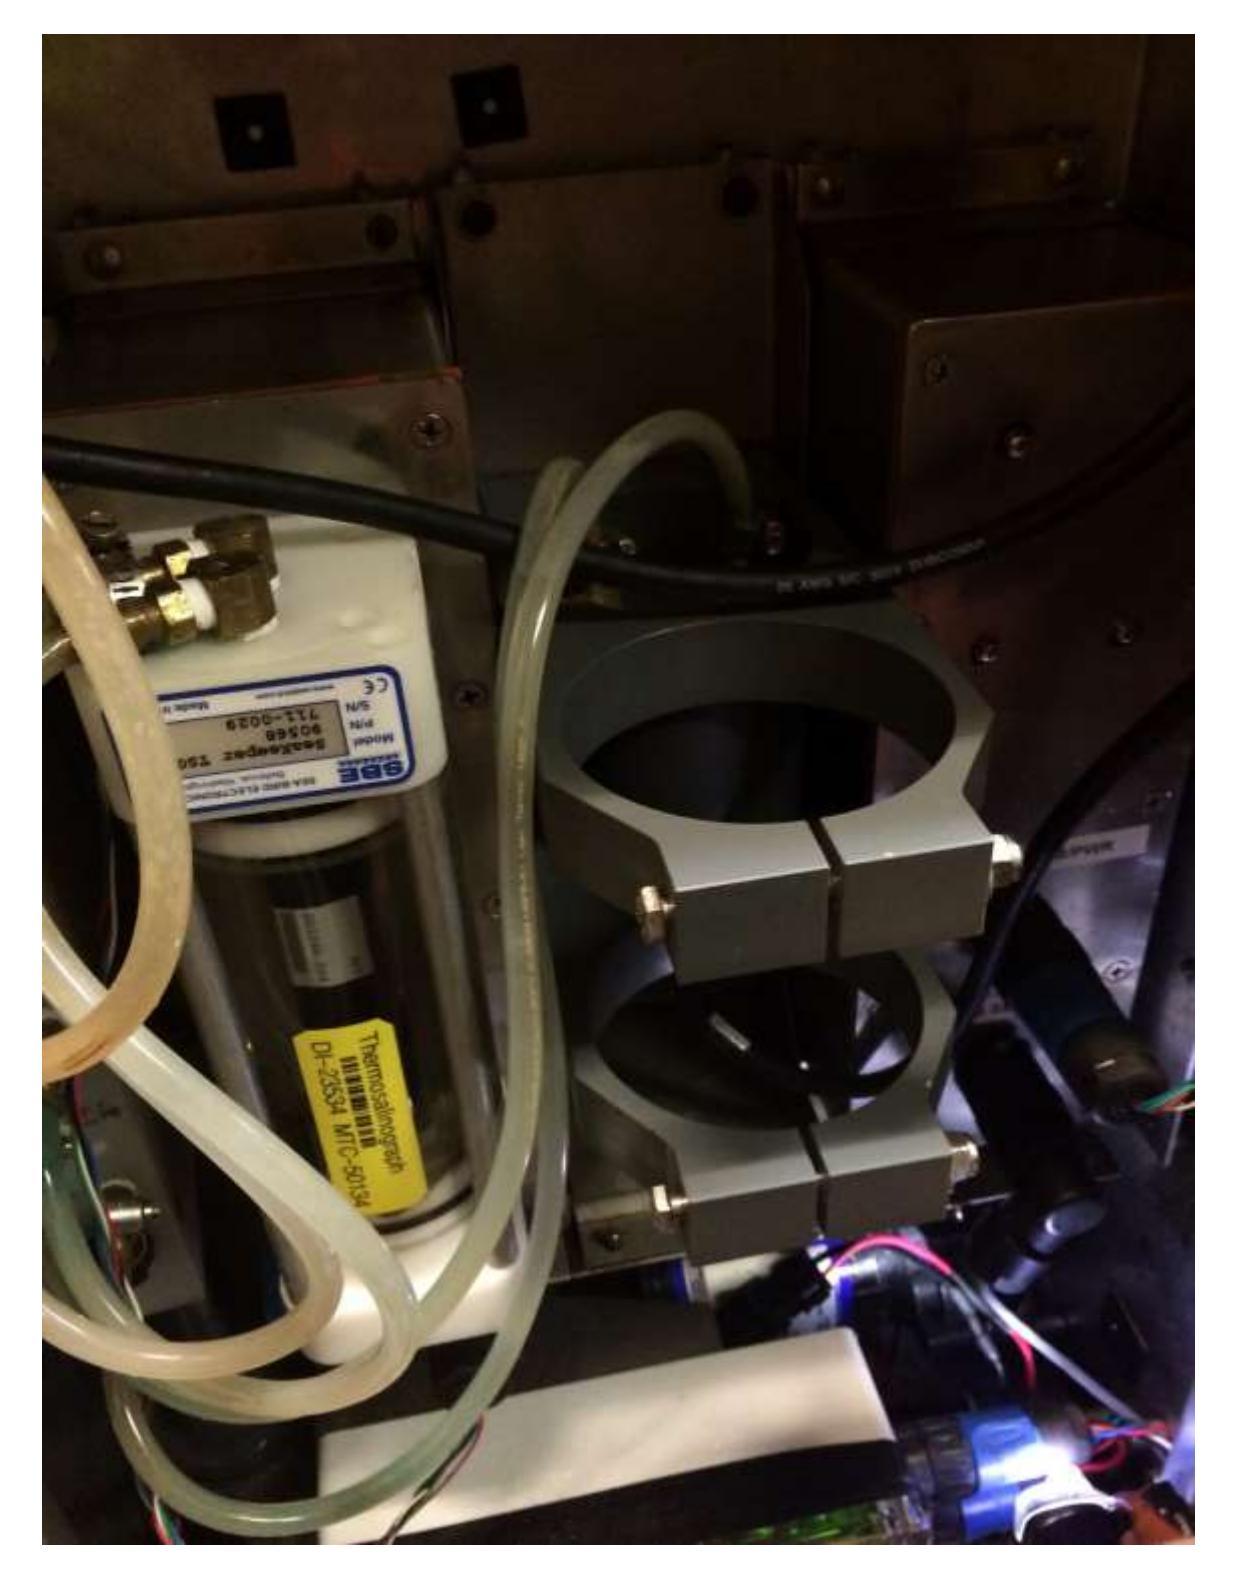
SBE thermosalinograph/CT and optode sensors prior to service.

- **8.** Conduct Diet Coke, and Sprite calibration measurement on BBFL2
- 9. Conduct 2 point measurement on Optode
- **10.** Clean and service instruments

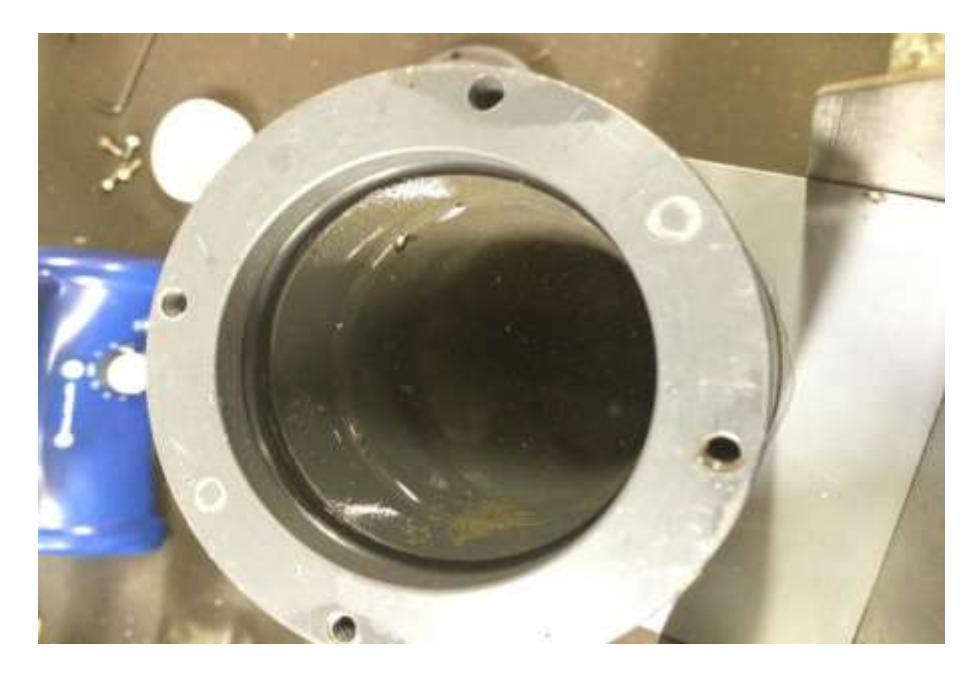
BBFL2 prior to pop calibration measurements

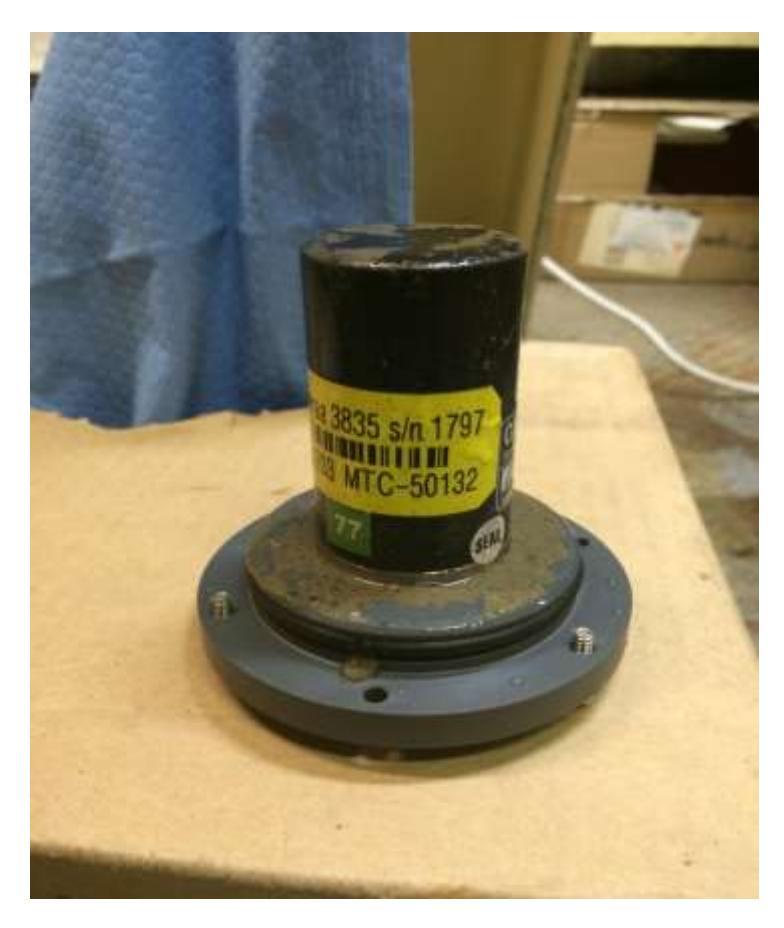
AADI Optode prior to cleaning/ 2 point cal measurement

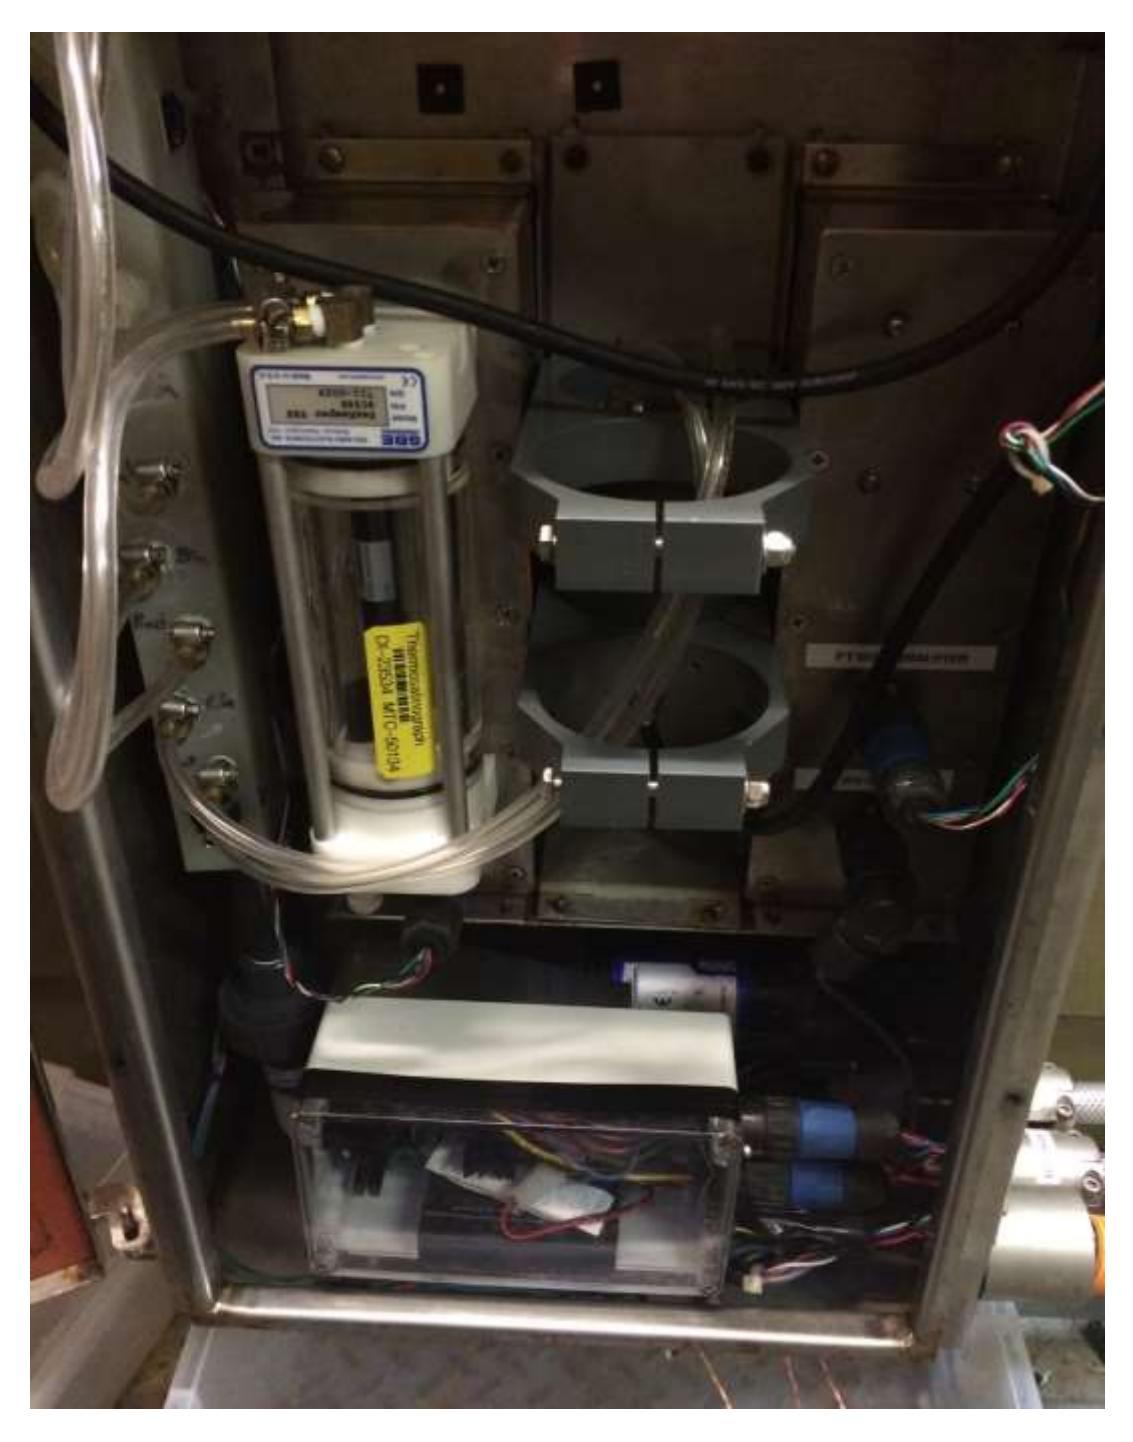
Instrument housing after service

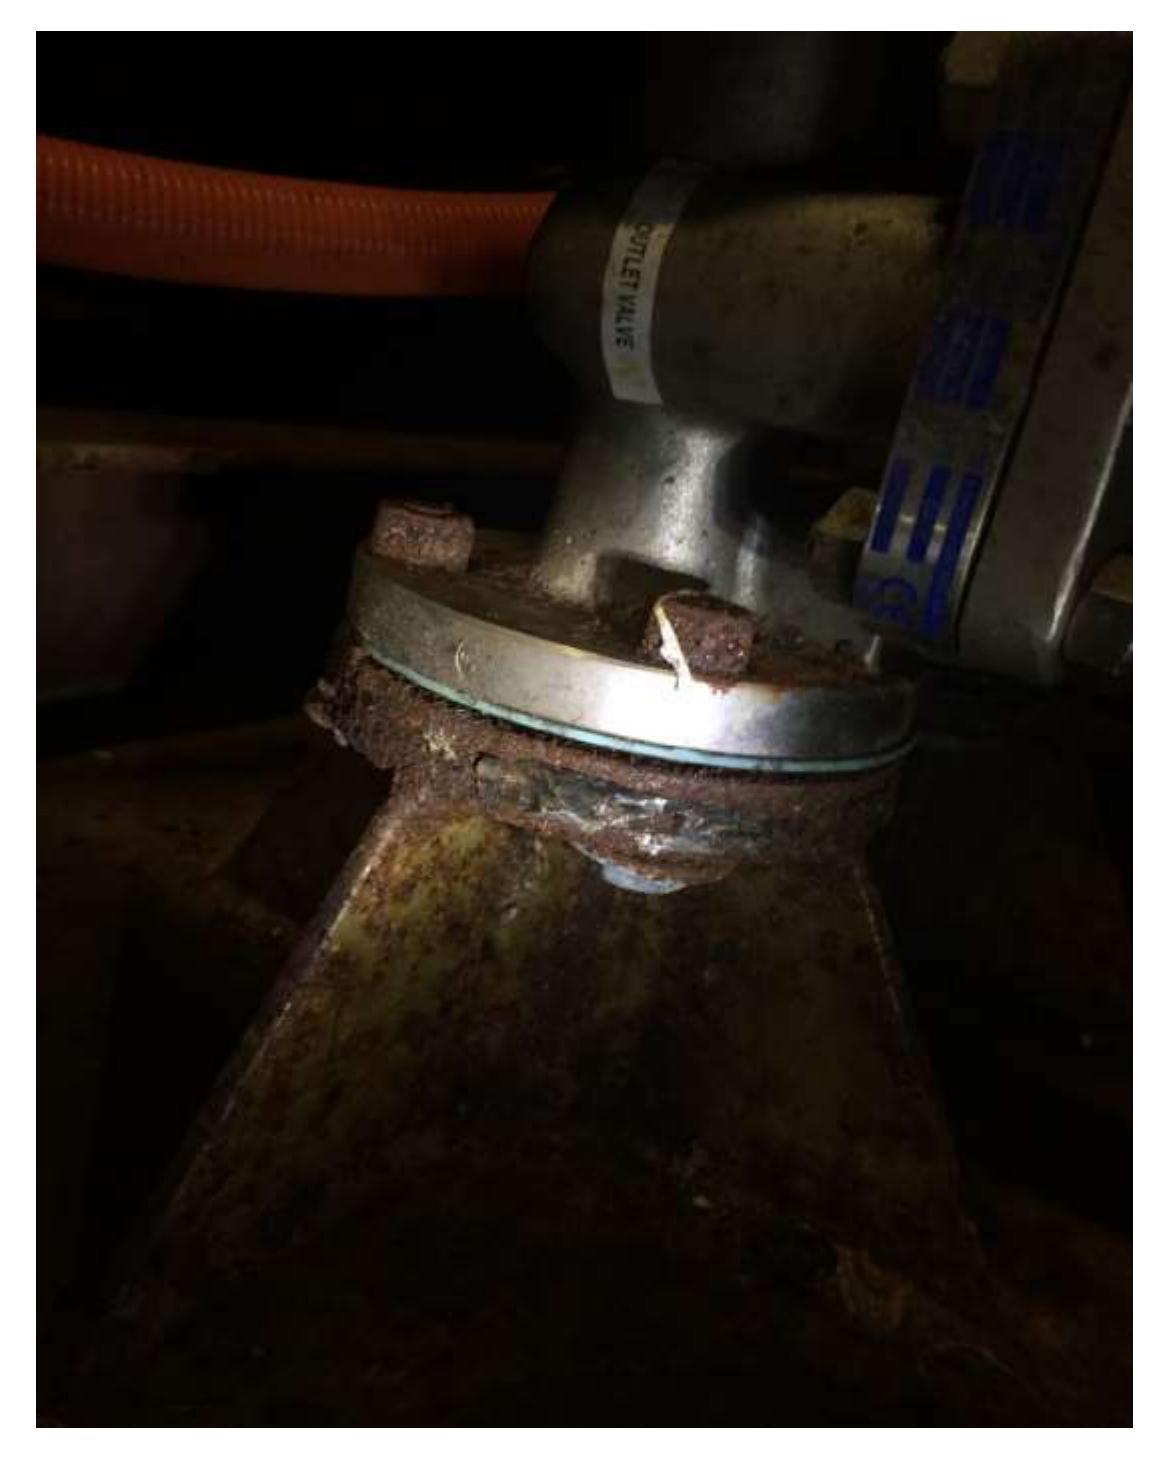
Outlet valve flange condition

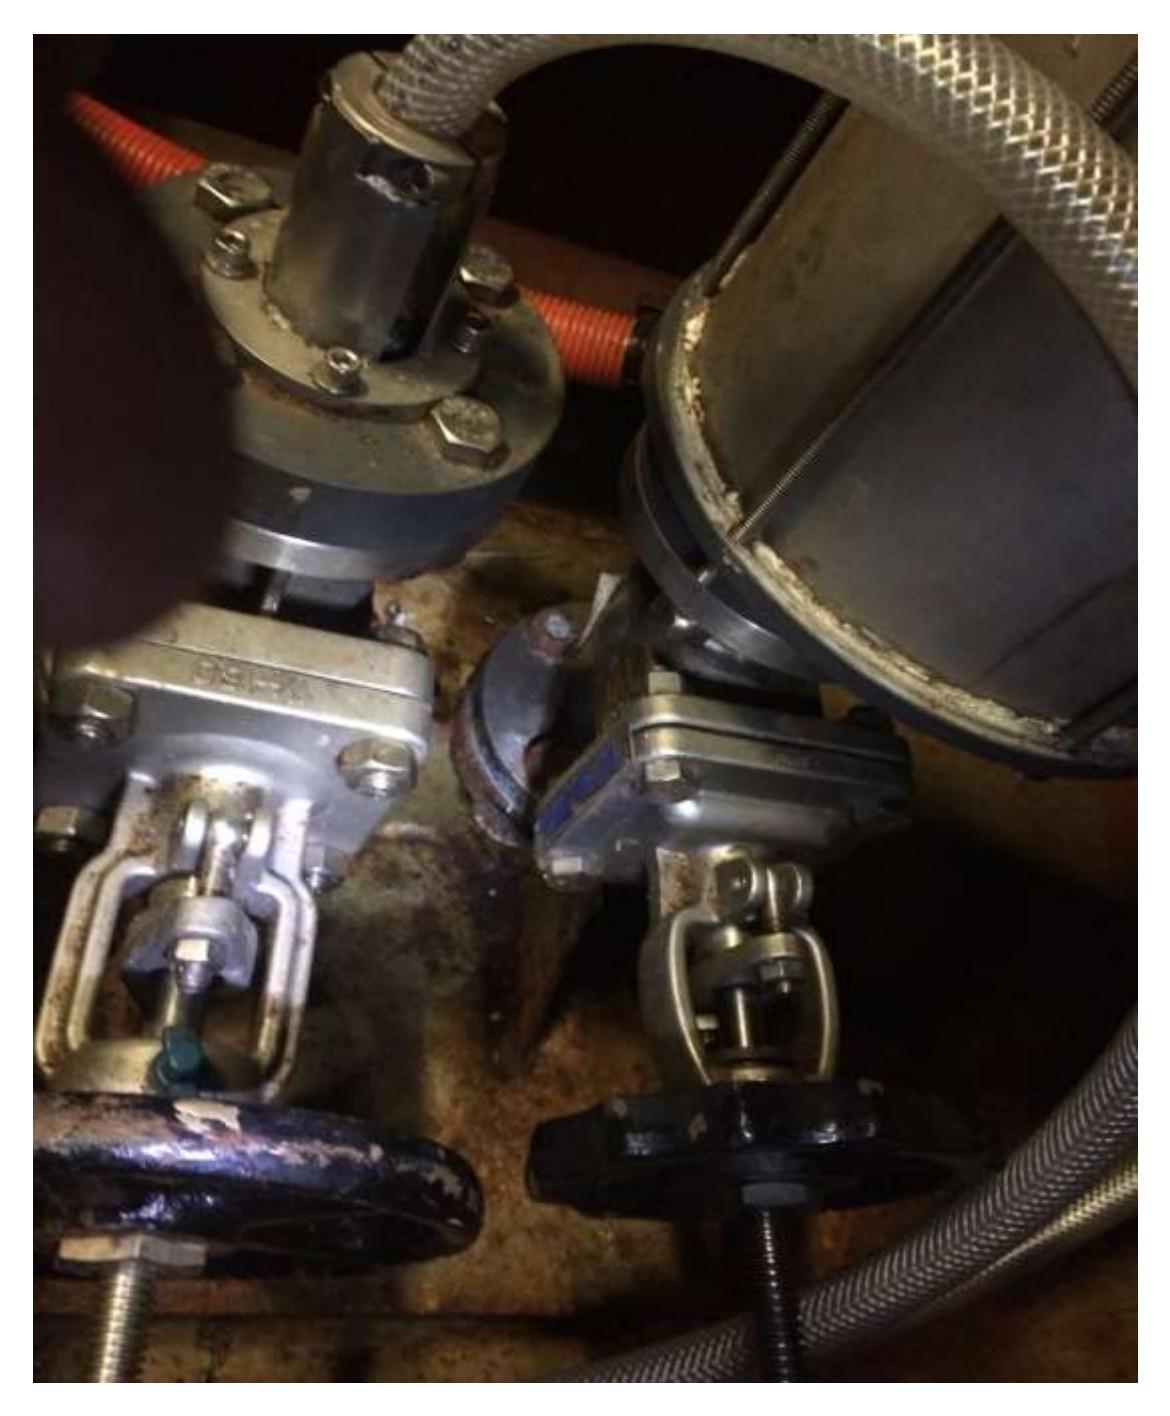
Intake (right) and Outlet (left) valves

- 1. Pull apart at outer instrument housing the seawater intake shut off valves (valve where we take sea water samples from). Corrosion may be building up inside the valve which cause improper shutoff and may cause slow leaks inside the tote.
- 2. Bring glue gun to glue down the PC connectors ie) PS2 cable for keyboard, and mouse
- 3. Bring flat 2 L Diet Coke, and Sprite and leave on ferry
- 4. Meet with ONC "BC Ferries group" staff to discuss and plan QoA SAS tracker install
- 5. Minimize our carry on load on all BC Ferry ships field trips. Carry on tool box has got/ is very heavy to pull and carry down steep + narrow ship /facilities stairs.

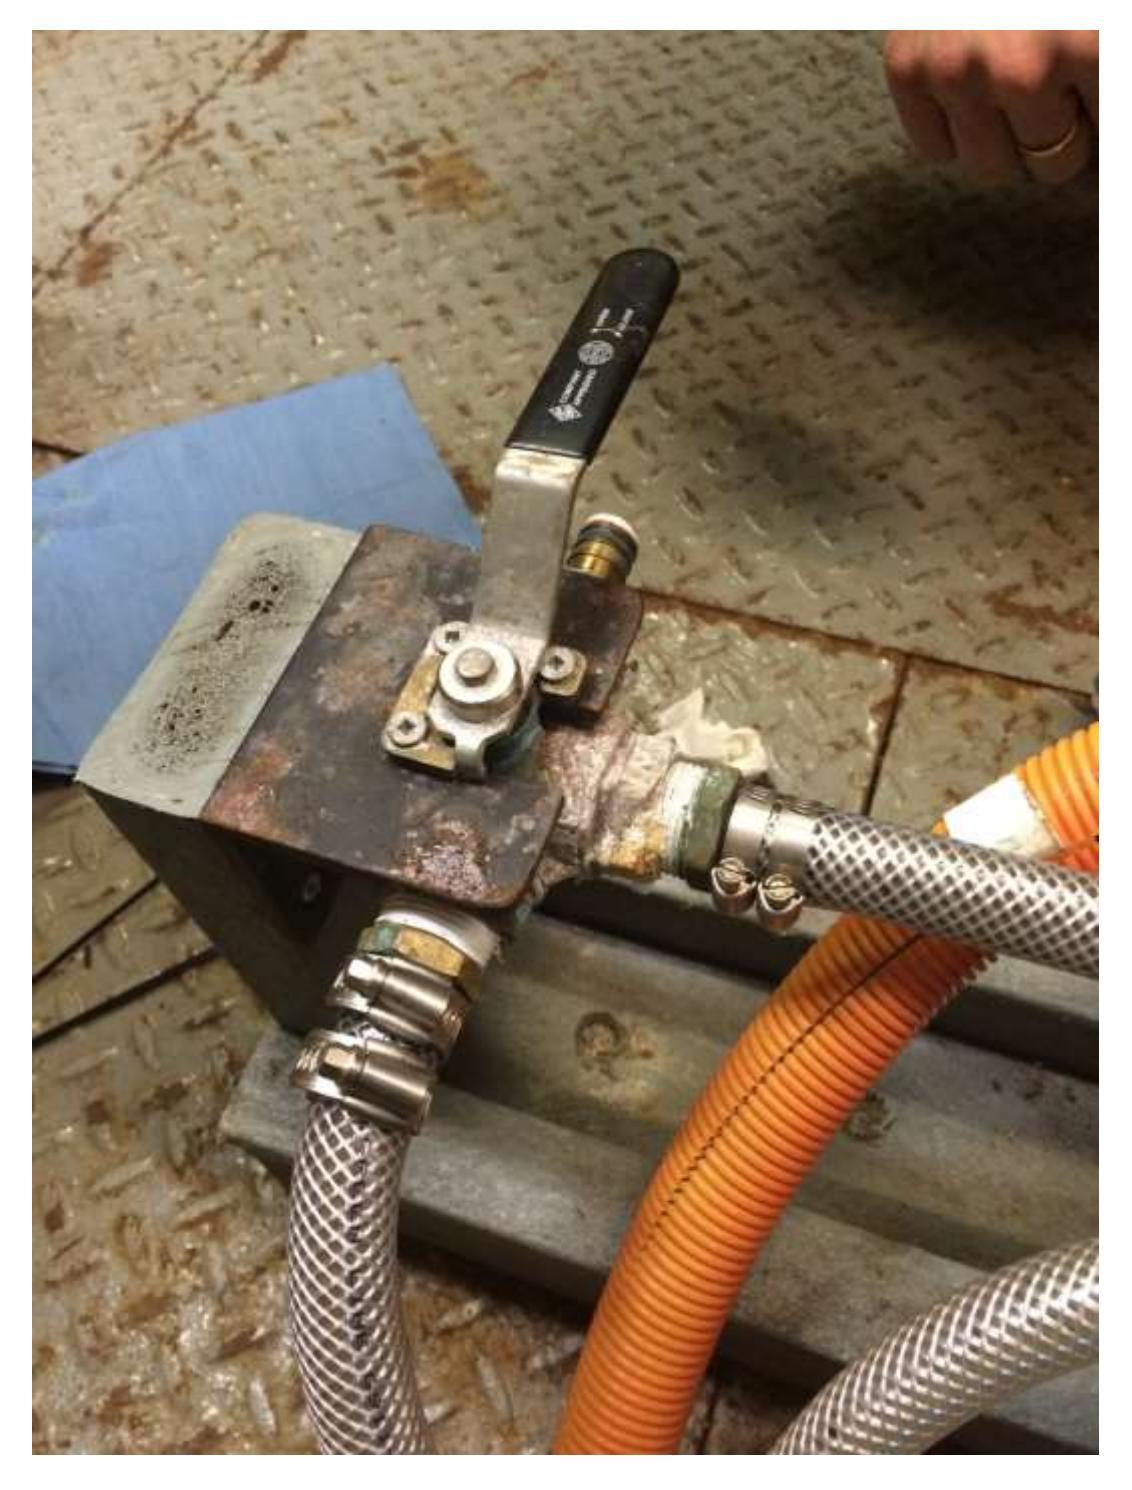
Sea water Intake "for sampling" valve condition

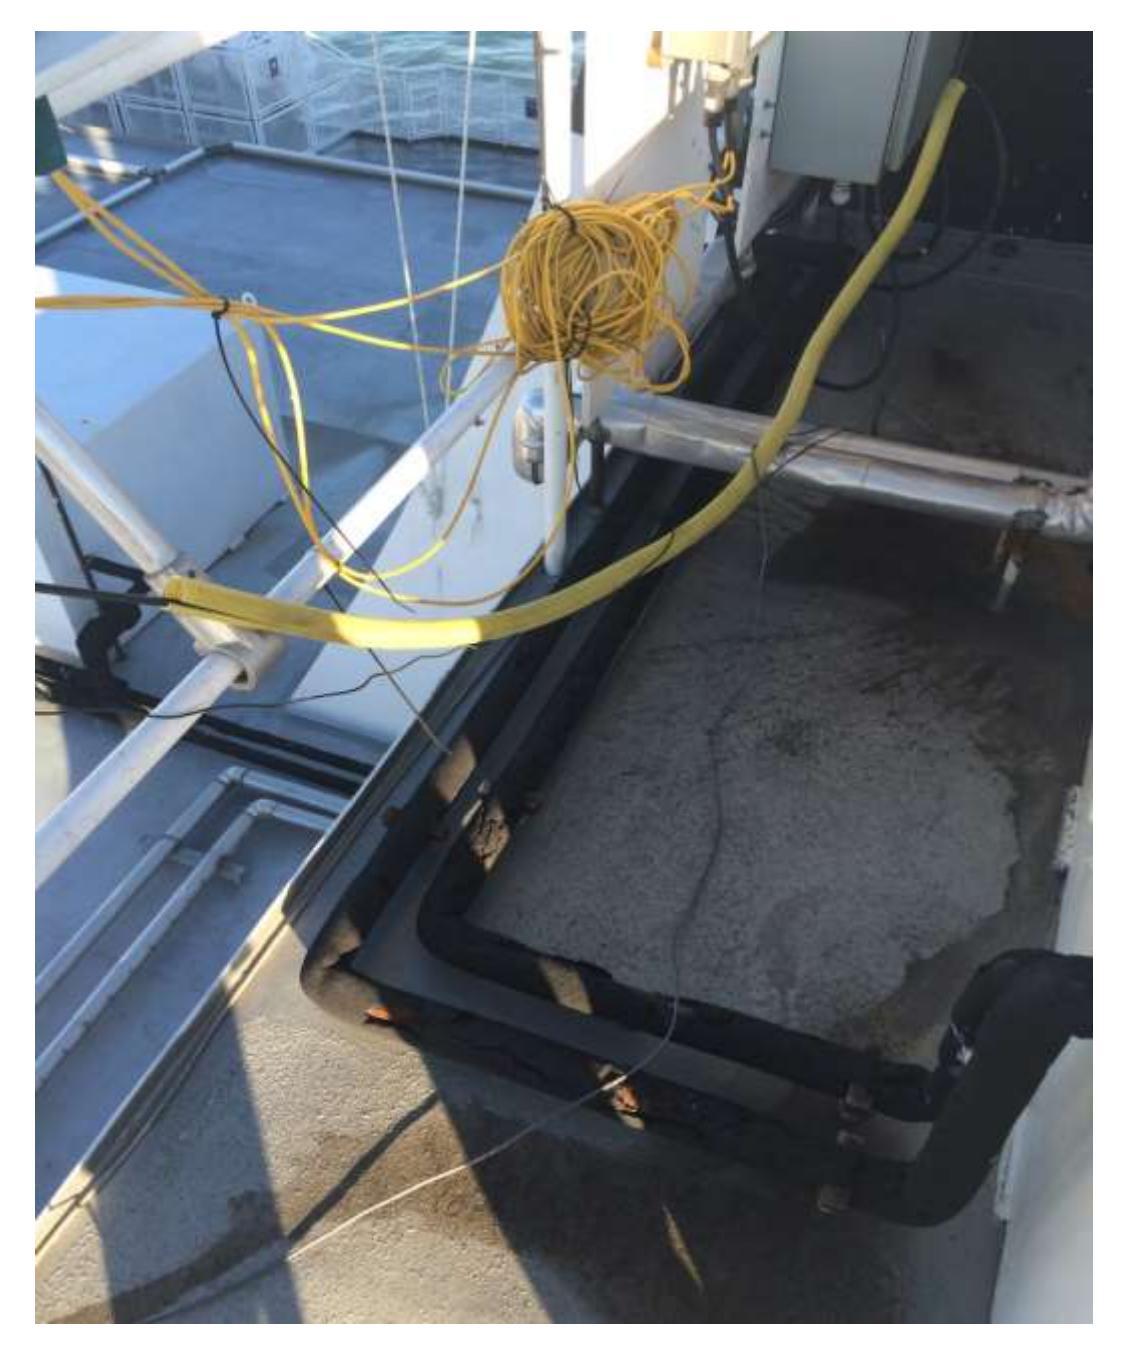
- **25.** At upper instrument decks the cables were loose. Perhaps strong wind must have blown them off the rails. Zip-tie cables back to the rails. Inspect connections couple corroded connector shrouds.

Upper deck instrumentation cables upon arrival. Lying on warm/hot pipes on floor, and not attached to side railings. Strong winds must have done this.

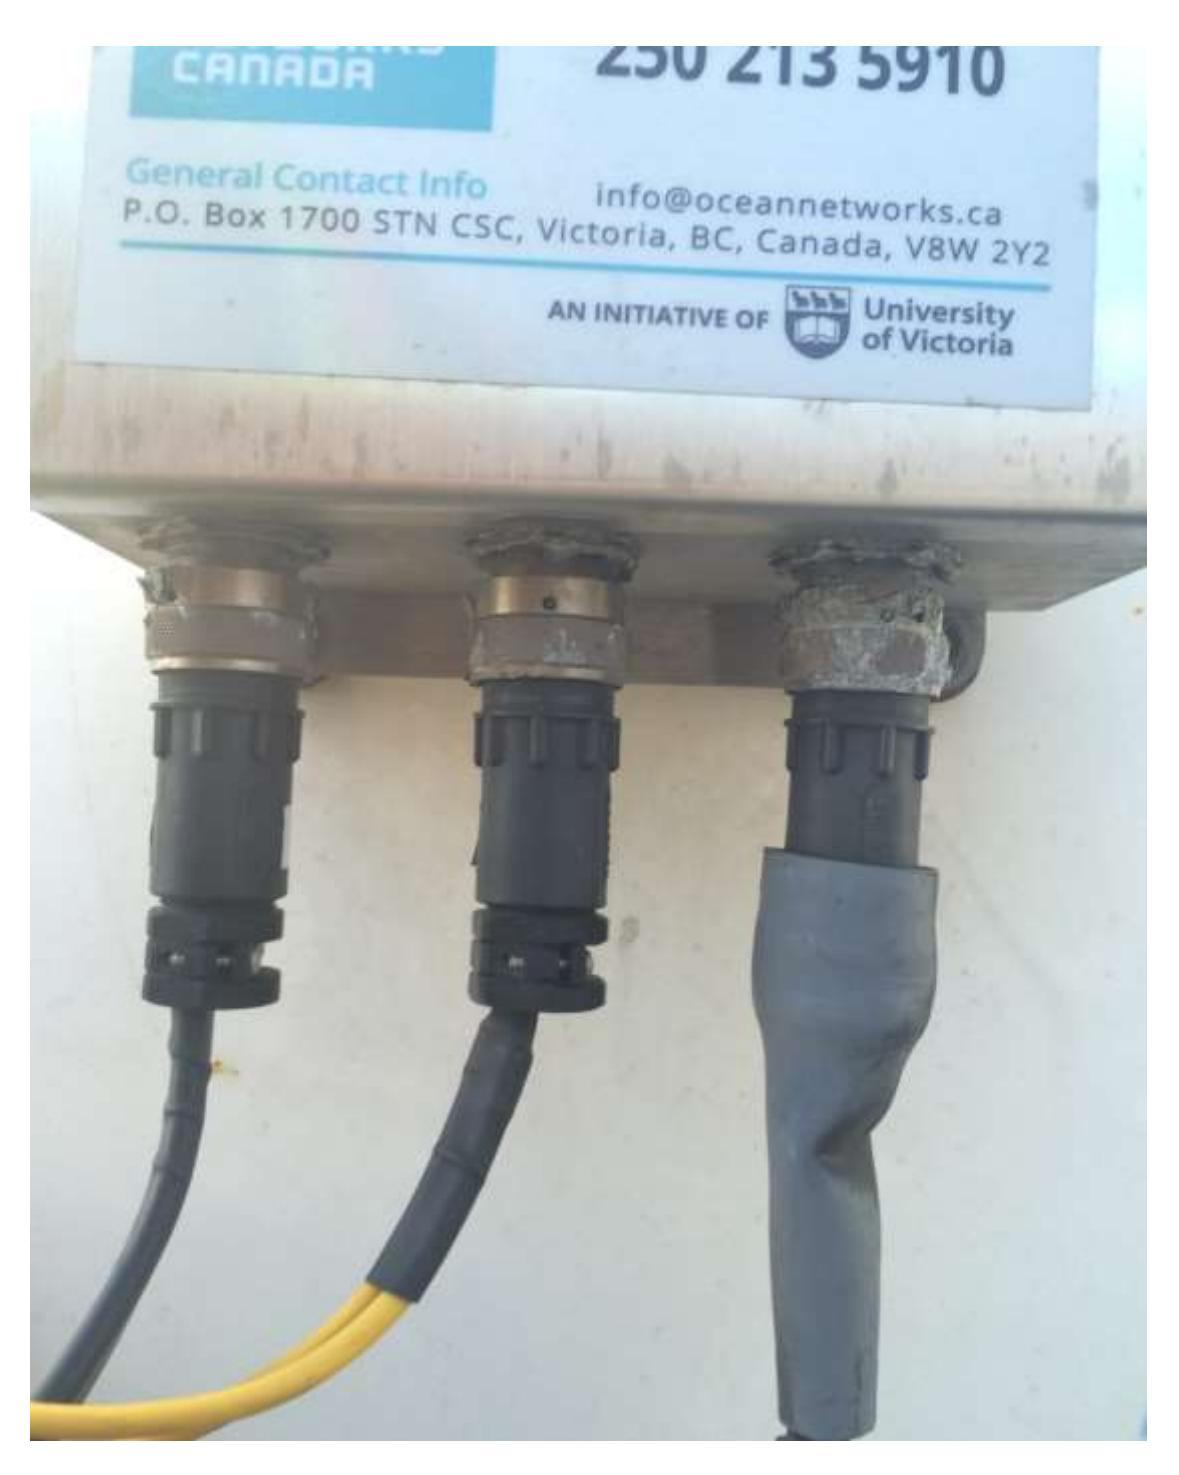
The radiometer electronics housing at upper deck; shrouds are corroding.
