OCEAN
NETWORKS
CANADA
INNOVATION

Barkley Canyon Infrastructure Update

Jarrett Little

4 October 2015

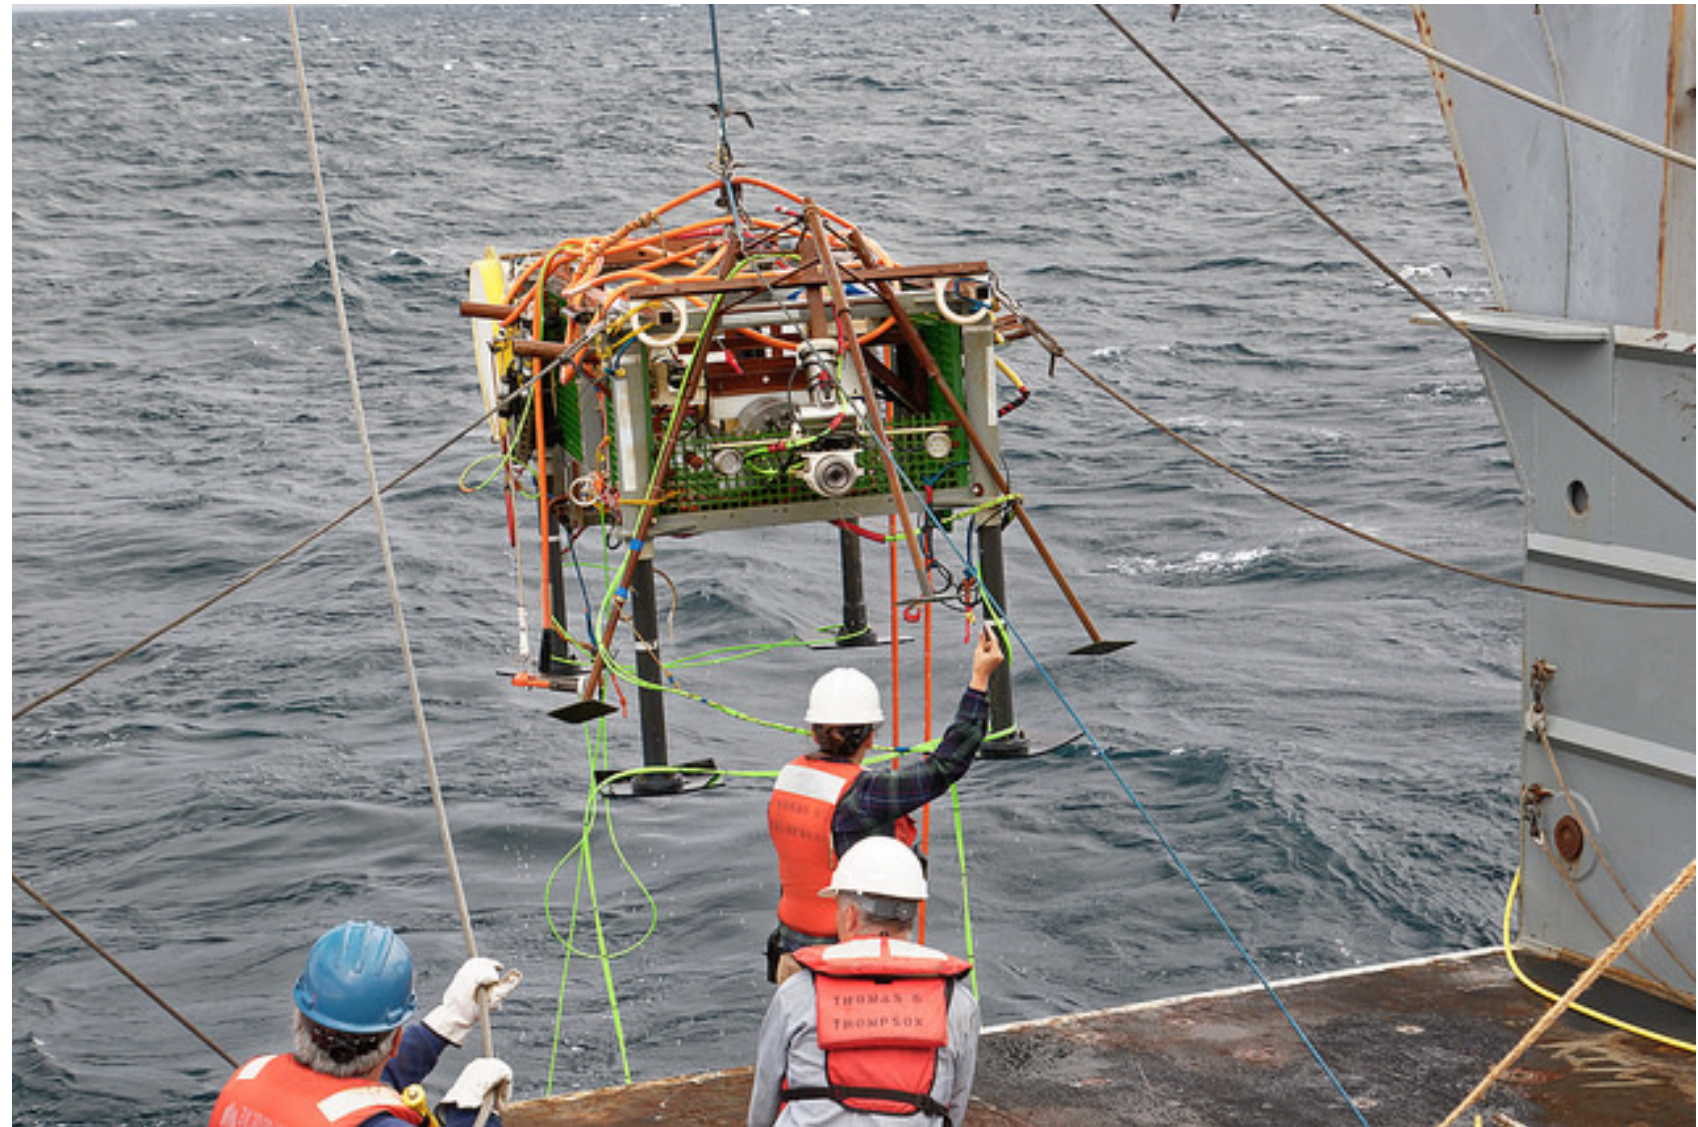
- Node, TRF, and CTA recovered and back at MTC.
- Hydrates science cable fixed and on the seafloor.
- Upper slope science cable still needs to be recovered and ODI assembly installed.
- Both CTA's have been damaged. ODI has removed the HV connectors for inspection.
- Pods 1, 2, 3, and 4 have been recovered. VPS still on seafloor.
- Wally in process of being shipped back to Germany.

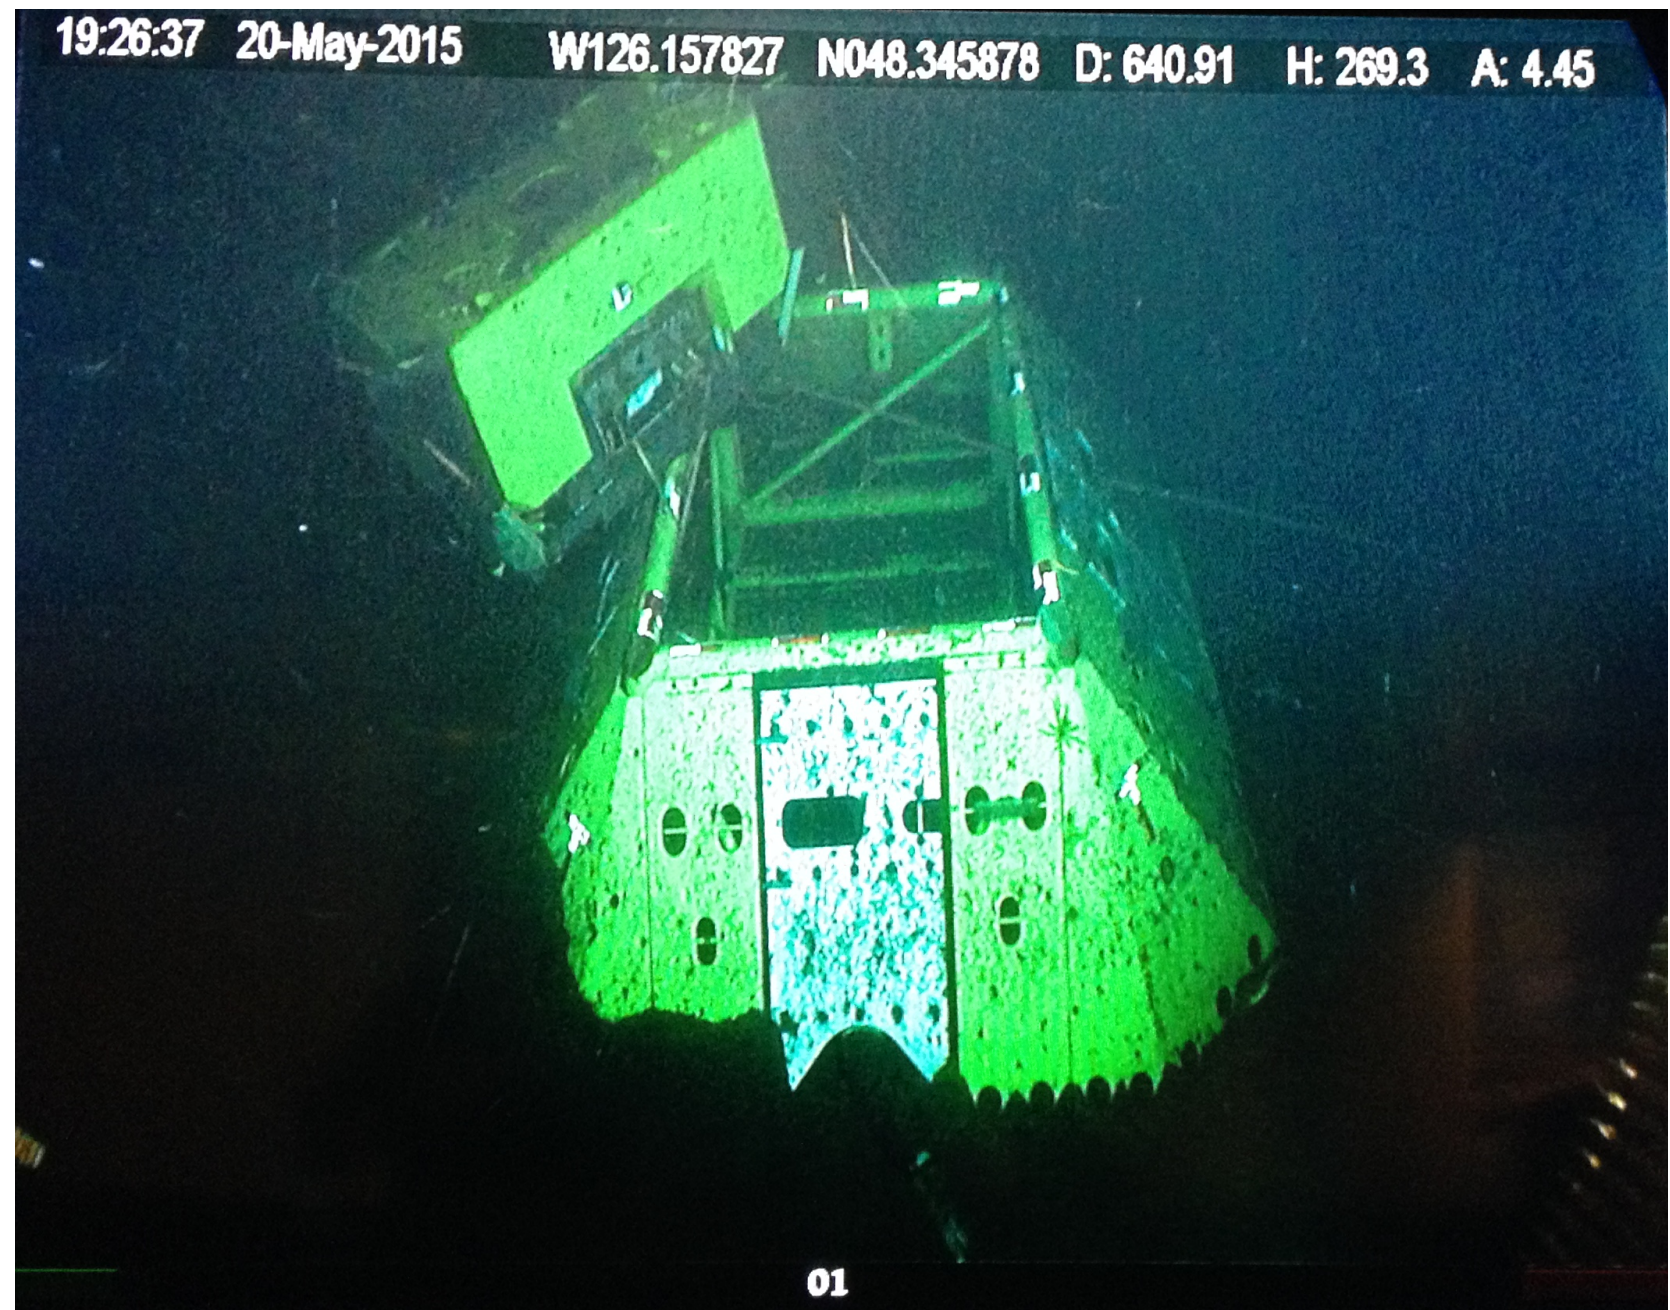
- Successfully recovered original node.
- Recovered damaged CTA after cutting away the HV and comms cables.
- Recovered and repaired hydrates cable termination with the Wave Venture.
- Deployed spare node beside TRF.
- Spliced spare CTA into branching cable and deployed beside node.

- HV connector shorted to sea water on initial power up of spare node.
- Upper slope cable partially repaired.
- TRF frame flipped by cable ship.

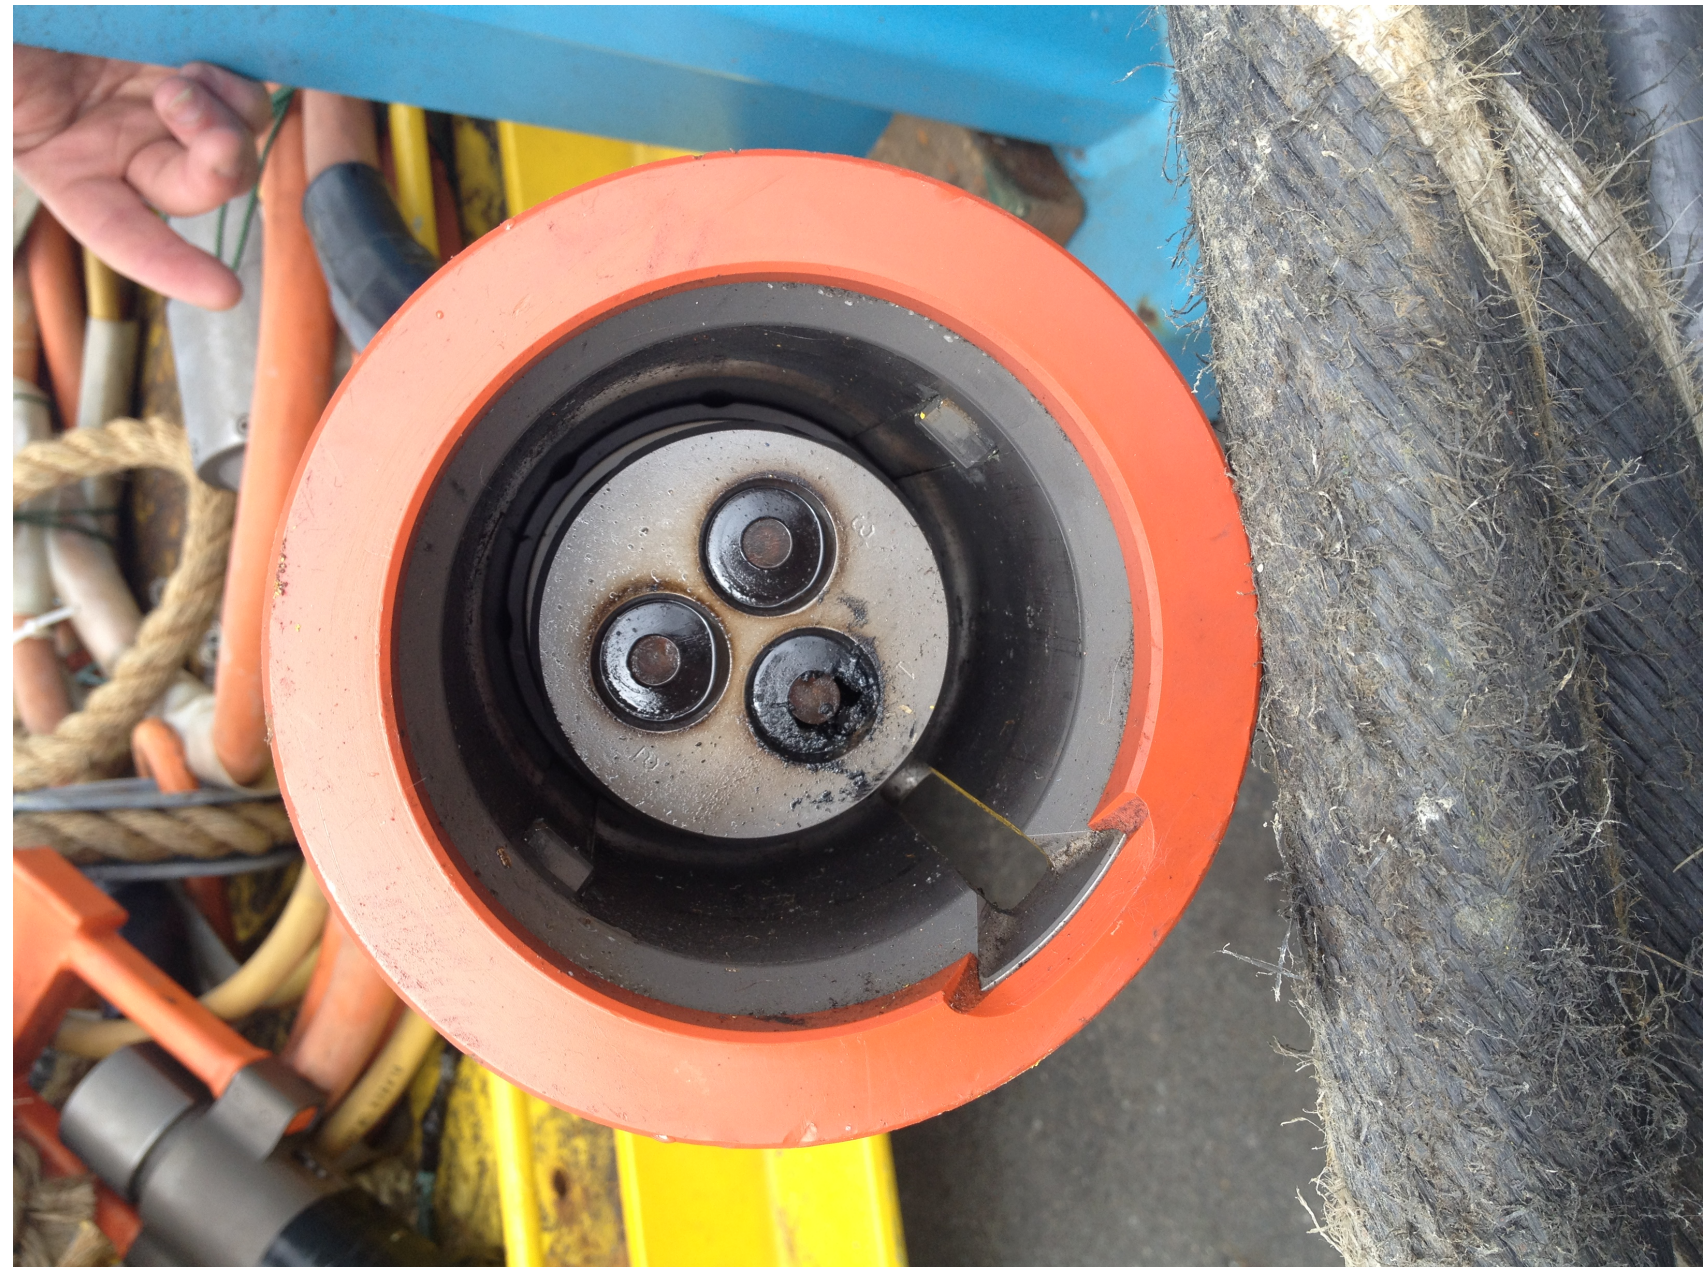
- Both nodes, CTA's, and the TRF have been recovered.
- ODI has removed the HV connectors off the damaged node and the CTA.
- ODI is investigating the cause of the short to seawater on the HV connector.
- Should have an answer before end of year.

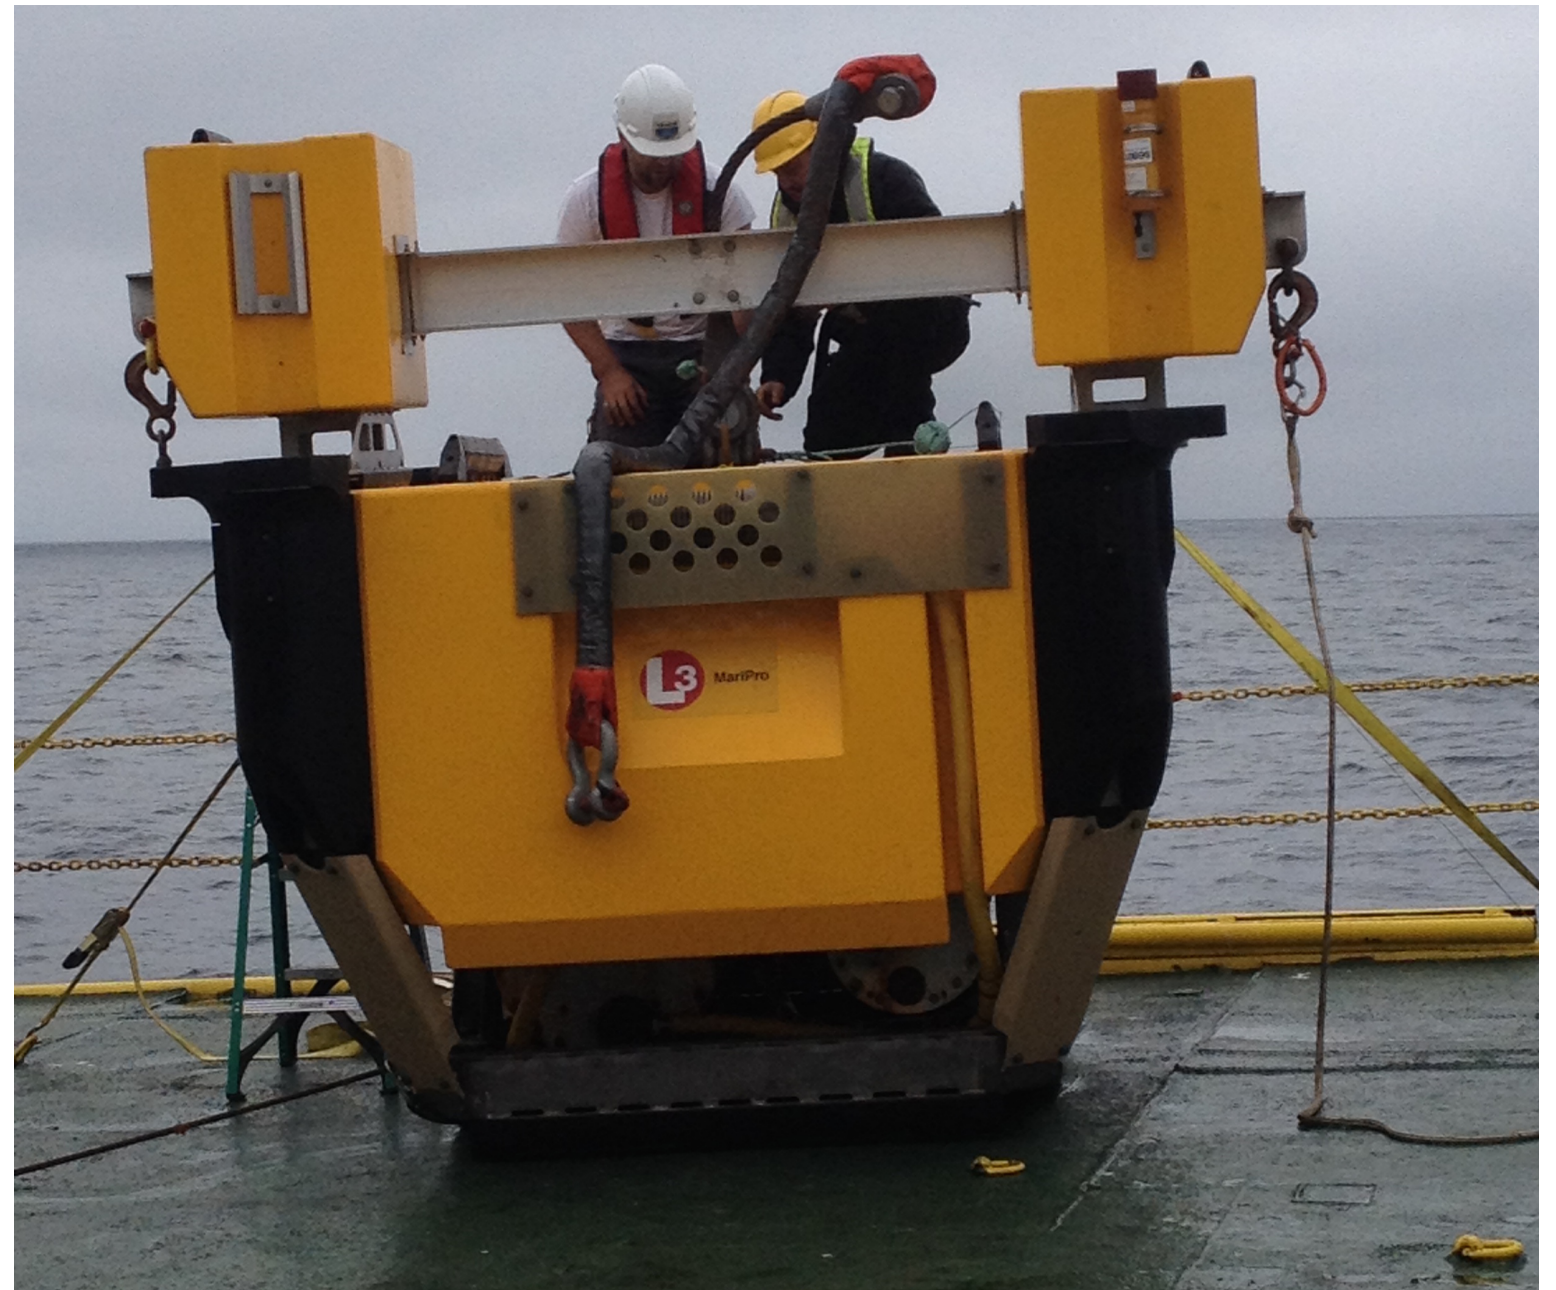
- Deploy Node and TRF together as one package.
- Two ship operation. Cable ship and support ROV ship.
- Removing the ODI HV connector for a hardwired solution.
- Permanent linkage between the Node (MVC) and CTA penetrators.
- Node to be secured inside the TRF while still removable for recovery.
- CTA will be bolted into the TRF
- TRF will be rebuilt and all hardware swapped.
- Deck and seabed procedures are still to be determined.

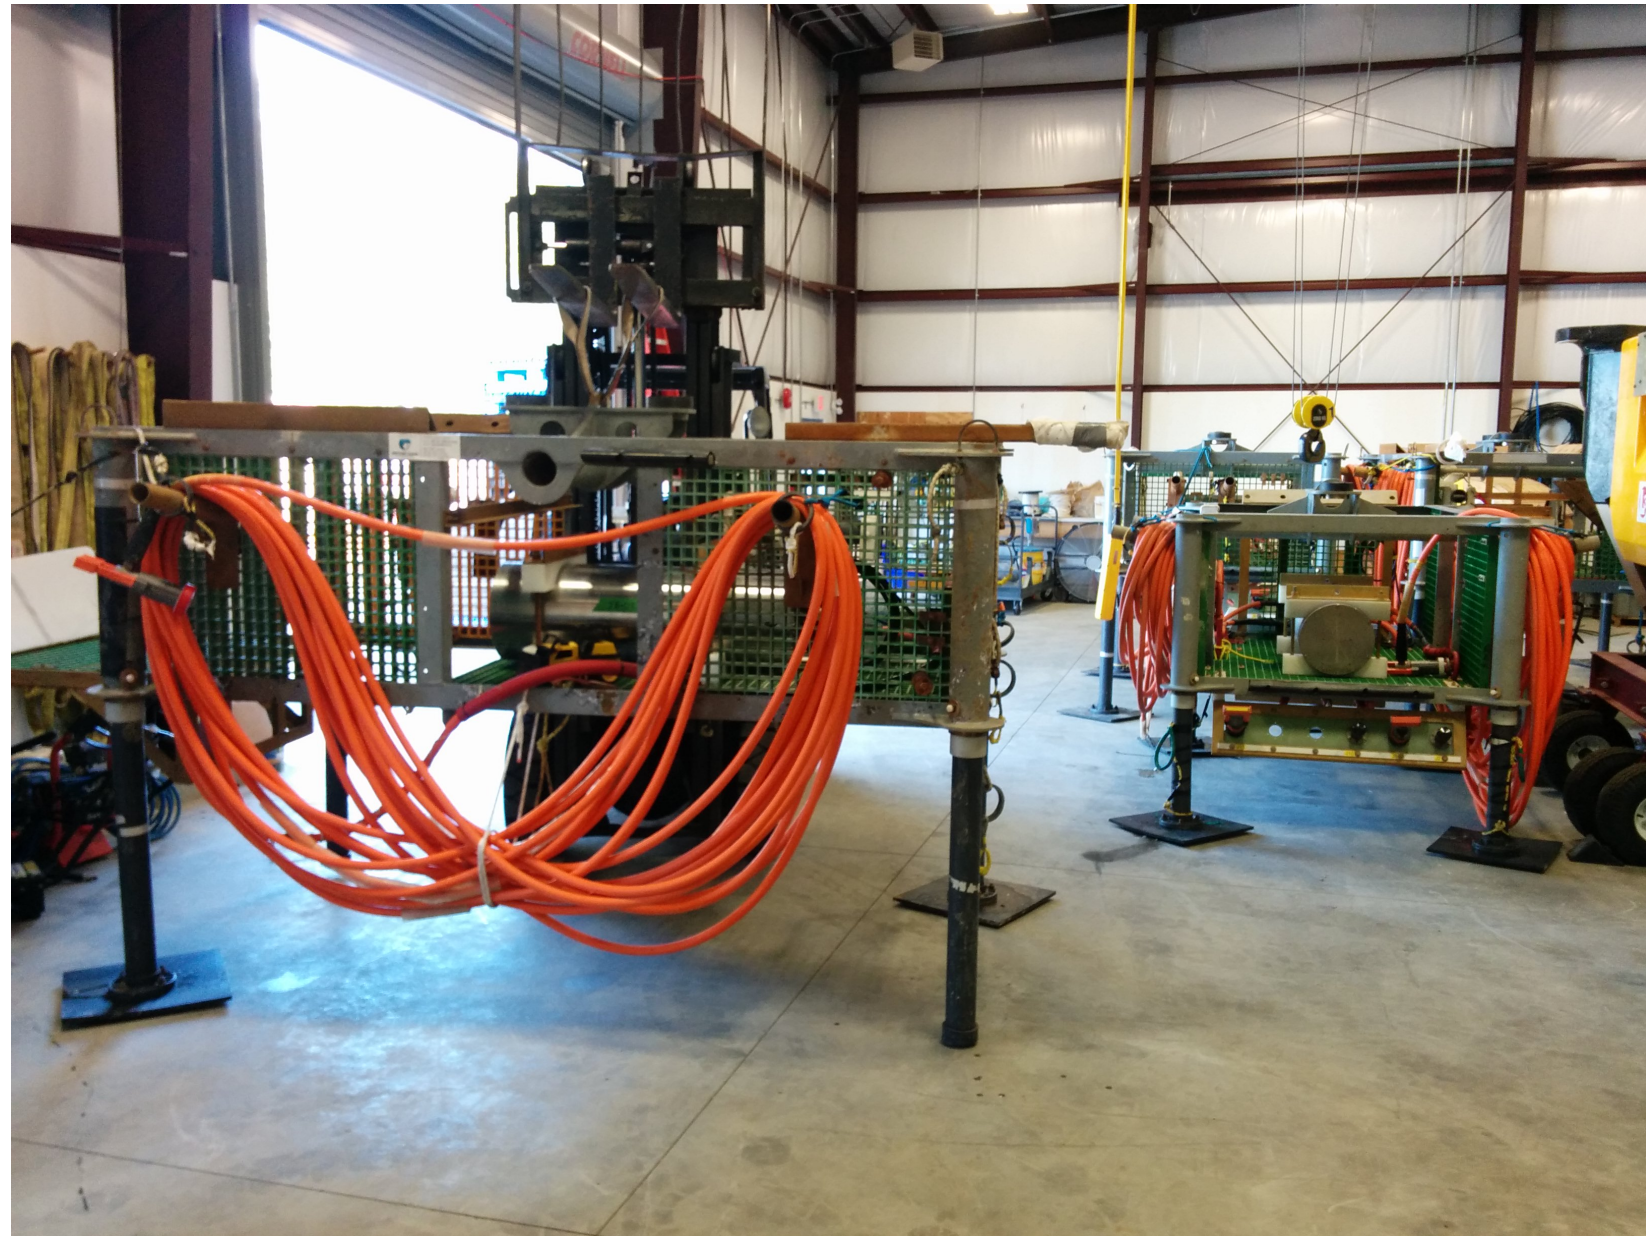
- Pods 1, 2, 3, and 4 have been recovered during the ONC cruise aboard the R/V Thompson.
- Wally was recovered and is in the process of being shipped back to Germany.
- Two rotary sonars have been recovered from Wally Land tri-pods.
- All instruments have been removed from the platforms cleaned and are being prepped for calibration and refurbishment.

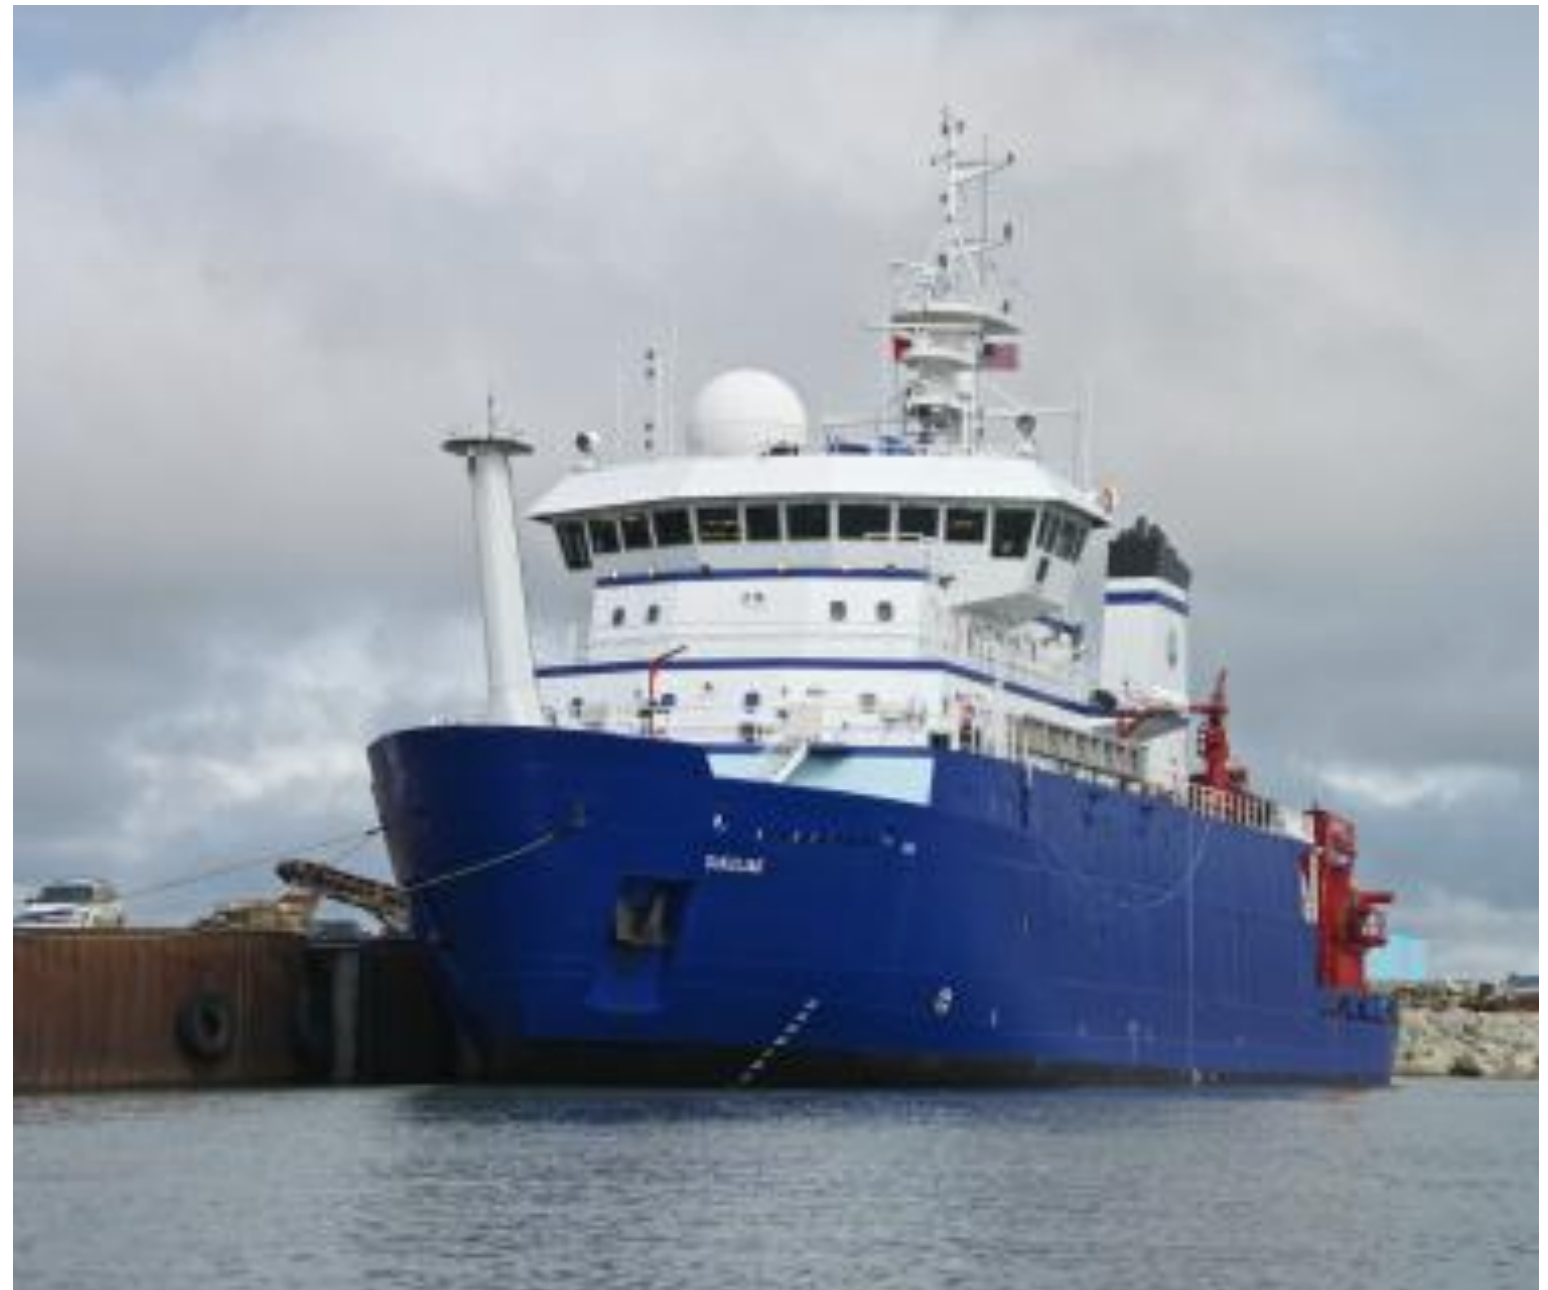
- Pod 3 and Pod 4 will be combined.
- Pod 4 will be used as a spare junction box.
- Full platform maintenance will be completed this fall/winter 15/16.
- Redesign instrument mounts including camera tri-pods.
- Methods of attaching instruments to platforms will be rethought.
- All platforms will be pre-rigged and ready for deployment by April 2016.
- Potential deployment date of July 2016 with the R/V Sikuliaq.
