Ocean Networks Canada

Ferry Maintenance Report – Queen of Alberni

Date: August 15, 2014

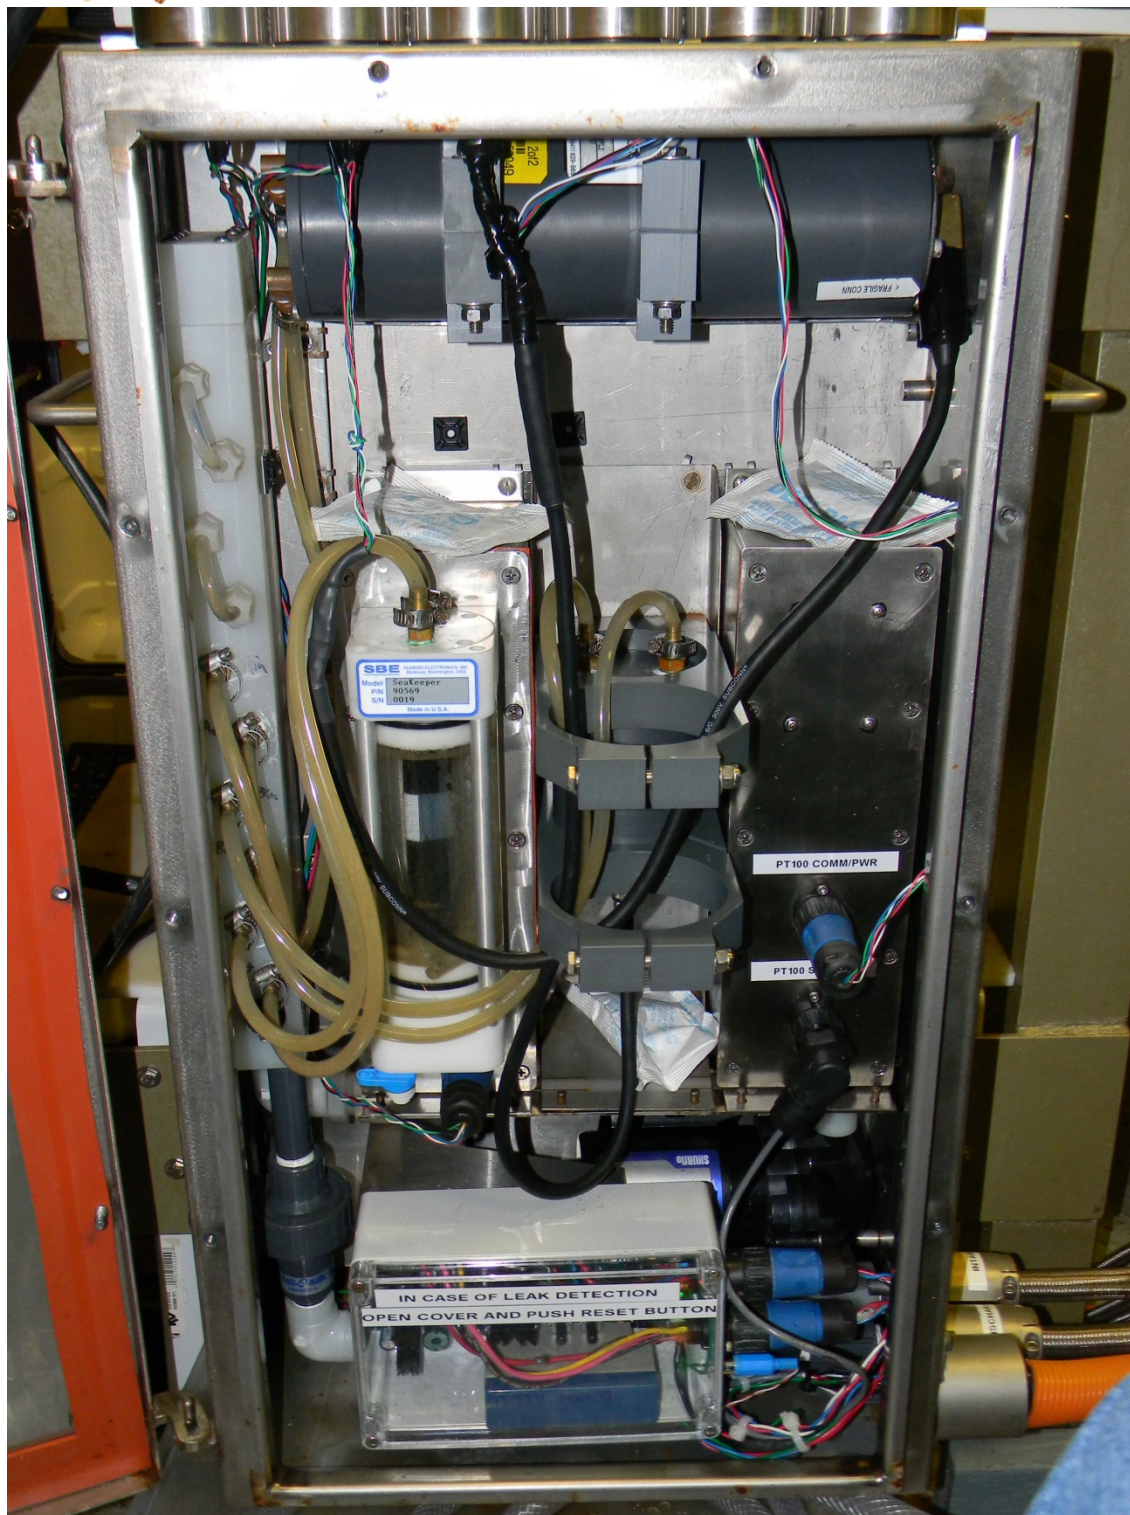
1. There were no signs of moisture or leaks In the Instrument Box.
2. The AADI optode had very little or no debris but had sediment/biofilm growth within the housing.
3. The BBFL2 had a partial layer of sediment in the housing and fouling on the sensing surface. Fouling was noticed on the “bottom” surface of the horizontal housing.
4. The Seabird 45 CT sensor very dirty, with to mussels approximately 3/8” long found growing within the housing on the sensor intake port.
5. The flex tubing needed to be replaced due to biofouling.
6. The sea chest showed no signs of leaks.
7. The inline filter (sea strainer) was checked and was found to be dirty and required cleaning.
8. The CT connector corrosion has grown slightly but no evidence for signal degradation yet.

Figure 1: Instrument box as found at start of servicing

1. Opened both boxes and observed function. Both were working well, no leaks anywhere.
2. Powered down and disassembled instruments in lower assembly.
3. Cleaned and checked over instruments in Engineering room. Cleaned CT sensor connector to remove sediment and biofouling growth. Removed two mussels from interior of housing.
4. Replaced all tubing with new stock.

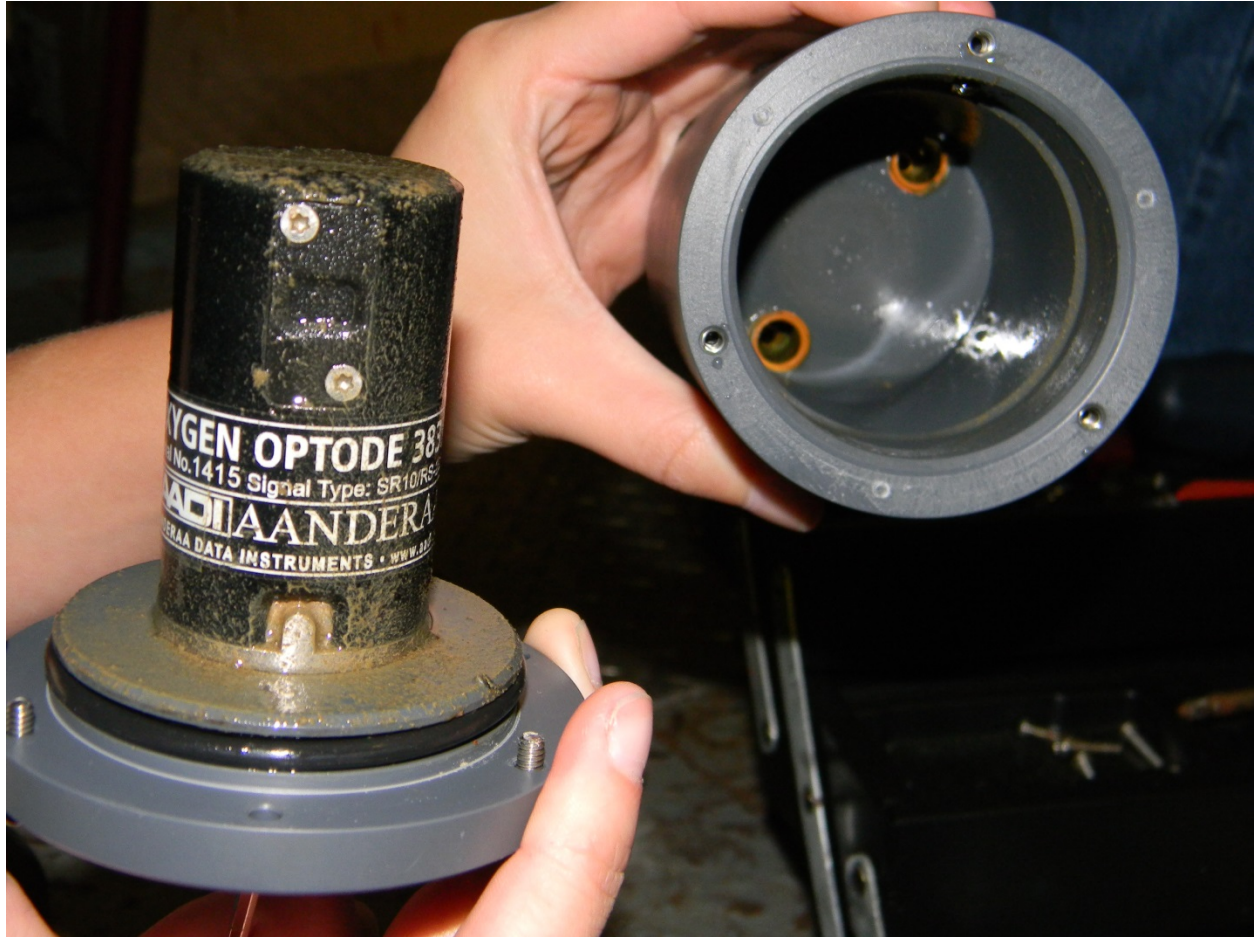
Figure 3: Optode Sensor

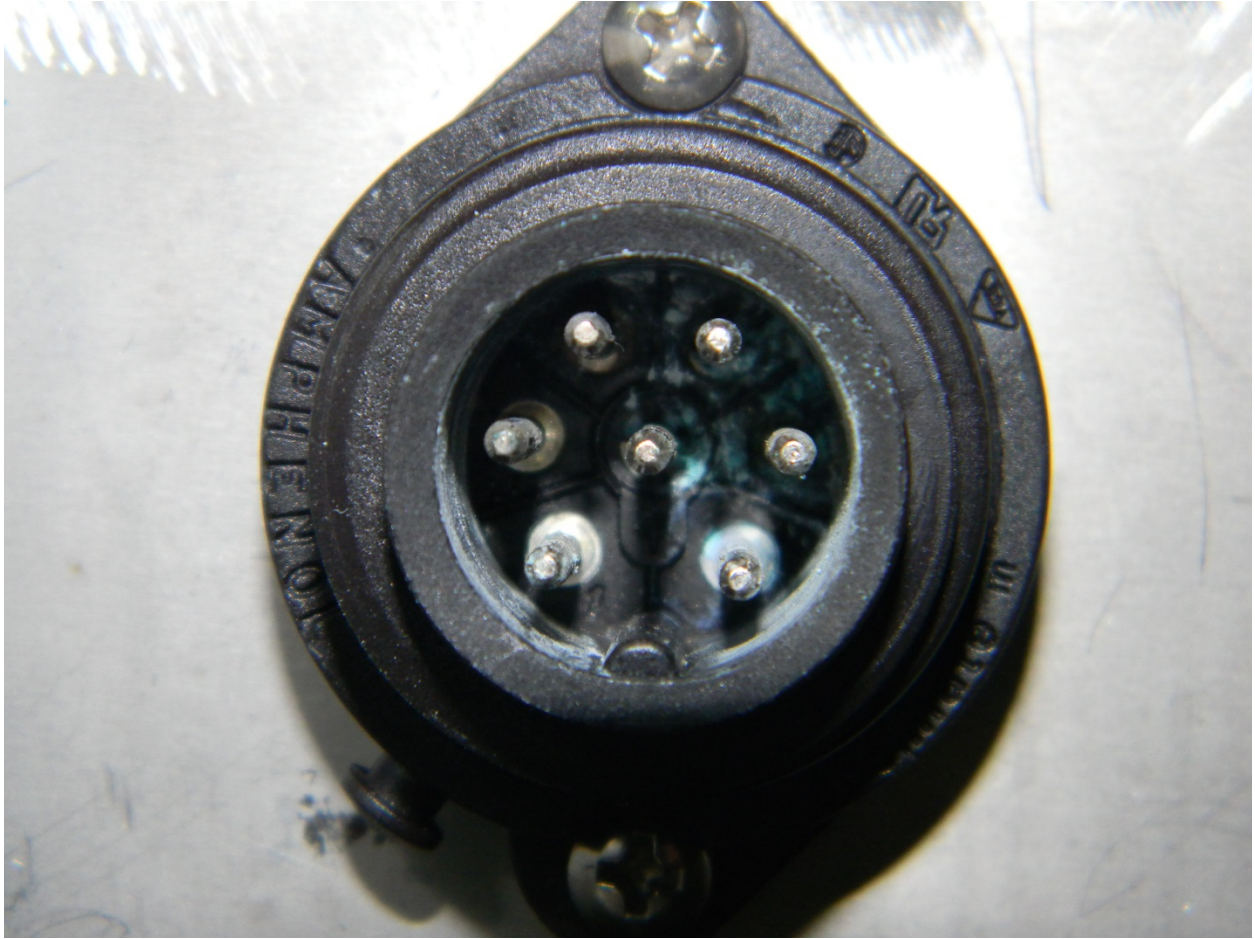
Figure 4: CT Sensor connector

6. Re-assembled the instruments in the lower box.
7. Greased the CT connector with DOW #4 to correct some of the corrosion issues.
8. Checked over Sea chest and valves, no leaks apparent.

1. Potentially replace CT connector (shipboard connector will need to be re-soldered).
2. Monitor growth of Mussels within the system.
3. Purchase new #2 Philips Screwdriver (missing from toolkit).
4. November refit, replace all metallic connectors on upper boxes with plastic glands.

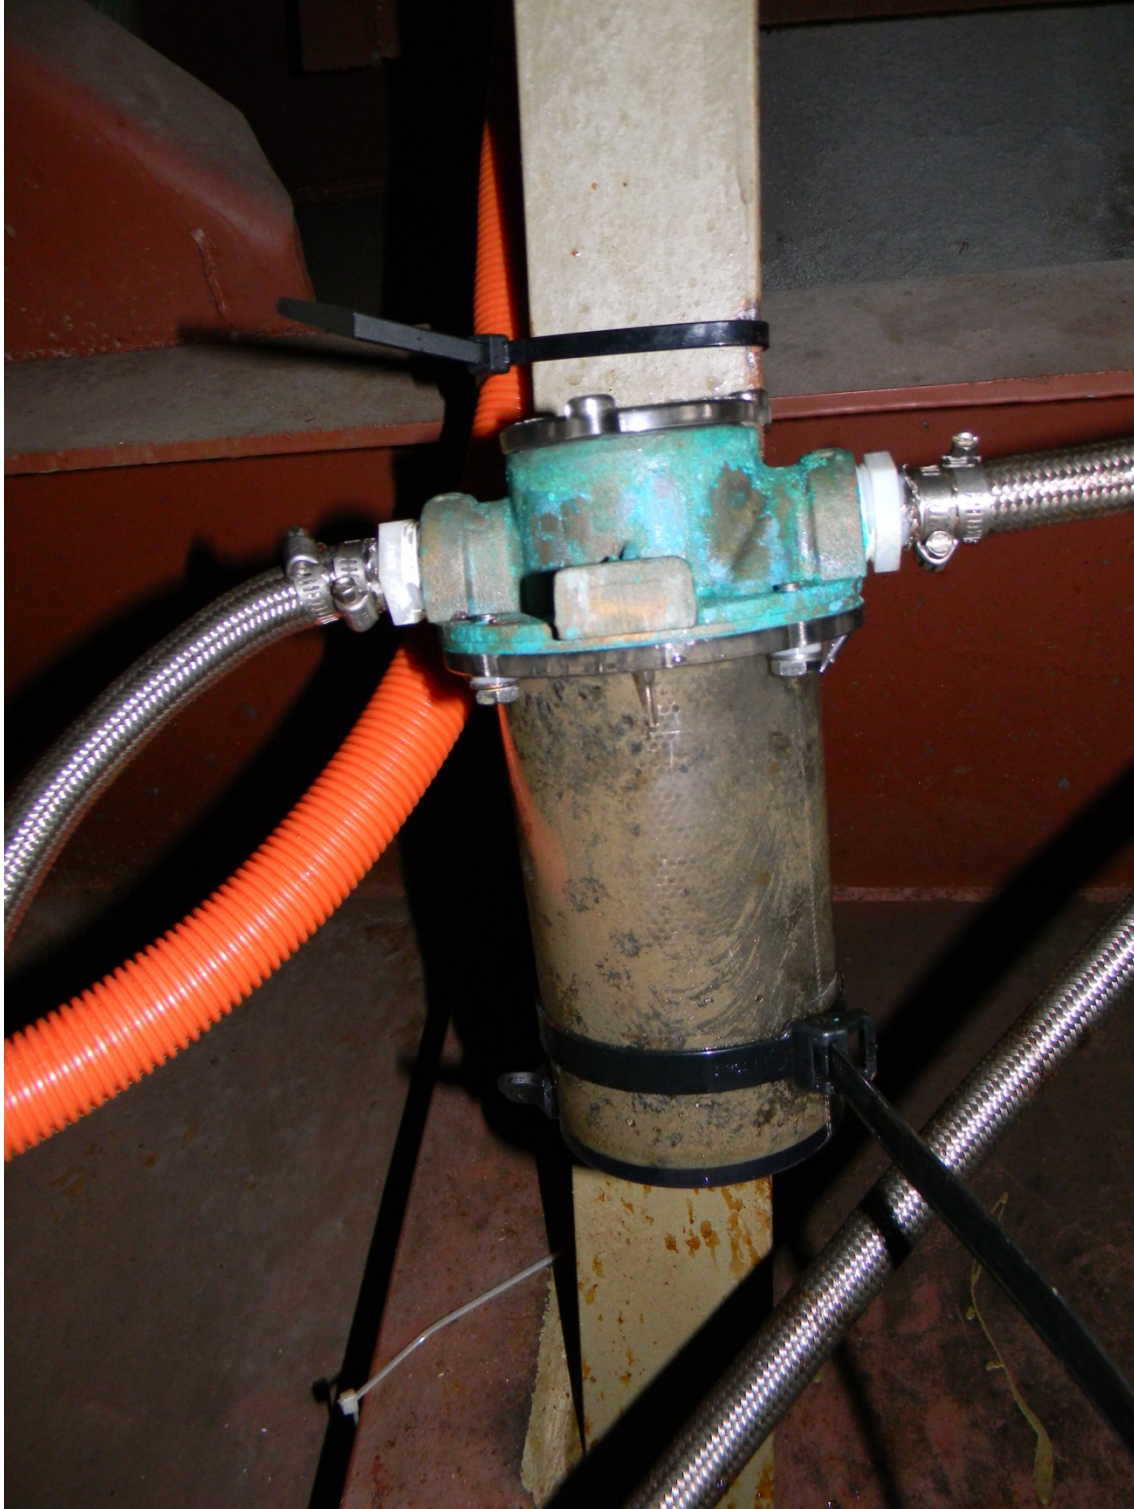
Figure 5: Sea Strainer

9. Checked and cleaned the sea strainer.
10. Turned ON the system.
11. No leaks in instrument housing and checked flow output at sea strainer. Flow was good. Visually confirmed flow direction at the BBFL2 and confirmed the volume filled with water and began draining correctly.

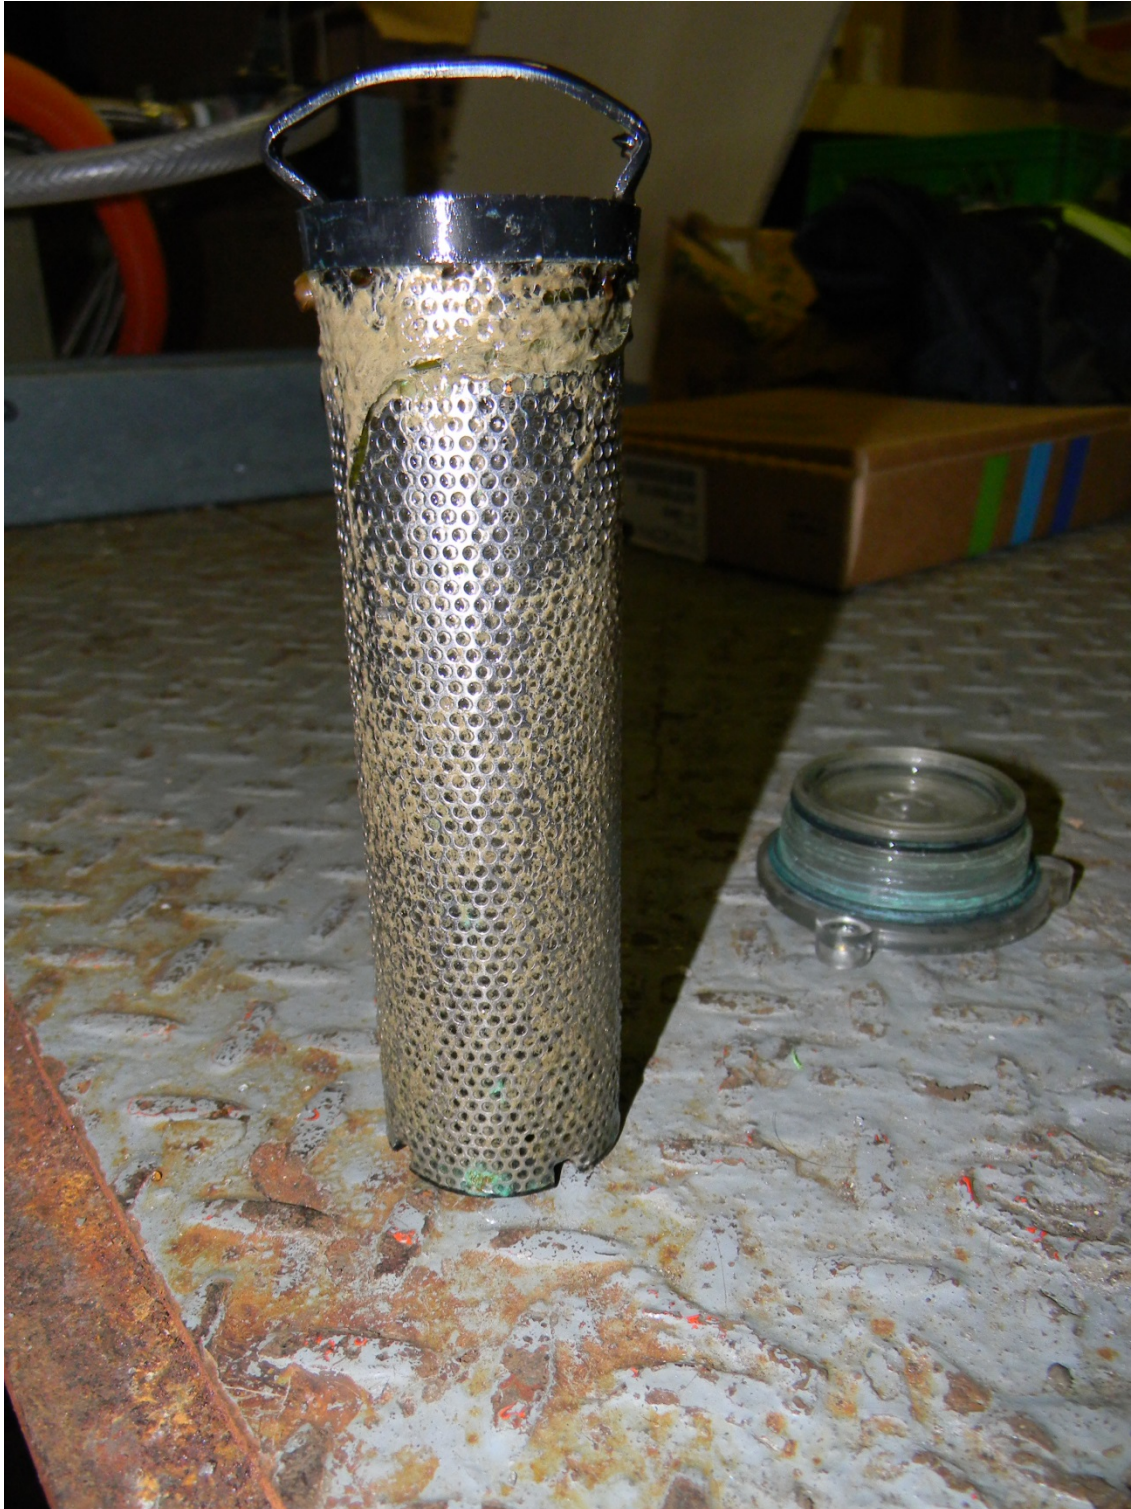
Figure 6: Sea Strainer
