Ocean Networks Canada

Ferry Maintenance Report – Queen of Alberni

Date: September 12, 2014

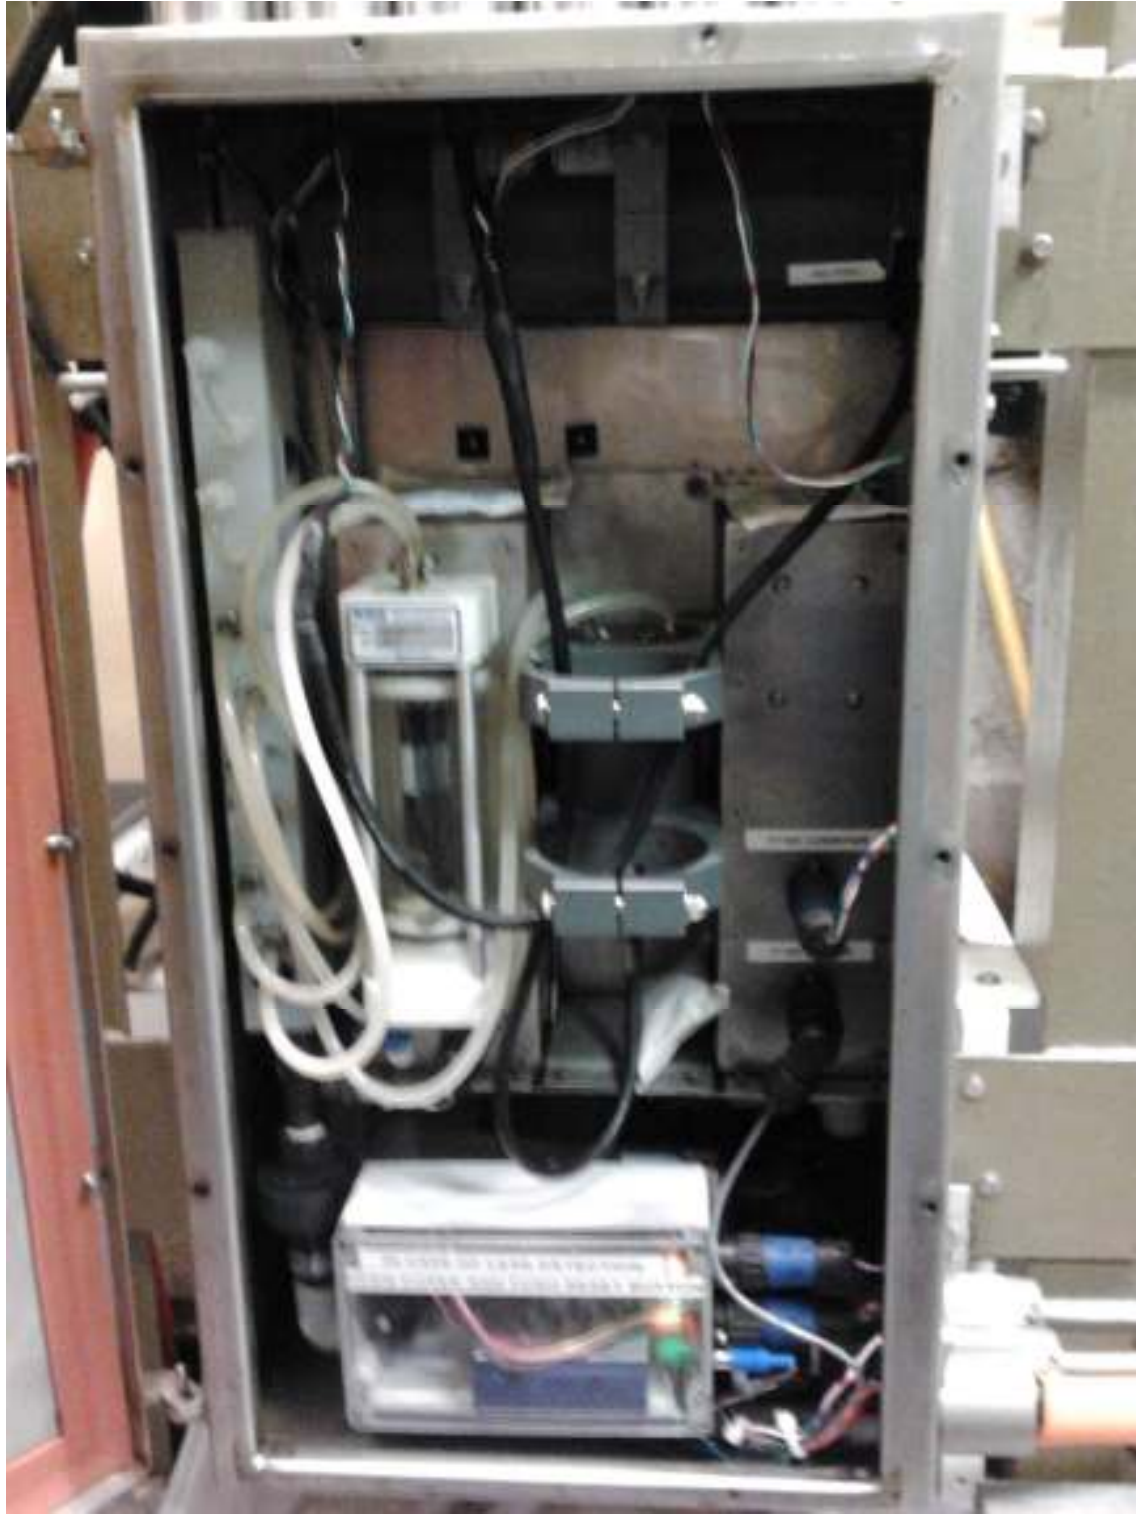
Figure 1: System upon arrival

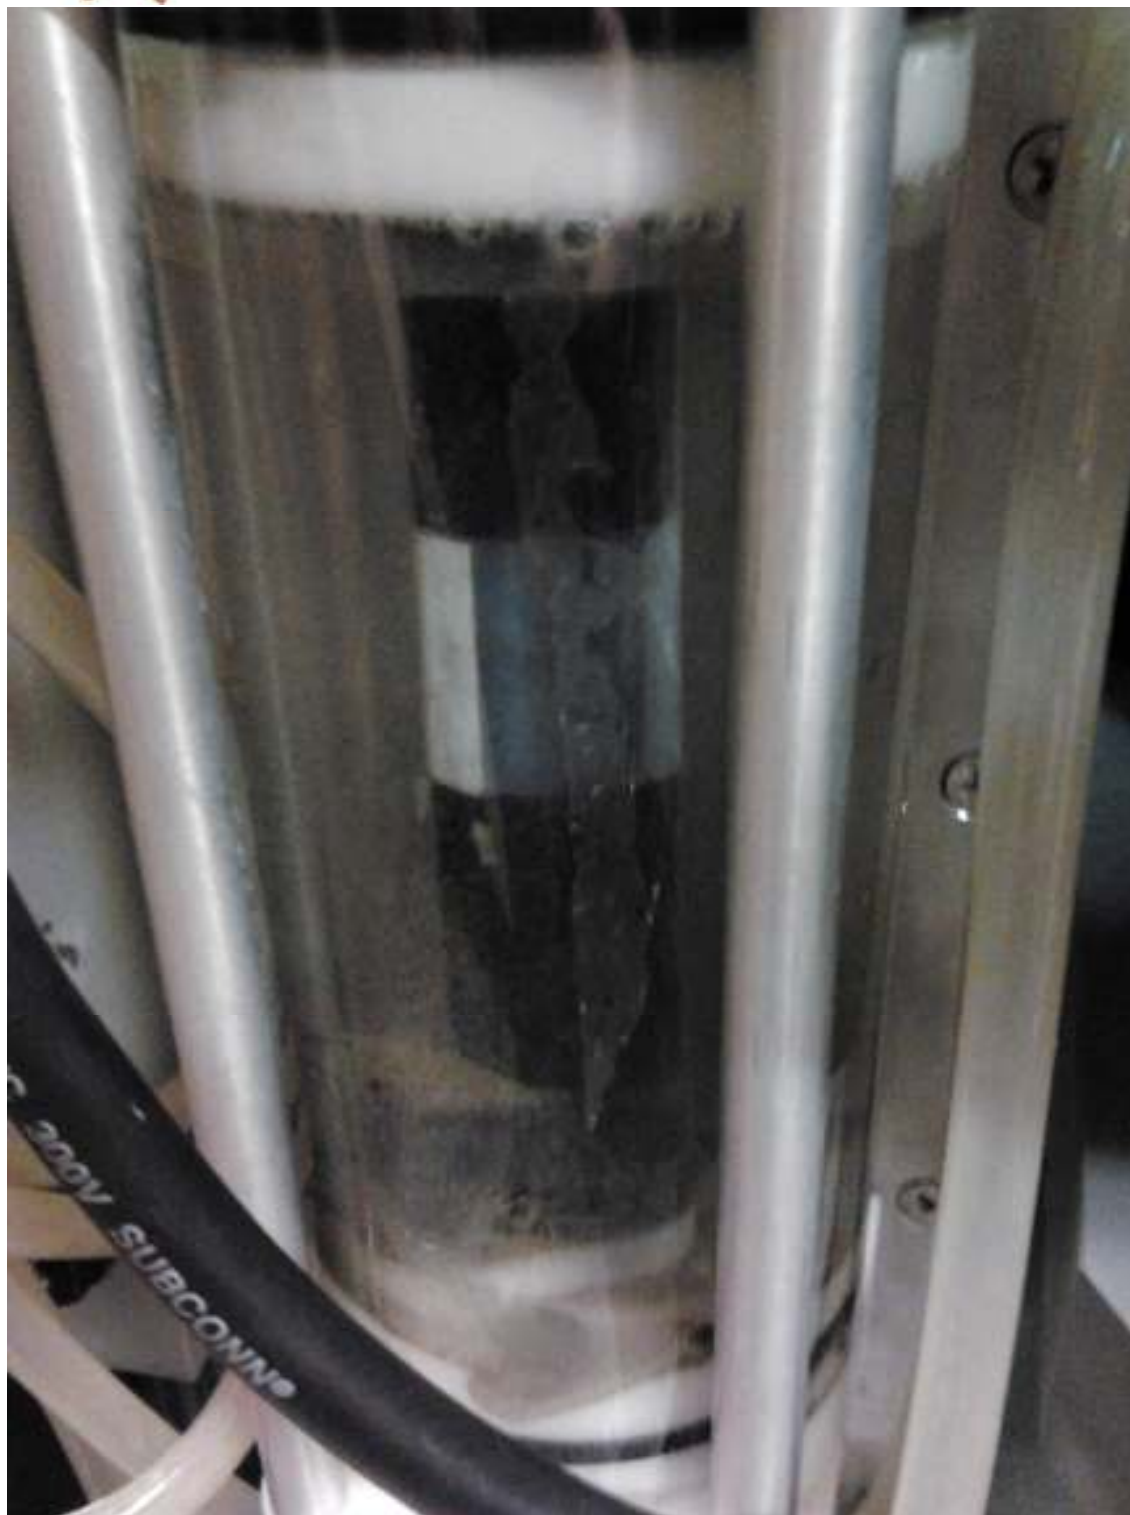
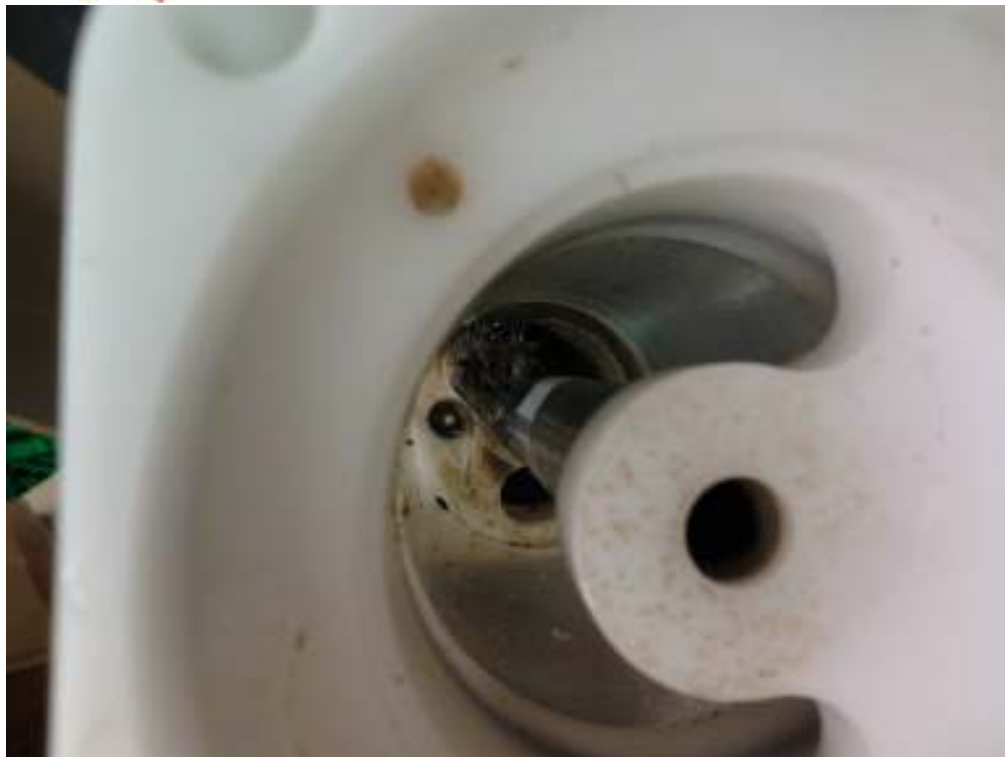
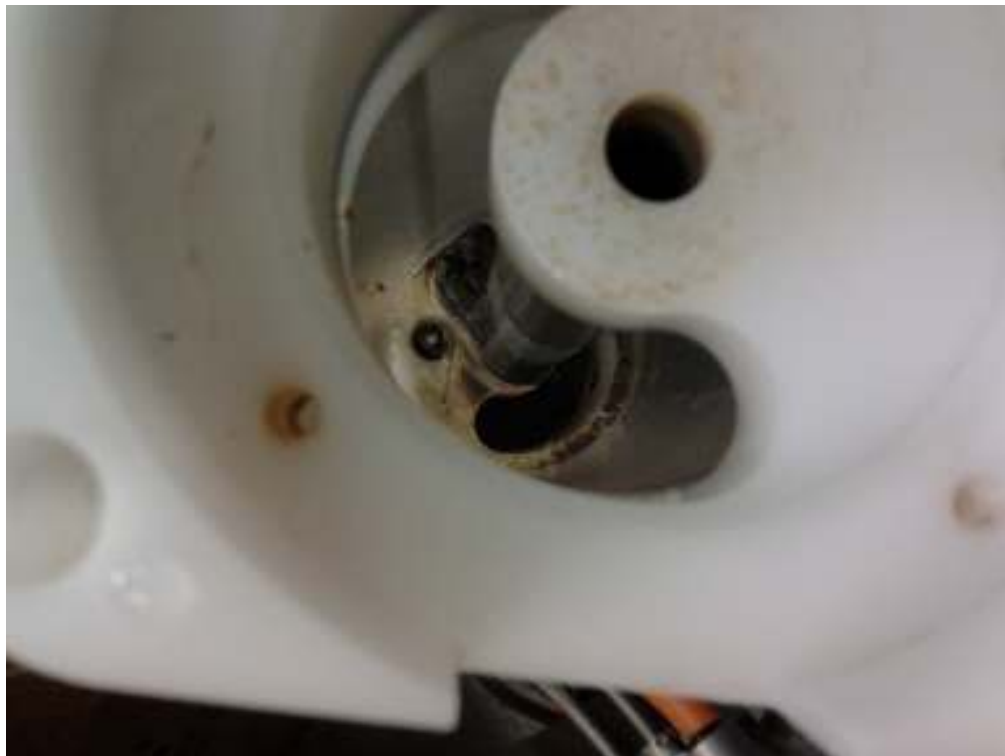
Figure 2: CT Sensor fouling

Figure 3: CT Sensor fouling

Figure 4: CT Sensor fouling

1. Opened both boxes and observed function. Both were working well, no leaks anywhere.
2. Powered down and disassembled instruments in lower assembly.
3. Cleaned and checked over instruments in Engineering room. Cleaned CT sensor connector to remove sediment and biofouling growth. Removed four mussels from interior of housing.
4. Ran pre- and post- calibration with standard solutions and with Orange test stick and blue test stick for CDOM fluorescence and Chl fluorescence.
5. Re-assembled the instruments in the lower box.
6. Checked over Sea chest and valves, no leaks apparent.

1. Potentially replace CT connector (shipboard connector will need to be re-soldered).
2. Monitor growth of Mussels within the system.
3. November refit, replace all metallic connectors on upper boxes with plastic glands.

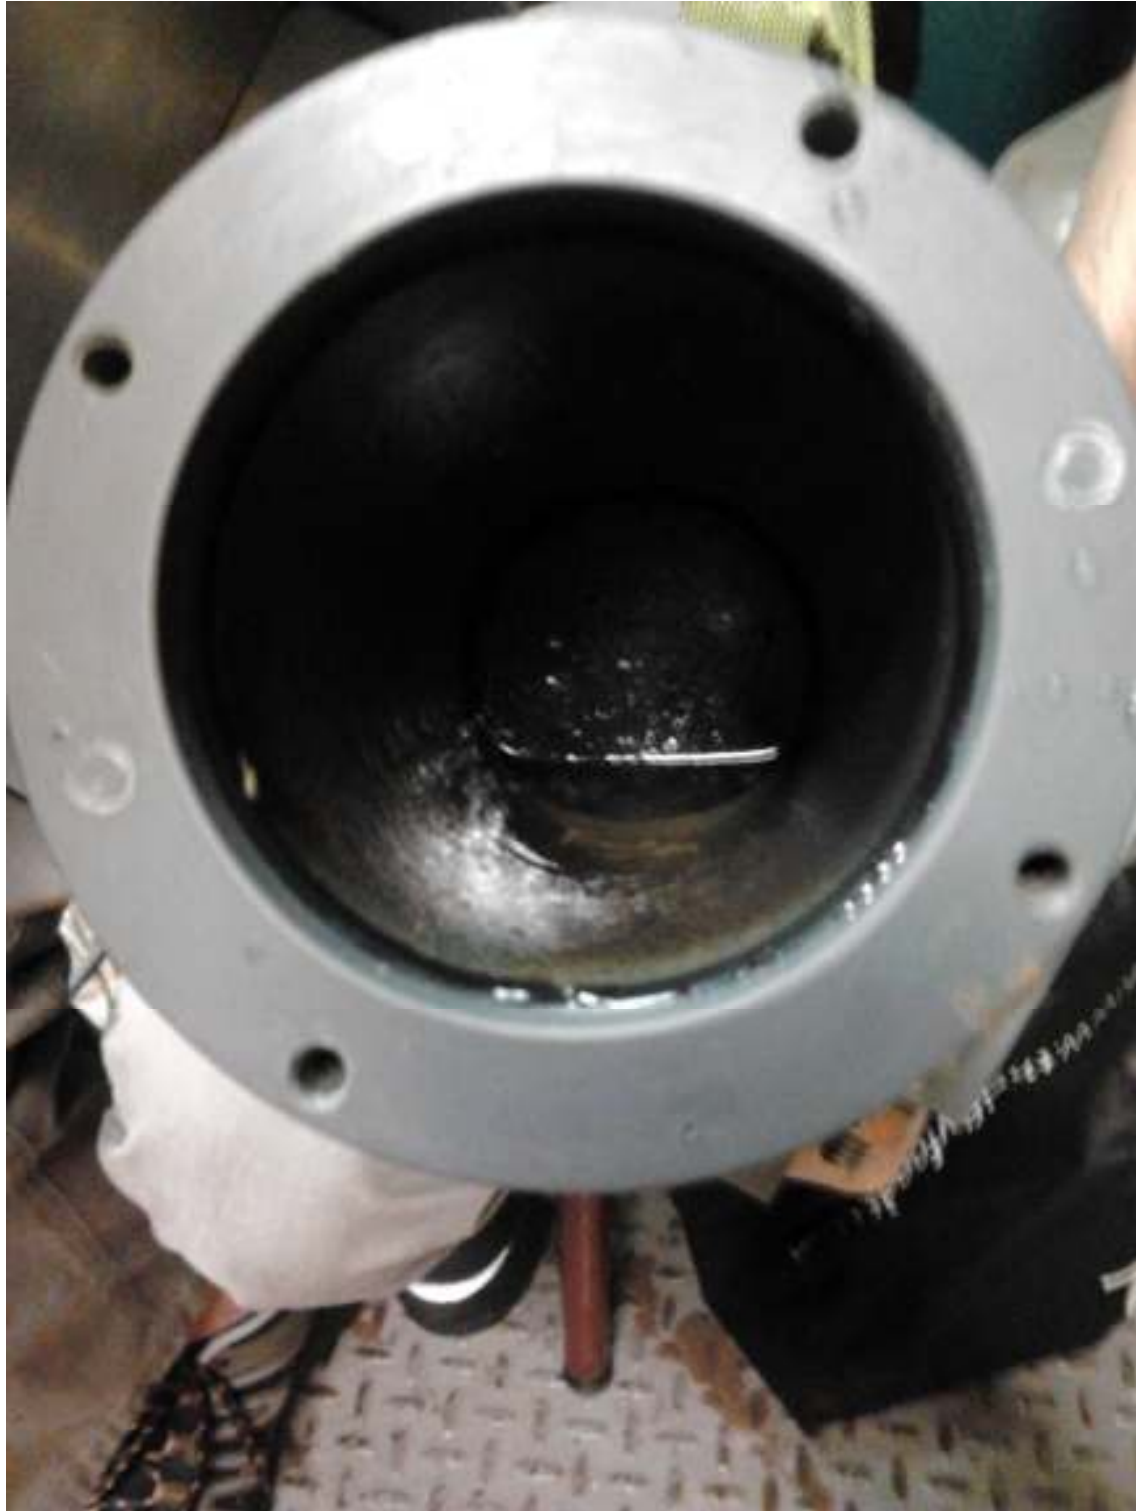
1. There were no signs of moisture or leaks In the Instrument Box.
2. The AADI optode was dirty with sediment/biofilm growth within the housing.
3. The BBFL2 had a partial layer of sediment in the housing and fouling on the sensing surface.
Fouling was noticed on the “bottom” surface of the horizontal housing.
4. The Seabird 45 CT sensor very dirty, with to mussels approximately 3/8” long found growing within the housing on the sensor outlet port.
5. The flex tubing was in good shape, having been replaced on the previous trip.
6. The sea chest showed no signs of leaks.
7. The inline filter (sea strainer) was checked and was found to be dirty and required cleaning.
Mussel growth was found inside the strainer basket.

Figure 5: BBFL2 Fouling

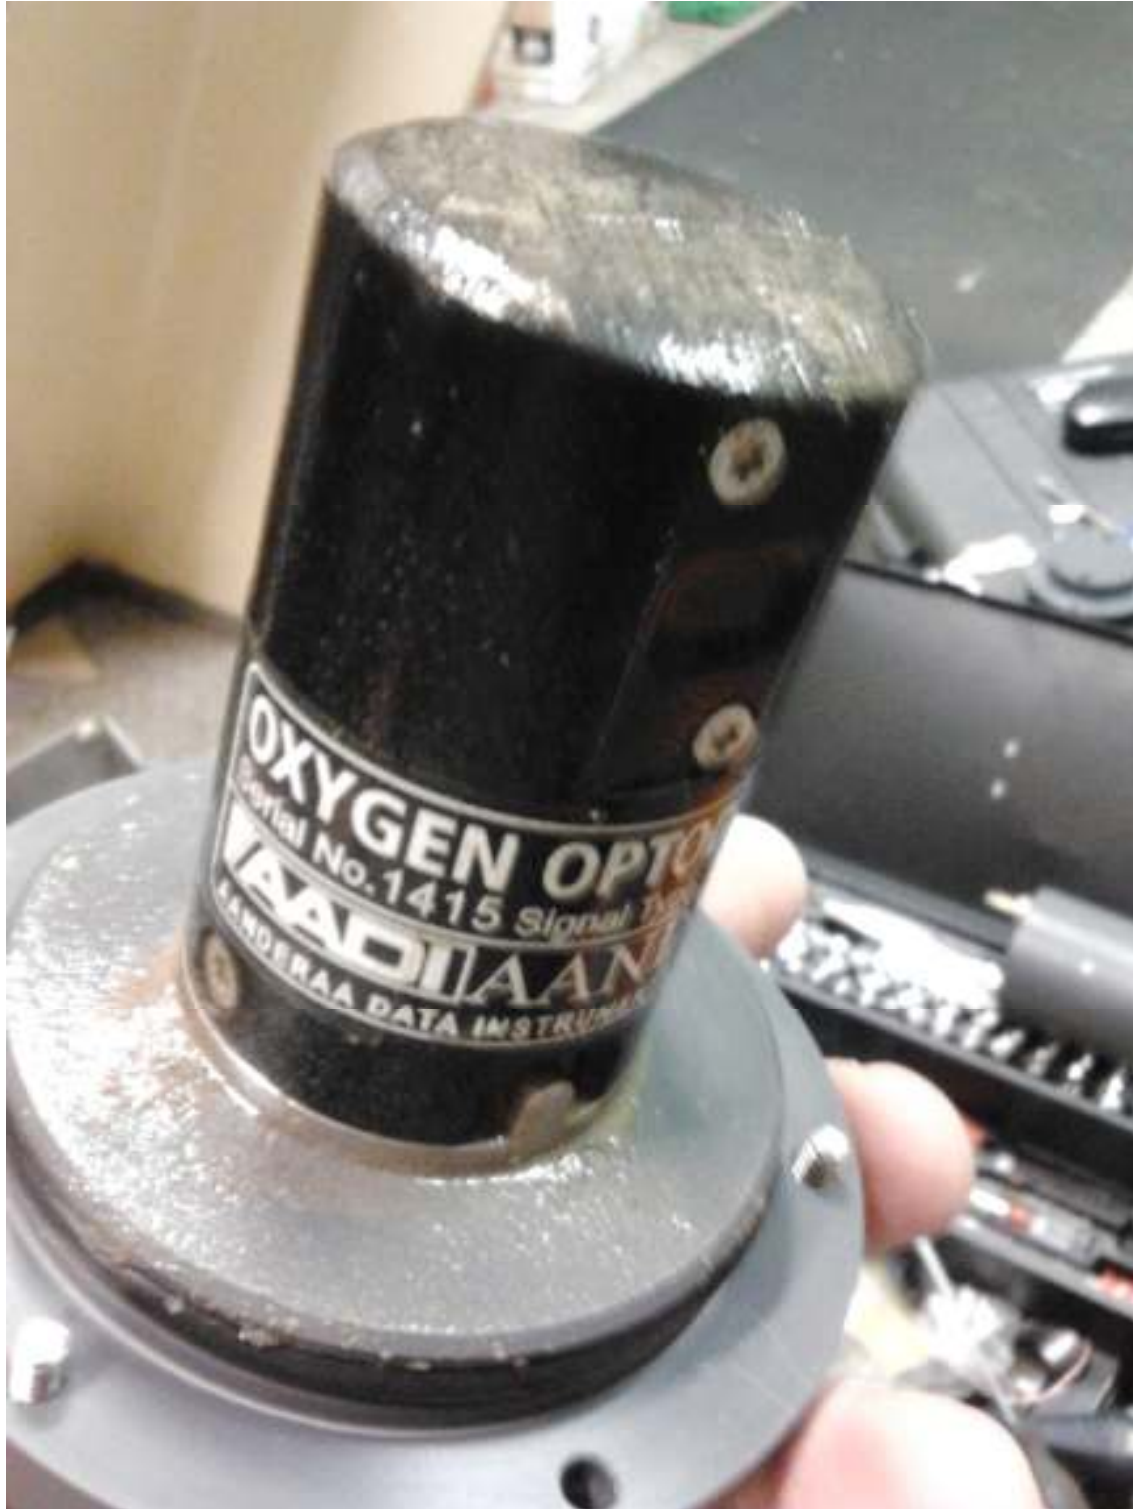
Figure 6: Optode fouling

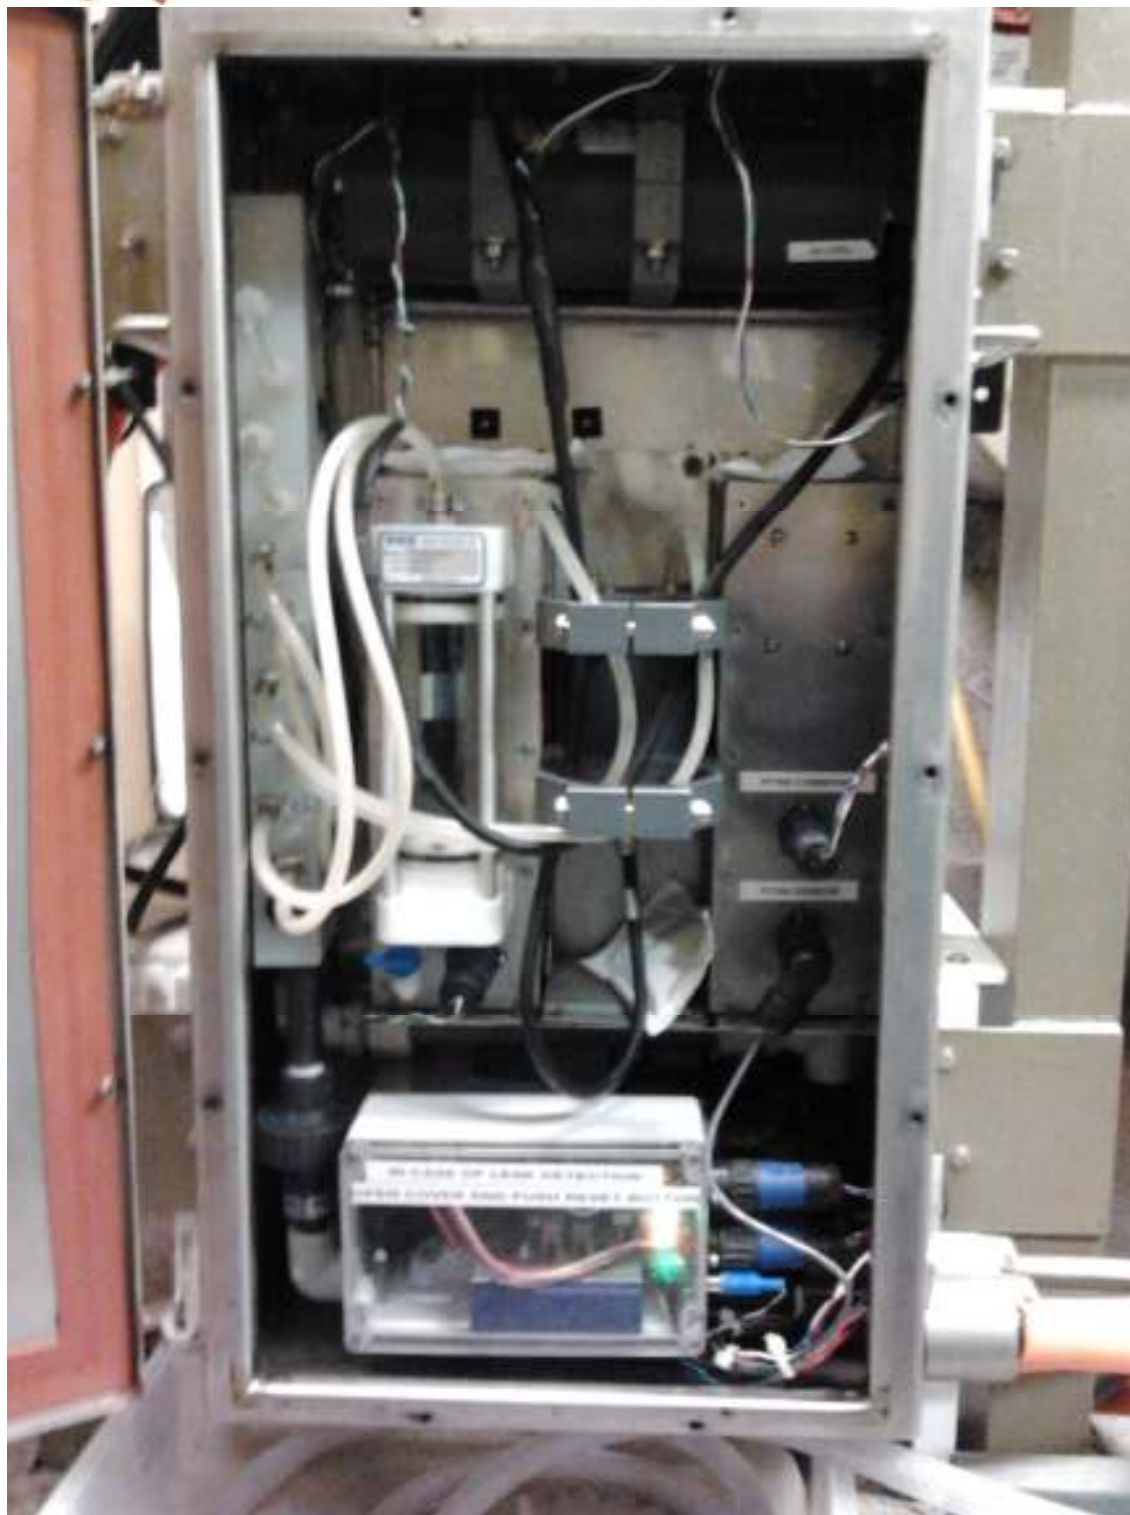
Figure 8: System upon completion
