# Ocean Networks Canada

## Ferry Maintenance Report – Queen of Alberni

**Date:** December 19, 2014

Regular instrument servicing + assessment of Optode Instruments calibration

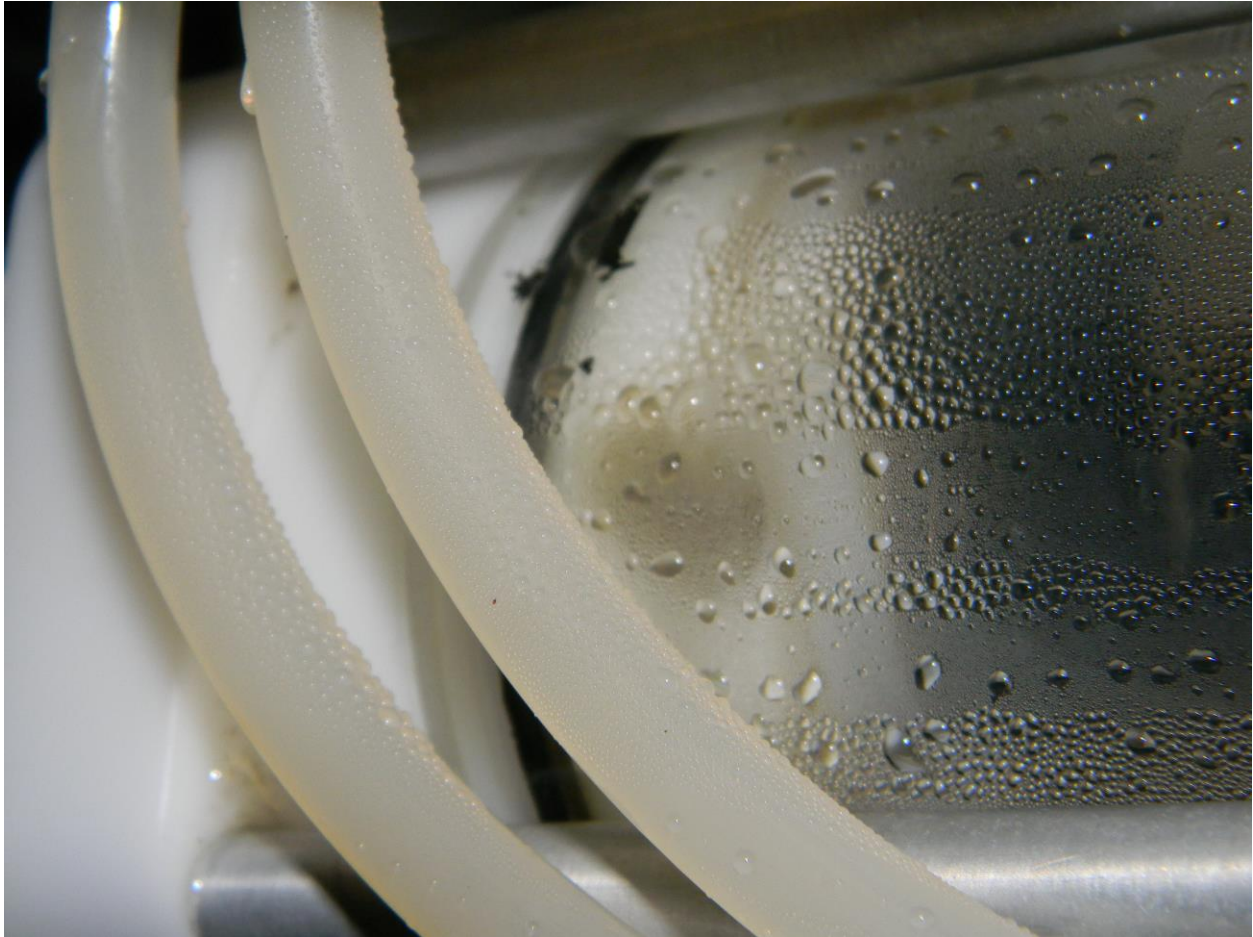
1. As per the last maintenance visit, we observed significant moisture within the SeaKeeper Box and that this moisture can be attributed to condensation on tubing between manifold and instruments.
2. The AADI optode was slightly dirty with some limited sediment/biofilm growth within the housing.
3. The BBFL2 had a partial yet minor layer of sediment in the housing and some minor fouling on the sensing surface. Fouling was noticed on the “bottom” surface of the horizontal housing.
4. The Seabird 45 CT sensor was generally clean.
5. The flex tubing was in good shape.
6. The sea chest showed no signs of leaks.
7. The inline filter (sea strainer) was checked and was found to be moderately dirty and required some cleaning.

Figure 1: Significant condensation along tubing and outer glass surface of the thermosalinograph.

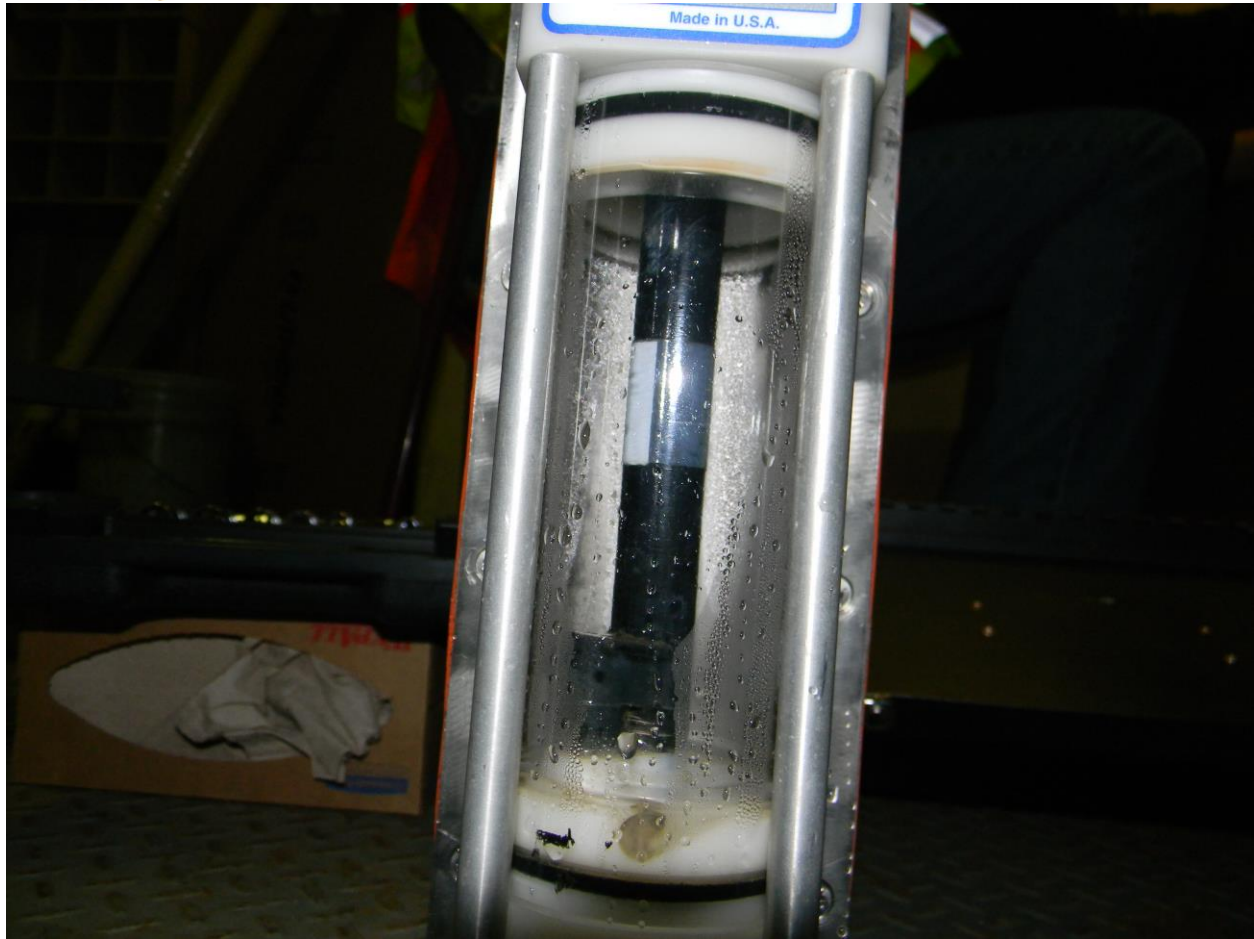
Figure 2: Moderate fouling apparent in the CT unit.

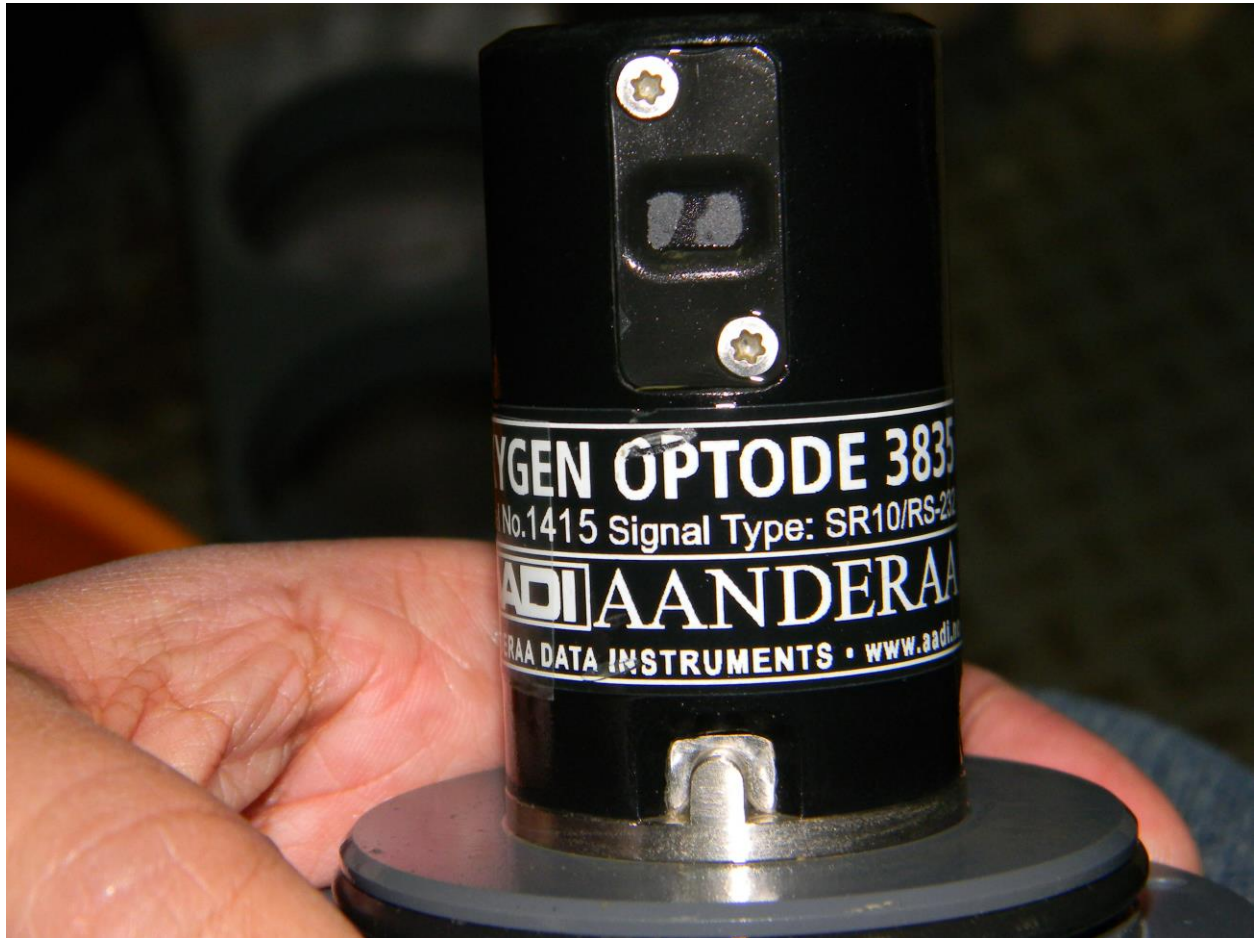
Figure 3: No obvious fouling and sediment on the OPTODE.

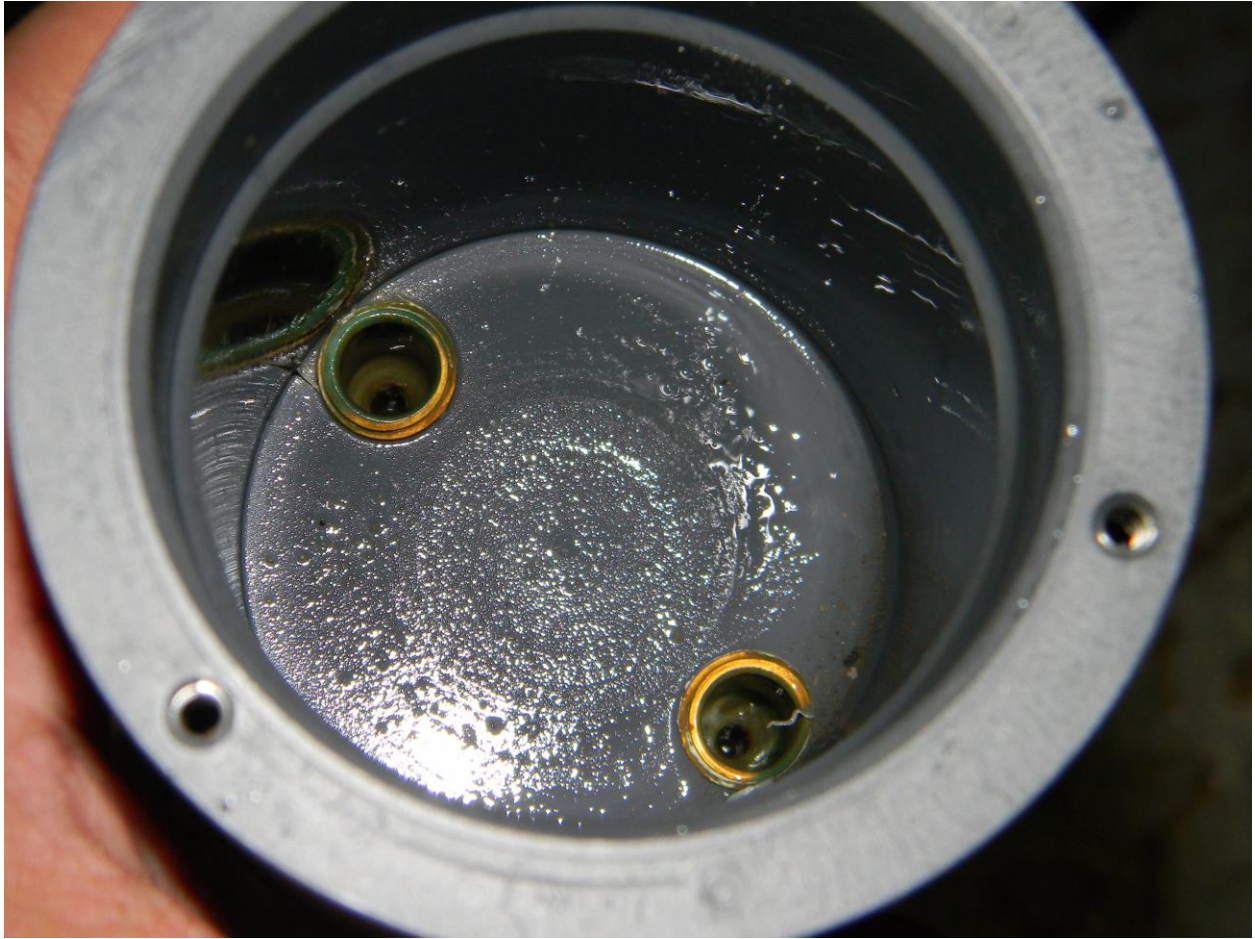
Figure 4: Minor sediment within the OPTODE housing.

1. Opened both boxes and observed function.
2. Powered down and disassembled instruments in lower assembly.
3. Cleaned and checked over instruments in Engineering room.

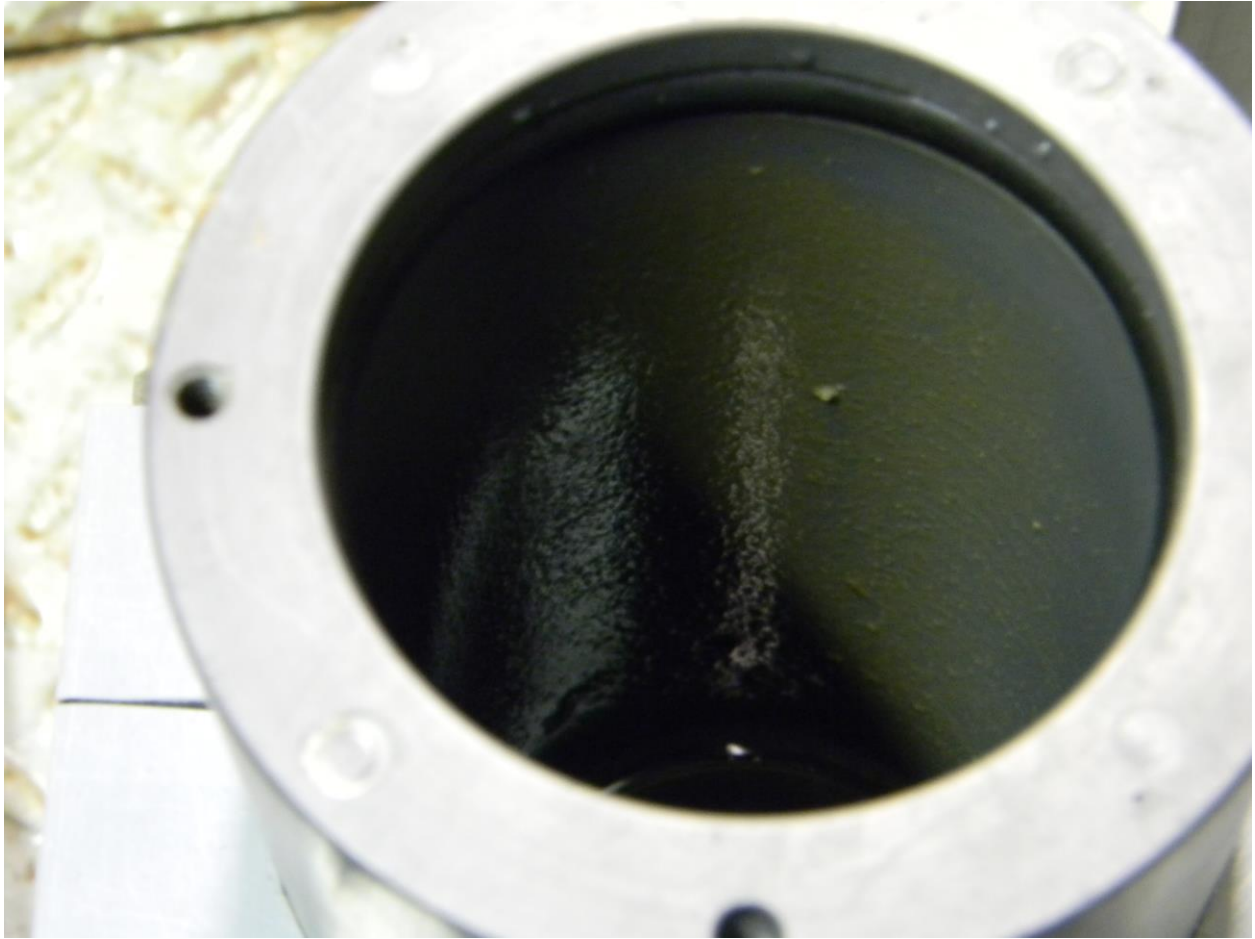
Figure 5: Minor biological growth along the inner BBFL2 housing wall.

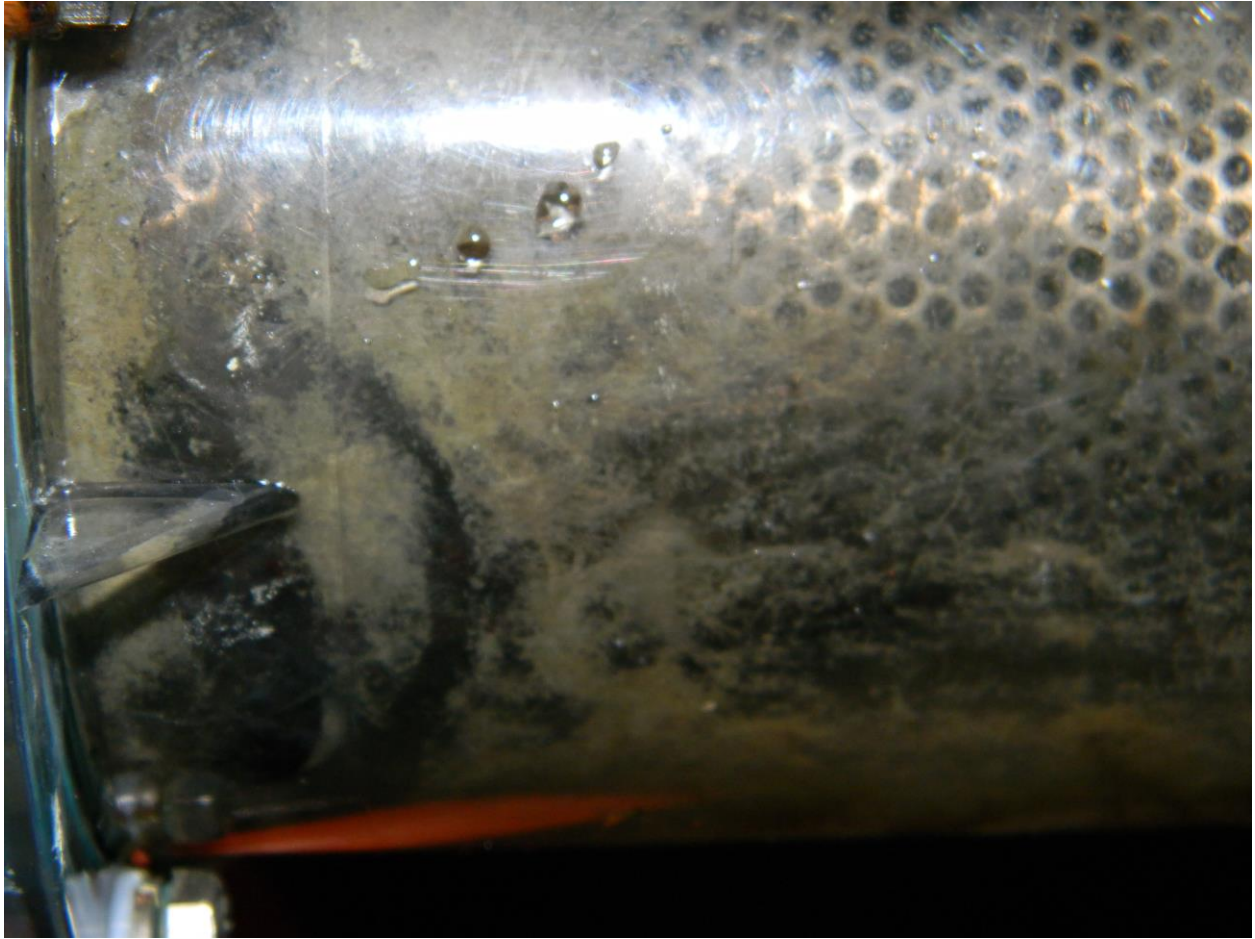
Figure 6: Sea Strainer.

6. Re-assembled the instruments in the lower box.
7. Checked over Sea chest and valves, no leaks apparent.
8. Checked and cleaned the sea strainer. Removed biofilm and sediment fouling from the strainer.

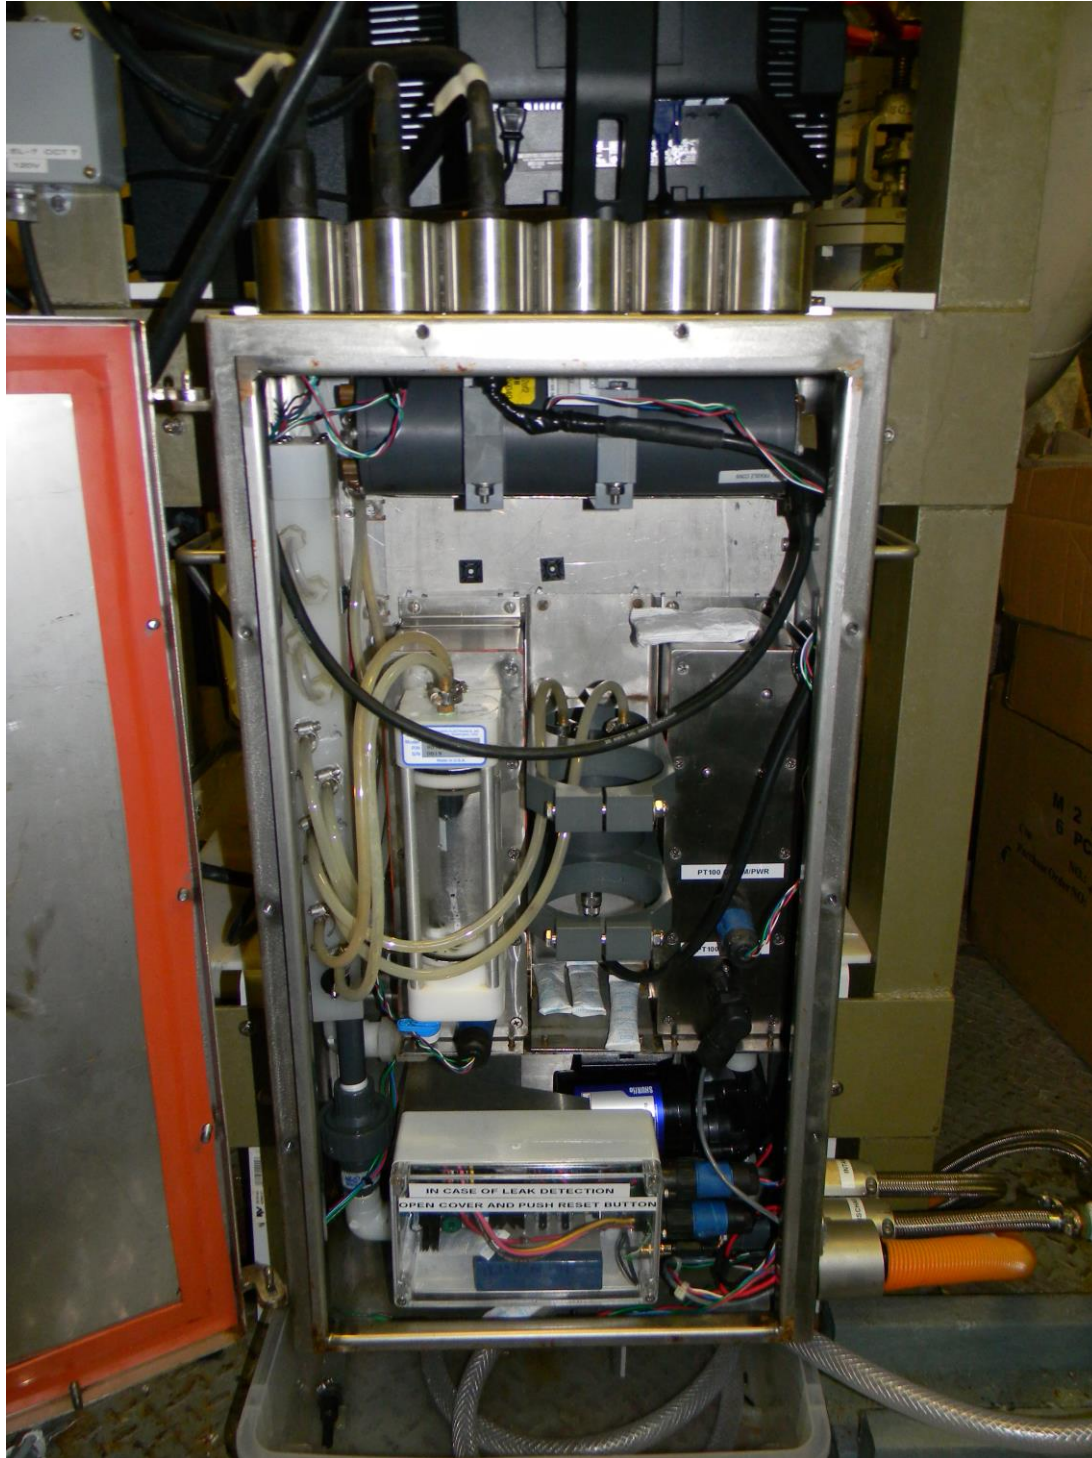
Figure 2: System upon completion.

9. Turned ON the system.
10. No leaks in instrument housing and checked flow output at sea strainer. Flow was good. Visually confirmed flow direction at the BBFL2 and confirmed the volume filled with water and began draining correctly.

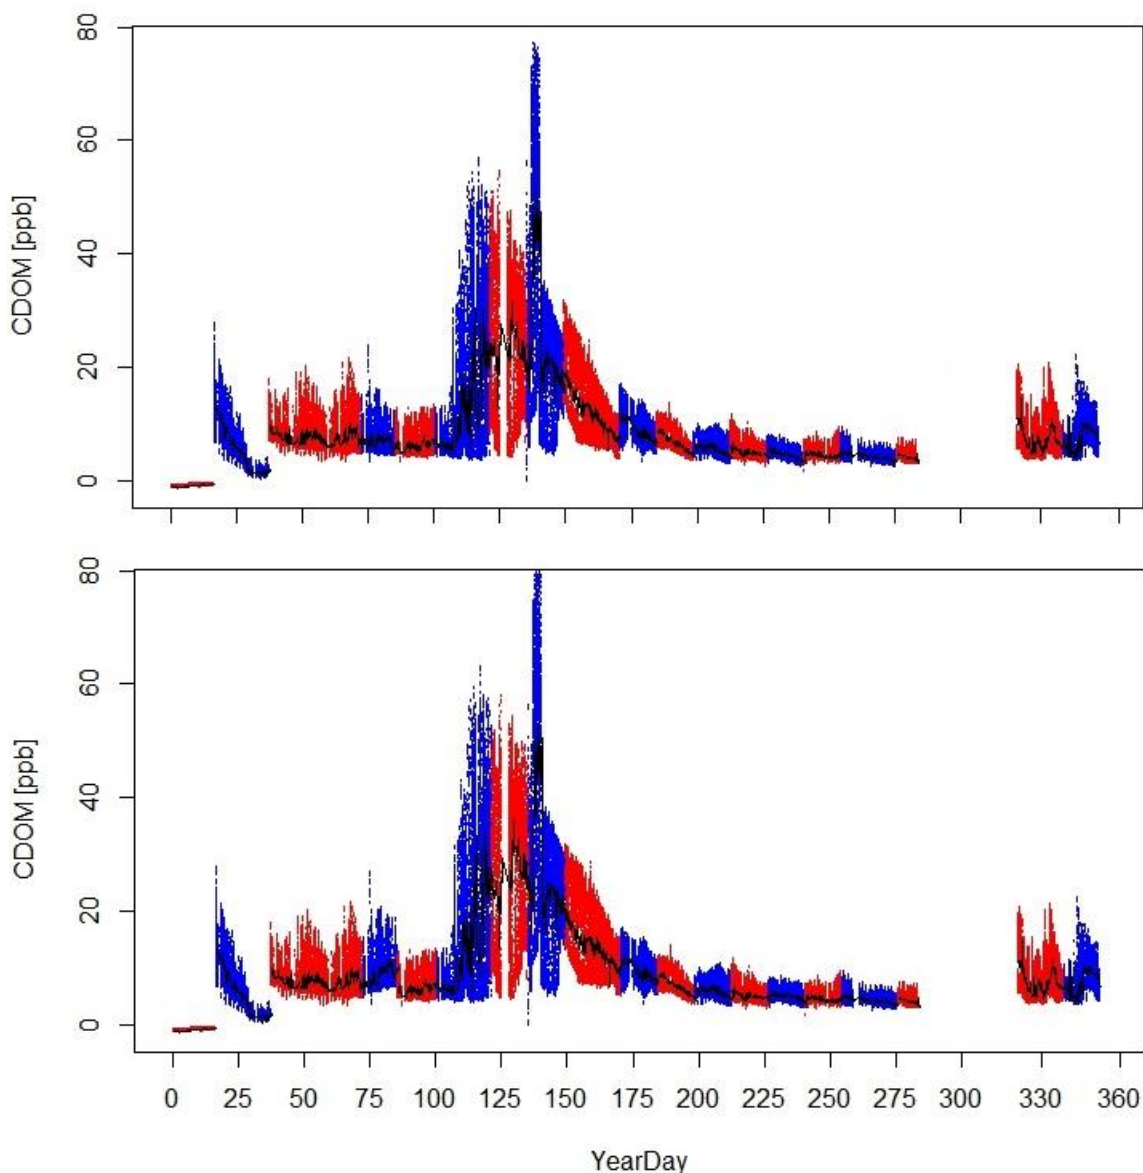
Figure 1. Time series of a) un-corrected; and b) corrected CDOM fluorescence measured en route between Duke Point (Vancouver Island) and Tsawwassen (Mainland, BC) by the BBFL2 unit of the SeaKeeper 1000 instrument suite on board the BC ferry, the Queen of Alberni. Red and blue symbols are used to distinguish between instrument cleaning dates. The difference between pre- and post-cleaning fluorescence of either diluted tonic water or Sprite Zero is typically used to calculate a correction factor (%) which was applied as a linear correction retrospectively between cleaning dates December 6 and December 19, 2014. The most recent cleaning event took place on December 19, 2014. Here we applied a correction based on pre- and post- fluorescence of Tonic Water. Note: an instrument inter-calibration applied to all data following day 149 when BBFL2-786 was swapped out for BBFL2-787.

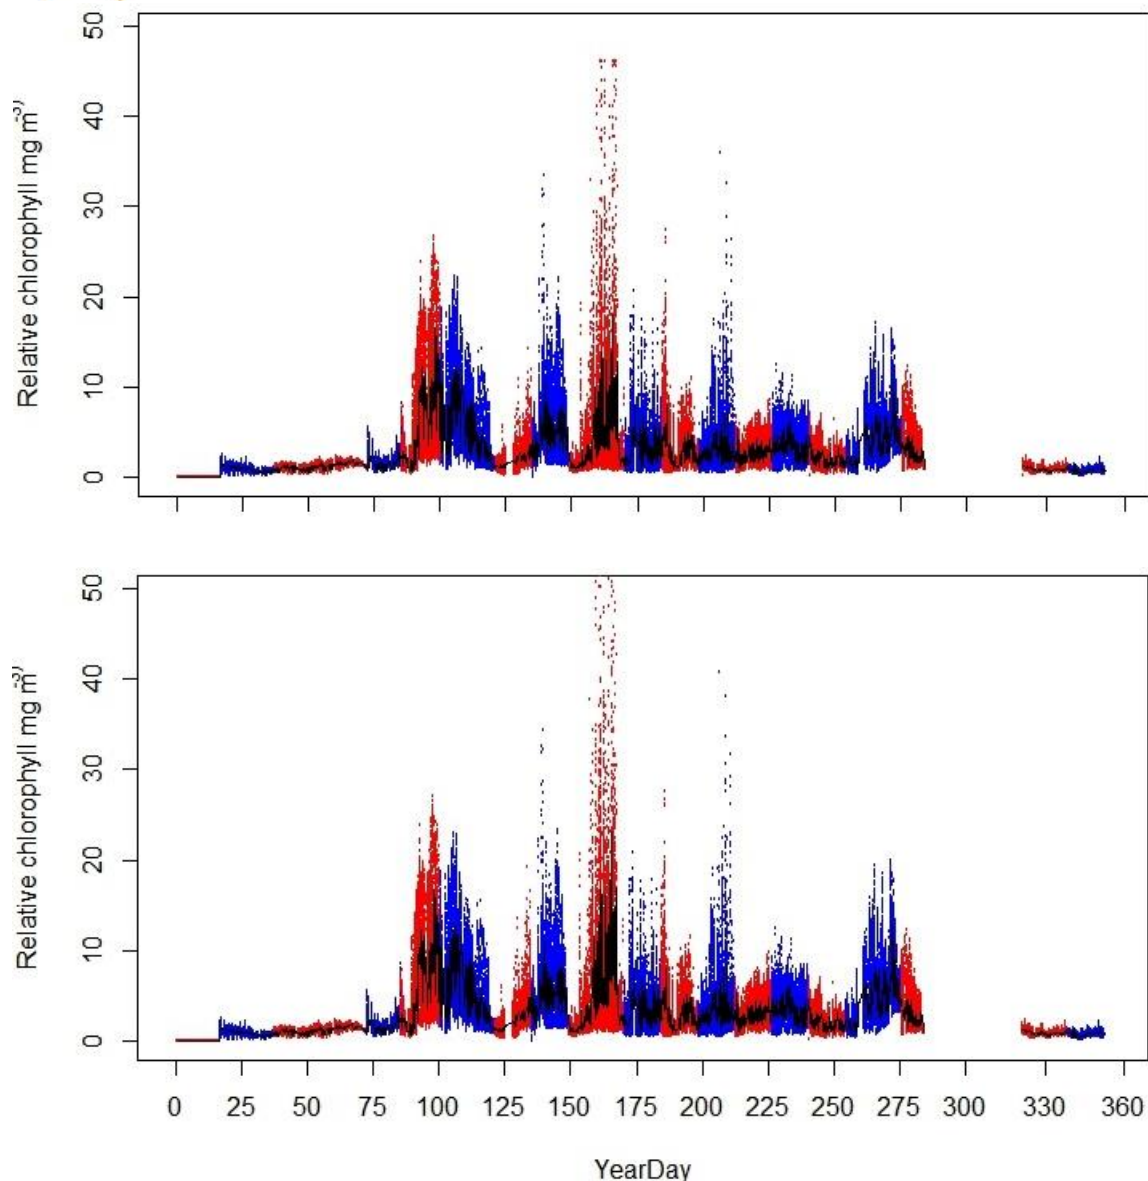
Figure 2. Time series of a) un-corrected; and b) corrected Chl fluorescence measured en route between Duke Point (Vancouver Island) and Tsawwassen (Mainland, BC) by the BBFL2 unit of the SeaKeeper 1000 instrument suite on board the BC ferry, the Queen of Alberni. Red and blue symbols are used to distinguish between instrument cleaning dates. The difference between pre- and post-cleaning fluorescence of diet coke was used to calculate a correction factor (%) which was applied as a linear correction retrospectively between cleaning dates. The most recent cleaning event took place on December 19, 2014. On this date we measured a positive (~5%) response of Diet Coke fluorescence to cleaning (see Table 1). This correction factor was applied retrospectively from December 6 through December 19, 2014. Note: an instrument inter-calibration applied to all data following day 149 when BBFL2-786 was swapped out for BBFL2-787.
