# Ocean Networks Canada

## Ferry Maintenance Report – Queen of Alberni

**Date:** January 9, 2015

Regular instrument servicing + Calibration/comparison of Optode Instruments measurements  
Replacement of failed Optode instrument

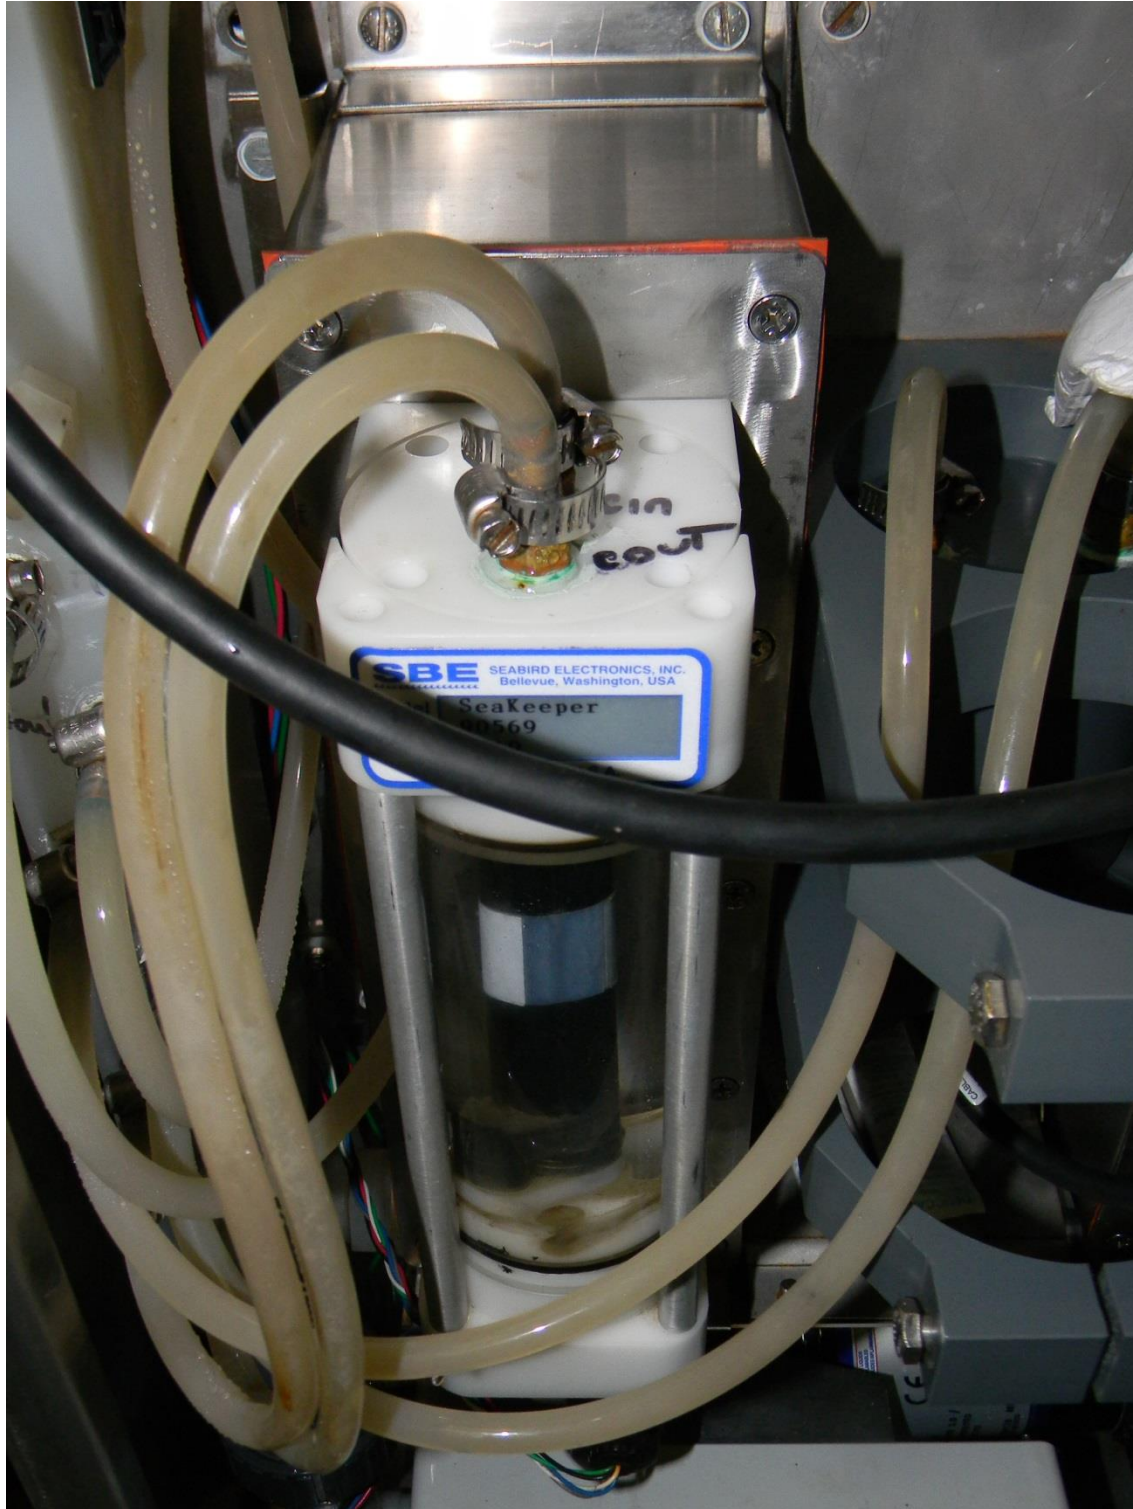
1. There was slight moisture in the Instrument Box. The moisture, from all indications, came from condensation.
2. The AADI optode was slightly dirty with some limited sediment/biofilm growth within the housing.
3. The BBFL2 had a partial layer of sediment in the housing and some minor fouling on the sensing surface. Fouling was noticed on the “bottom” surface of the horizontal housing.
4. The Seabird 45 CT sensor was mildly dirty, with no mussels found growing within the housing on the sensor outlet port.
5. The flex tubing was dirty and too short to re-terminate. All tubing was replaced with new longer lengths.
6. The sea chest showed no signs of leaks.
7. The inline filter (sea strainer) was checked and was found to be slightly dirty and required cleaning.

Figure 2: CT Unit. Note condensation on tubing

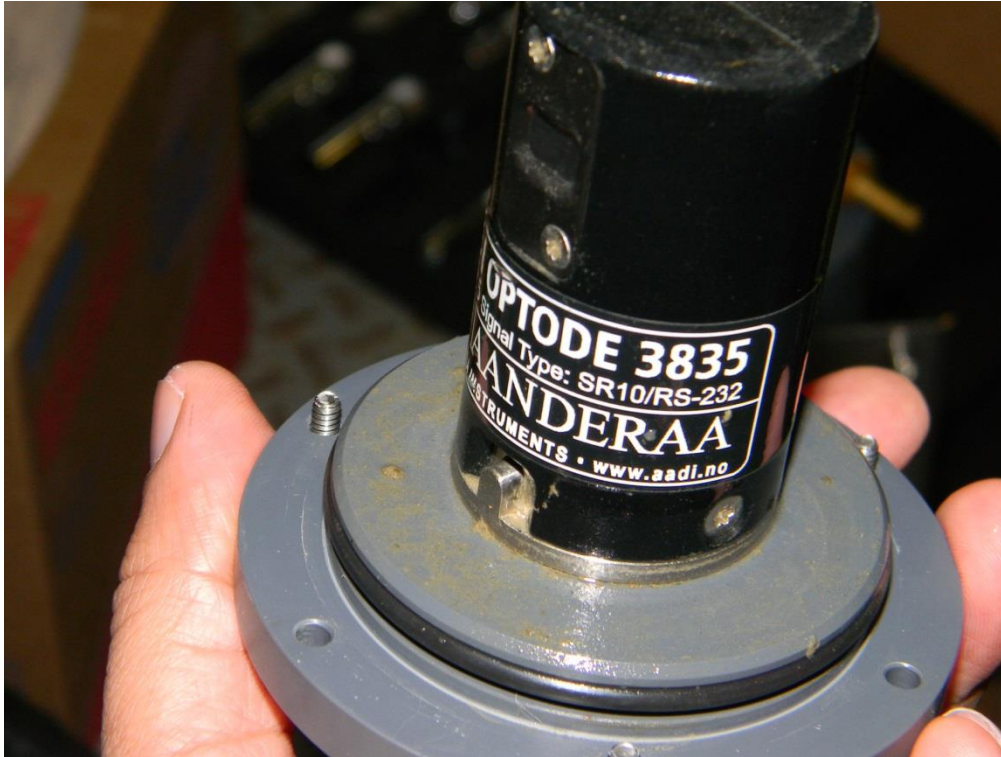
Figure 3: Optode fouling

2. Powered down and disassembled instruments in lower assembly.
3. Cleaned and checked over instruments in Engineering room.
4. Ran pre- and post- calibration with standard solutions and with Orange test stick and blue test stick for CDOM fluorescence and Chl fluorescence.

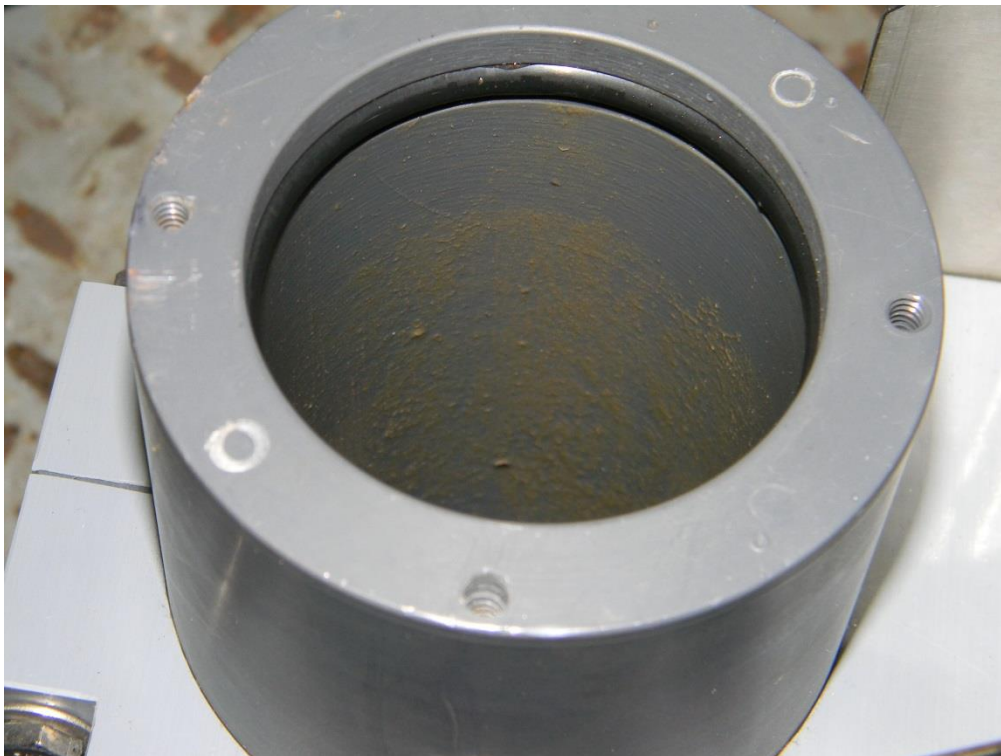
Figure 4: BBFL2 Fouling

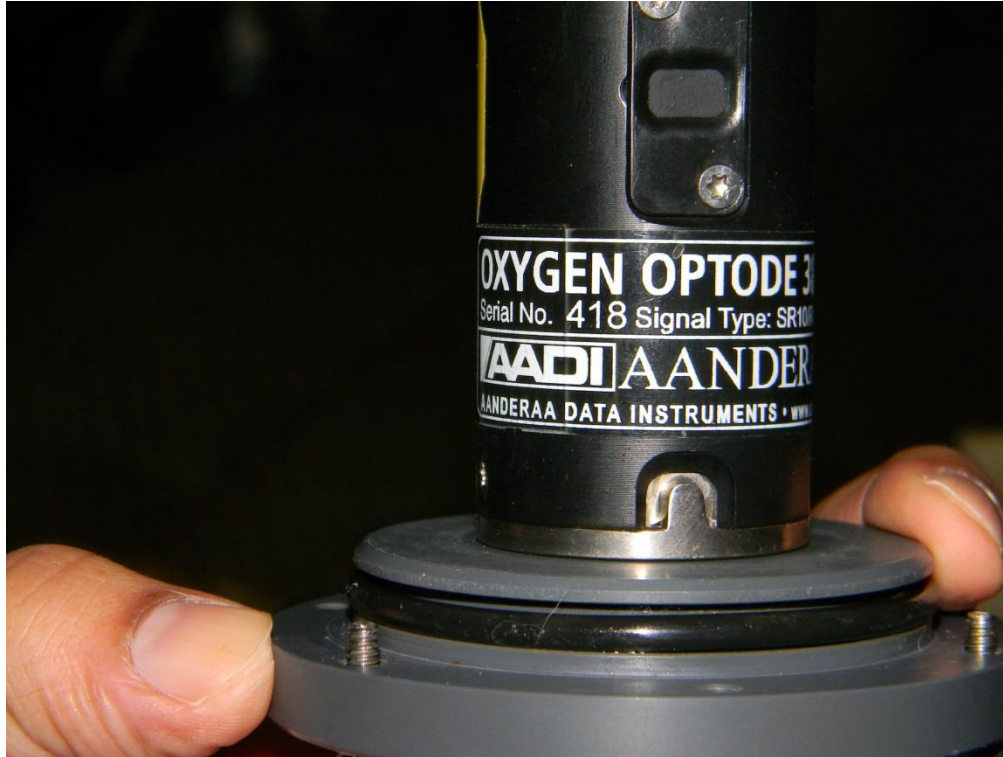
Figure 5: New Optode Mounted

8. Installed replacement OPTODE system (SN 418).
9. Turned ON the system.
10. No leaks in instrument housing and checked flow output at sea strainer. Flow was good. Visually confirmed flow direction at the BBFL2 and confirmed the volume filled with water and began draining correctly. Noted that flow was lower than expected.

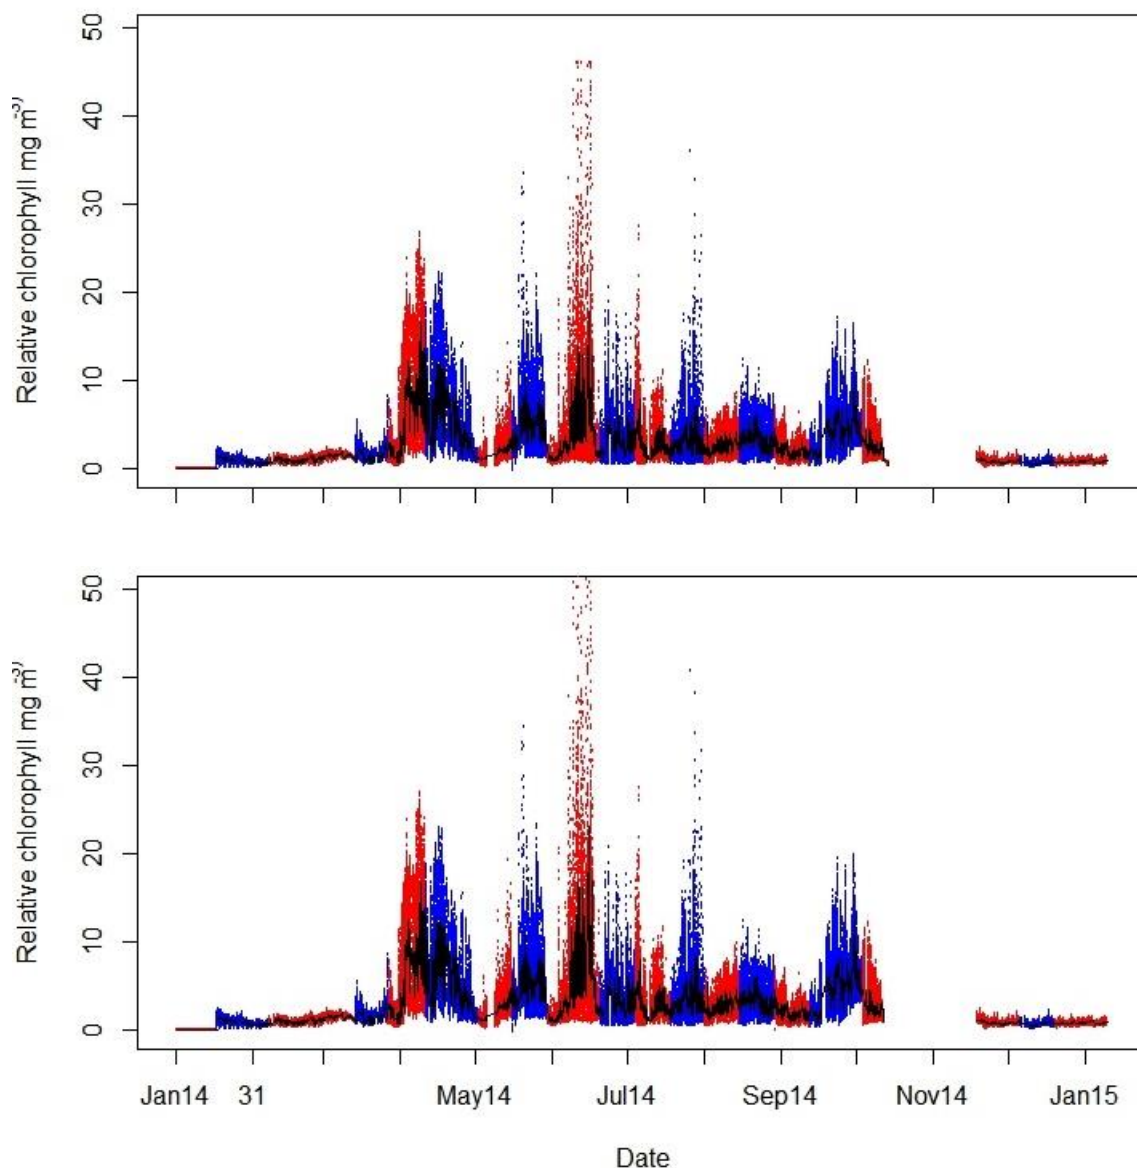
Figure 2. Time series of a) un-corrected; and b) corrected Chl fluorescence measured en route between Duke Point (Vancouver Island) and Tsawwassen (Mainland, BC) by the BBFL2 unit of the SeaKeeper 1000 instrument suite on board the BC ferry, the Queen of Alberni. Red and blue symbols are used to distinguish between instrument cleaning dates. The difference between pre- and post-cleaning fluorescence of diet coke was used to calculate a correction factor (%) which was applied as a linear correction retrospectively between cleaning dates. The most recent cleaning event took place on January 9, 2015. On this date we measured a positive (<1%) response of Diet Coke fluorescence to cleaning (see Table 1). This correction factor was applied retrospectively from December 19, 2014 through January 9, 2015. Note: an instrument inter-calibration applied to all data following day 149 when BBFL2-786 was swapped out for BBFL2-787.
