Ocean Networks Canada

Ferry Maintenance Report – Queen of Alberni

Date: March 20, 2015

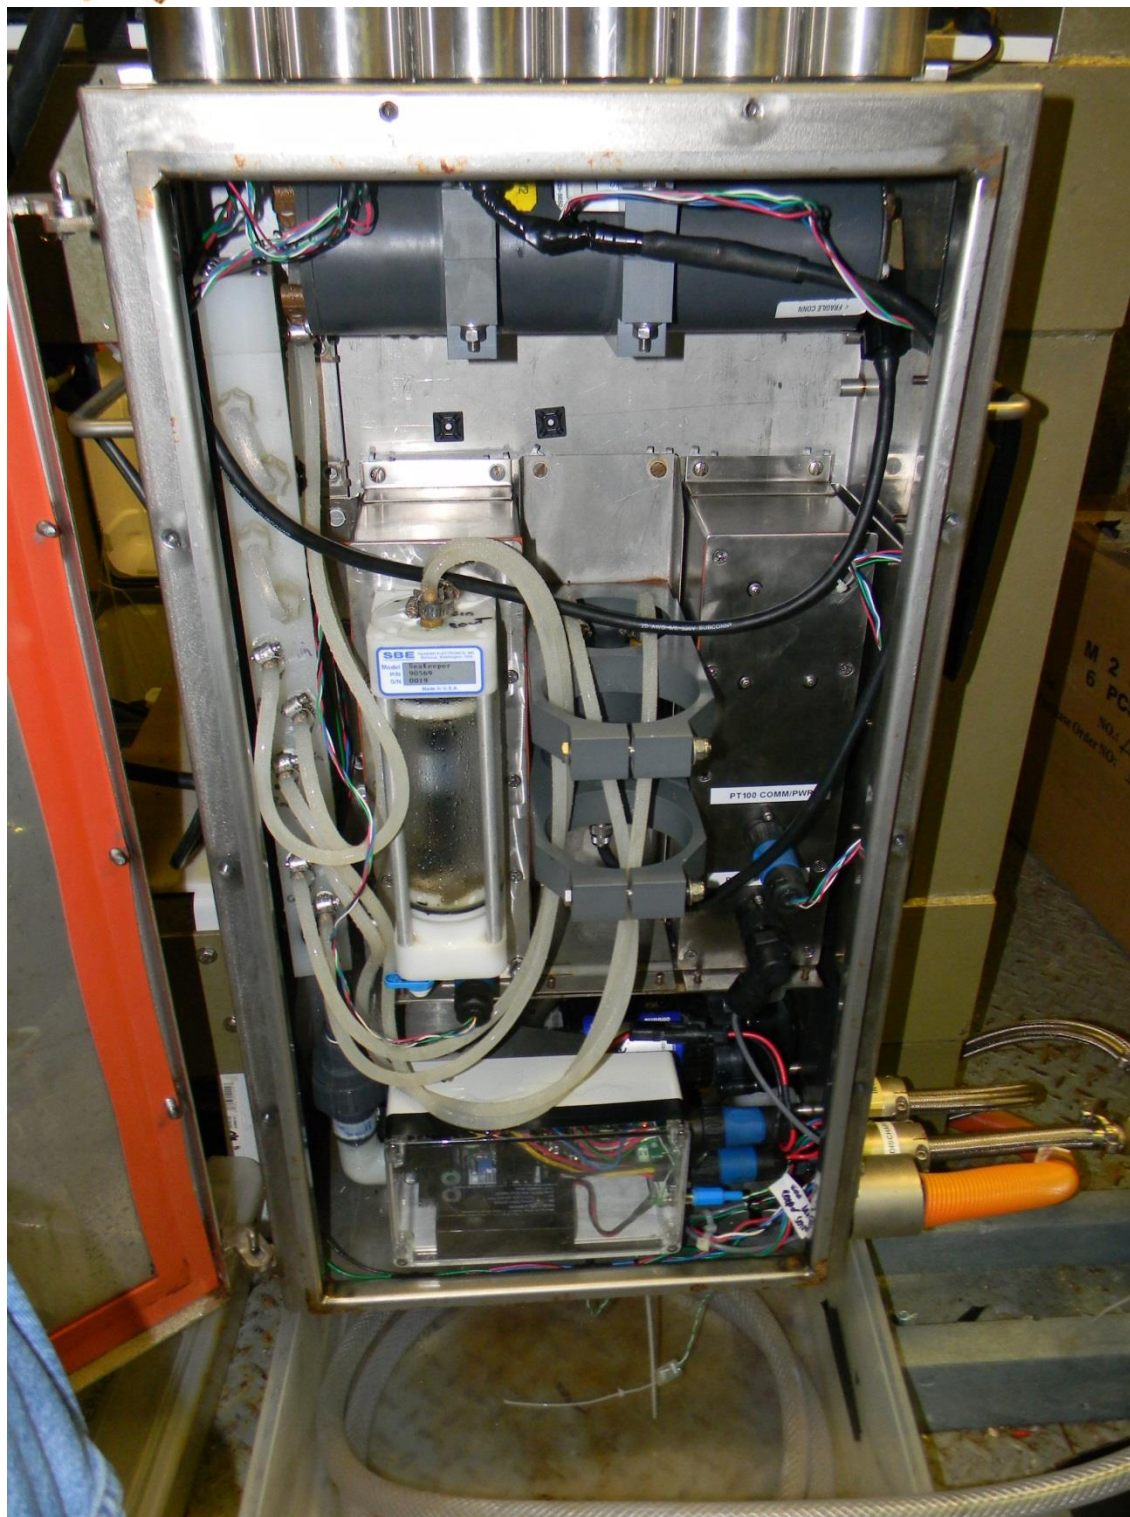
Figure 1: Instrument Box upon arrival. Note condensation throughout. Note dry catchment basin.

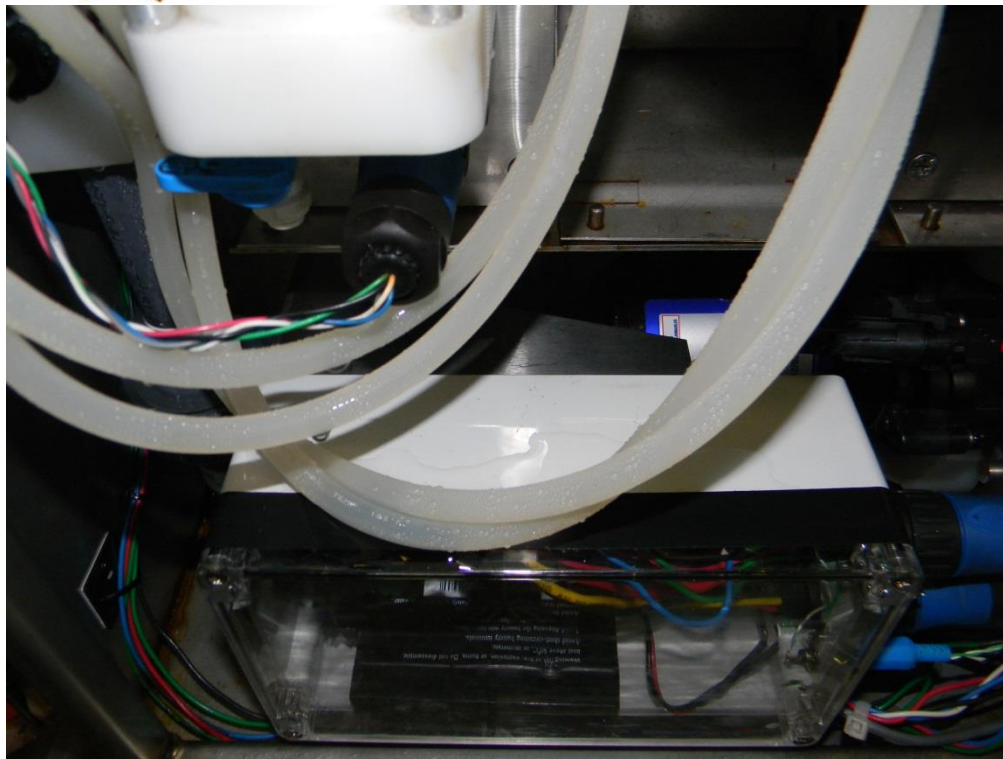
Figure 2: Condensation on tubing and on top of Pump Control Box.

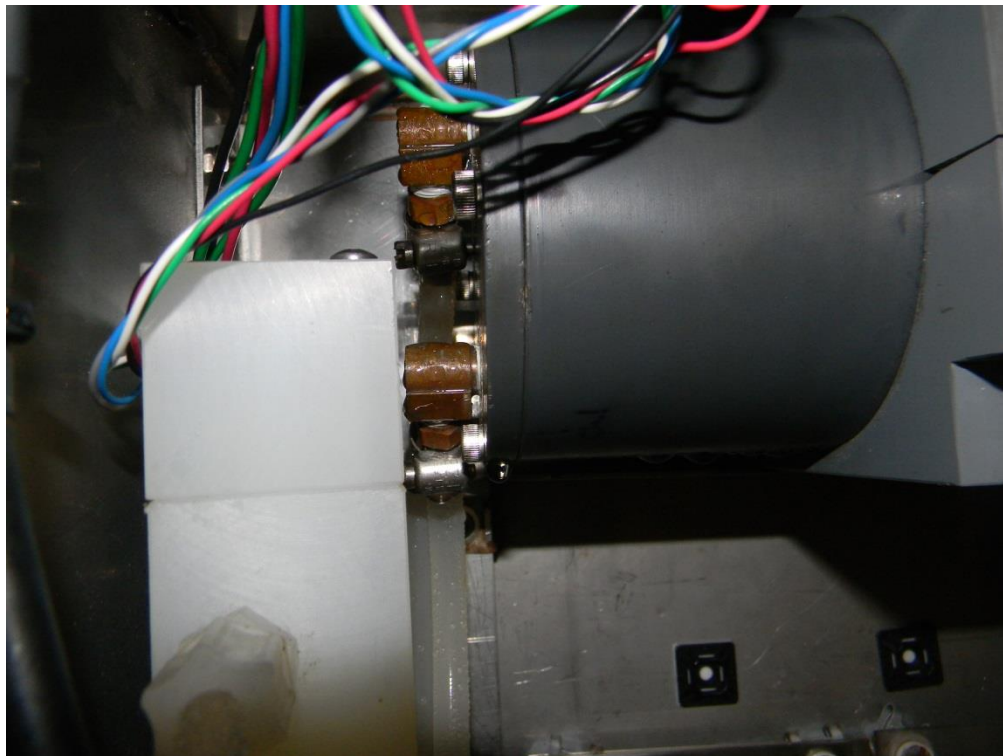
Figure 3: Condensation on/around BBFL2.

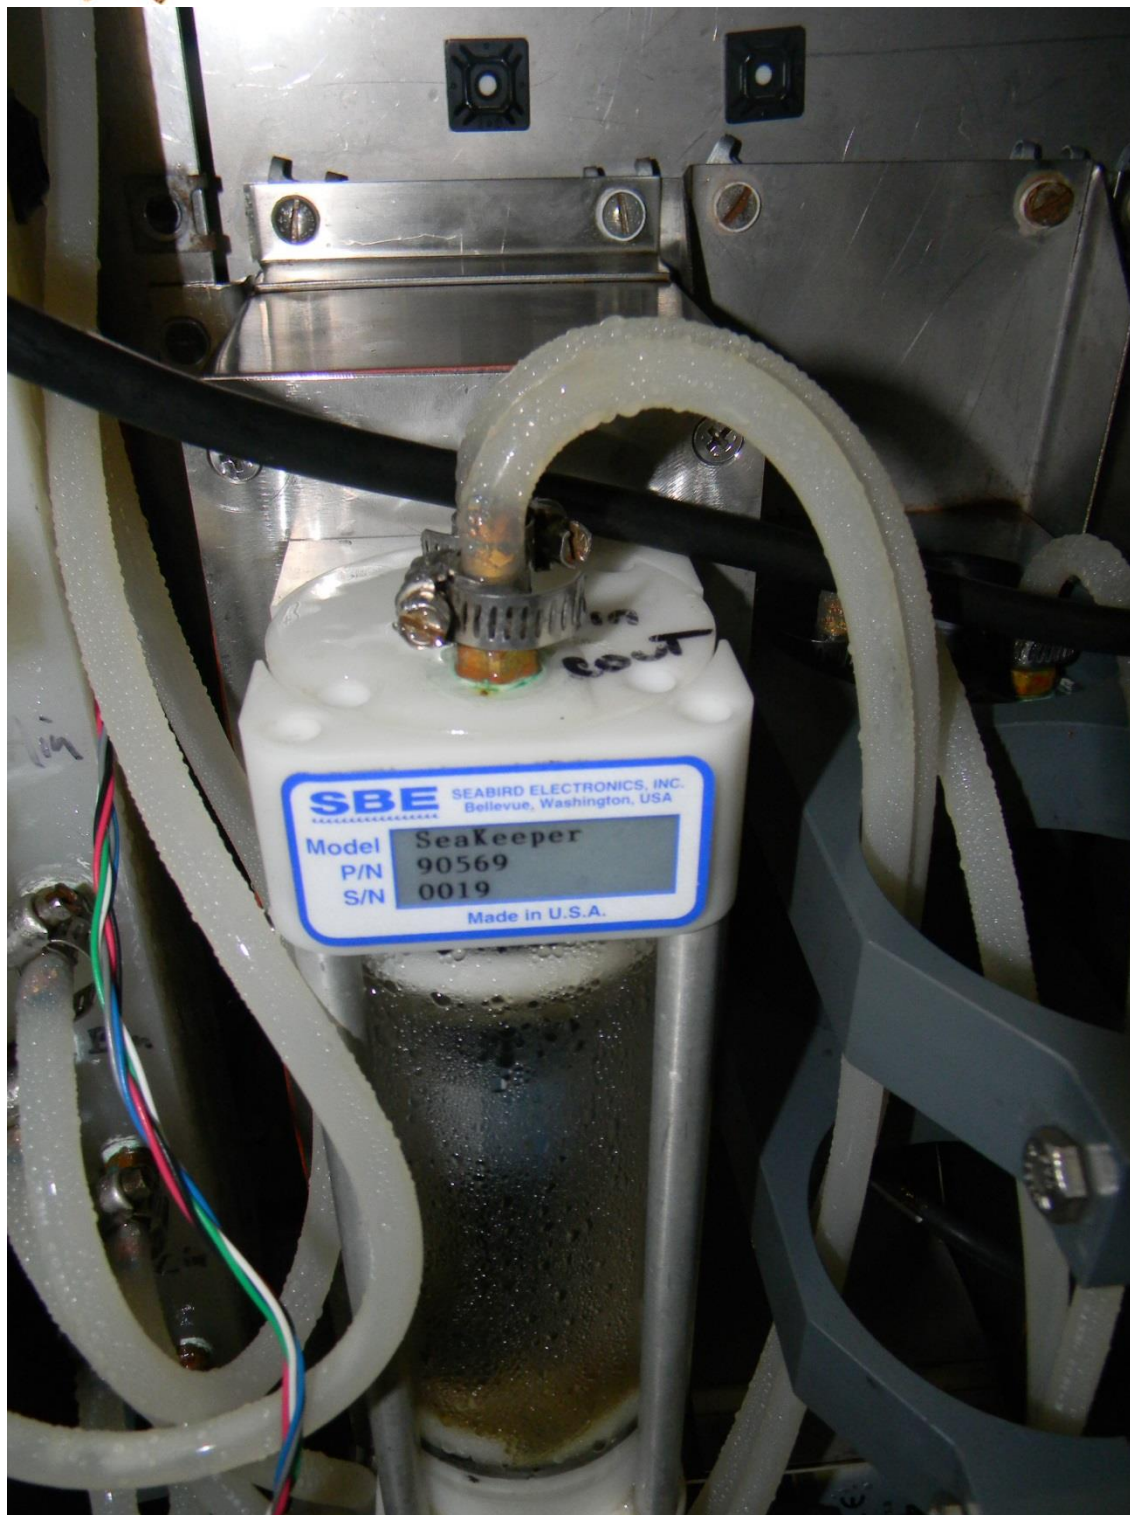
Figure 4: Condensation on CT unit.

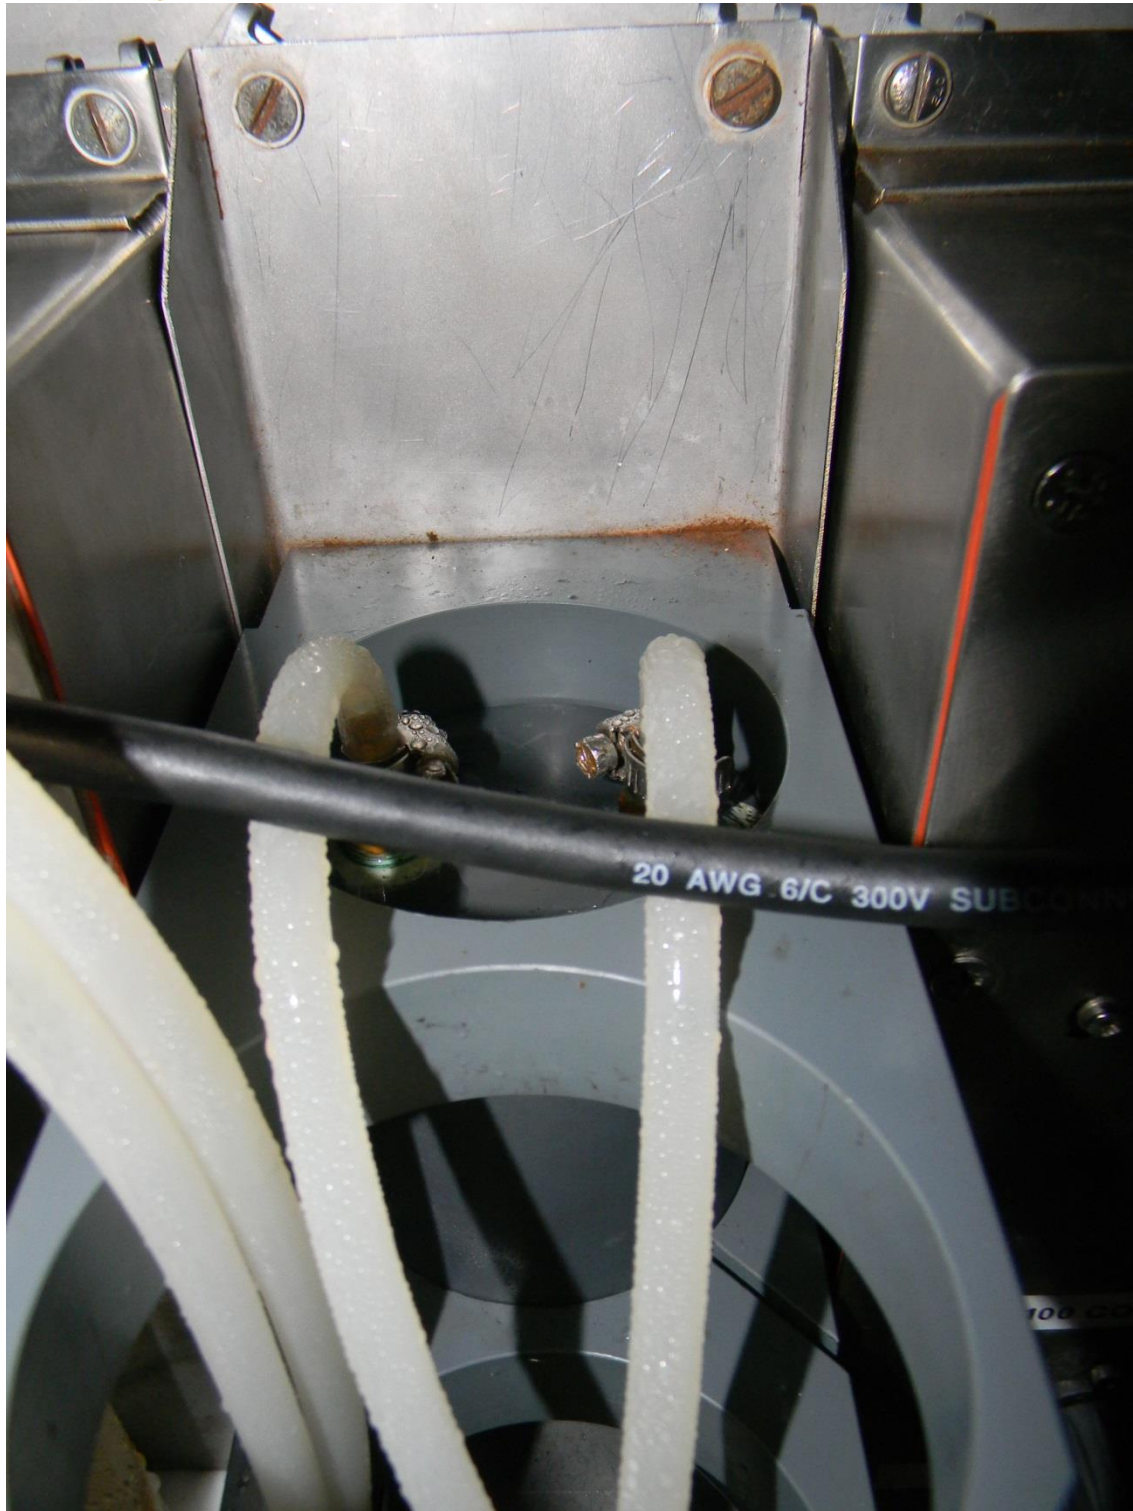
Figure 5: Condensation on OPTODE unit.

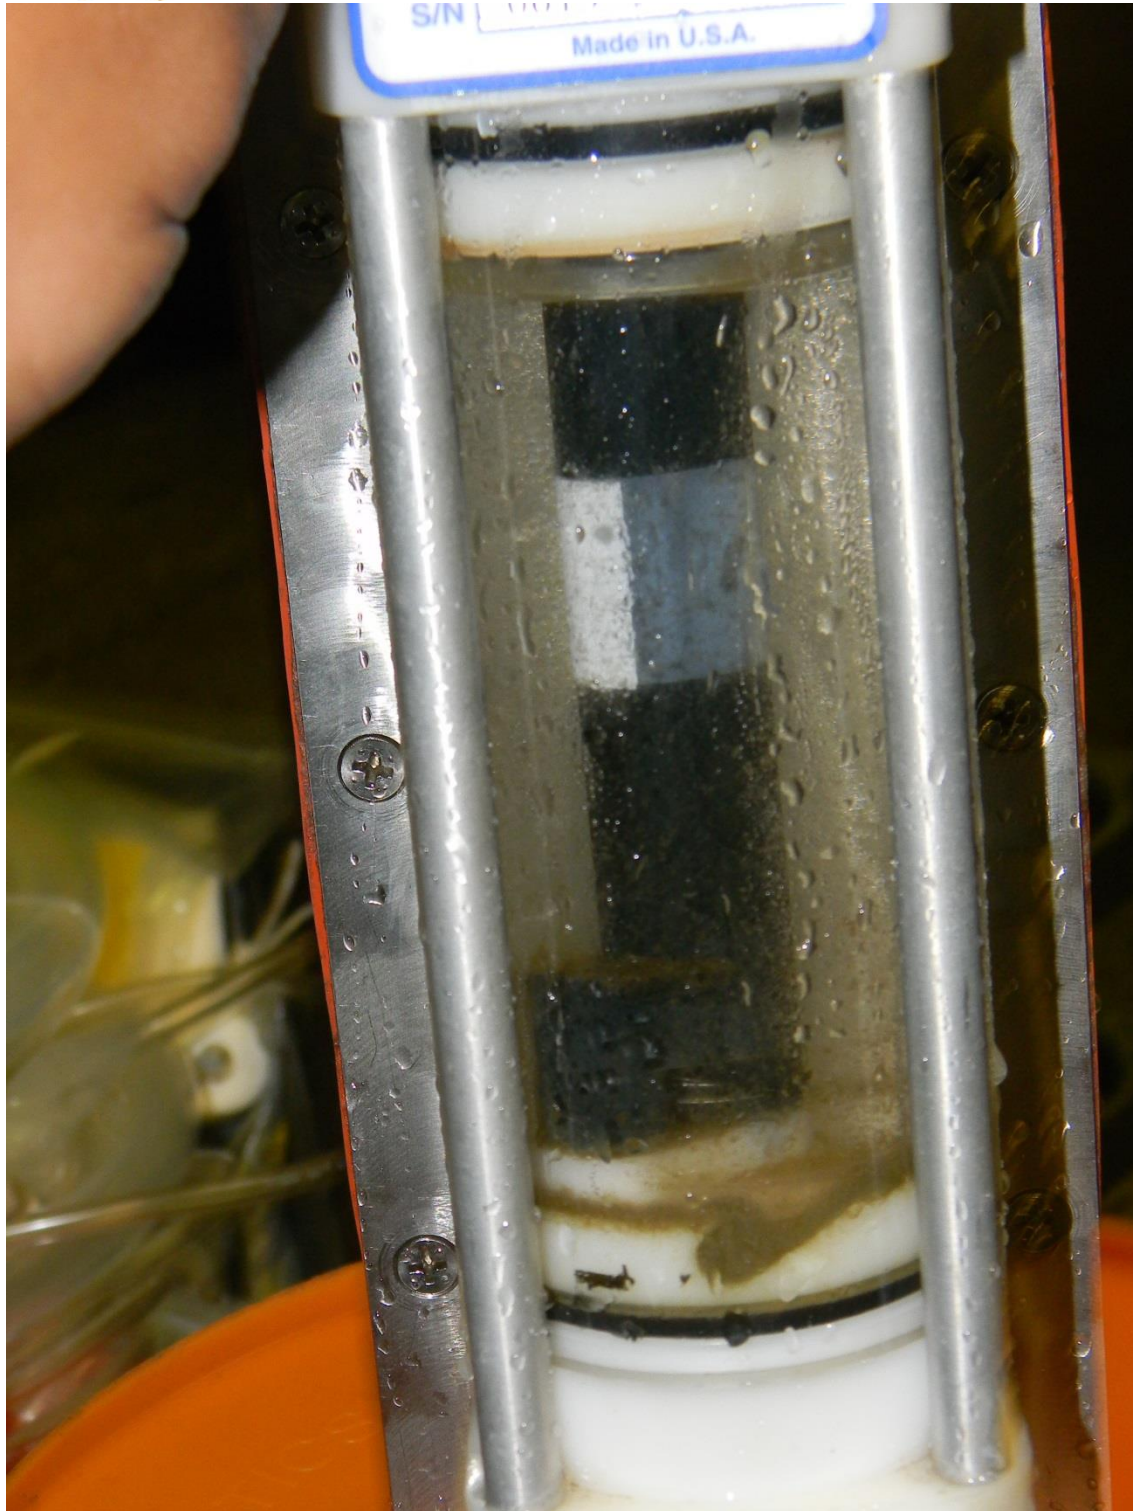
Figure 6: Sedimentation/biofouling within CT unit.

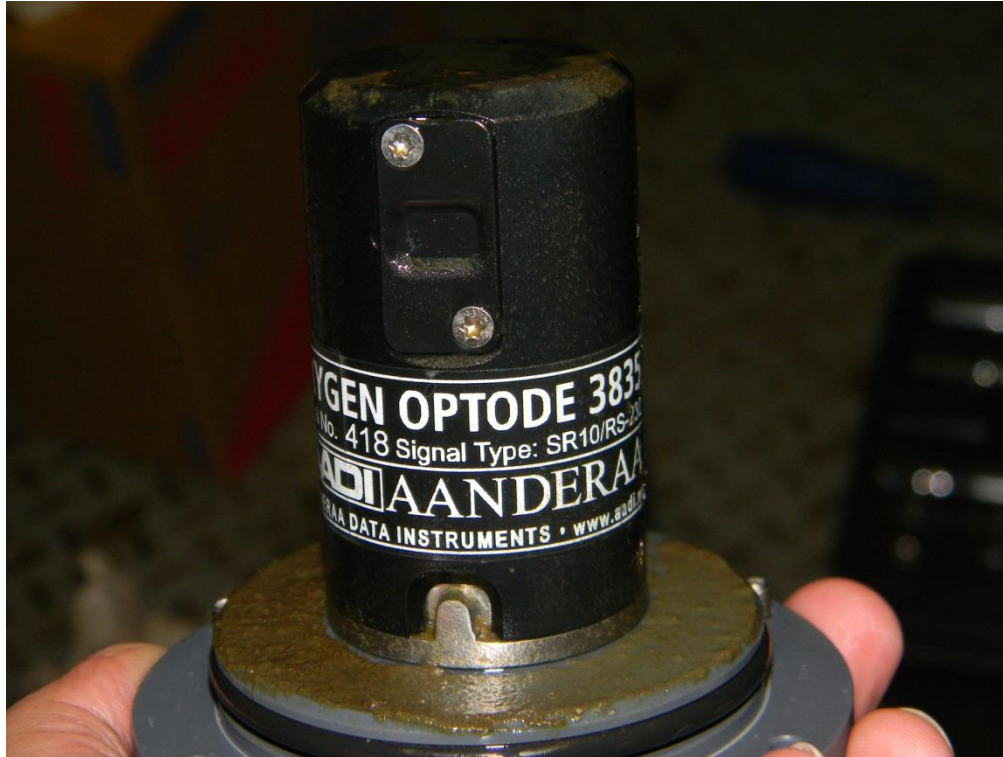
Figure 7: Biofouling on OPTODE unit.

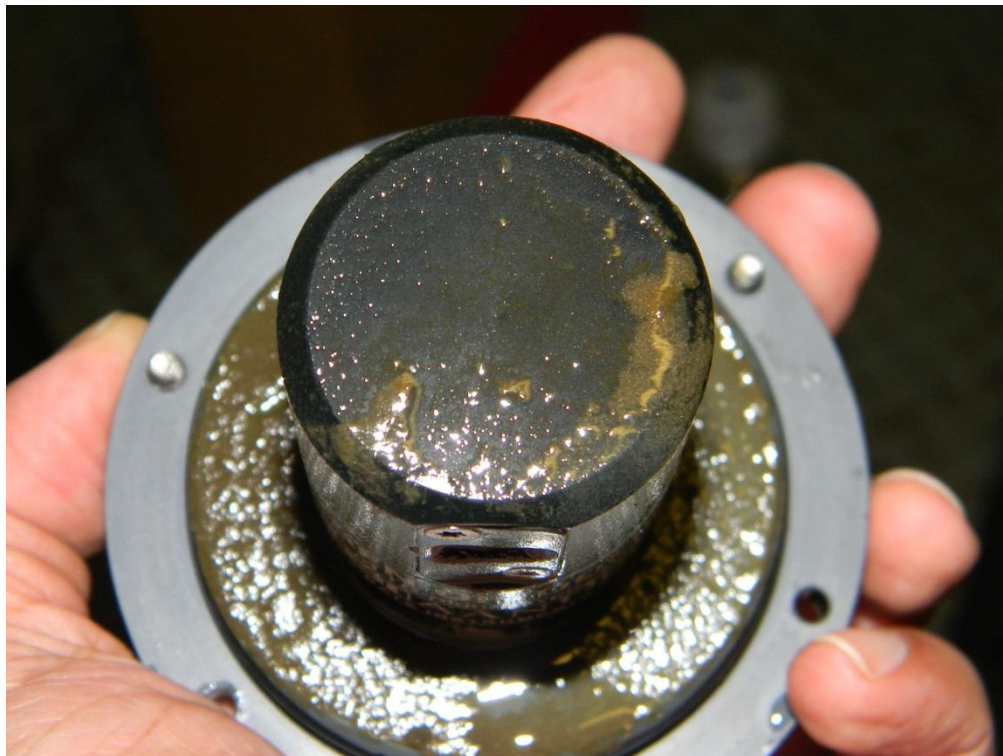
Figure 8: Biofouling on OPTODE unit.

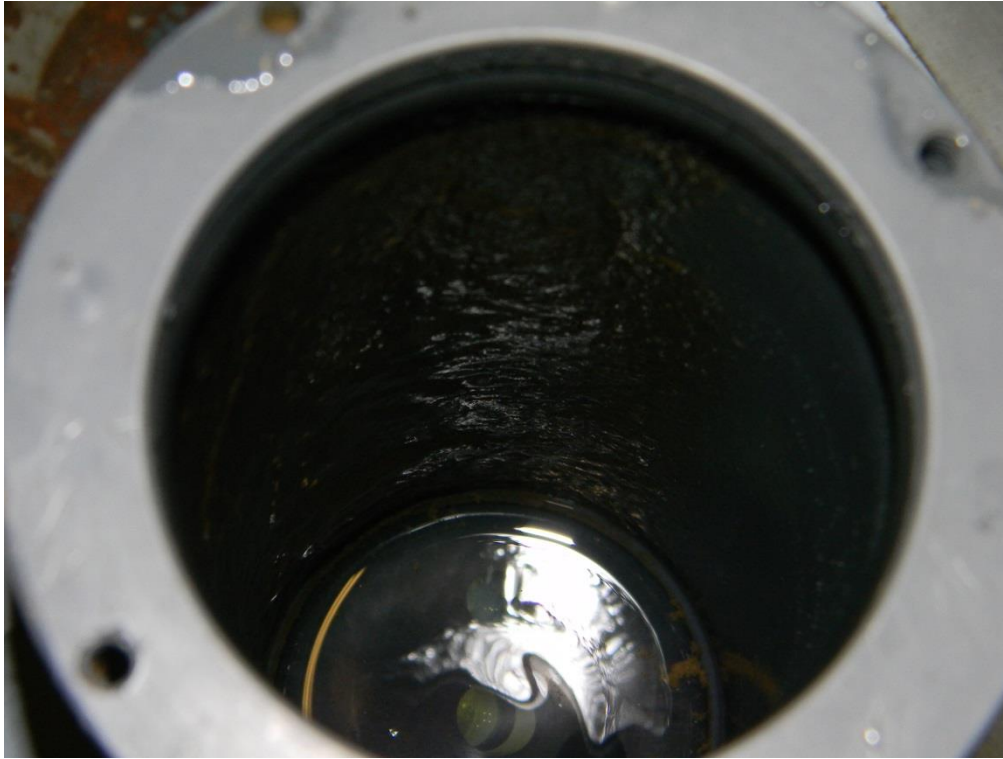
Figure 9: Biofouling within BBFL2 unit.

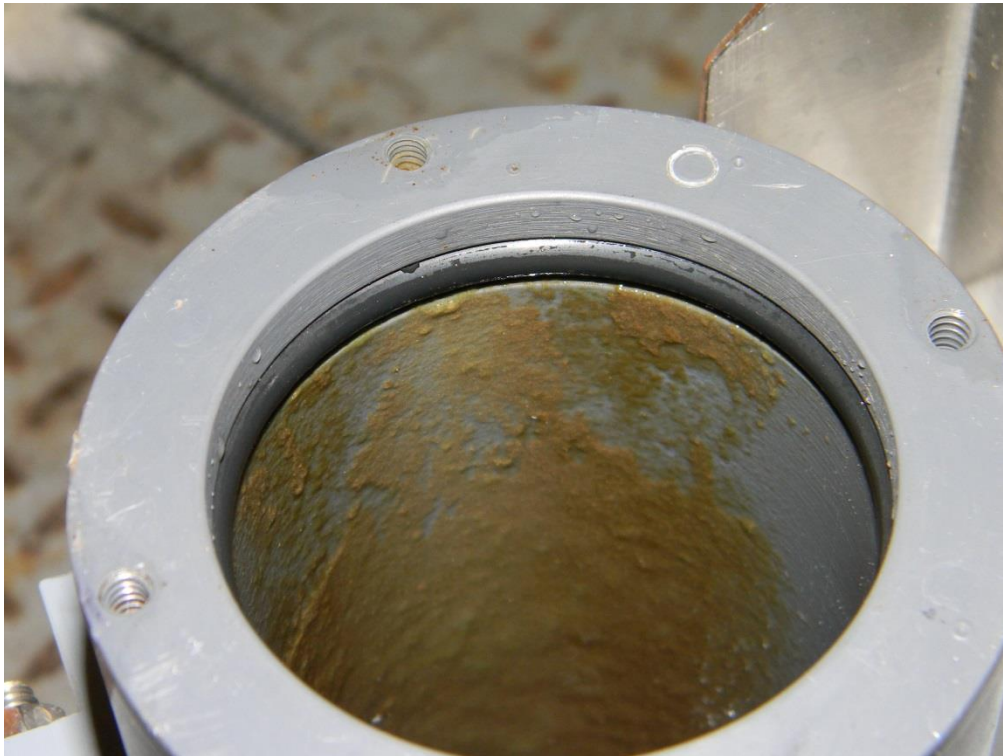
Figure 10: Biofouling within BBFL2 unit.

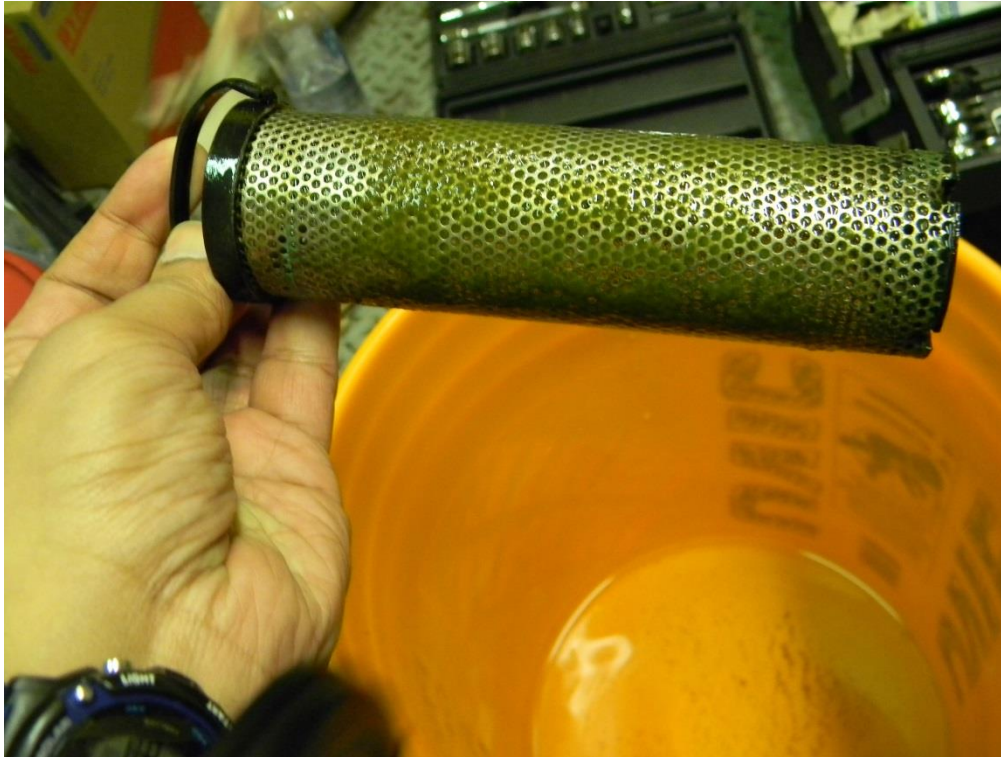
Figure 11: Biofouling of Sea Strainer.

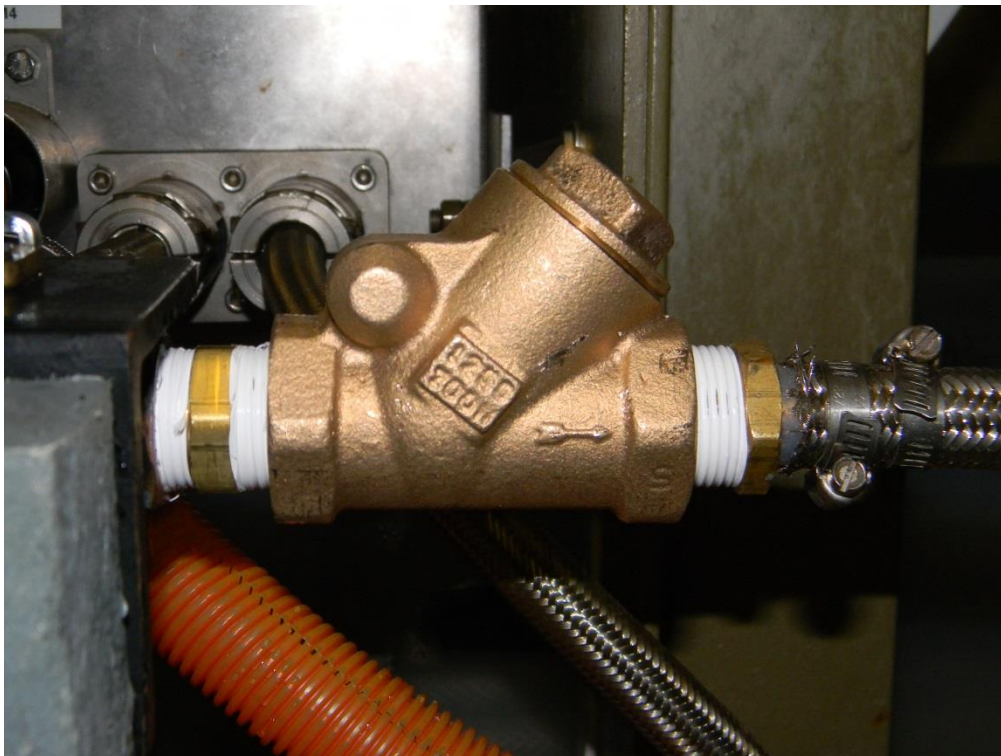
Figure 12: New backflow preventer check valve on output line.

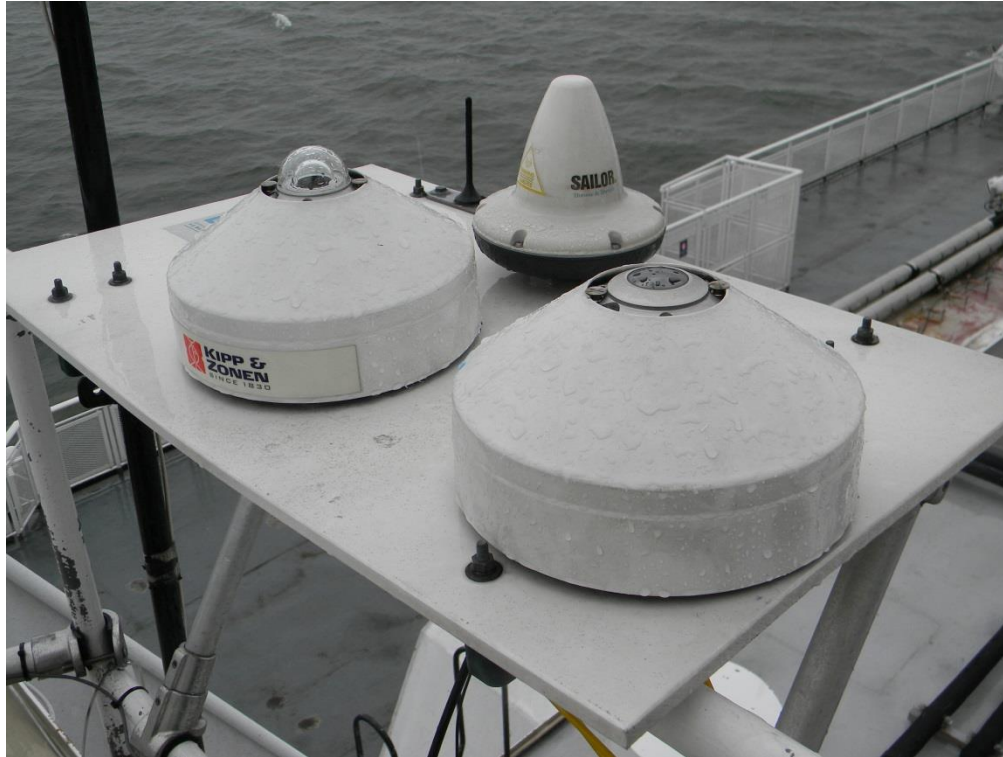
Figure 13: Radiometer and Pyranometer as remounted.

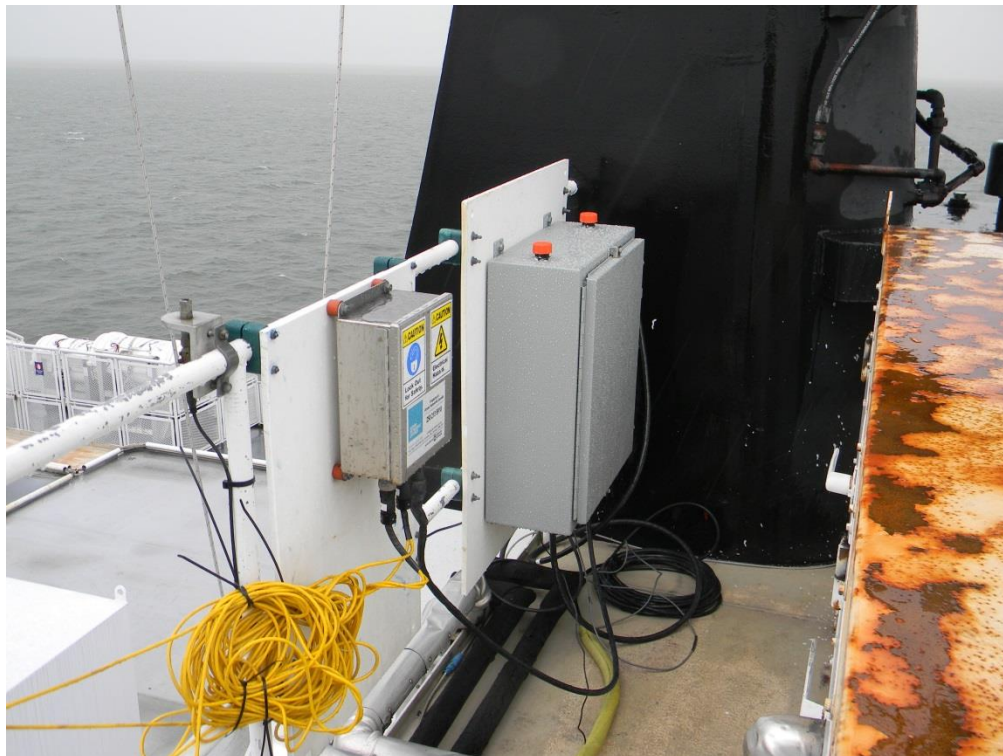
Figure 14: Remounted Campbell Scientific interface box.
