## **Ocean Networks Canada**

### **Ferry Maintenance Report – Queen of Alberni**

**Vessel: Queen of Alberni** @ Twass.Terminal docked at Berth 3

Date: May 6th 2015

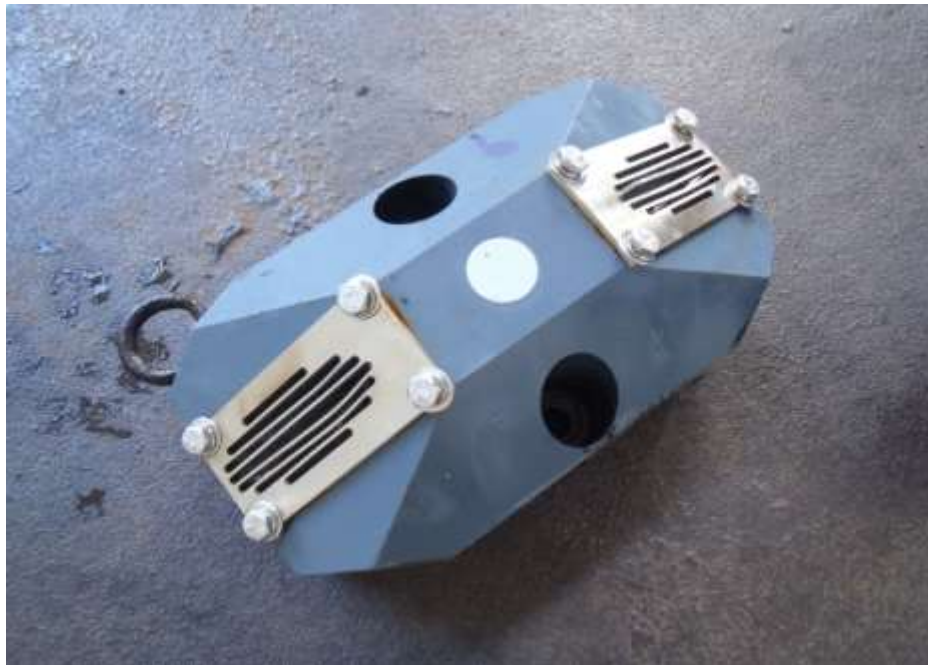
11. Pod on deck. Pod Ball easily moving left to right inside its chamber. Observed slight dents on each side of stainless steel intake screens.
12. Dismantle pod. Clean pod thoroughly. Insert new ball and insert 3" copper tubing into intake to refrain pod from twisting. Twisting or turning of the pod is possible due to the missing lug. The 3" copper tubing may help position the pod in place, and help pod from turning on its side.

Intake Pod after recovery – notice dents in grills

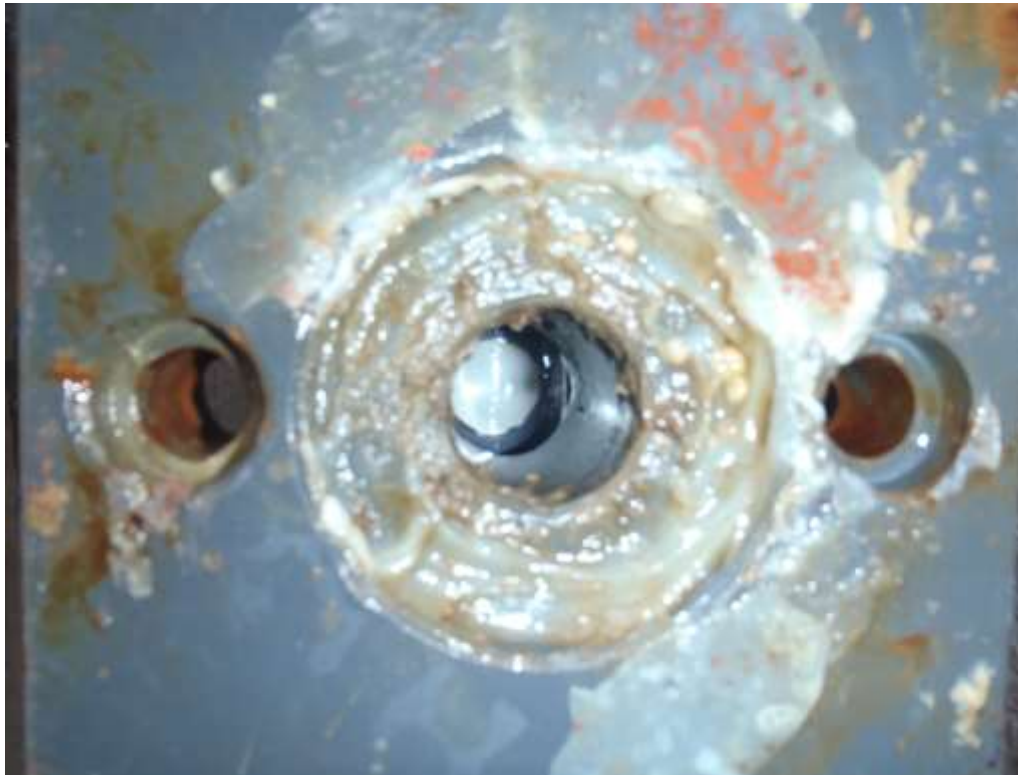
9. Diver located pod intake. Diver noticed that there is a lug missing from the pod. There seemed that only one lug held down the pod.
10. Diver visually looked into the intake valve and it showed minimal or next to none growth. Diver wiped with finger the insides of the intake chamber. Video is being developed by All Sea, and will be available to ONC once emailed to us.

Intake Pod internals –notice minimal growth

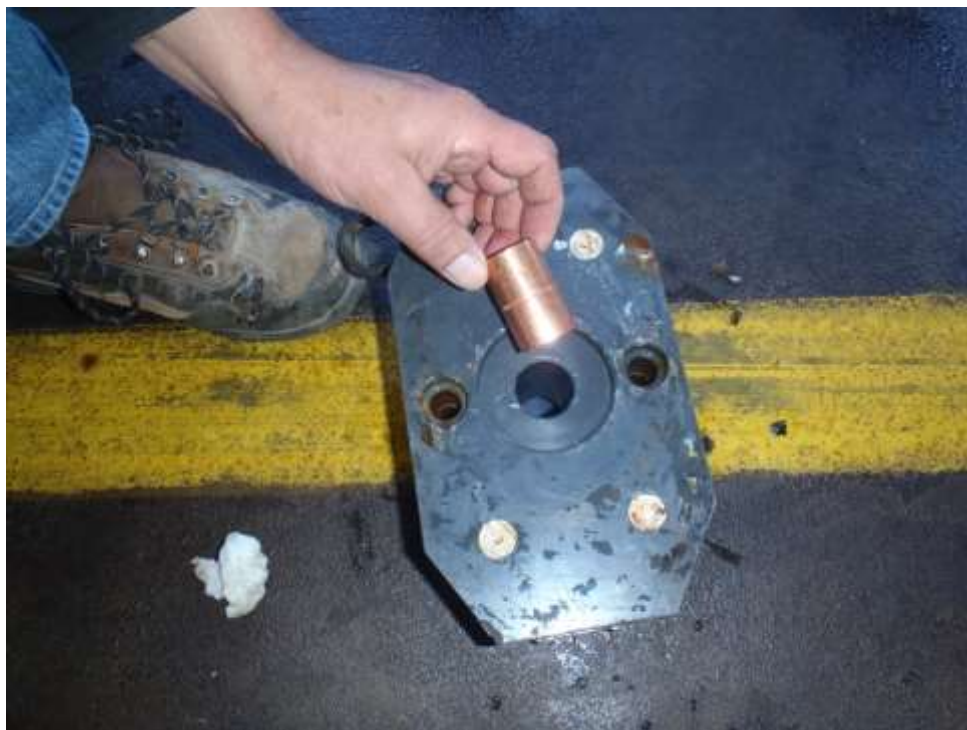
Intake Pod – insert Copper piping in intake chamber to resist twisting when ship is underway and pod under pressure. Had to do this due to one of the lugs to tighten the pod was missing.

1. Use All SEA divers to weld on top of the existing POD intake lug bolt a plate that has four lugs pre-attached. Intake pod can be mounted, and tighten down on top of this new plate.
2. Bring more Desicant bags
3. QoA on Dry dock Oct 2016
4. Update Rogers Cell network card /service to better service system/ network
5. Strip down Intake manifold if not replace it. Internal manifold back flow spring loaded valve may be bad, or marine growth (especially mussels) may be building in areas where we cannot see.

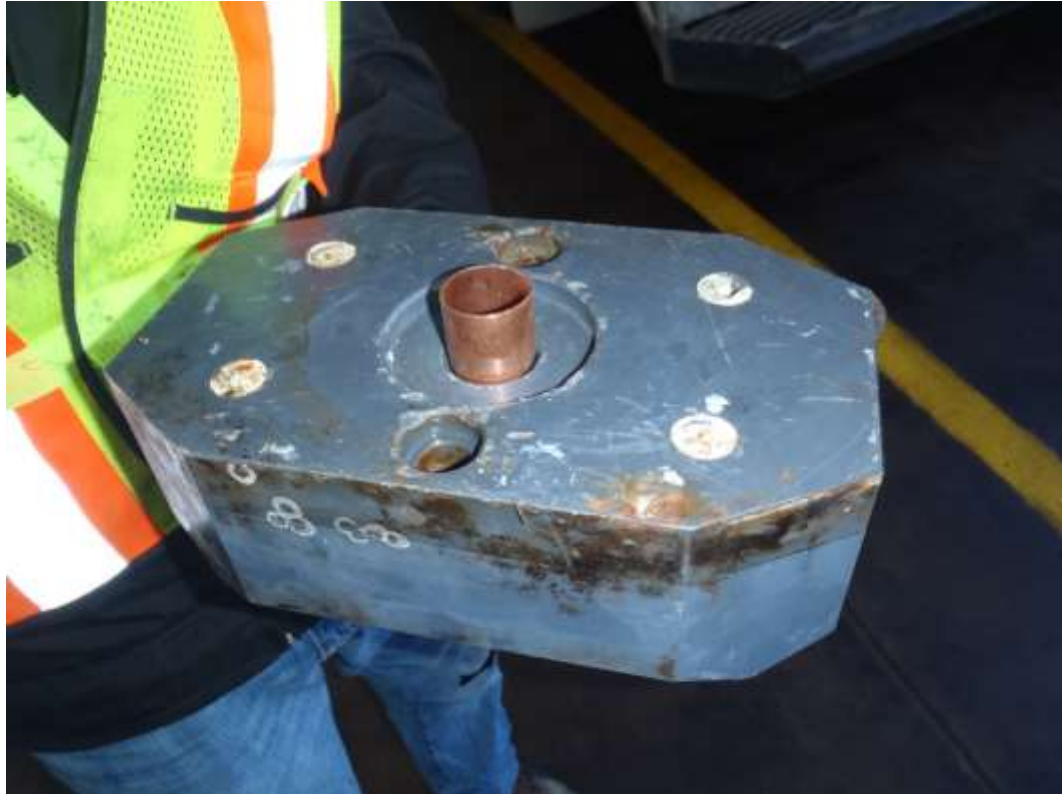
Intake Pod – Copper tube inserted into intake

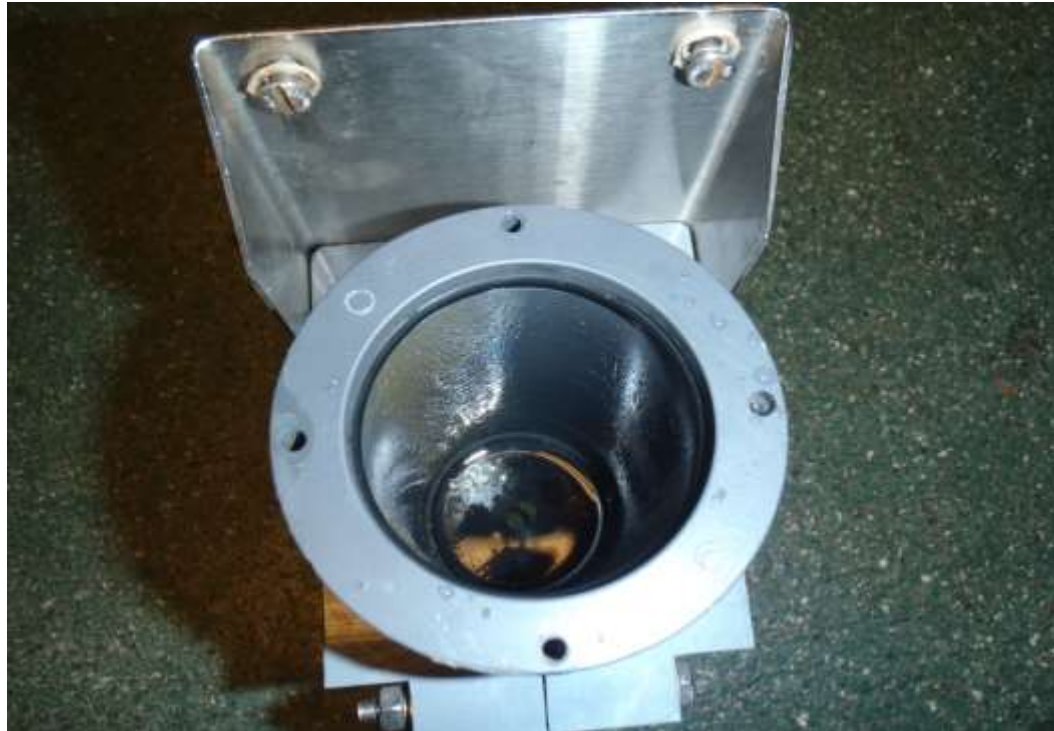
BBFL2 prior to cleaning

13. Diver install pod, and check OK. Video of dive has been captured. Josh to email copy of video.
14. Power down system, and pull off BBFL2 instrument. Clean, and re-mount.
15. Power system back ON. Check instrumentation data output via Hyperterminal and Seakeepers software.
16. Ran pump for couple minutes to check leaks. No leaks apparent. Turn OFF pump, but, left system powered ON. Close housings.
17. Sign out at Engineering room

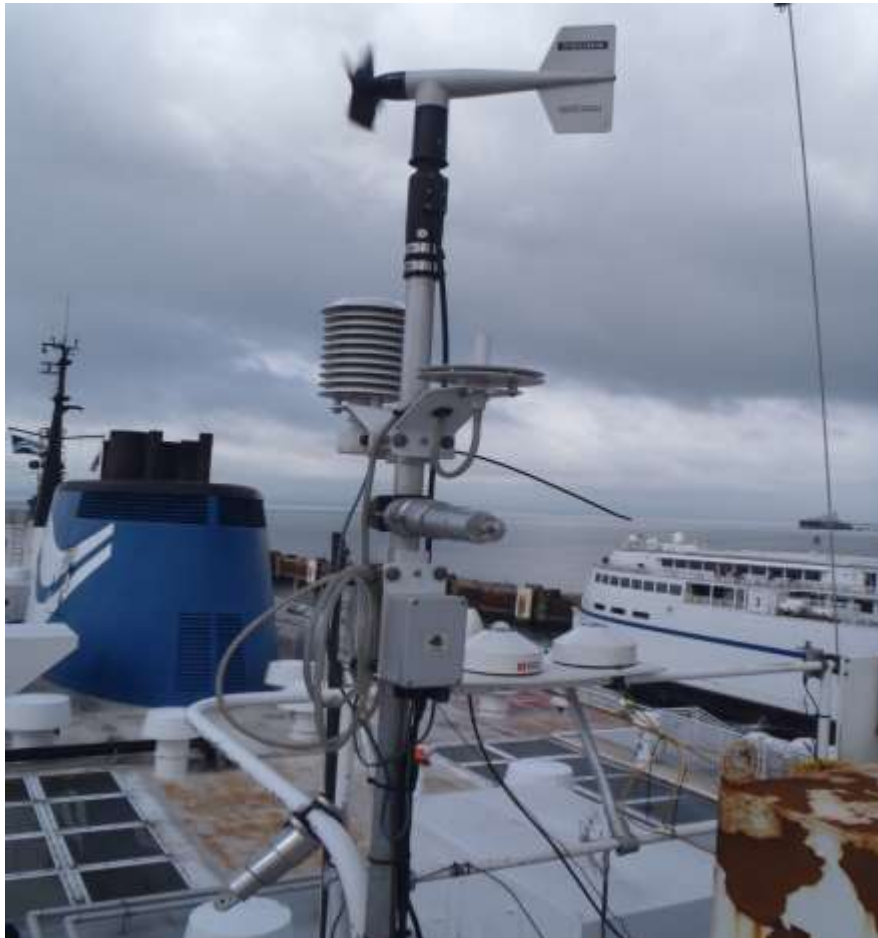
MET station at upper deck with Radiometers/GPS in background

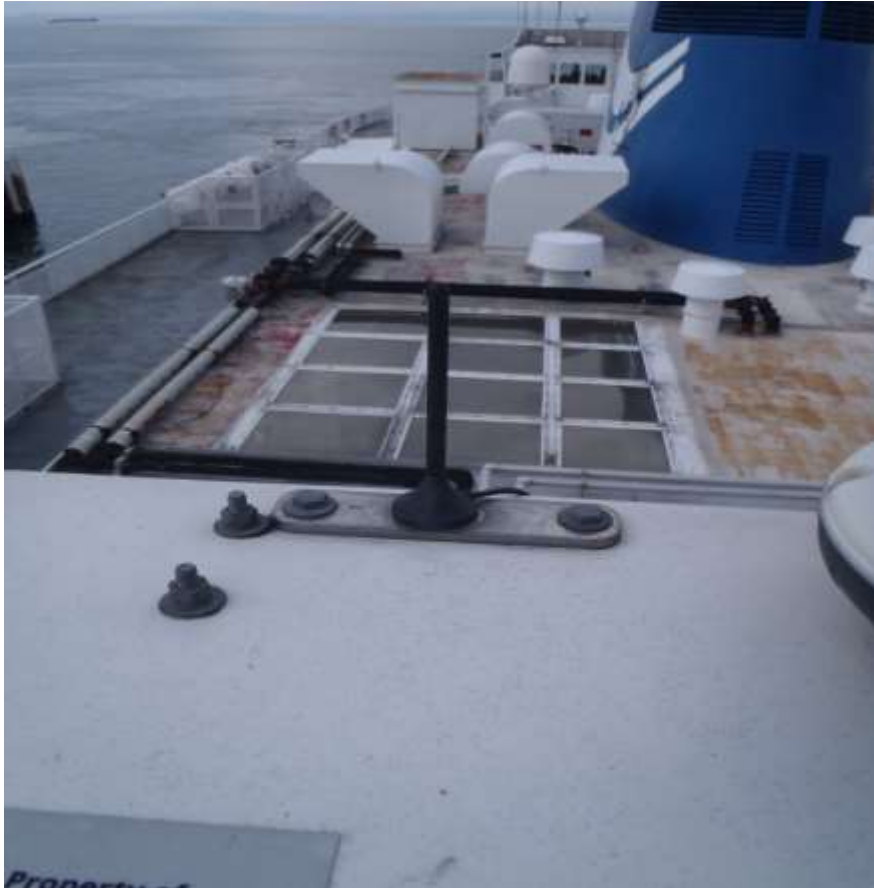
4. Instrument housing dry and clean.
5. During diving setup, went up to upper bird nest to inspect upper instrumentation. The wires/ cables visually look good. Cell antenna OK. Radiometer electronics housing connectors corroded. Need to swap with another box with no connectors externally.

Cell Antenna – no damage/ looks good !

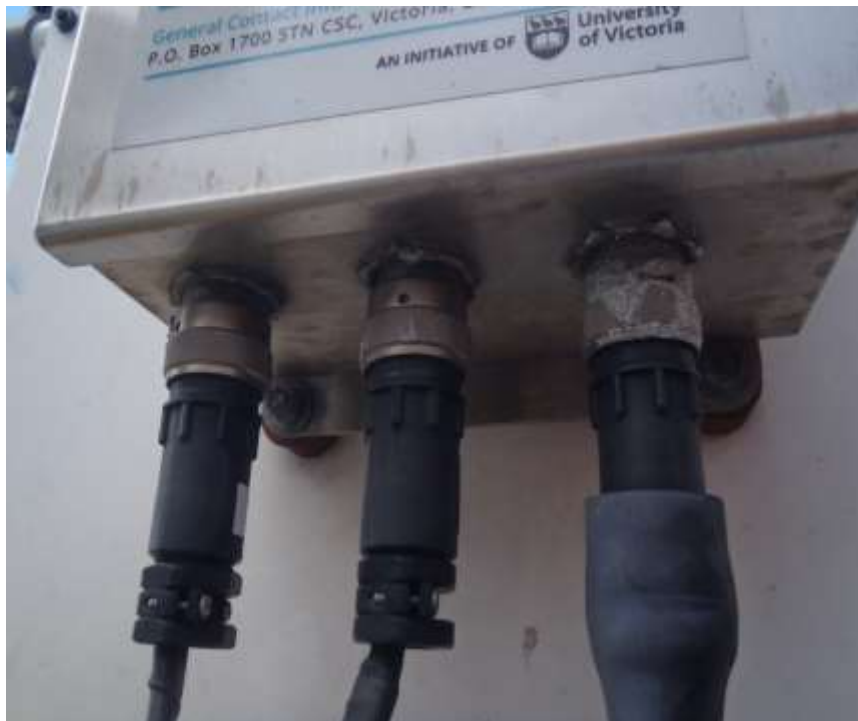
Radiometer Data Logger box – connectors corroding

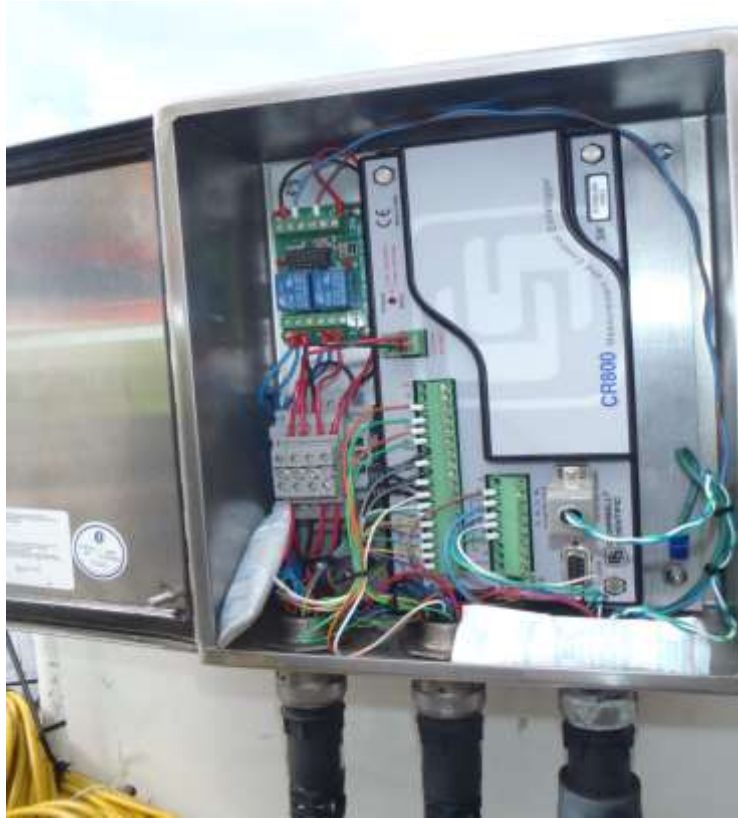
7. Open Radiometer box. Internal box shows no signs of moisture. Connections /wires OK.
8. Divers in water at 11am. Must be out by 12:15pm due to a set of ships arriving back to terminal.

Data logger housing interior – dry, and connections intact

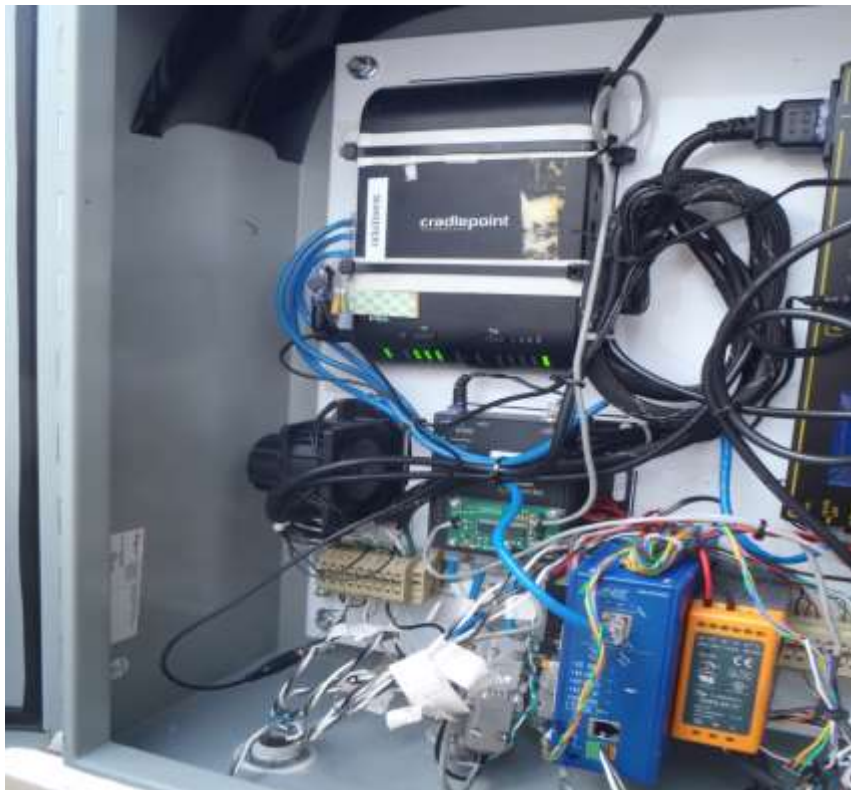
6. Open Upper box, and check for loose items. Verify Rogers Comm. Card fully connected to USB port. Check OK. Was glued in place. DC adapters connected and glued OK. No signs of Moisture within box. Close box.

Upper deck electronics housing – dry and connections intact

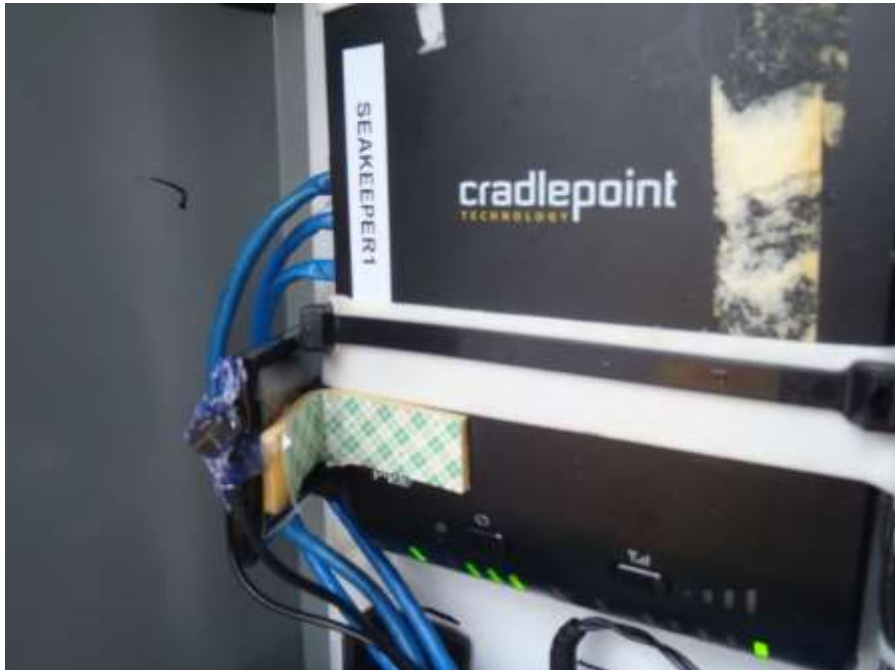
Rogers Wireless Card/adaptor at LHS – connections good + glued in place
