Ocean Networks Canada

Ferry Maintenance Report – Queen of Alberni

Date: June 19, 2015

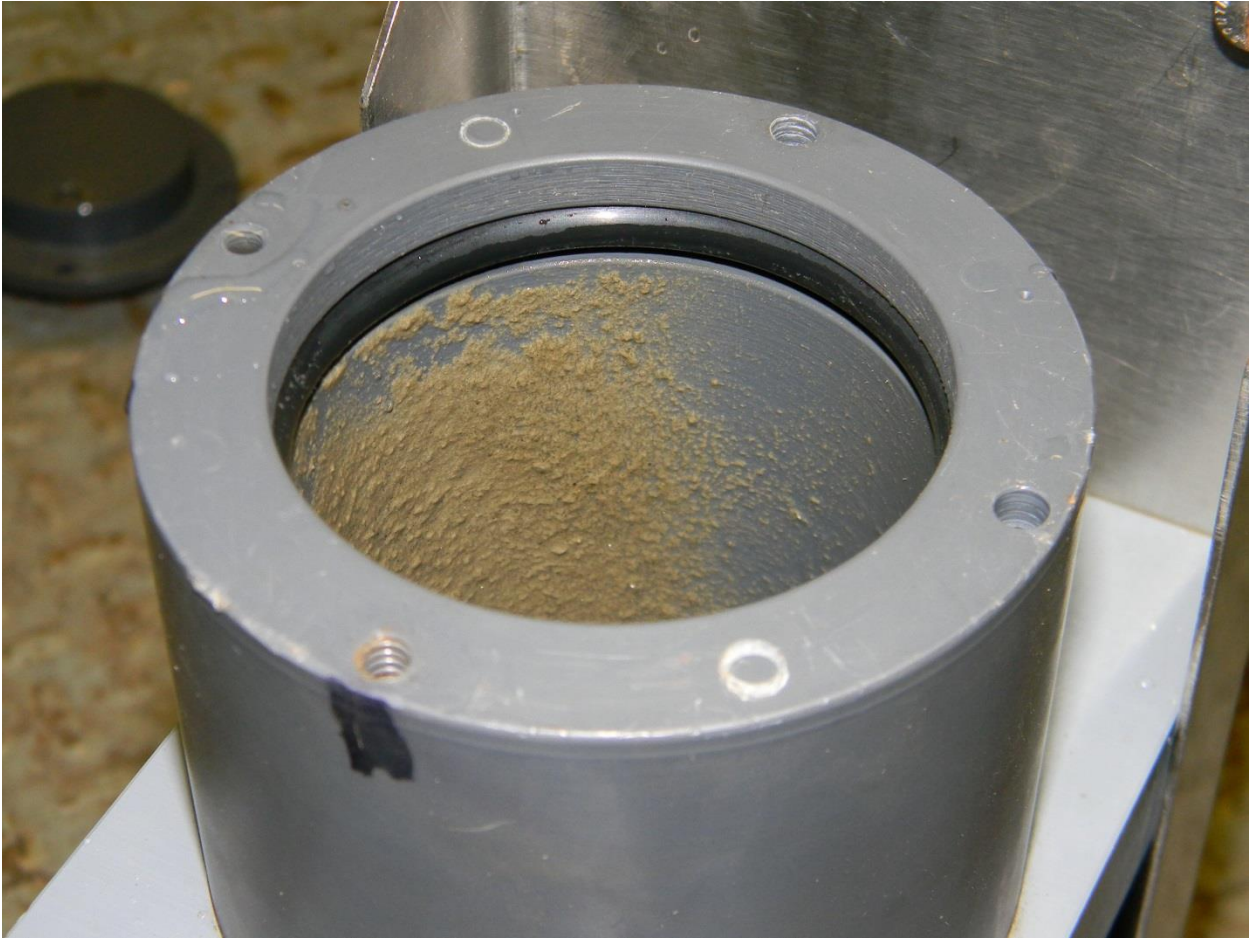
Figure 3: BBFL2 Sediment Film

Table 1. June 19, 2015. Mean (\pm standard error) values of pre- and post-cleaning fluorescence for solutions specific to CDOM and Chlorophyll fluorescence. 'fluor' values for Diet Coke (Chl) and Sprite Zero (CDOM) have been used for several of the past maintenance trips to assess the degree of signal decay between cleanings. The pre-cleaning fluorescence values standard solutions were all greater than post- values. The relatively high % difference values suggest significant bio-fouling of the BBFL2 lenses since the last maintenance trip on May 27, 2015.

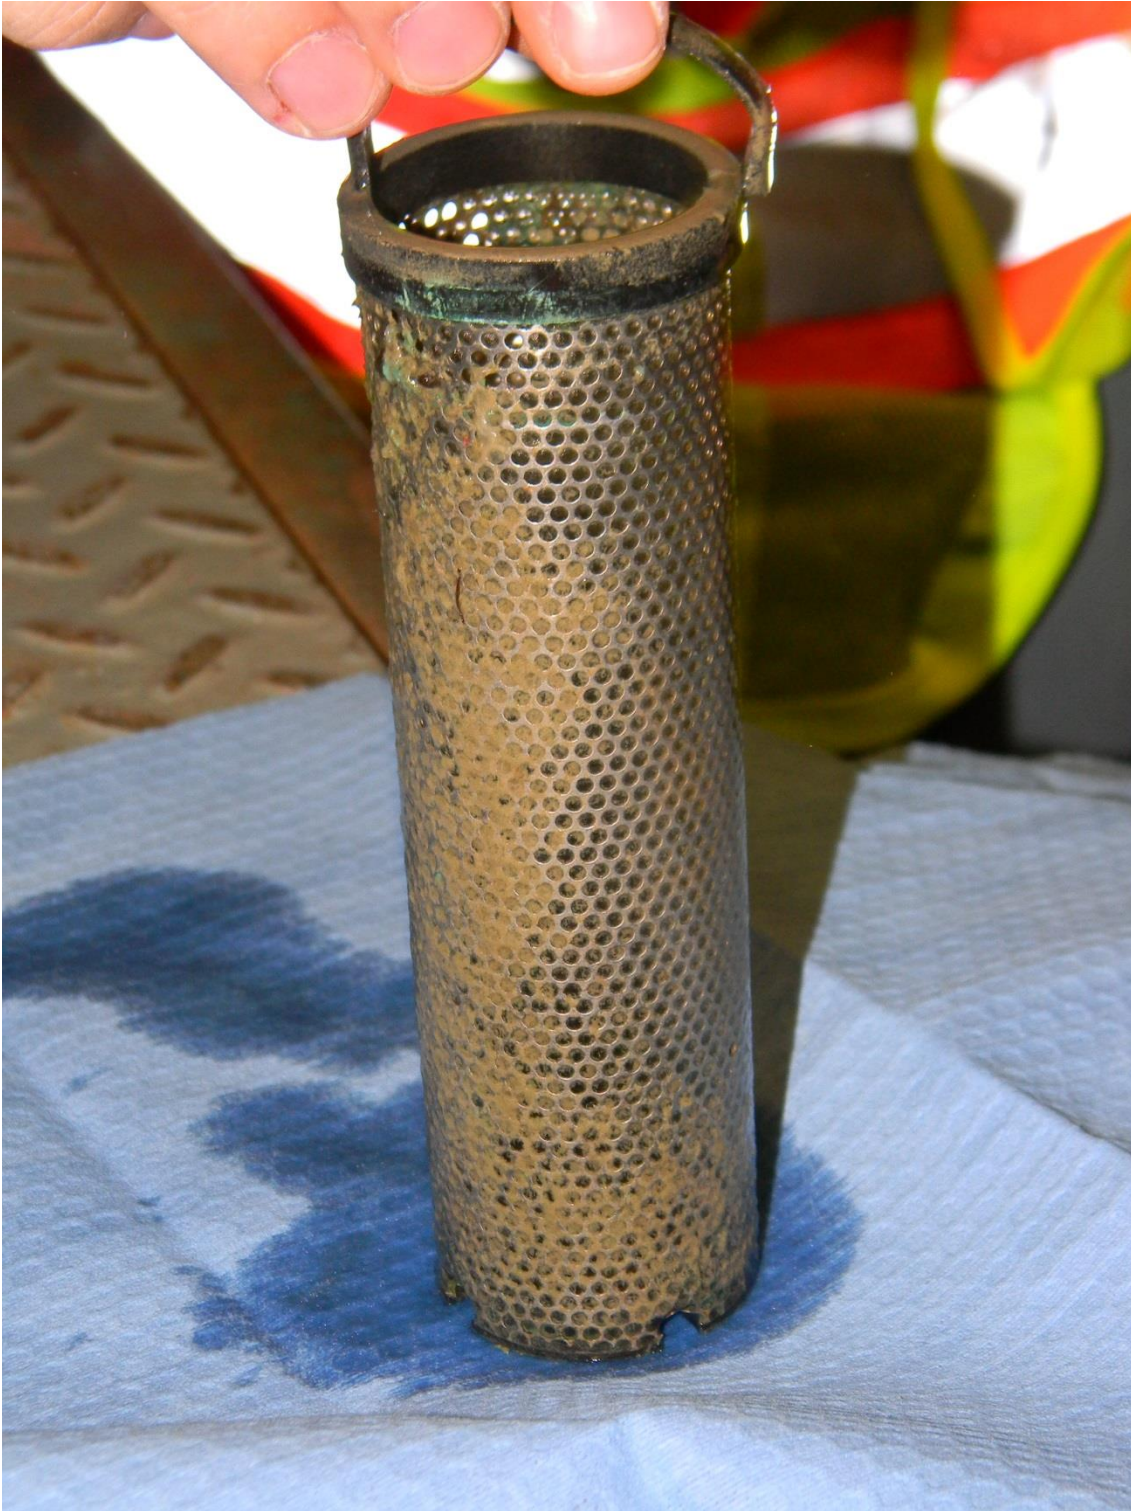
Figure 5: Sea Strainer

1. In the Instrument Box there were no signs of moisture at all.
2. The Sea Chest was dry with no evidence of leaks.
3. The Sea Strainer was dirty with one small crab inhabiting the region where the strained material resides.
