Ocean Networks Canada

Ferry Maintenance Report – Queen of Alberni

Date: August 1, 2014

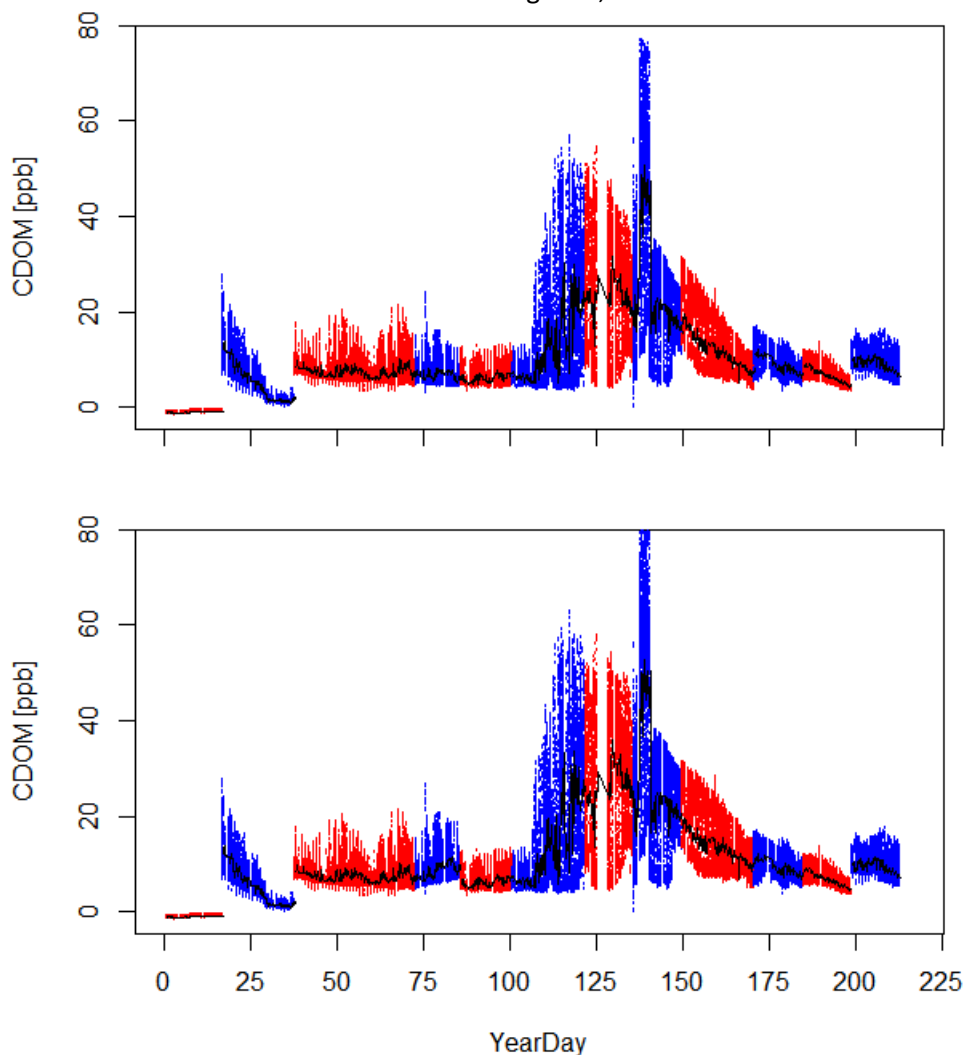
Figure 1. Time series of a) un-corrected; and b) corrected CDOM fluorescence measured en route between Duke Point (Vancouver Island) and Tsawwassen (Mainland, BC) by the BBFL2 unit of the SeaKeeper 1000 instrument suite on board the BC ferry, the Queen of Alberni. Red and blue symbols are used to distinguish between instrument cleaning dates. The difference between pre- and post-cleaning fluorescence of diluted tonic water was used to calculate a correction factor (%) which was applied as a linear correction retrospectively between cleaning dates. The most recent cleaning event took place on August 1, 2014. On this date, we failed to see a positive increase in CDOM fluorescence of diluted tonic water (see Table 1). Pre- and post- values for Sprite Zero were used instead. However, the derived correction factor appears to be too modest. Note: an instrument inter-calibration applied to all data following day 149 when BBFL2-786 was swapped out for BBFL2-787.

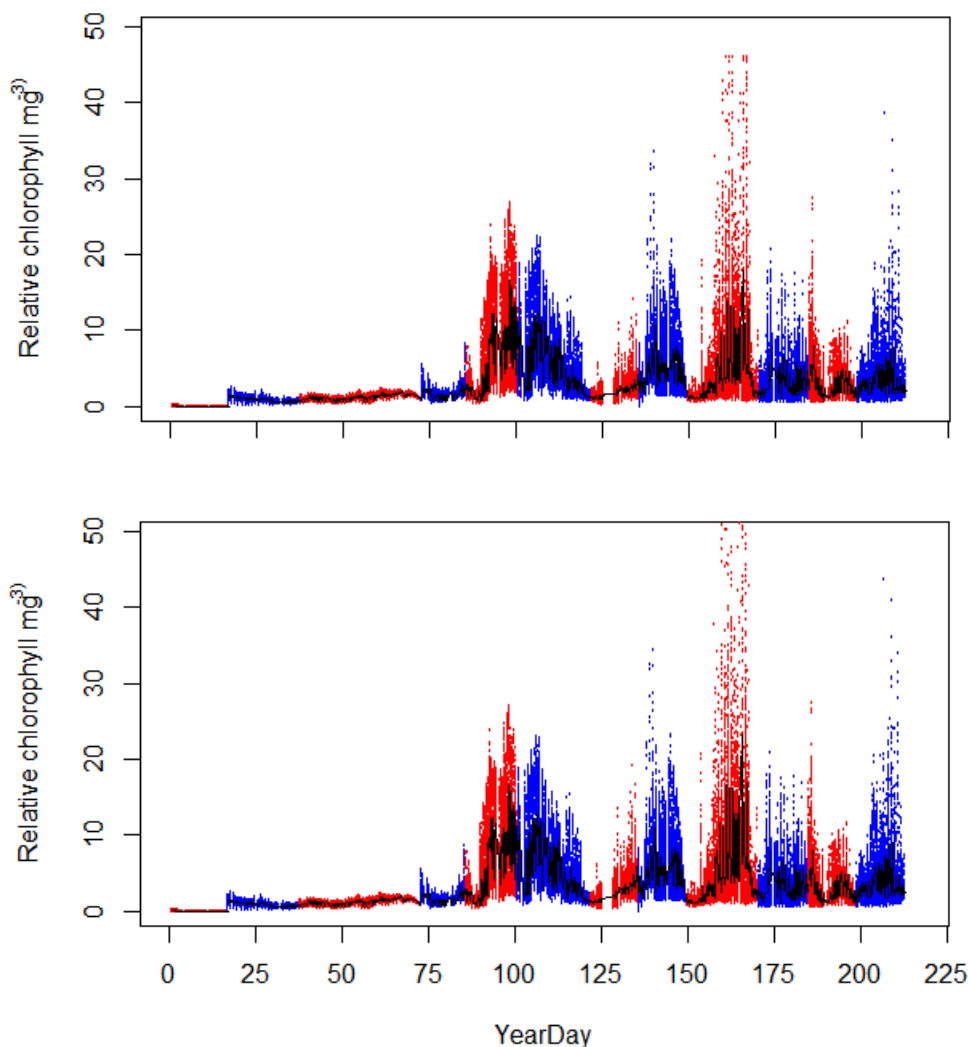
Figure 2. Time series of a) un-corrected; and b) corrected Chl fluorescence measured en route between Duke Point (Vancouver Island) and Tsawwassen (Mainland, BC) by the BBFL2 unit of the SeaKeeper 1000 instrument suite on board the BC ferry, the Queen of Alberni. Red and blue symbols are used to distinguish between instrument cleaning dates. The difference between pre- and post-cleaning fluorescence of diet coke was used to calculate a correction factor (%) which was applied as a linear correction retrospectively between cleaning dates. The most recent cleaning event took place on August 1, 2014. On this date, we measured a positive increase in Chl fluorescence of diet coke (see Table 1). Note: an instrument inter-calibration applied to all data following day 149 when BBFL2-786 was swapped out for BBFL2-787.
