Ocean Networks Canada

Ferry Maintenance Report – Queen of Alberni

Date: October 3rd, 2014

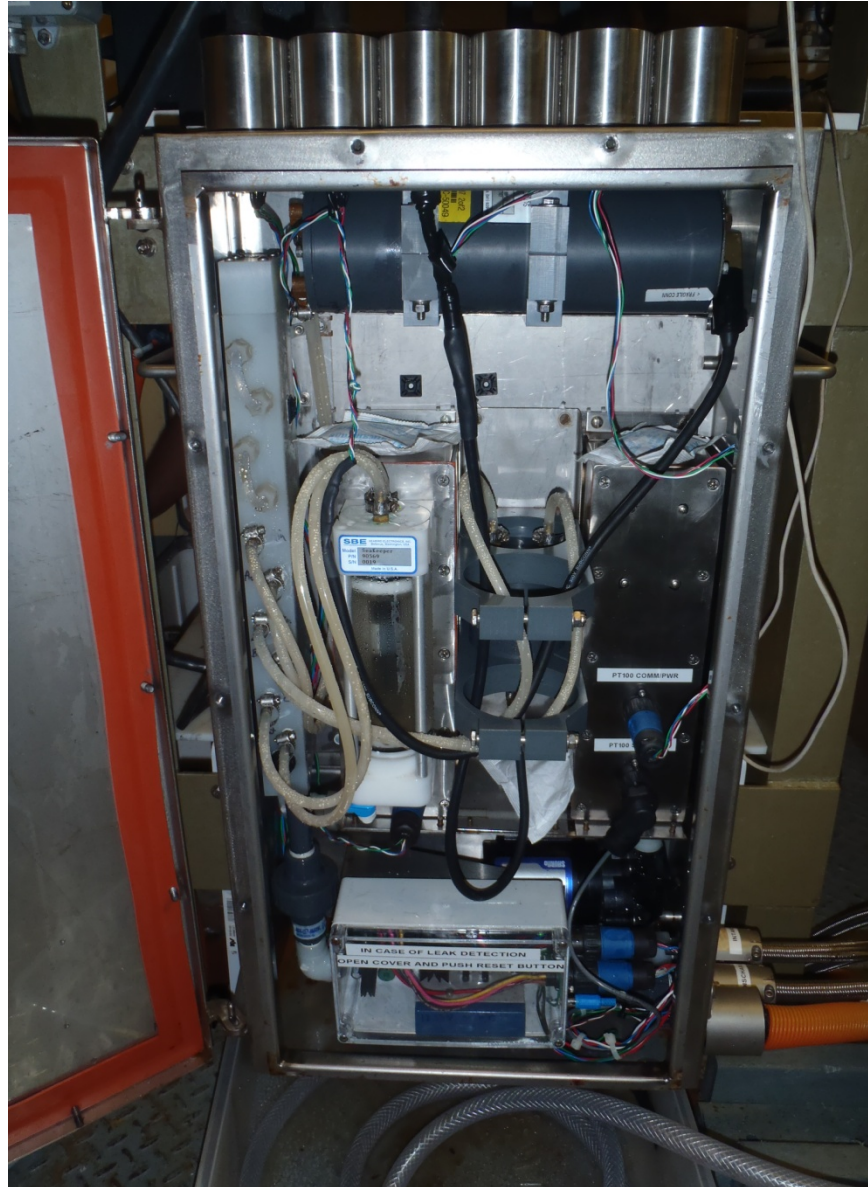
1. Signs of moisture at bottom of housing. Water manifold shows condensation.
2. The AADI optode (oxygen sensor) was slightly dirty with sediment/ bio film growth within the housing.

Figure 1: System upon arrival

1. Opened both boxes and observed function. Both were working well, no leaks anywhere. Dried off the moisture build up at bottom of instrument housing.
2. Powered down and disassembled instruments in lower assembly. CTD, Optode, lastly BBFL2.
3. Cleaned and checked over instruments in Engineering room. Cleaned CT sensor connector to remove sediment and biofouling growth. Take whole CTD apart. Wash clean.
4. Remove all tubing from Water manifold to instruments. Replace with new tubing.
5. Re-assembled the instruments in the lower box.
