Ocean Networks Canada

Ferry Maintenance Report – Queen of Alberni

Date: December 5, 2014

Regular instrument servicing + Calibration/comparison of Optode Instruments measurements

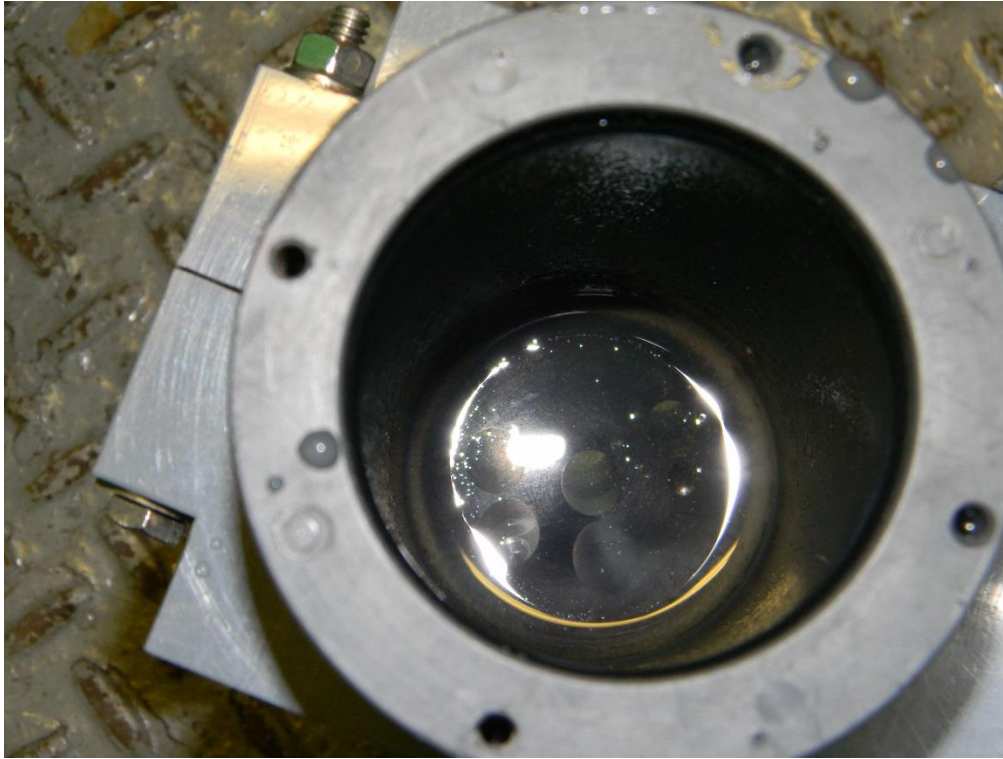
2. The AADI optode was slightly dirty with some limited sediment/biofilm growth within the housing.
3. The BBFL2 had a partial layer of sediment in the housing and some minor fouling on the sensing surface. Fouling was noticed on the “bottom” surface of the horizontal housing.

Figure 10: BBFL2 sensing face.

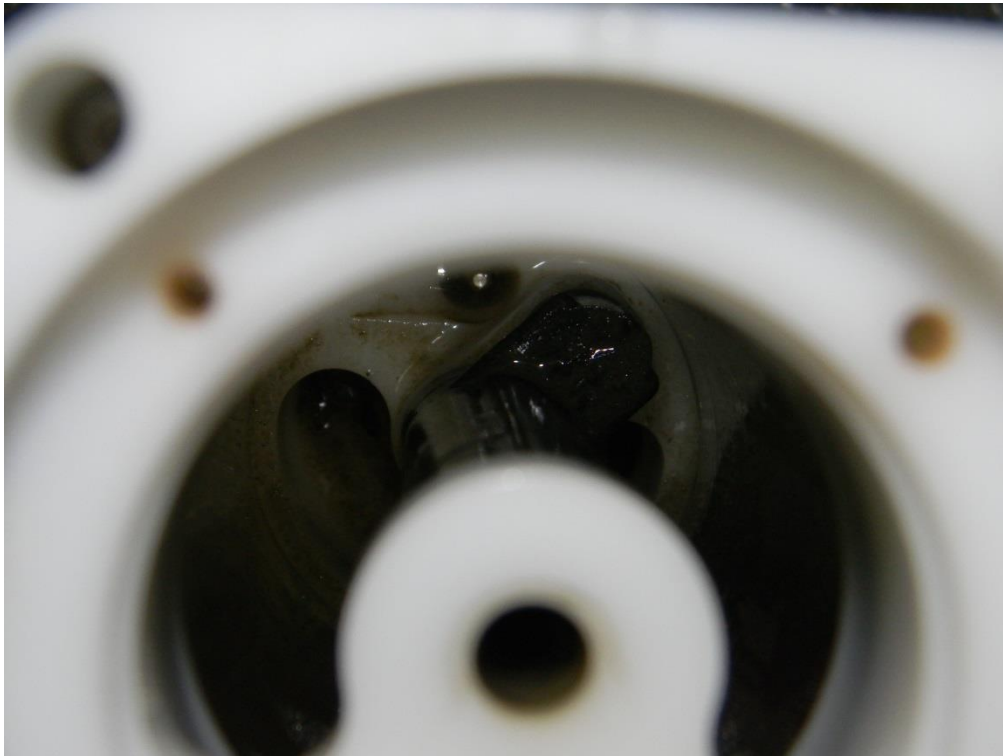
4. The Seabird 45 CT sensor was mildly dirty, with no mussels found growing within the housing on the sensor outlet port.
5. The flex tubing was in good shape, having been replaced recently. ALL of the barb fittings were, however, installed incorrectly, potentially causing one or more small micro-leaks and risking blowout of the piping.

Figure 11: Interior of CT sensor.

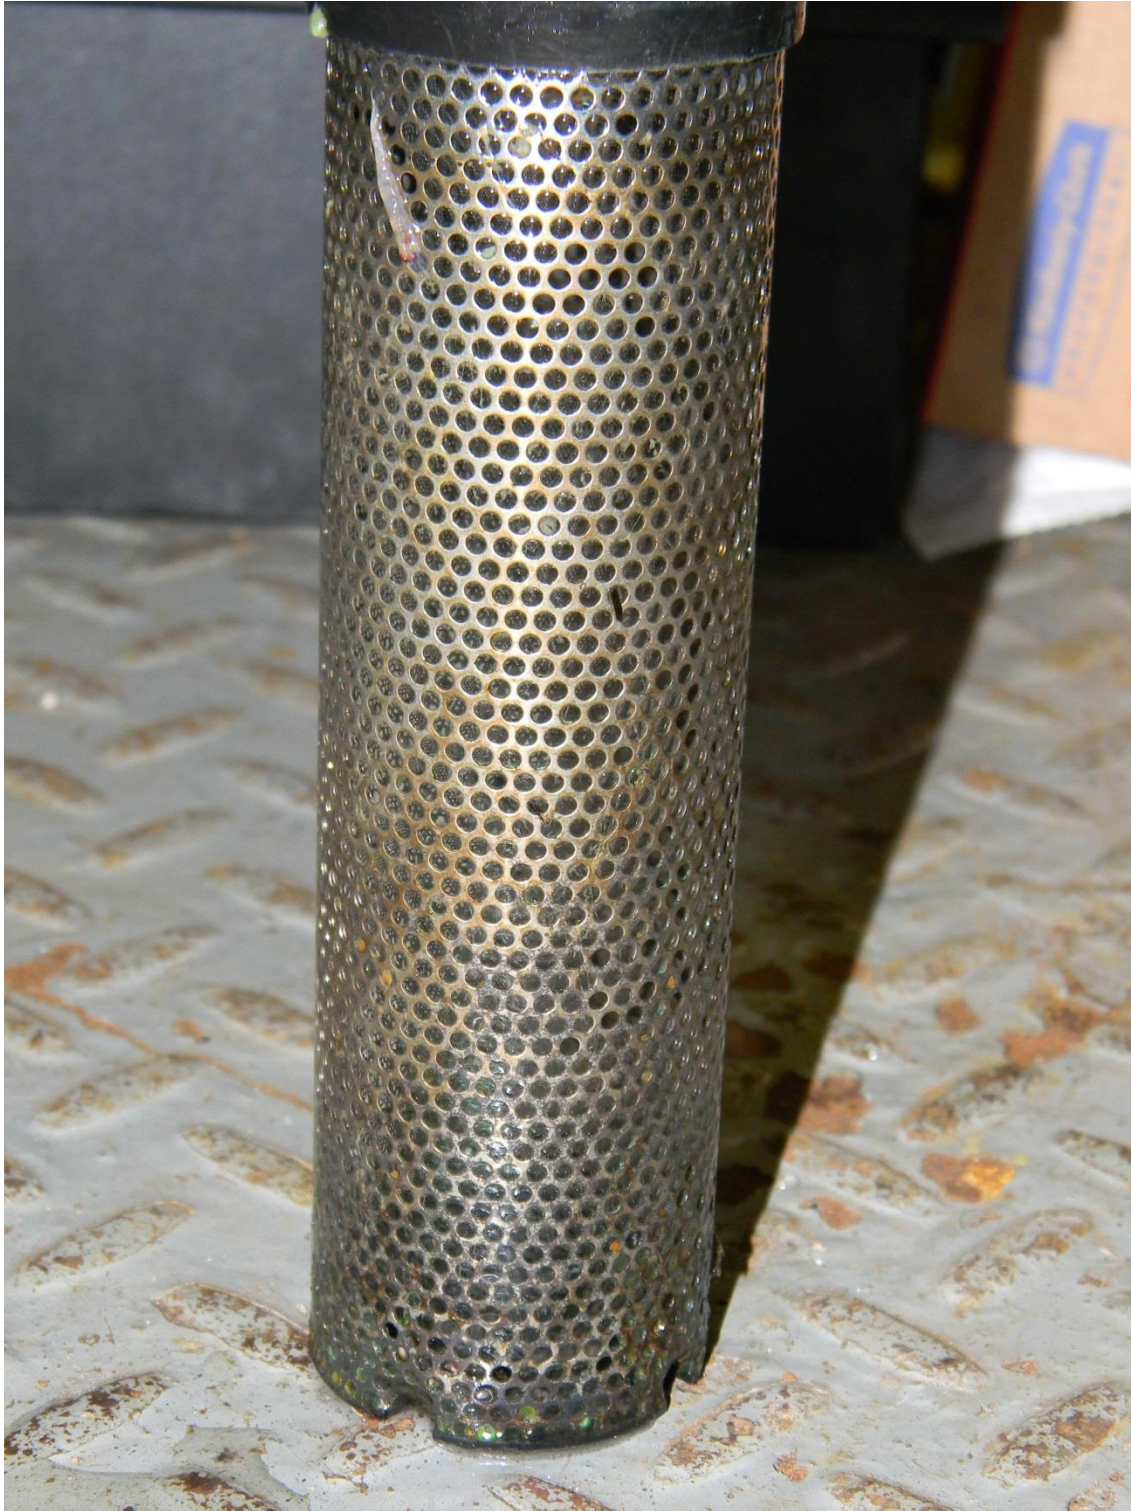
6. The sea chest showed no signs of leaks.
7. The inline filter (sea strainer) was checked and was found to be slightly dirty and required cleaning.
8. The leak sensor was incorrectly installed and incorrectly manufactured.

Figure 12: Sea strainer.

6. Checked over Sea chest and valves, no leaks apparent.
7. Checked and cleaned the sea strainer. Removed biofilm and sediment fouling from the strainer.

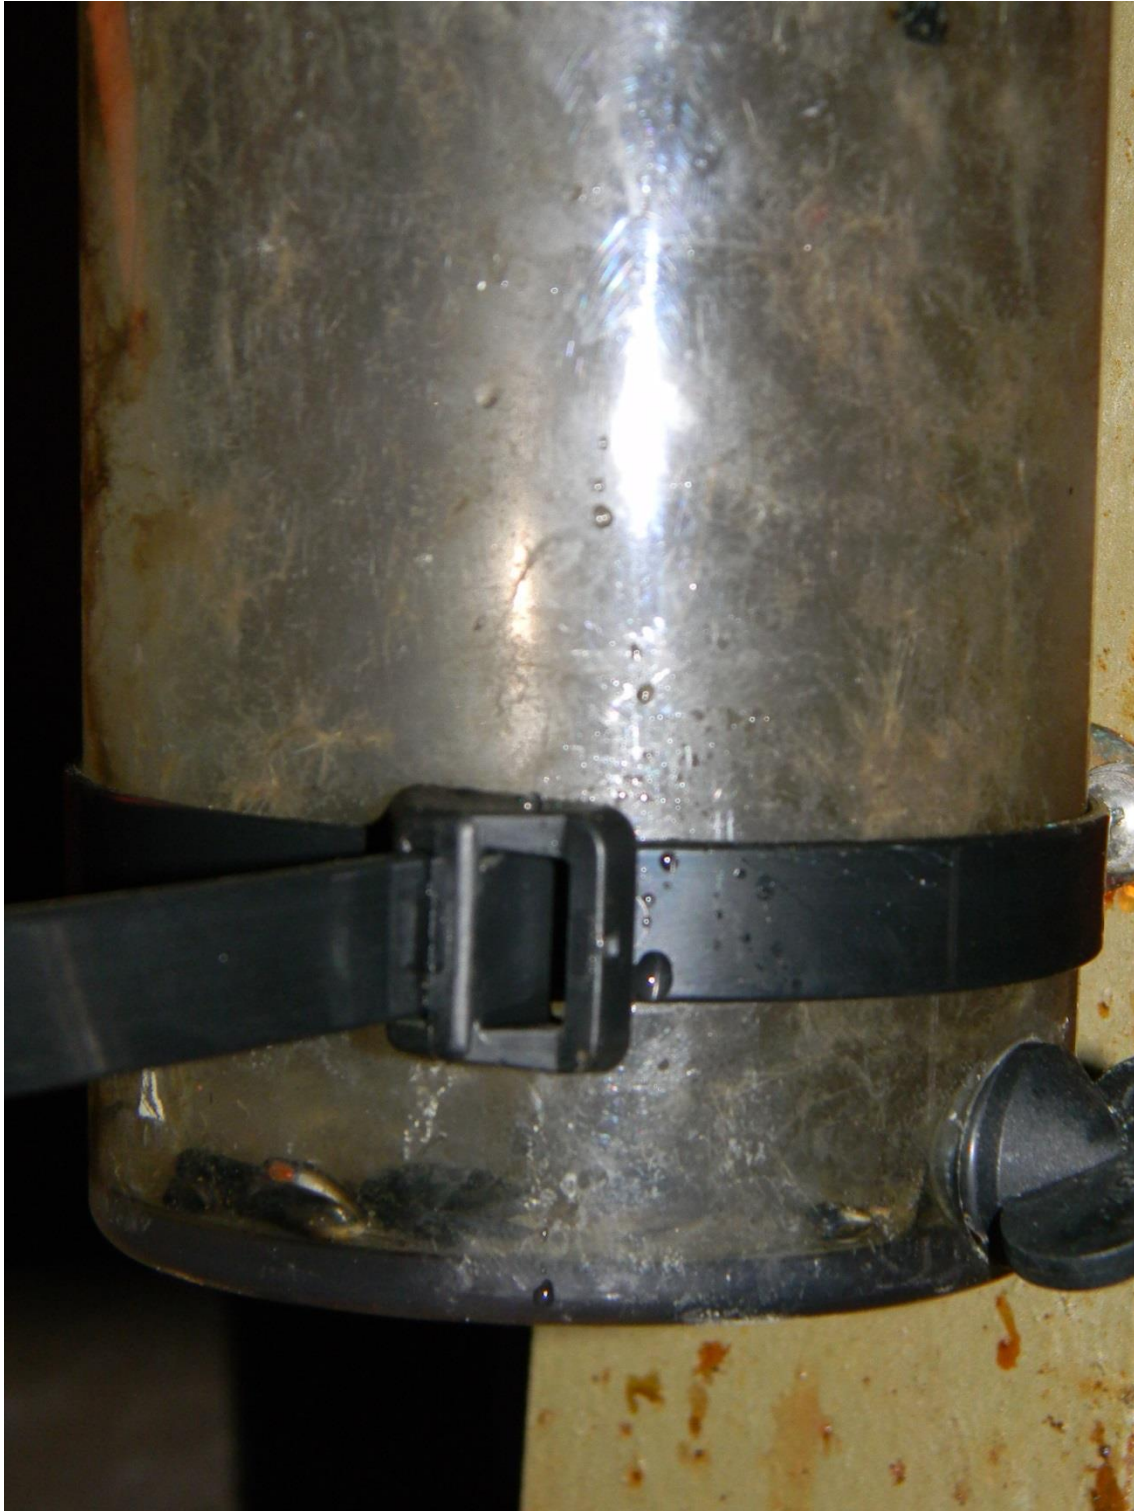
Figure 14: Sea Strainer.

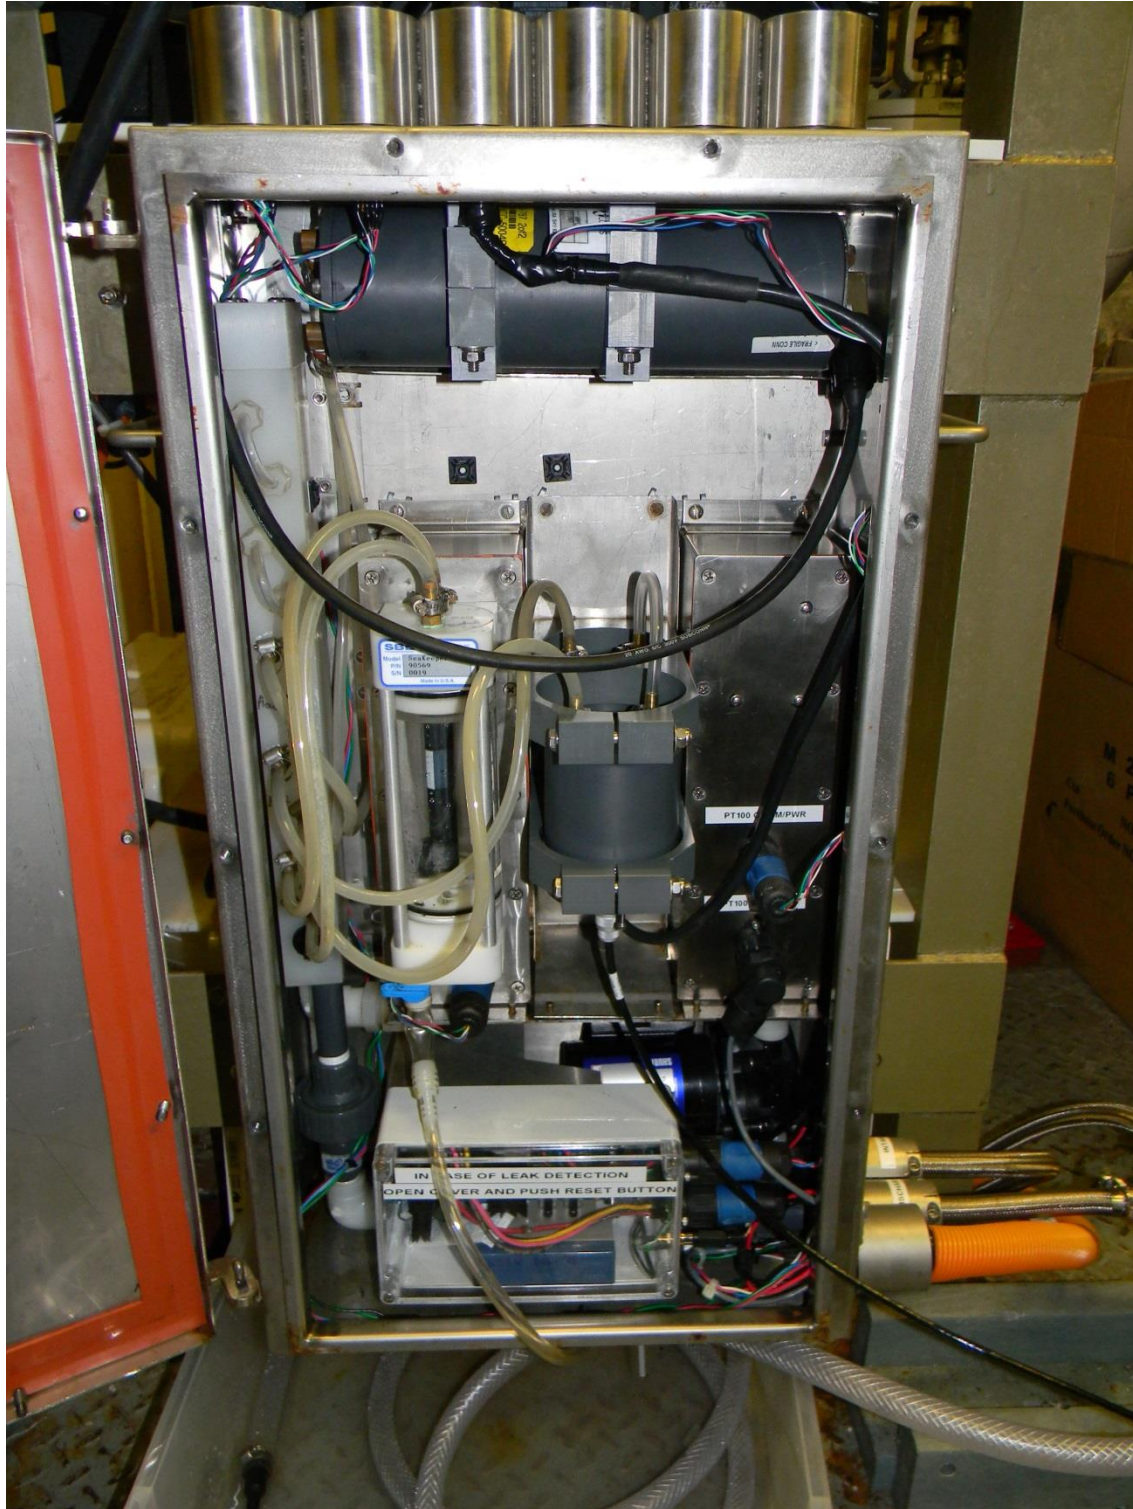
Figure 16: Temporary double-OPTODE and sample tube setup.

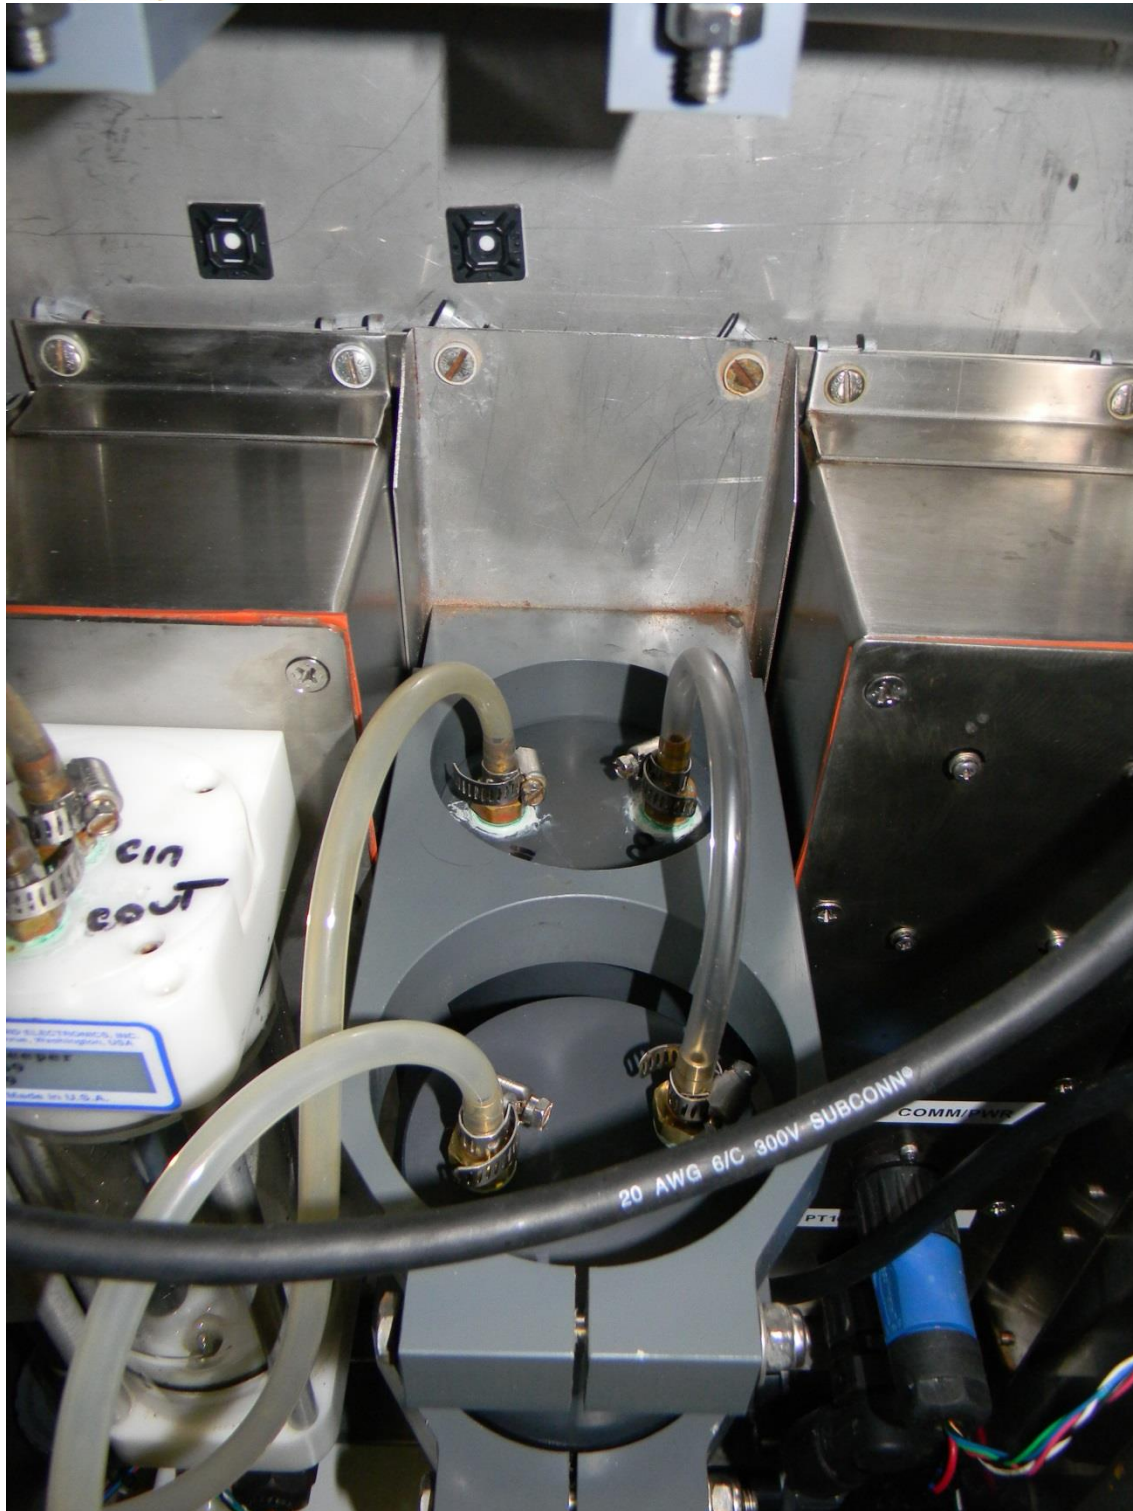
Figure 17: Double OPTODE setup.

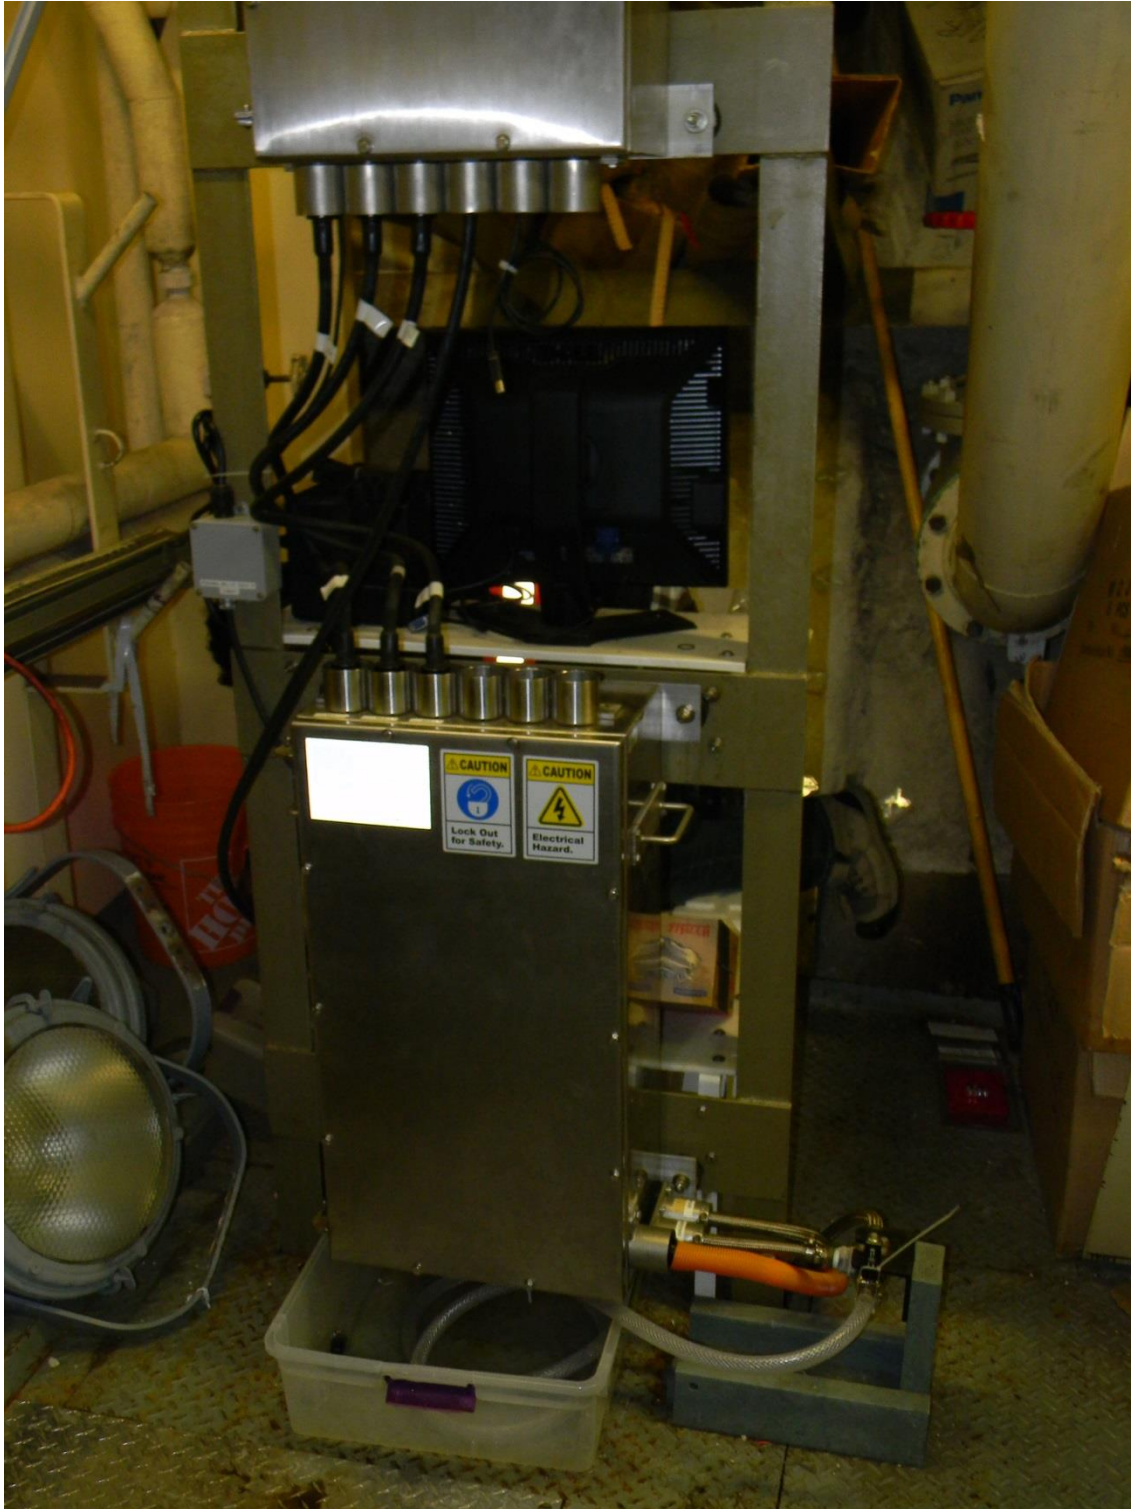
Figure 20: System upon completion.

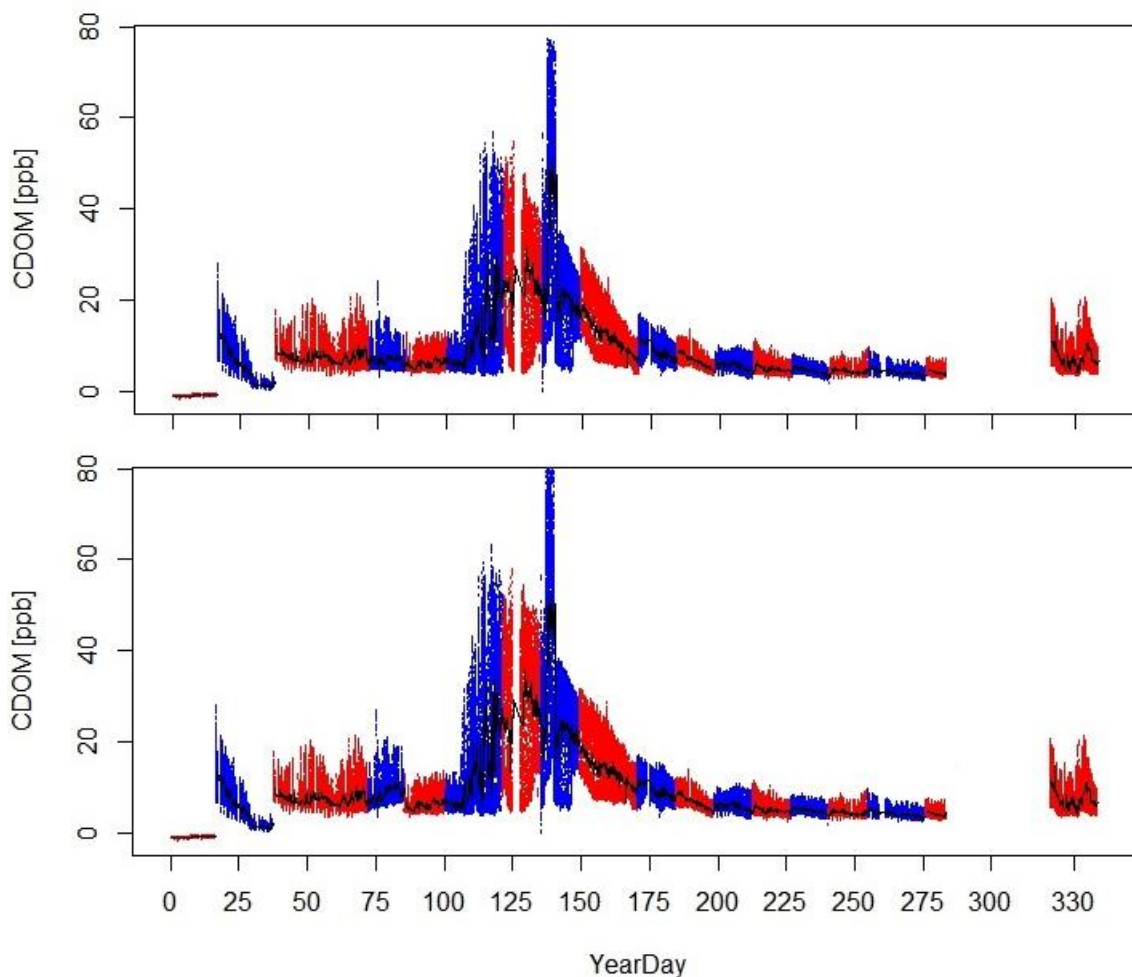
Figure 1. Time series of a) un-corrected; and b) corrected CDOM fluorescence measured en route between Duke Point (Vancouver Island) and Tsawwassen (Mainland, BC) by the BBFL2 unit of the SeaKeeper 1000 instrument suite on board the BC ferry, the Queen of Alberni. Red and blue symbols are used to distinguish between instrument cleaning dates. The difference between pre- and post-cleaning fluorescence of diluted tonic water was typically used to calculate a correction factor (%) which was applied as a linear correction retrospectively between cleaning dates. The most recent cleaning event took place on December 5, 2014. In keeping with most recent maintenance trips, we have used pre- and post- values for Sprite Zero (correction factor = $\sim 2\%$; See Table 1.) rather than Tonic water, although the difference between pre- and post- fluorescence values for Tonic Water were also positive. The correction factor was applied retrospectively to CDOM fluorescence values (b) between October 4 and December 5, 2014. The Queen of Alberni was out of service between October 11 and November 17, 2014. Note: an instrument inter-calibration applied to all data following day 149 when BBFL2-786 was swapped out for BBFL2-787.

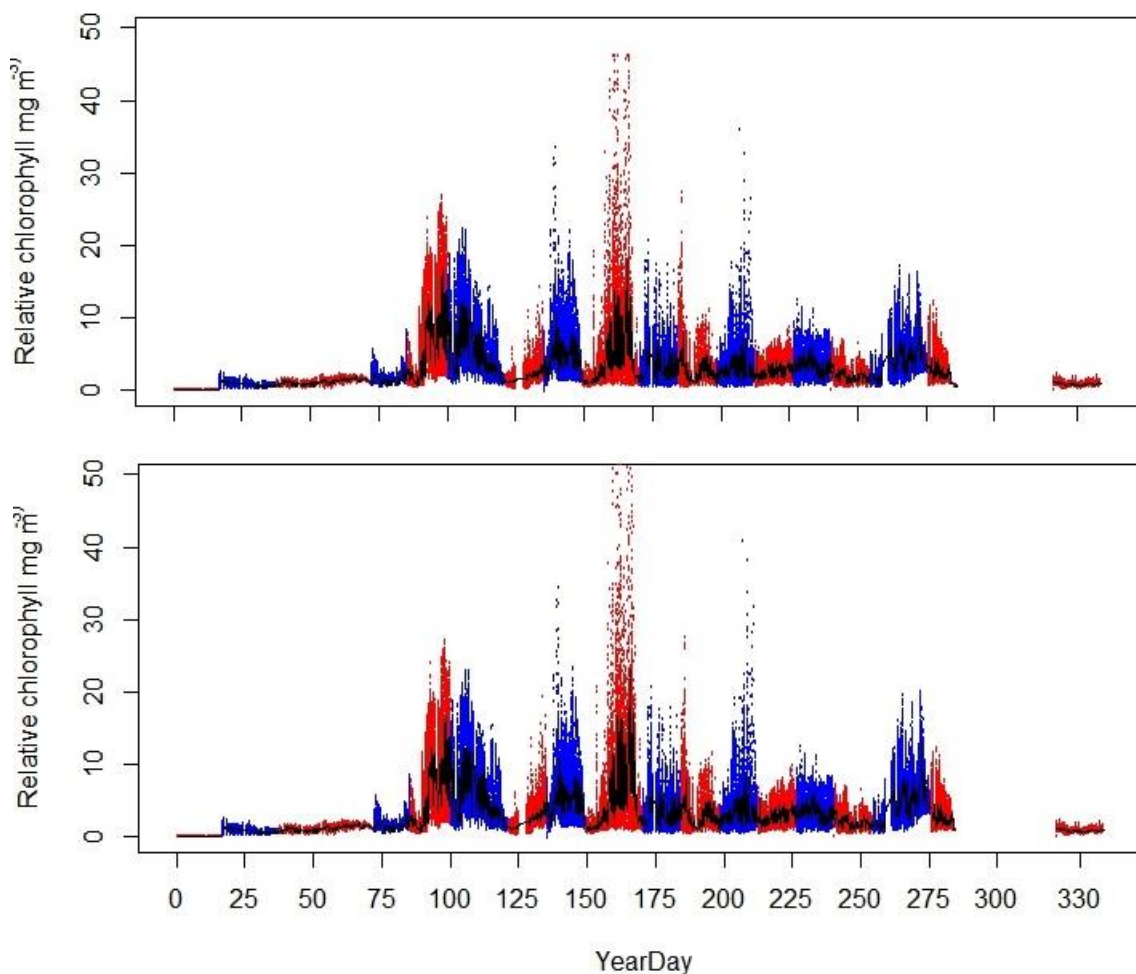
Figure 2. Time series of a) un-corrected; and b) corrected Chl fluorescence measured en route between Duke Point (Vancouver Island) and Tsawwassen (Mainland, BC) by the BBFL2 unit of the SeaKeeper 1000 instrument suite on board the BC ferry, the Queen of Alberni. Red and blue symbols are used to distinguish between instrument cleaning dates. The difference between pre- and post-cleaning fluorescence of diet coke was used to calculate a correction factor (%) which was applied as a linear correction retrospectively between cleaning dates. The most recent cleaning event took place on December 5, 2014. On this date we measured a positive (~2%) response of Diet Coke fluorescence to cleaning (see Table 1). This correction factor was applied retrospectively from October 4 through December 5, 2014. Note: an instrument inter-calibration applied to all data following day 149 when BBFL2-786 was swapped out for BBFL2-787.
