Ocean Networks Canada Ferry Maintenance Report – Queen of Alberni

Date: March 25, 2015

Reason for Visit

Investigate anomalous instrument readings.

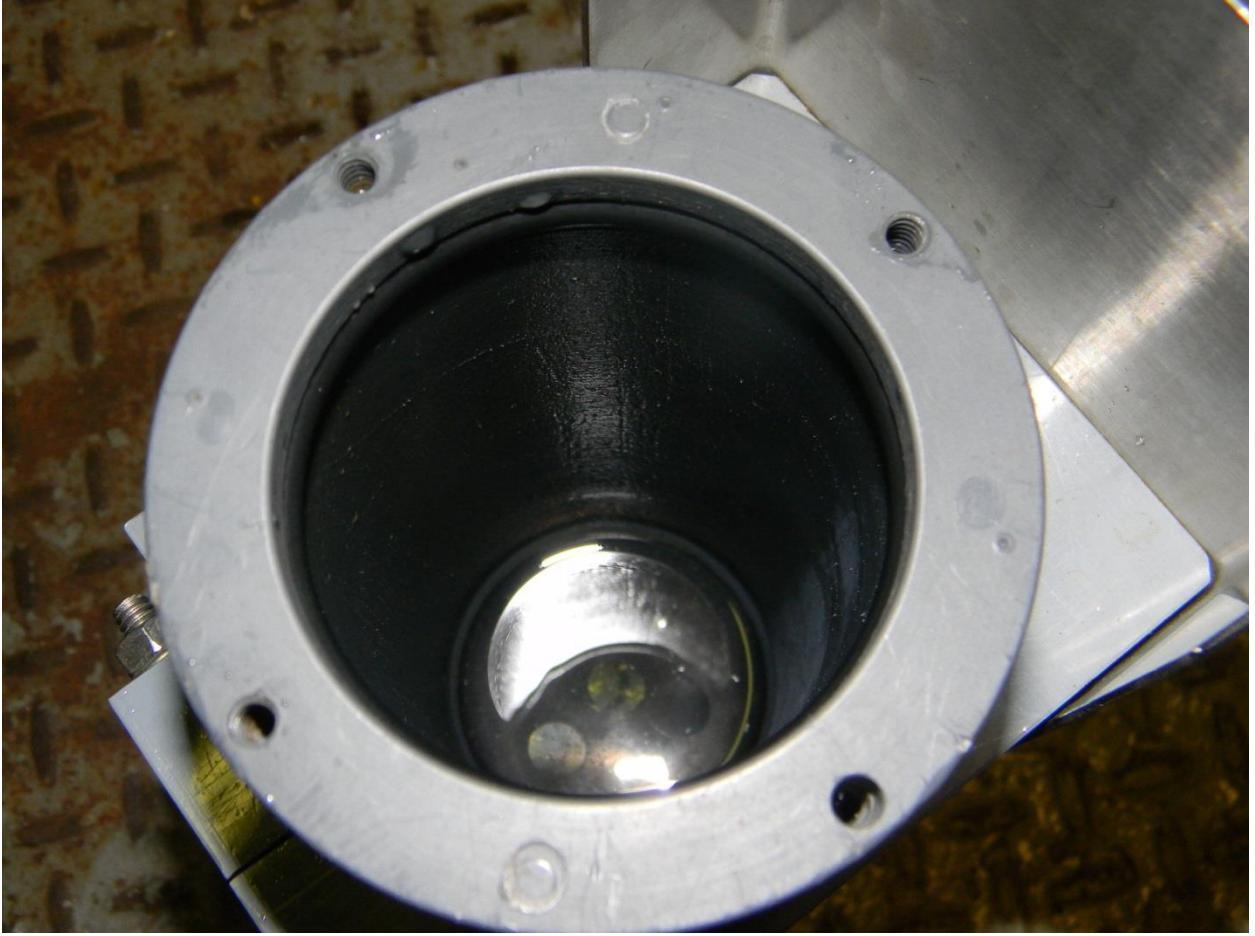
Figure 7: BBFL2 Interior.

- Switched off the system and proceeded with normal instrument cleaning and calibration procedures.
- 4. Minor biofouling was observed within all instrument housings. Some indications of spring bloom were present (biological growth).
