Ocean Networks Canada

Ferry Maintenance Report – Queen of Alberni

Vessel: Queen of Alberni

Date: Nov 19th 2015

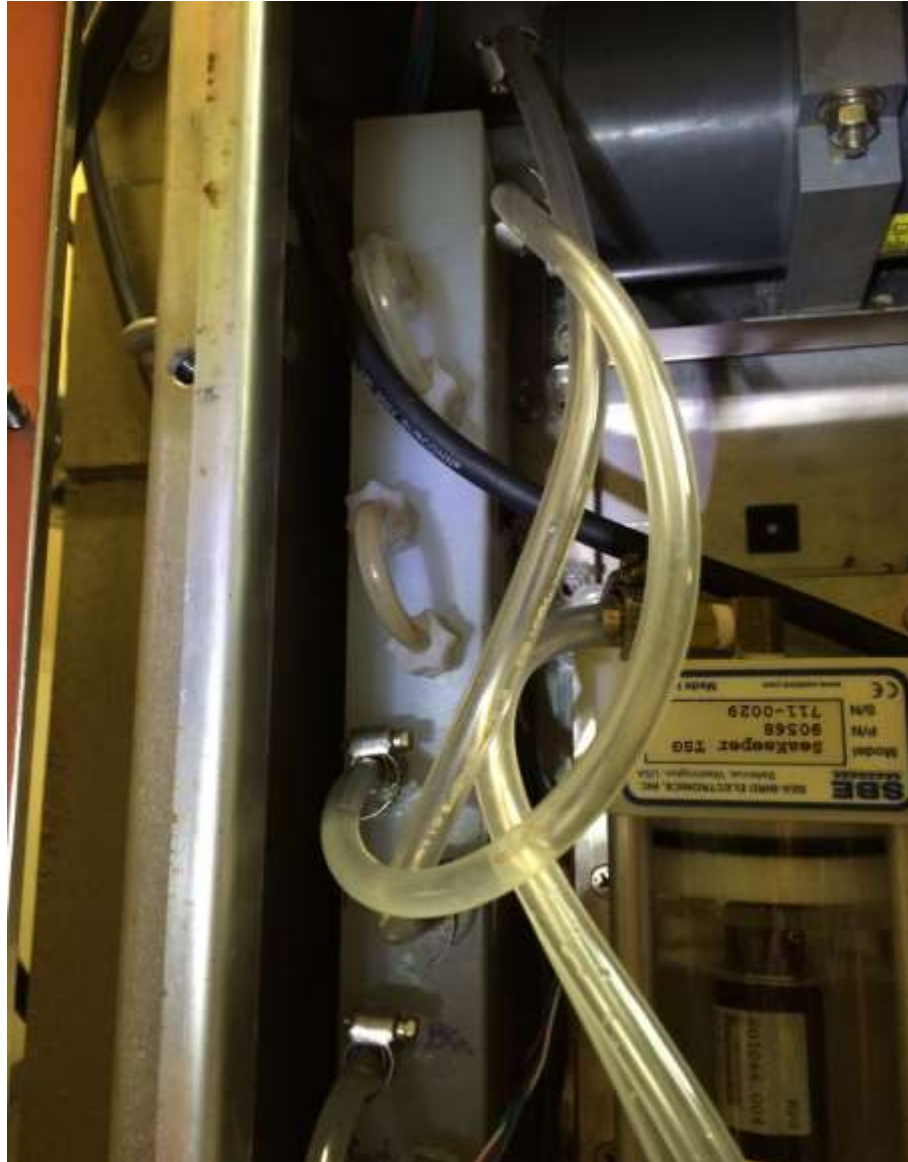
Pictures

9. Found mussel growth inside the tube before the Ball valve. Cleaned out carefully.
10. Re-assemble Sea chest
11. Power ON sea keeper system and monitor, and check for leaks.
