## Ocean Networks Canada Ferry Maintenance Report – Queen of Alberni

#### Date: August 29, 2014

Regular instrument servicing

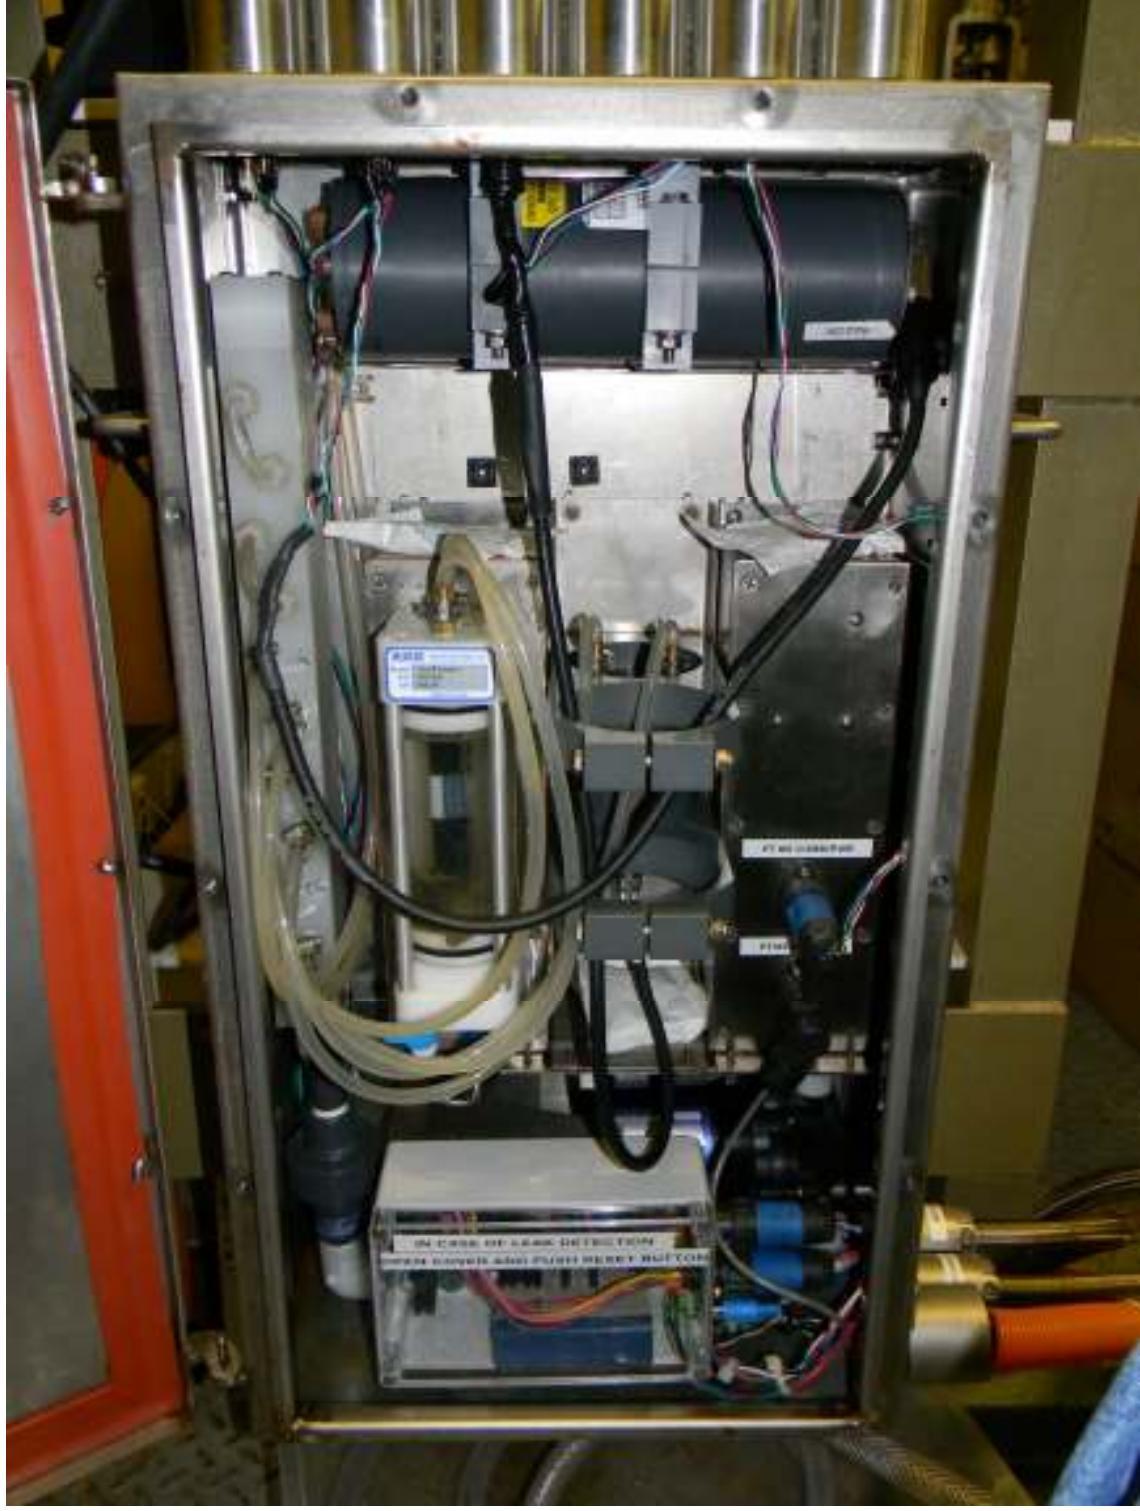
Figure 1: Instrument box upon arrival

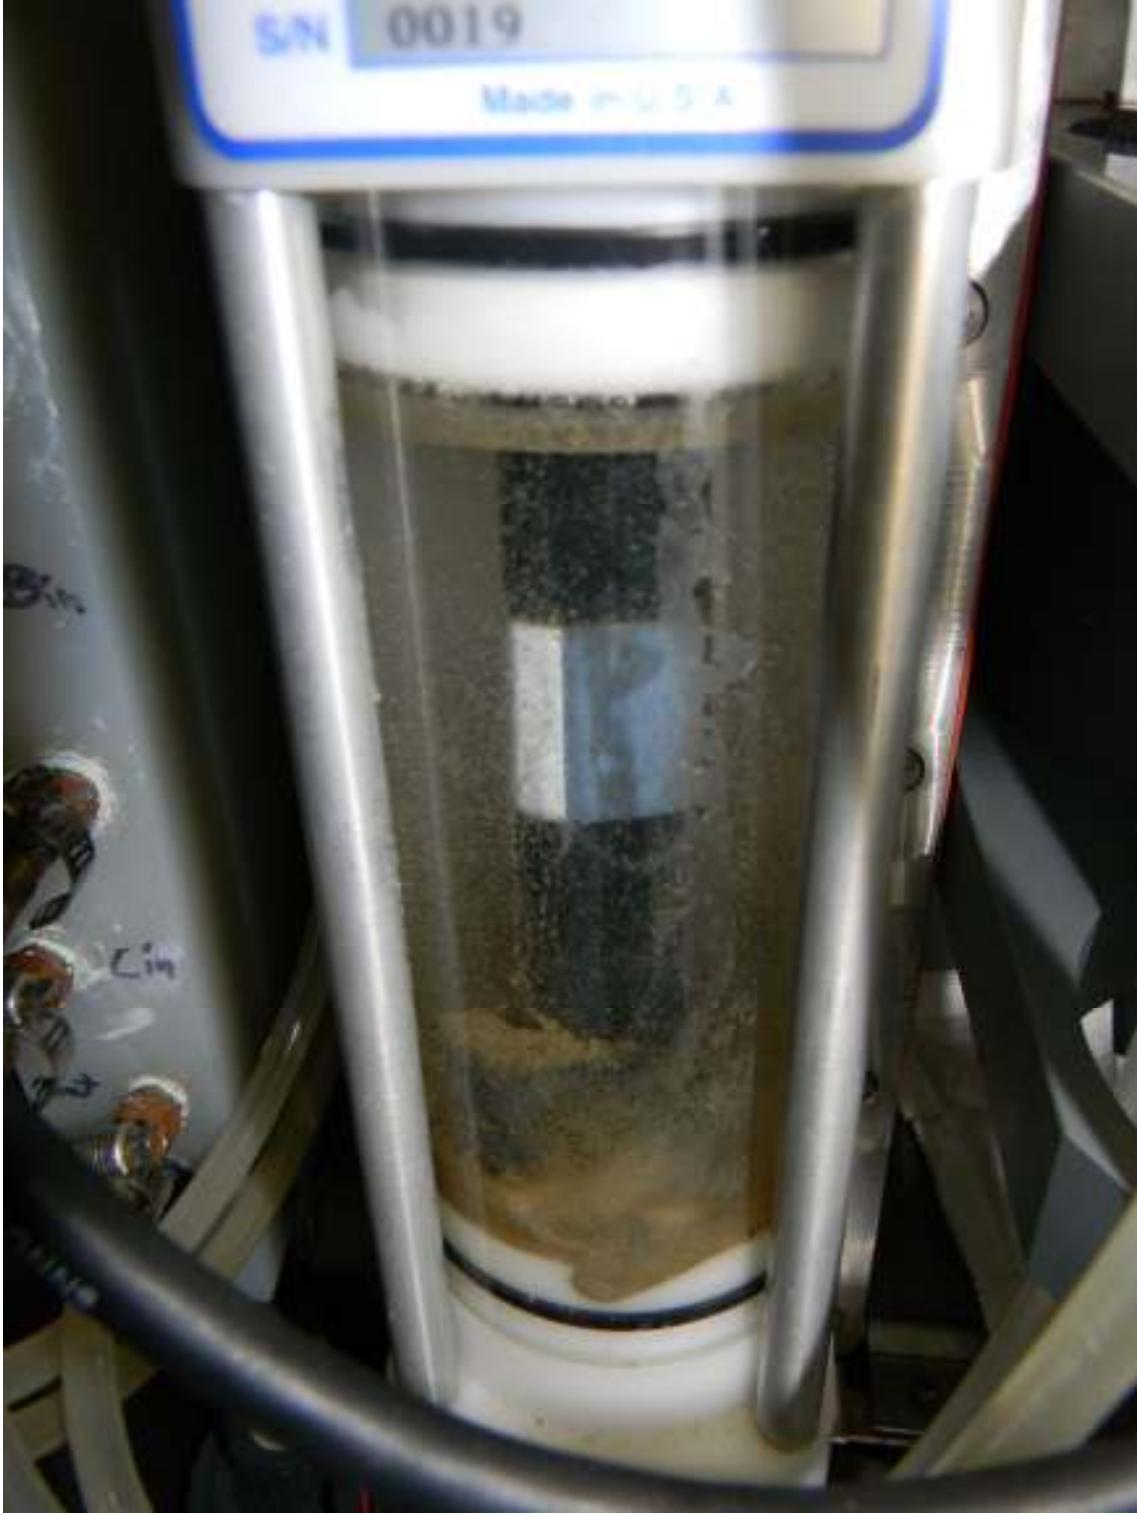
Figure 2: CT sensor fouling

- 1. Opened both boxes and observed function. Both were working well, no leaks anywhere.
- 2. Powered down and disassembled instruments in lower assembly.
- 3. Cleaned and checked over instruments in Engineering room. Cleaned CT sensor connector to remove sediment and biofouling growth. Removed three mussels from interior of housing.
- 4. Ran pre- and post- calibration with standard solutions and with Pink test stick and blue test stick for CDOM fluorescence and Chl fluorescence.

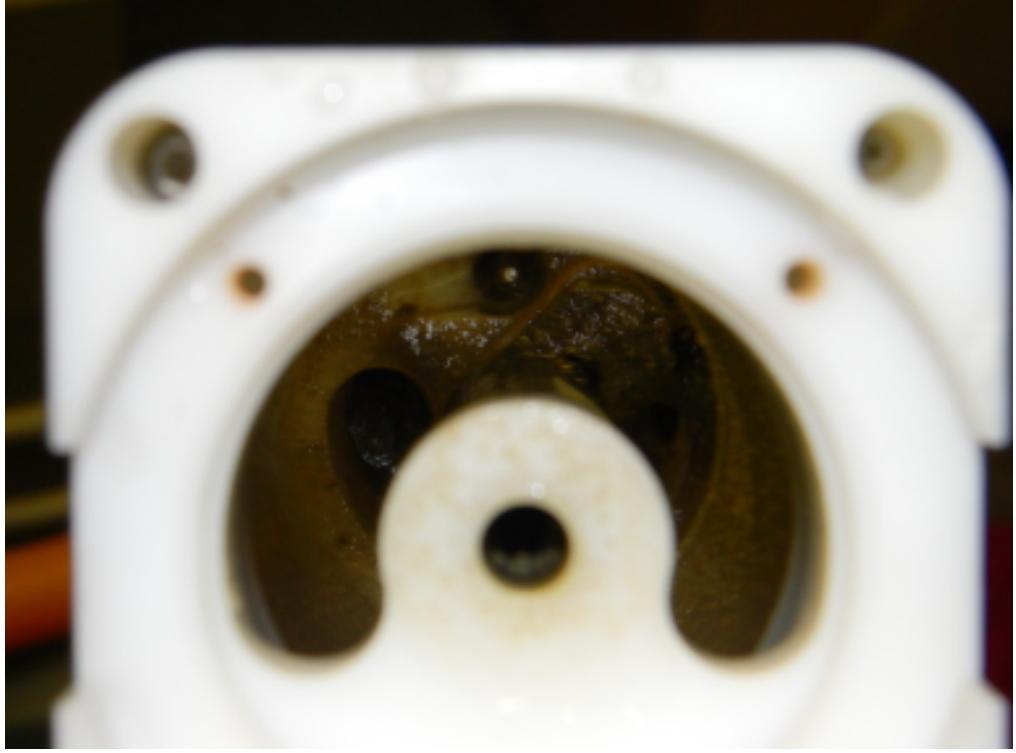
Figure 3: Fouling within the CT sensor (Temp sensor at top)

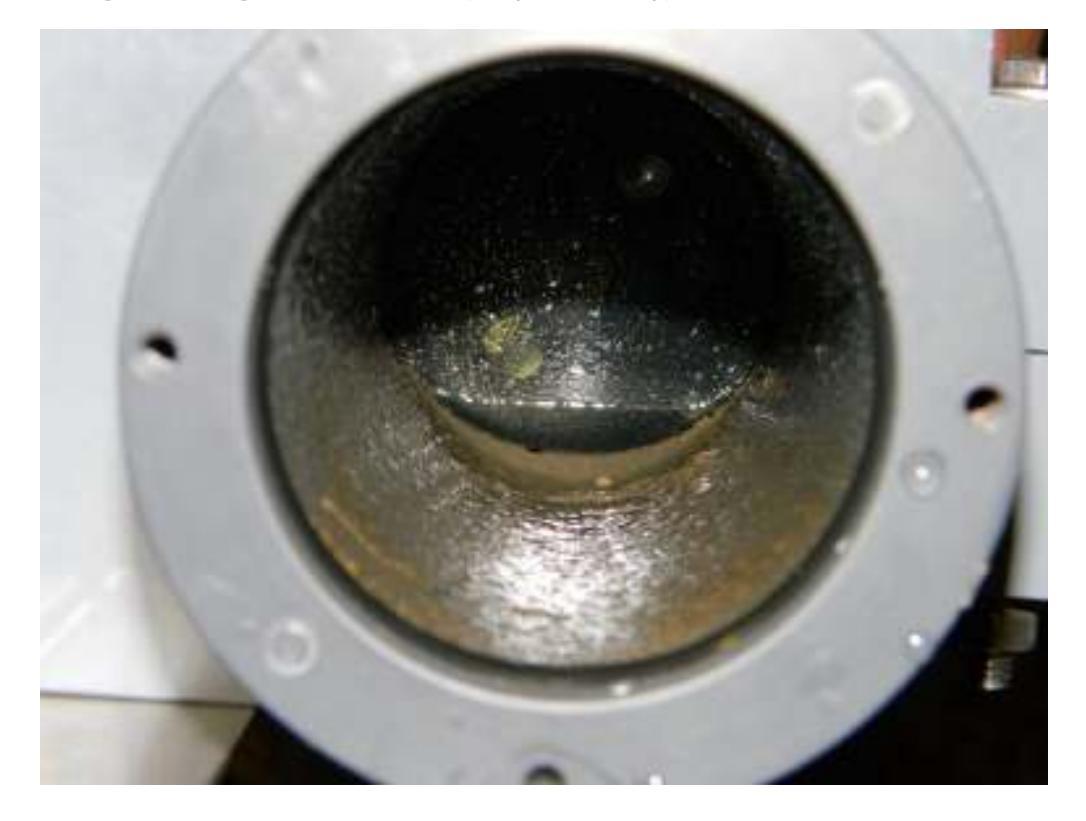
- 1. There were no signs of moisture or leaks In the Instrument Box.
- 2. The AADI optode was very dirty with sediment/biofilm growth within the housing.
- The BBFL2 had a partial layer of sediment in the housing and fouling on the sensing surface.
  Fouling was noticed on the "bottom" surface of the horizontal housing.
- 4. The Seabird 45 CT sensor very dirty, with to mussels approximately 3/8" long found growing within the housing on the sensor outlet port.
- 5. The flex tubing was in good shape, having been replaced on the previous trip.
- 6. The sea chest showed no signs of leaks.
- The inline filter (sea strainer) was checked and was found to be dirty and required cleaning. Mussel growth was found inside the strainer basket.
- 8. The CT connector corrosion appears to have been halted due to maintenance activities with no evidence for signal degradation yet.

Figure 4: BBFL2 Fouling

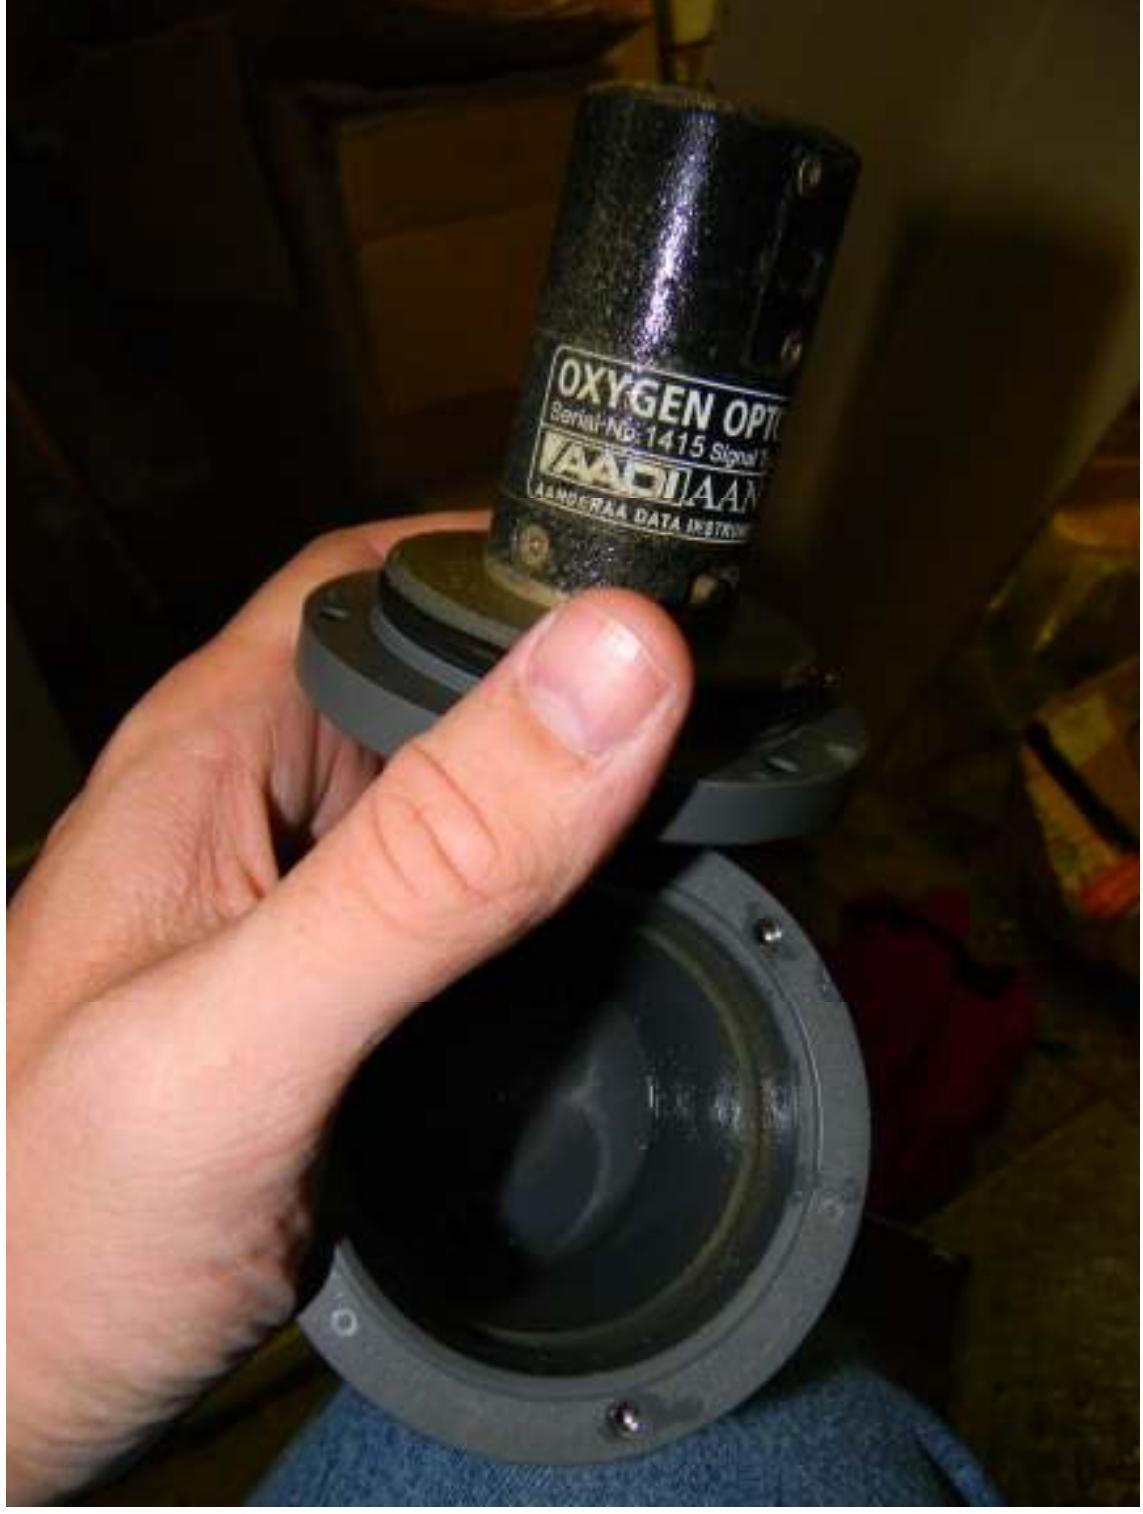
Figure 5: Optode fouling

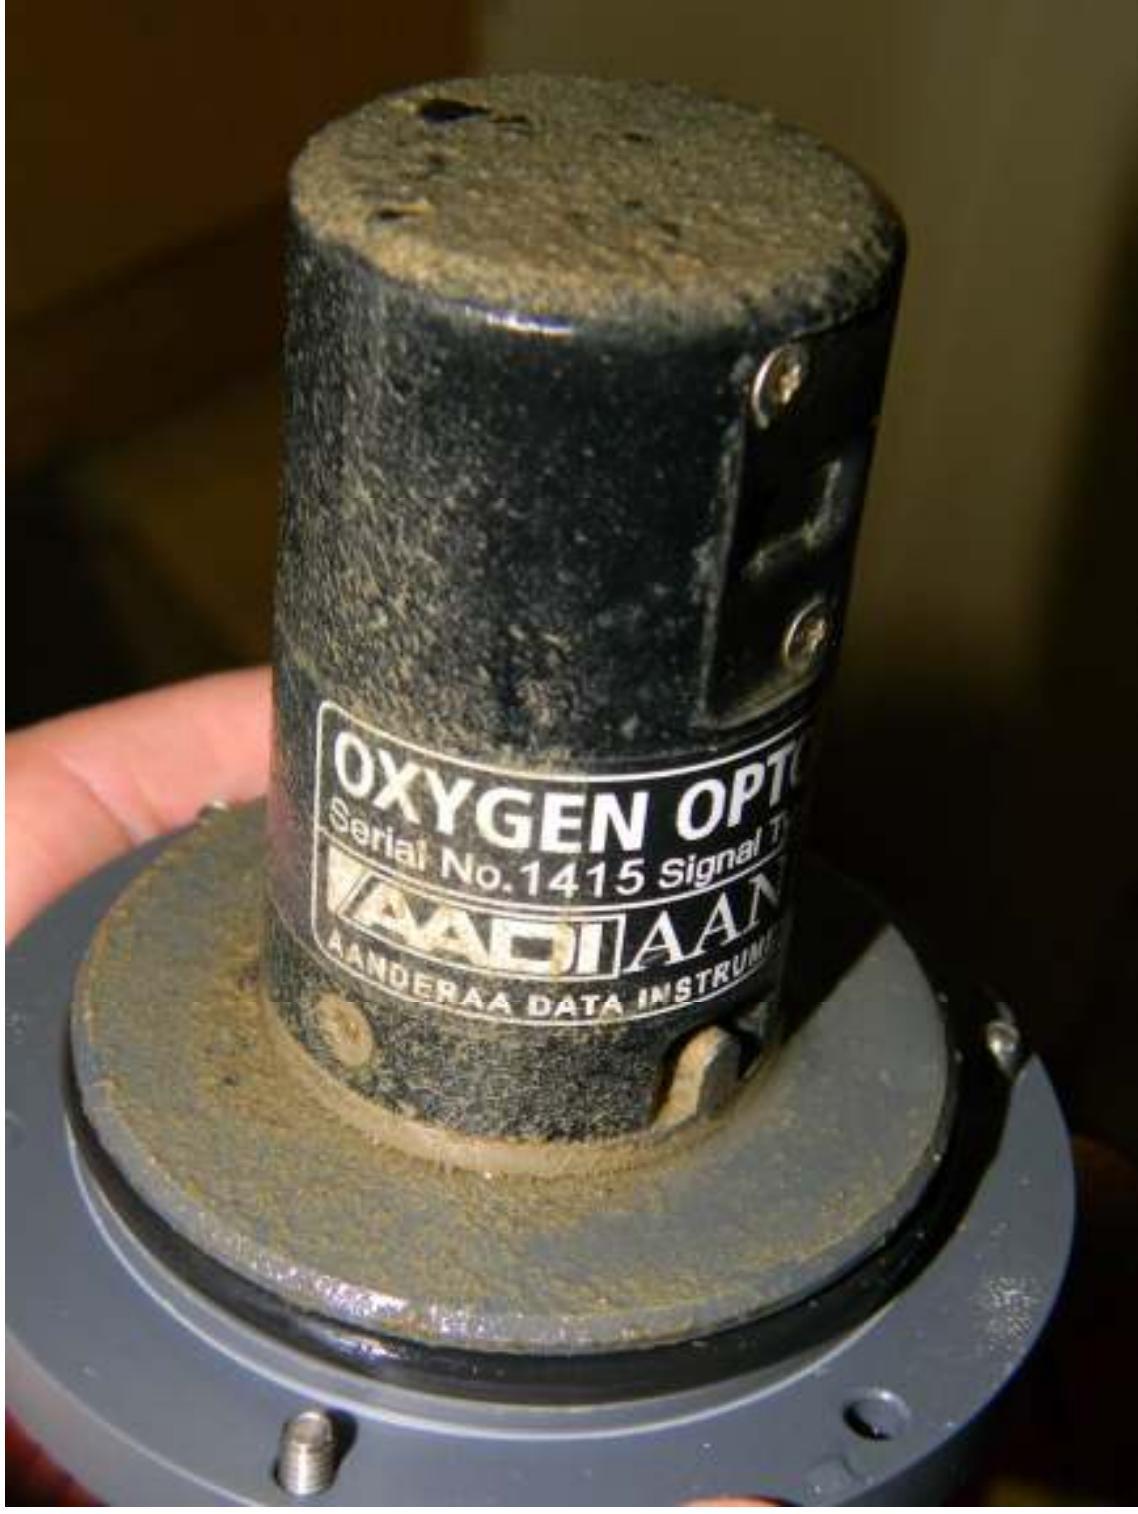
Figure 6: Optode fouling

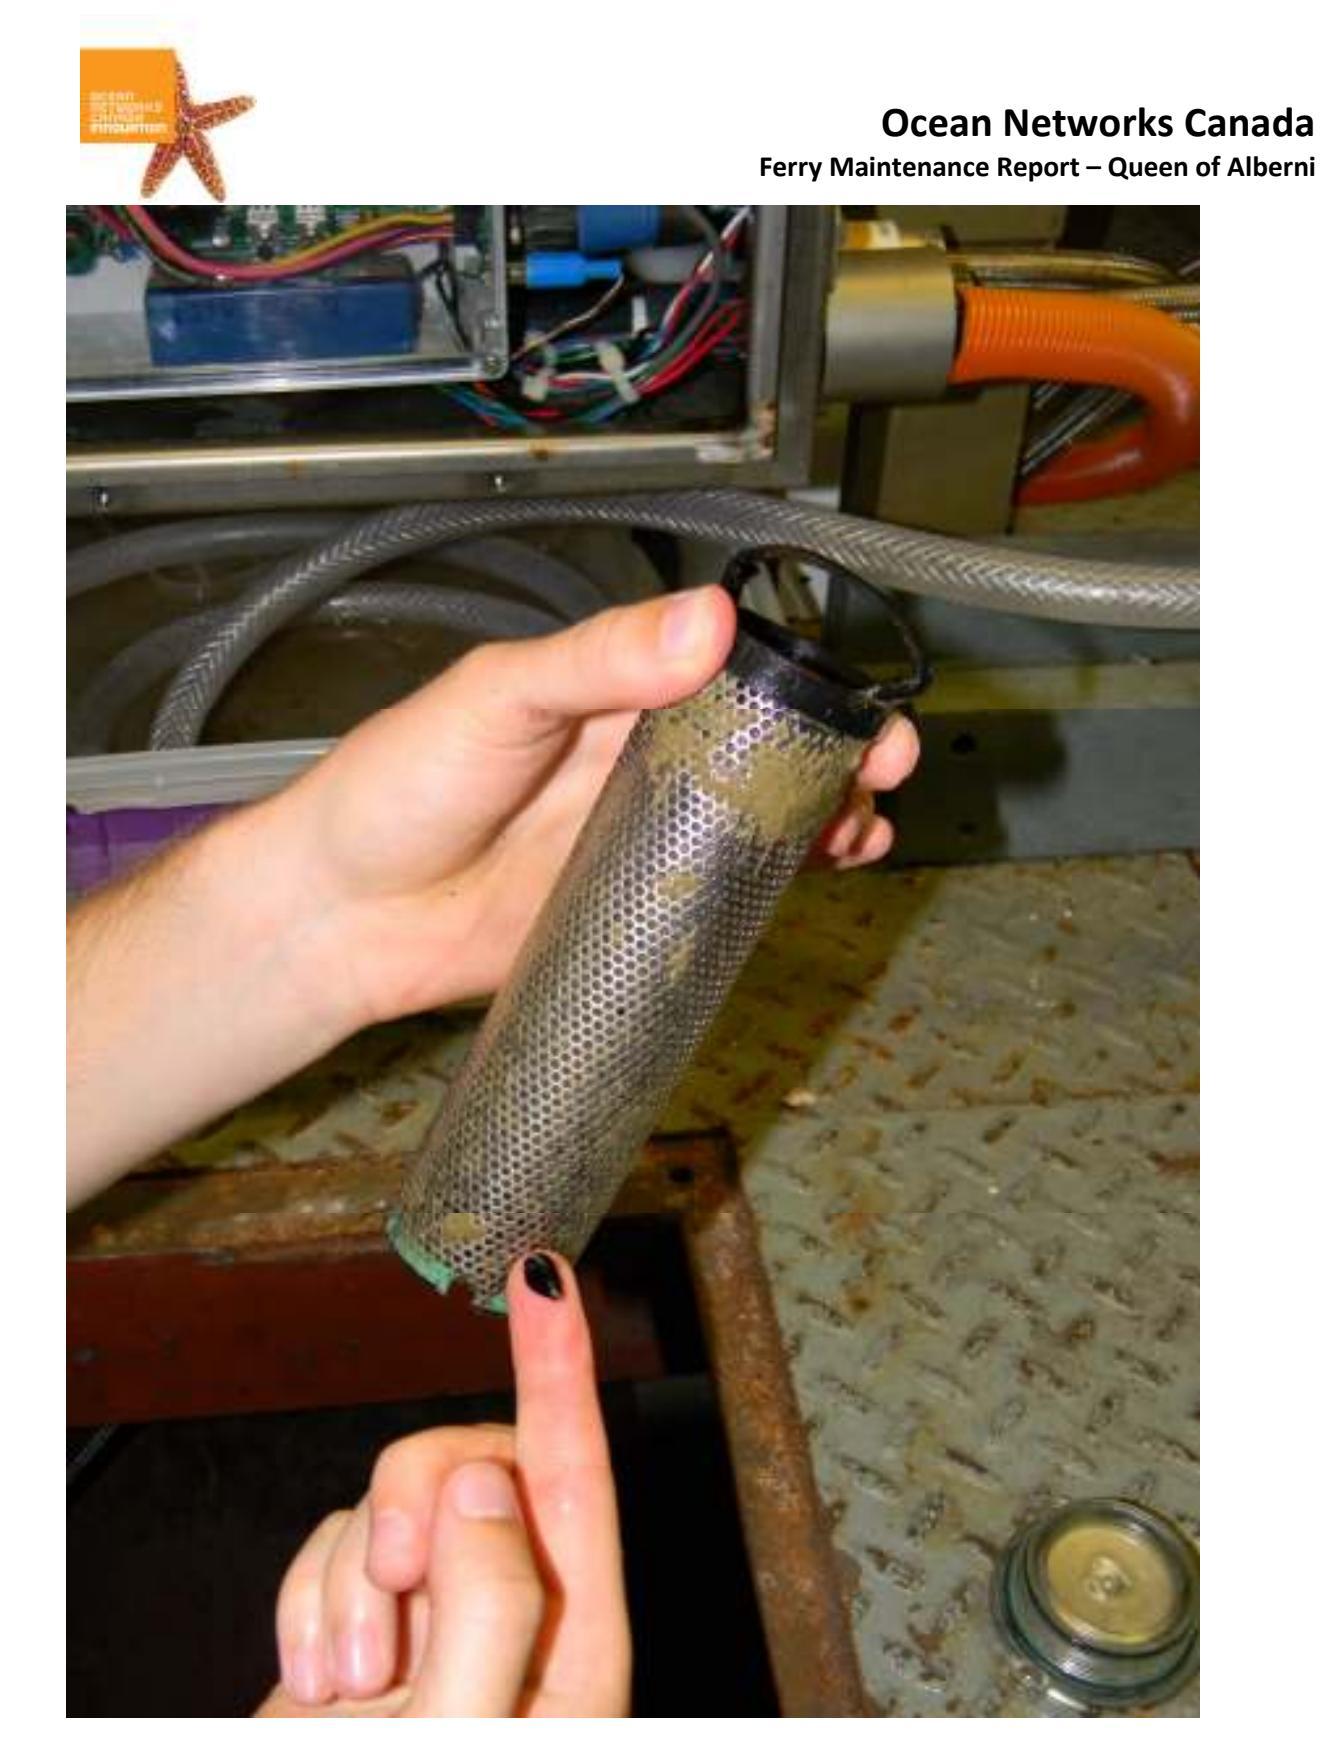
Figure 7: Fouling of Sea Strainer with example mussel from strainer

- 5. Re-assembled the instruments in the lower box.
- 6. Checked over Sea chest and valves, no leaks apparent.
- 7. Checked and cleaned the sea strainer. Removed mussels, biofilm and sediment fouling from the strainer.
- 8. Turned ON the system.
- 9. No leaks in instrument housing and checked flow output at sea strainer. Flow was good. Visually confirmed flow direction at the BBFL2 and confirmed the volume filled with water and began draining correctly.
- 10. Signed out at Engineering room.

- 1. Potentially replace CT connector (shipboard connector will need to be re-soldered).
- 2. Monitor growth of Mussels within the system.
- 3. November refit, replace all metallic connectors on upper boxes with plastic glands.

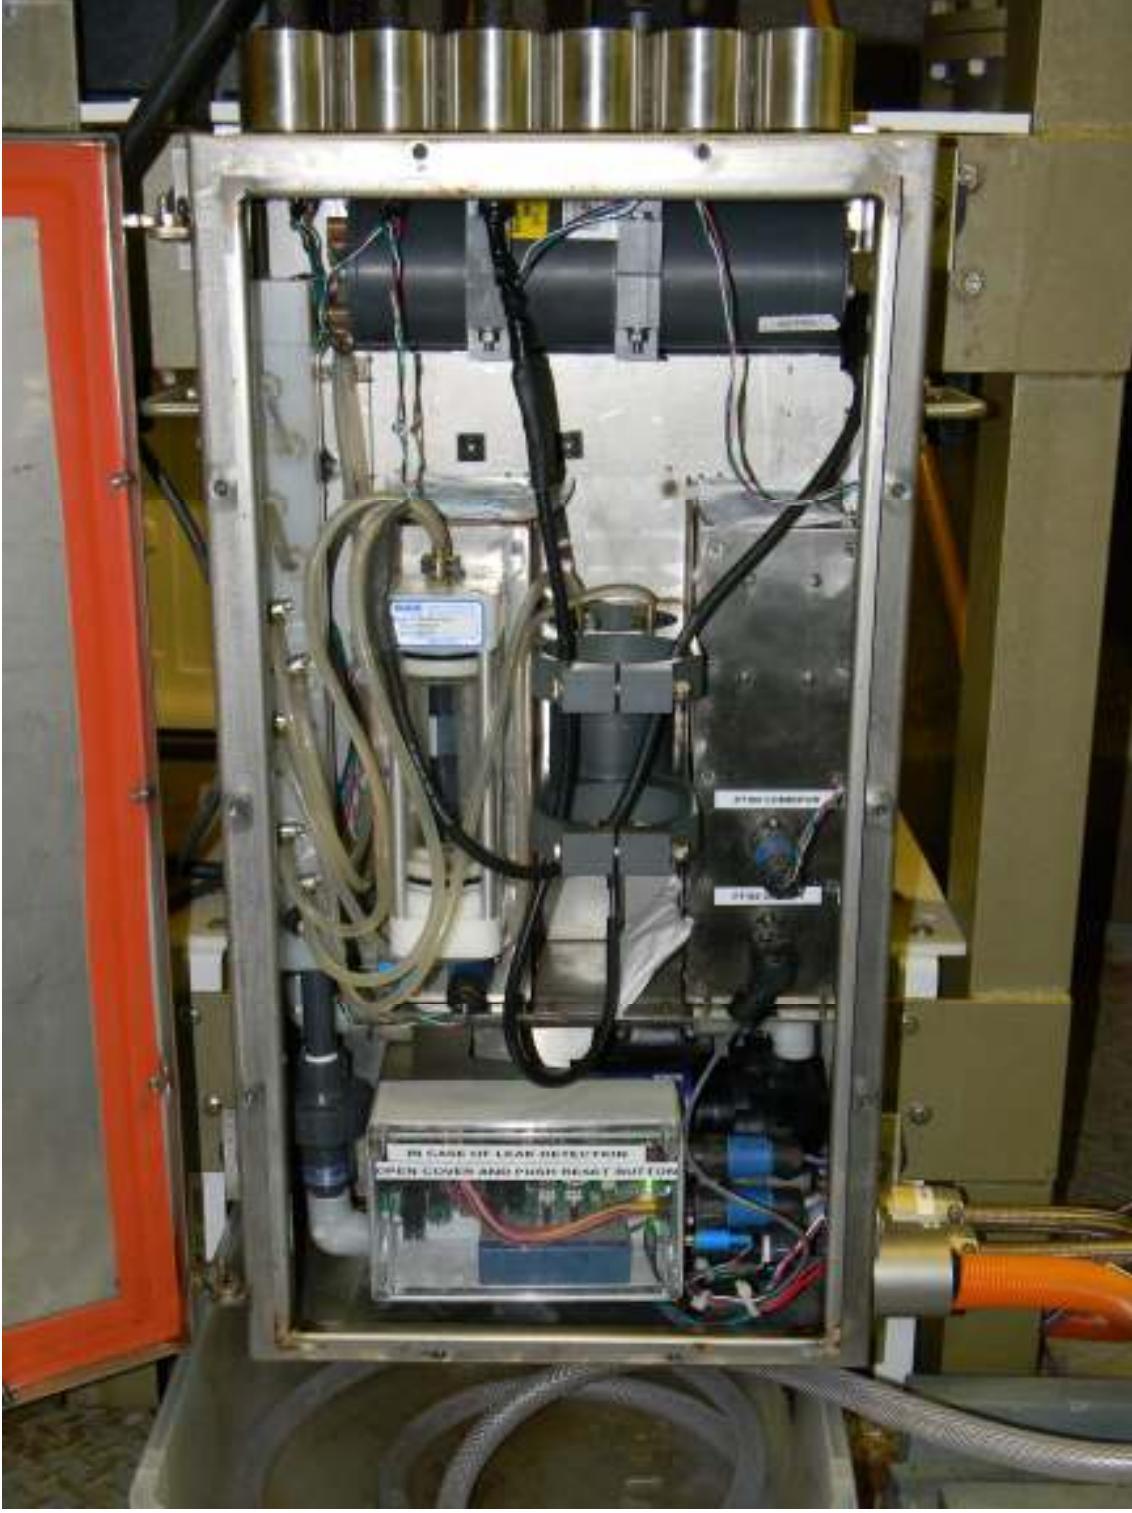
Figure 8: Instrument box operating as closed up

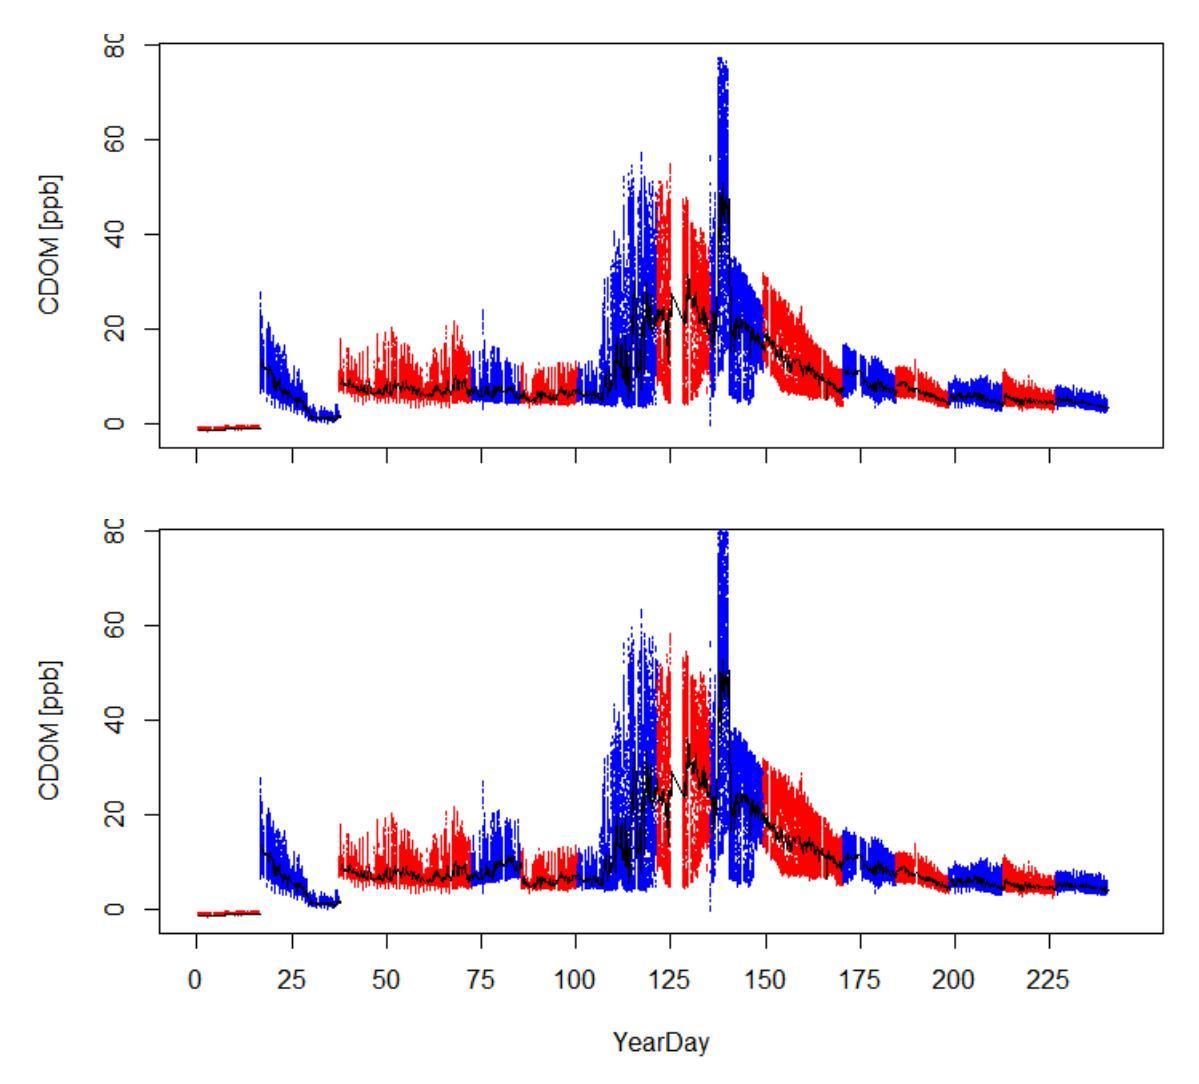
Figure 1. Time series of a) un-corrected; and b) corrected CDOM fluorescence measured en route between Duke Point (Vancouver Island) and Tsawwassen (Mainland, BC) by the BBFL2 unit of the SeaKeeper 1000 instrument suite on board the BC ferry, the Queen of Alberni. Red and blue symbols are used to distinguish between instrument cleaning dates. The difference between pre- and post-cleaning fluorescence of diluted tonic water was used to calculate a correction factor (%) which was applied as a linear correction retrospectively between cleaning dates. The most recent cleaning event took place on August 29, 2014. Pre- and post-values for Sprite Zero were used for corrections to CDOM between August 16 and August 29, 2014. Note: an instrument inter-calibration applied to all data following day 149 when BBFL2-786 was swapped out for BBFL2-787.

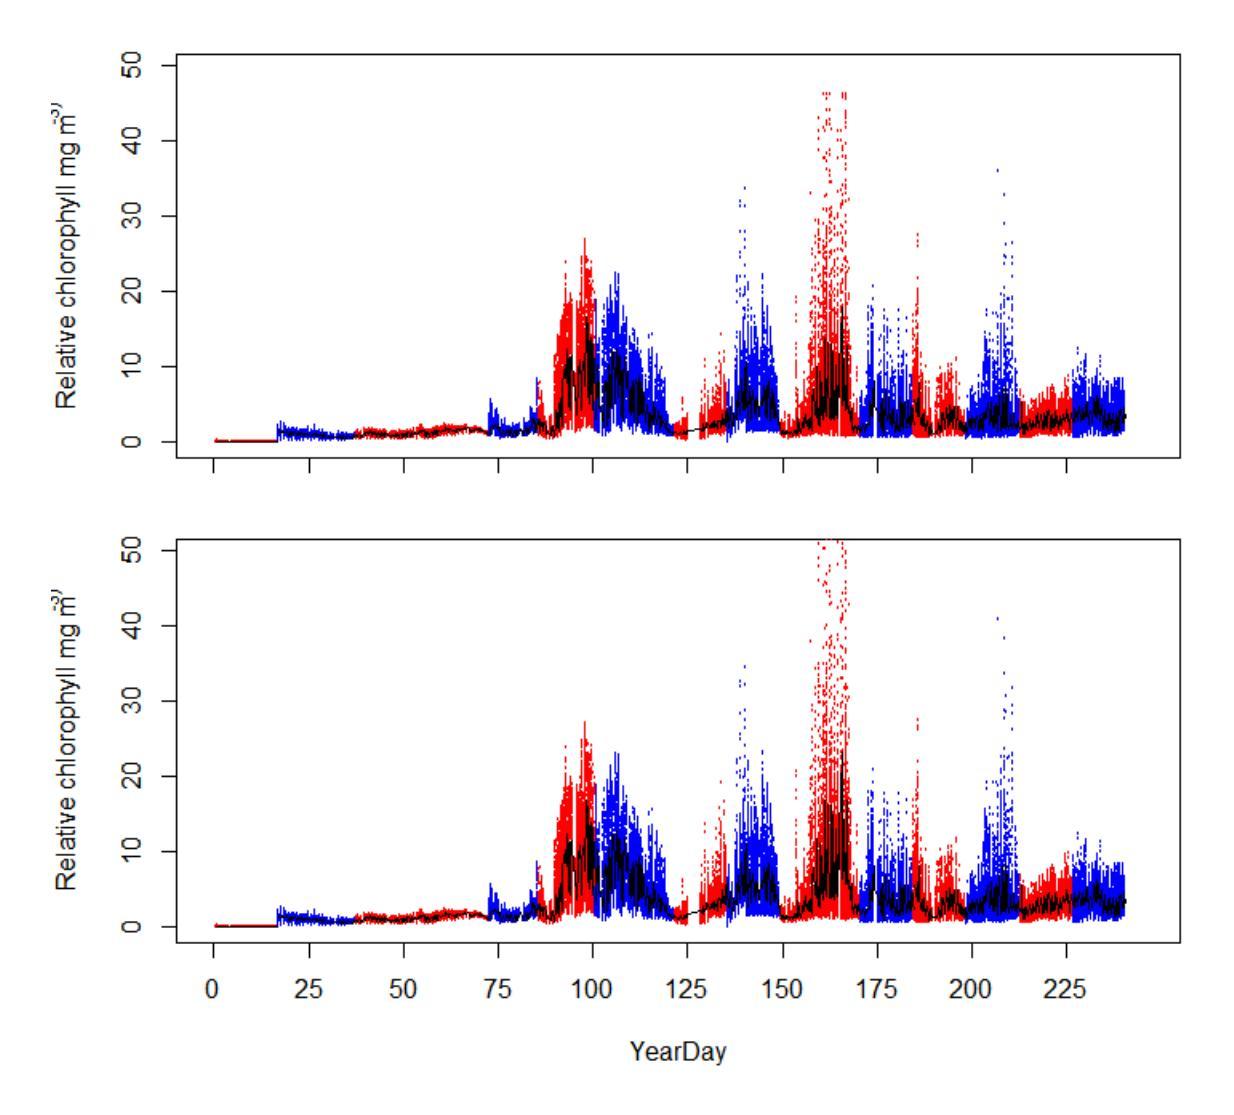
Figure 2. Time series of a) un-corrected; and b) corrected Chl fluorescence measured en route between Duke Point (Vancouver Island) and Tsawwassen (Mainland, BC) by the BBFL2 unit of the SeaKeeper 1000 instrument suite on board the BC ferry, the Queen of Alberni. Red and blue symbols are used to distinguish between instrument cleaning dates. The difference between pre- and post-cleaning fluorescence of diet coke was used to calculate a correction factor (%) which was applied as a linear correction retrospectively between cleaning dates. The most recent cleaning event took place on August 29, 2014. On this date, we measured a negative esponse in Chl fluorescence of diet coke to cleaning (see Table 1). No correction was applied to the most recent period (August 16-August 29, 2014). Note: an instrument inter-calibration applied to all data following day 149 when BBFL2-786 was swapped out for BBFL2-787.
