Ferry Maintenance Report - Queen of Oak Bay

Vessel: Queen of Oak Bay

Instrument cleaning and benchmarking

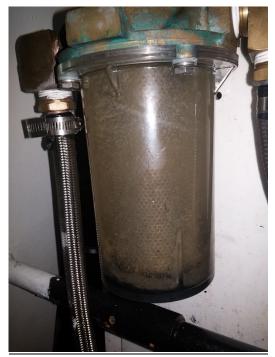
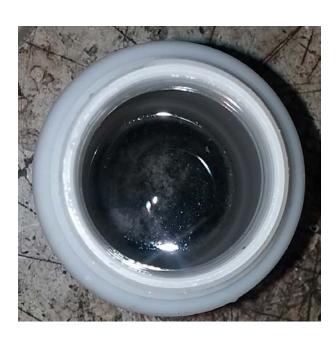
Above: this is the crap in the seastrainer. Probably organic but there may be other stuff.

- 1. Shut off output gate valve, otherwise system pressure causes constant water flow from open tubes.
- 2. Cleaned and performed benchmarks on optode s/n 418 and BBFL2 s/n 1053.
- 3. Cleaned out TSG s/n 17, had sediment and some growth in it.
- 4. Replaced instrument ¼" brass barb fitting on BBFL2 and matching manifold fitting with regular 3/16" barb fitting.
- 5. Cleaned and flushed seastrainer.
- 6. Opened output gate valve, started system, verified no leaks.
